COLUMBIA

ACCIDENT INVESTIGATION BOARD

REPORT VOLUME I
AUGUST 2003

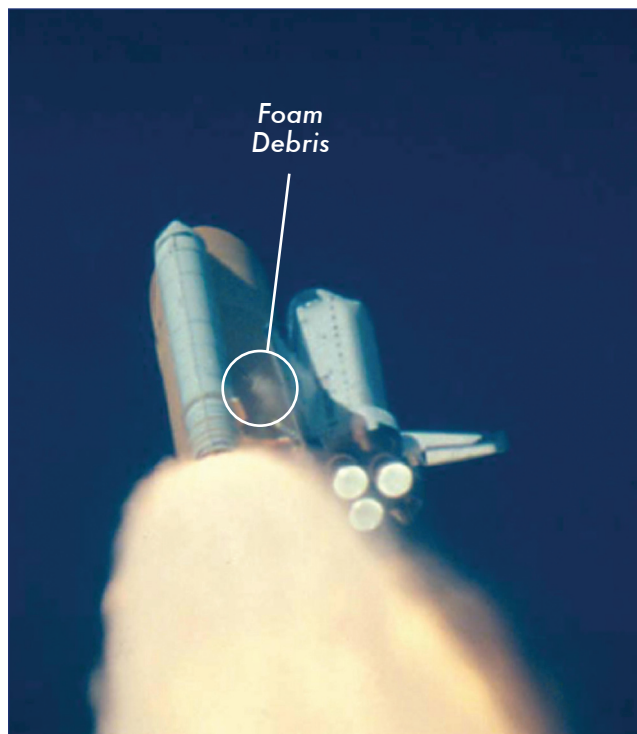
Figure 2.3-2. A shower of foam debris after the impact on *Columbia's* left wing. The event was not observed in real time.

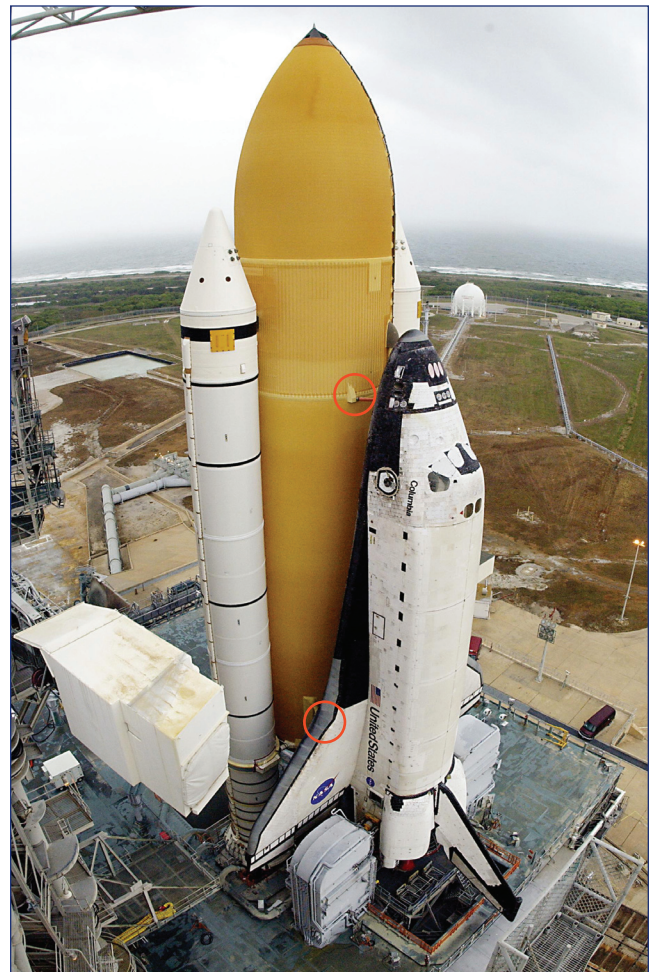
Figure 3.1-1. Columbia sitting at Launch Complex 39-A. The upper circle shows the left bipod (-Y) ramp on the forward attach point, while the lower circle is around RCC panel 8-left.

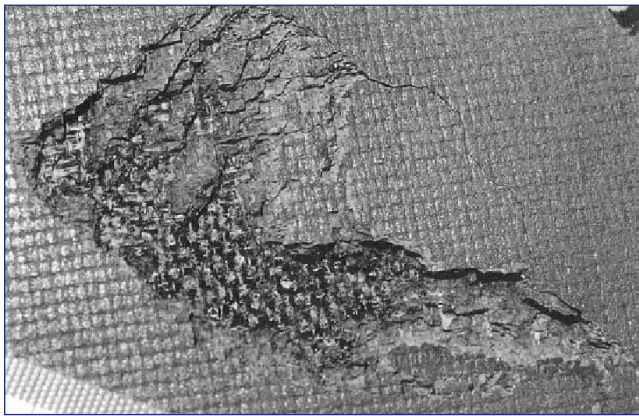
Figure 3.3-2. Damage on the outer surface of RCC panel 10-right from *Atlantis* after STS-45.

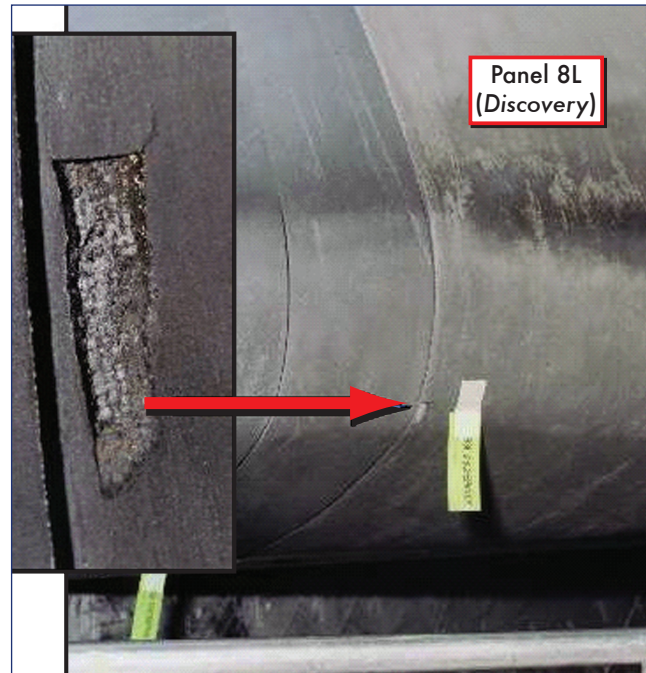
Figure 3.3-5. RCC panel 8-left from *Discovery* had to be scrapped after STS-103 because of the damage shown here.

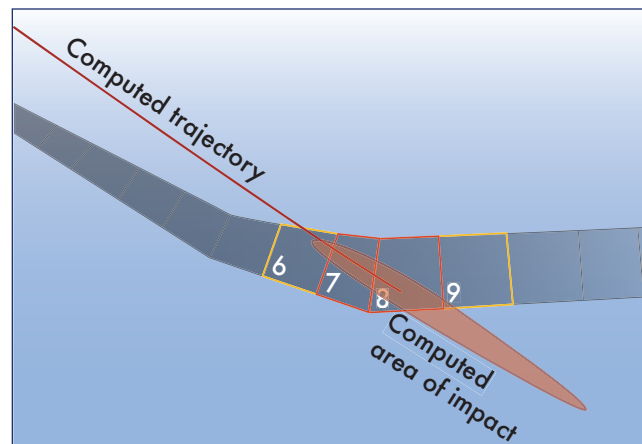
Figure 3.4-3: The best estimate of the site of impact by the center of the foam.

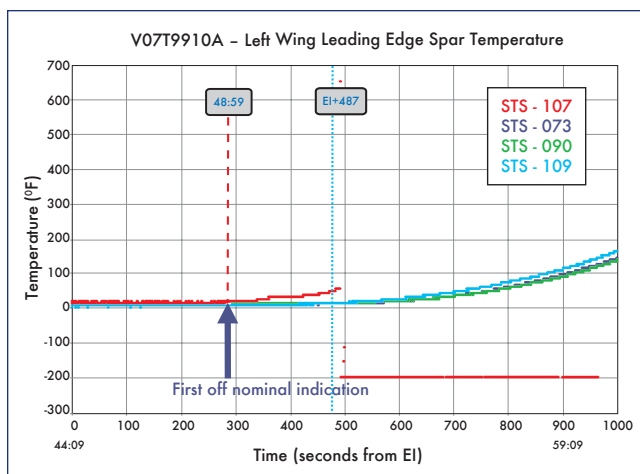
Figure 3.6-4. This temperature thermocouple (Sensor 2) was mounted on the outside of the wing leading edge spar behind the insulation that protects the spar from radiated heat from the RCC panels. It clearly showed an off-nominal trend early in the re-entry sequence and began to show an increase in temperature much earlier than the temperature sensor behind the spar.

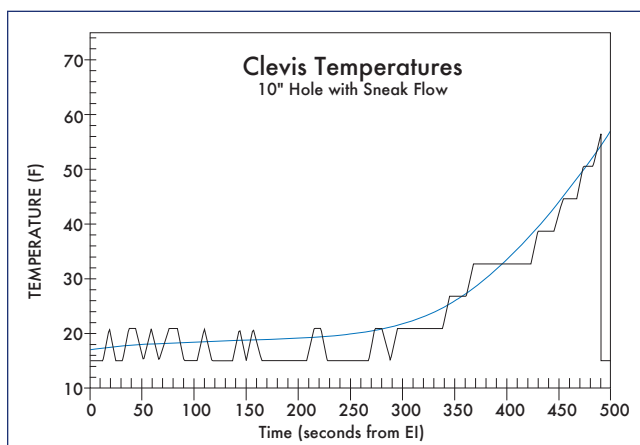
Figure 3.6-5. The analysis of the effect of a 10-inch hole in RCC panel 8 on Sensor 2 from EI to EI+500 seconds. The jagged line shows the actual flight data readings and the smooth line the calculated result for a 10-inch hole with some sneak flow of superheated air behind the spar insulation.

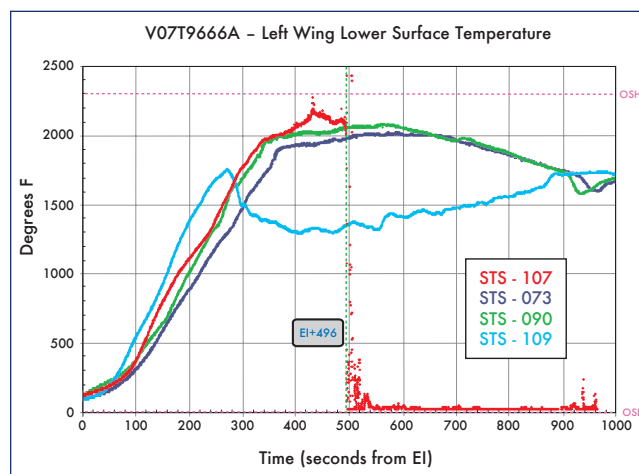
Figure 3.6-6. As early as EI+370, Sensor 3 began reading significantly higher than on previous flights. Since this sensor was located in a thermal tile on the lower surface of the left wing, its temperatures are much higher than those for the other sensors.

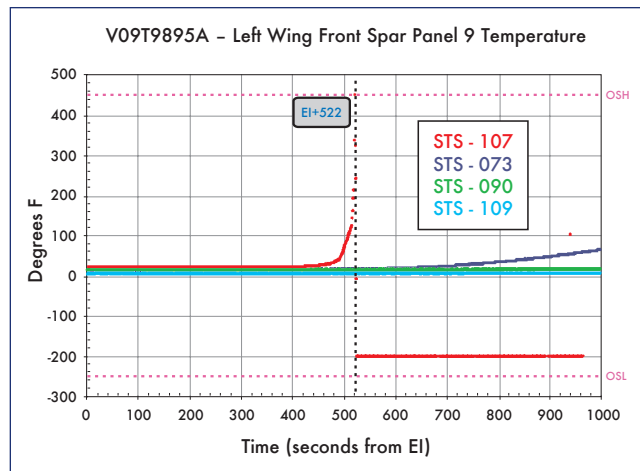
Figure 3.6-7. Sensor 4 also began reading significantly higher than previous flights before it fell off-scale low. The relatively late reaction of this sensor compared to Sensor 2, clearly indicated that superheated air started on the outside of the wing leading edge spar and then moved into the mid-wing after the spar was burned through. Note that immediately before the sensor (or the wire) fails, the temperature is at 450 degrees Fahrenheit and climbing rapidly. It was the only temperature sensor that showed this pattern.

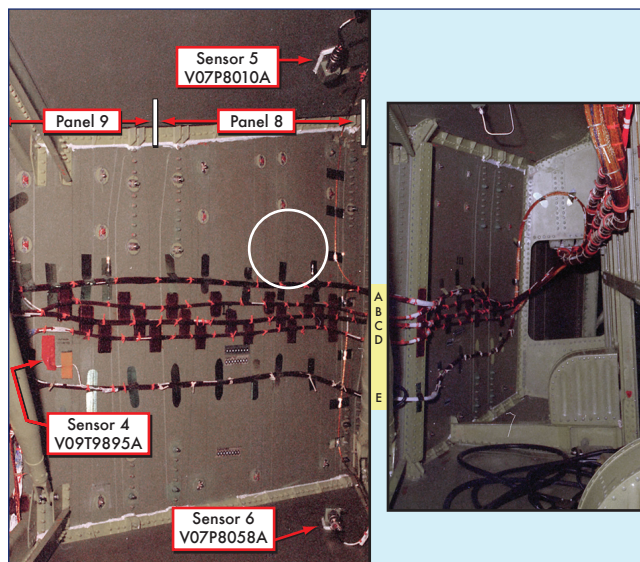
Figure 3.6-8. The left photo above shows the wiring runs on the backside of the wing leading edge behind RCC panel 8 – the circle marks the most likely area where the burn through of the wing leading edge spar initially occurred at EI+487 seconds. The right photo shows the wire bundles as they continue forward behind RCC panels 7 and 6. The major cable bundles in the upper right of the right photo carried the majority of the sensor data inside the wing. As these bundles were burned, controllers on the ground began seeing off-nominal sensor indications.

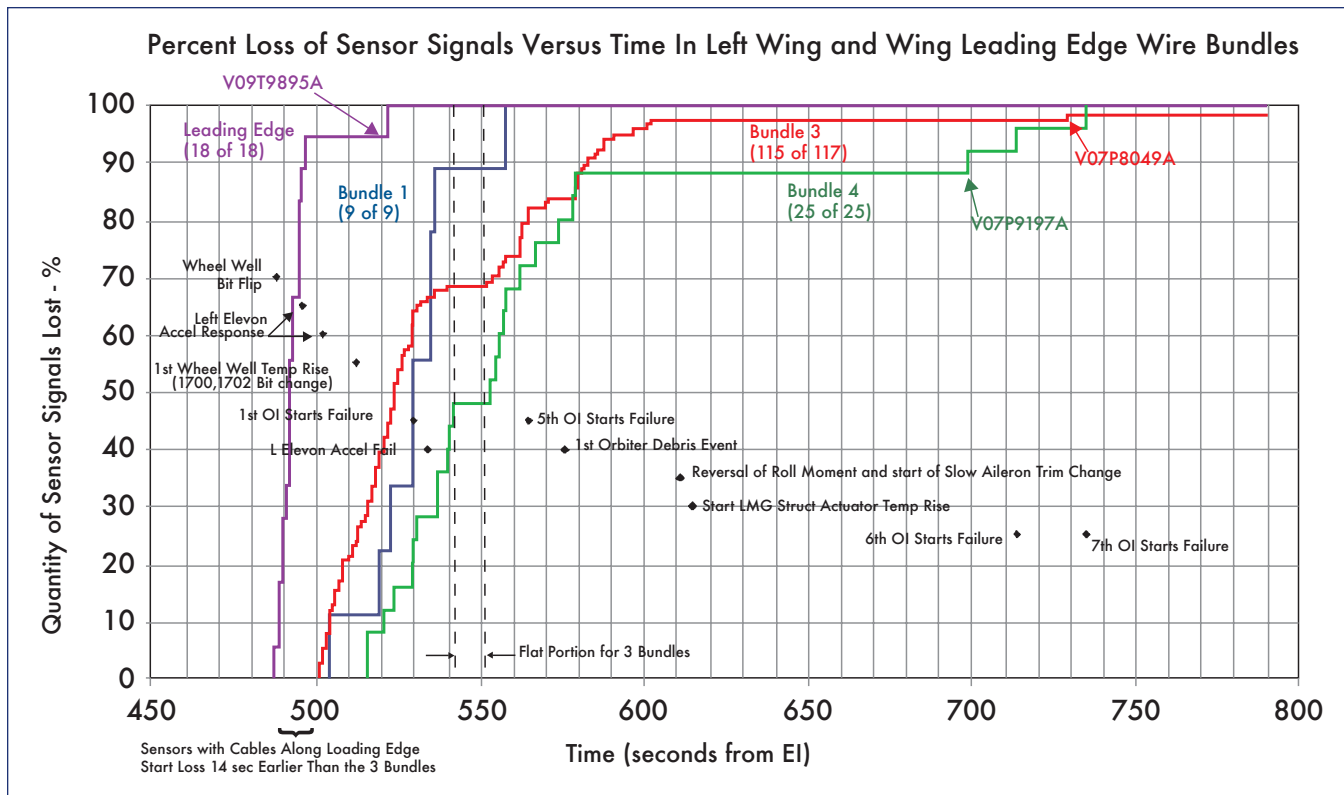
Figure 3.6-10. This chart shows how rapidly the wire bundles in the left wing were destroyed. Over 70 percent of the sensor wires in the wiring bundles burned through in under a minute. The black diamonds show the times of significant timeline sensor events.

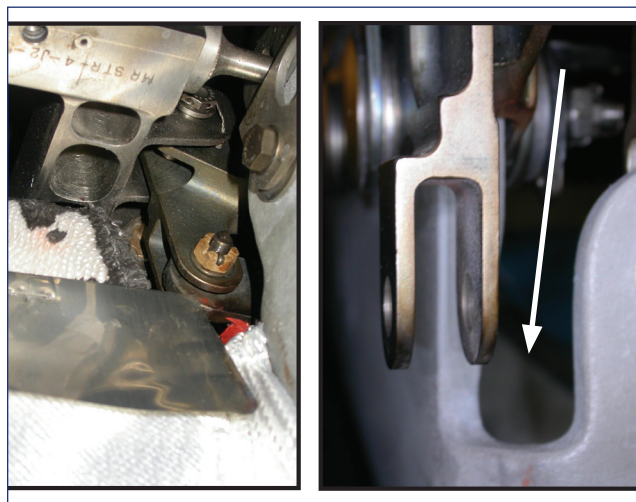
Figure 3.7-2. Each RCC panel has a U-shaped slot (see arrow) in the back of the panel. Once superheated air entered the breach in RCC panel 8, some of that superheated air went through this slot and caused substantial damage to the Thermal Protection System tiles behind this area.

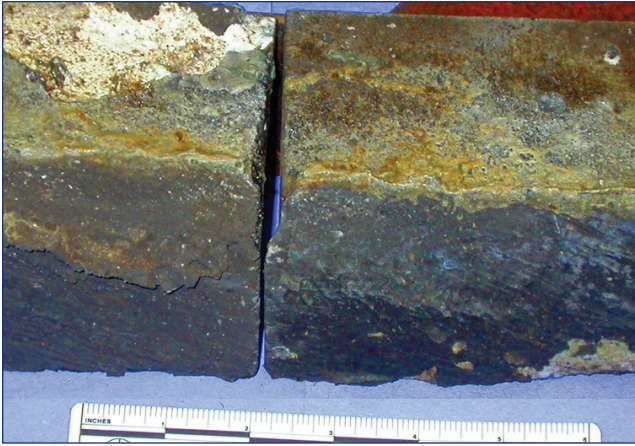
Figure 3.7-3. Superheated airflow caused erosion in tiles around the RCC panel 8 and 9 interface. The tiles shown are from behind the area where the superheated air exited from the slot in Figure 3.7-2. These tiles showed much greater thermal damage than other tiles in this area and chemical analysis showed the presence of metals only found in wing leading edge components.

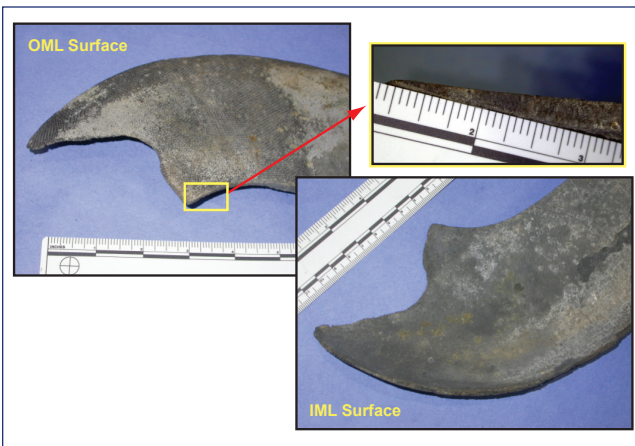
Figure 3.7-4. The outboard rib of panel 8 and the inboard rib of panel 9 showed signs of extreme heating and erosion. RCC erosion of this magnitude was not observed in any other location on the Orbiter.

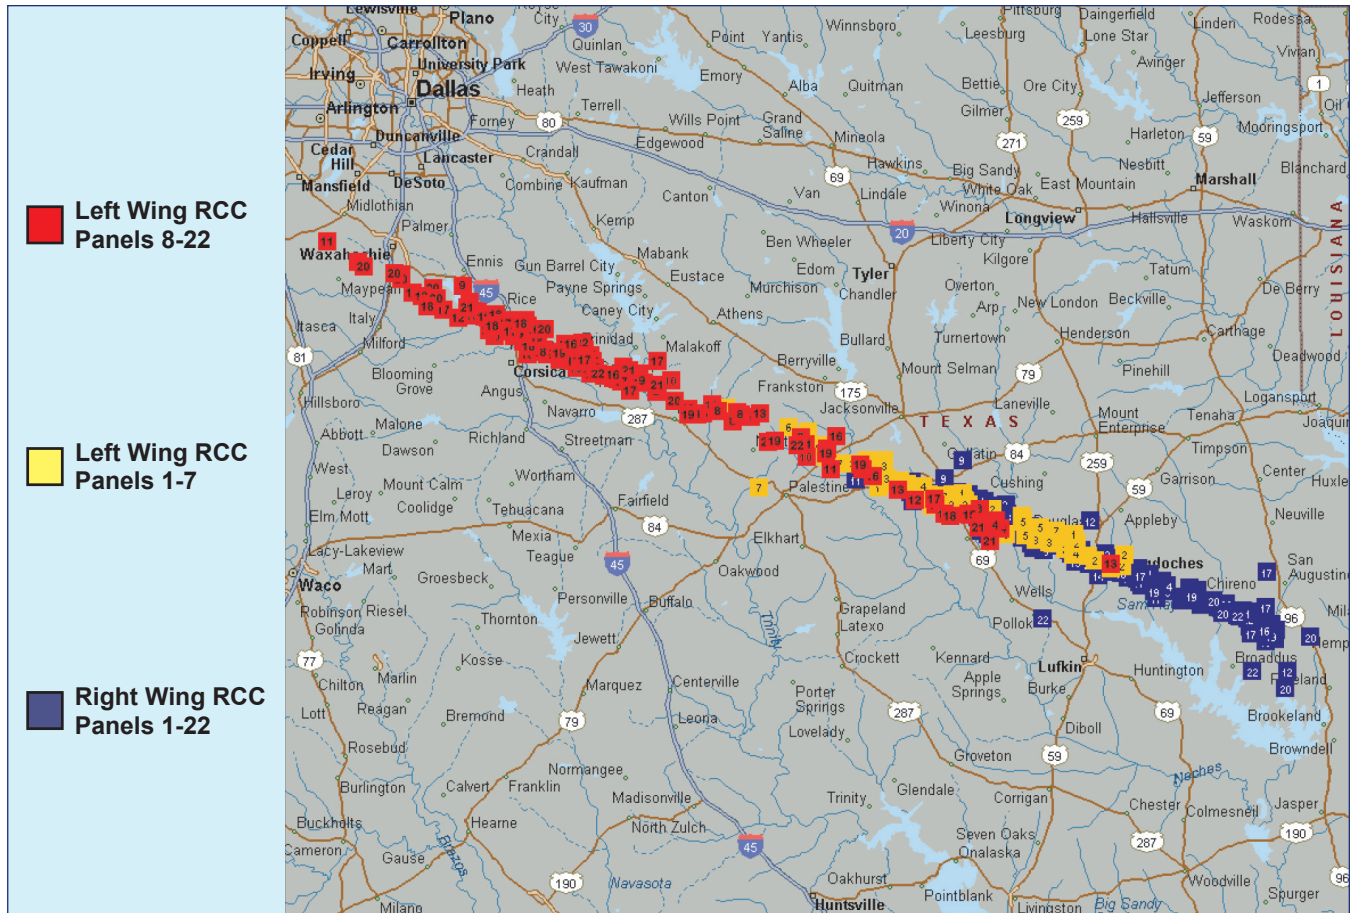
Figure 3.7-5. The location of RCC panel debris from the left and right wings, shown where it was recovered from in East Texas. The debris pattern suggested that the left wing failed before the right wing, most likely near left RCC panels 8 and 9.

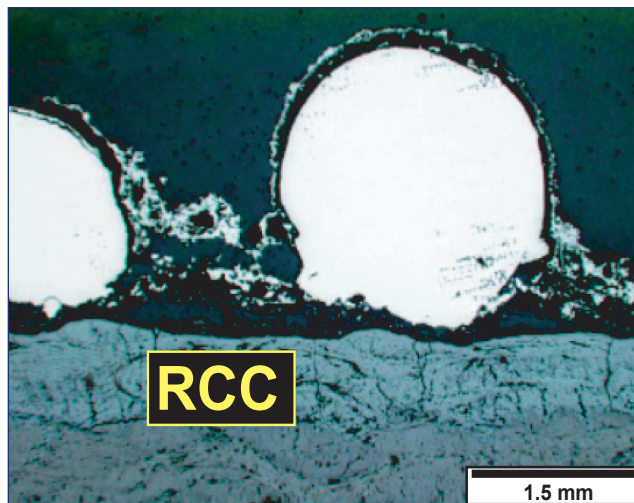
Figure 3.7-8. Spheroids of Inconel 718 and Cerachrome were deposited directly on the surface of RCC panel 8-left. This slag deposit pattern was not seen on any other RCC panels.

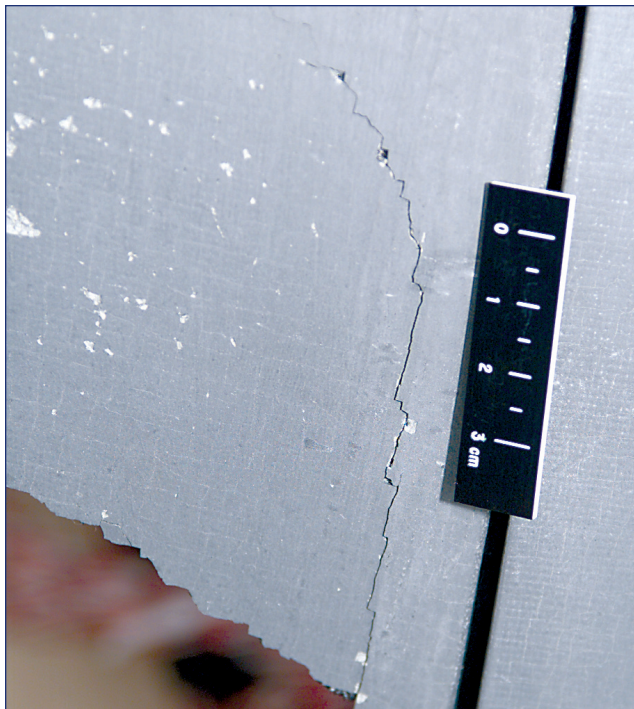
Figure 3.8-10. Numerous cracks were also noted in RCC Panel 8.

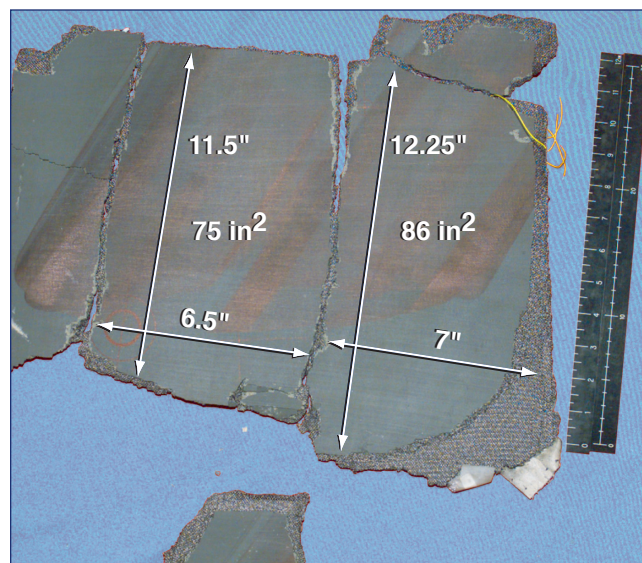
Figure 3.8-11. Three large pieces of debris from the panel face sheet were lodged within the hollow area behind the RCC panel.

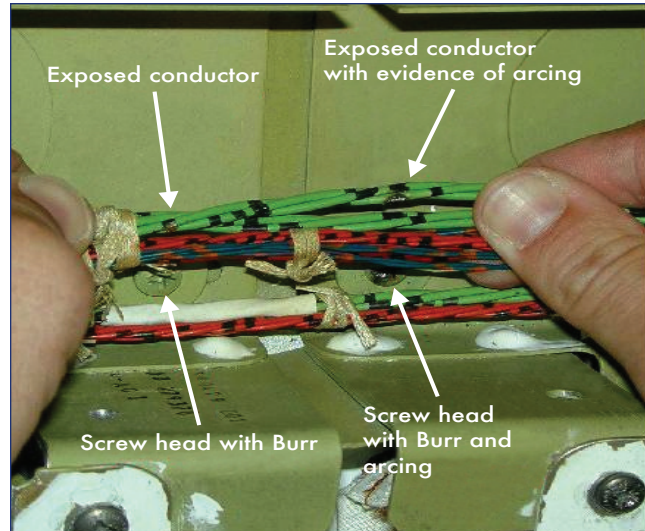
Figure 4.2-2. Arc tracking damage in Kapton wiring.

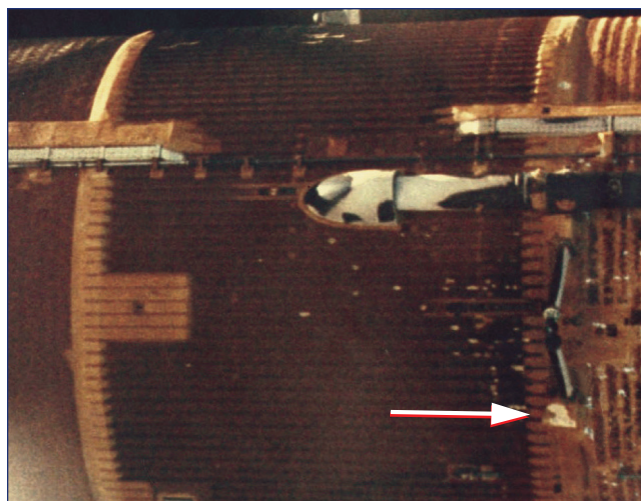
Figure 6.1-2. The first known instance of bipod ramp shedding occurred on STS-7 which was launched on June 18, 1983.

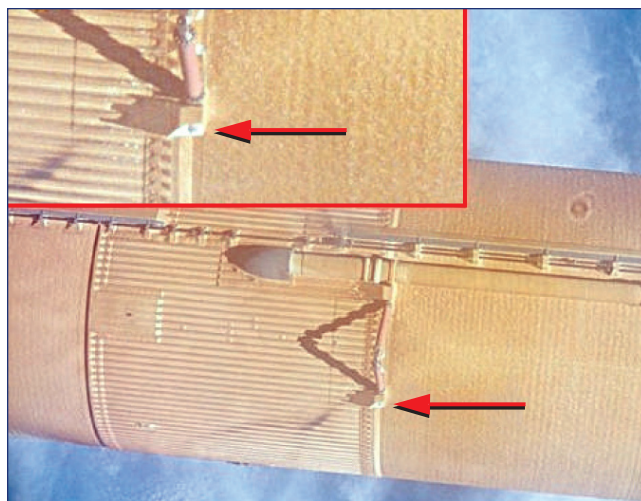
Figure 6.1-3. Only three months before the final launch of Columbia, the bipod ramp foam had come off during STS-112.
