# COLUMBIA

## ACCIDENT INVESTIGATION BOARD

REPORT  
VOLUME II

OCTOBER  
2003

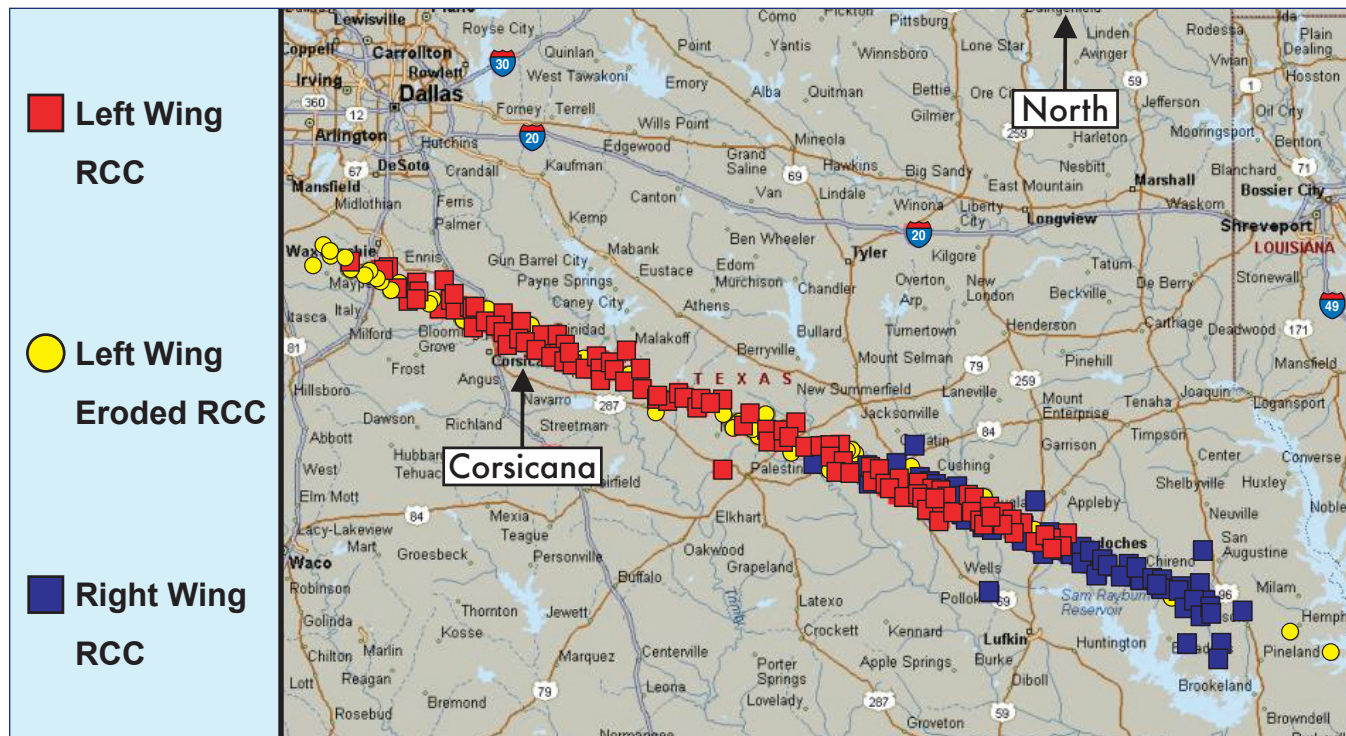
Figure 5-8. RCC panel debris location.

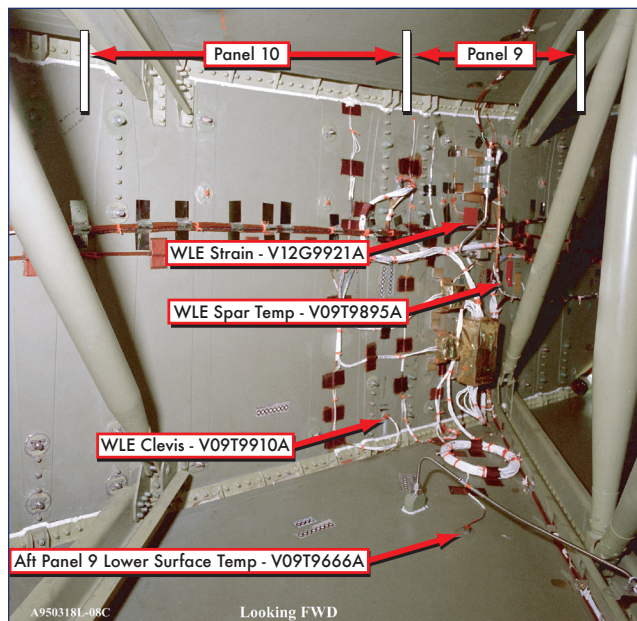
Figure 5-12. MADs sensors inside left wing.

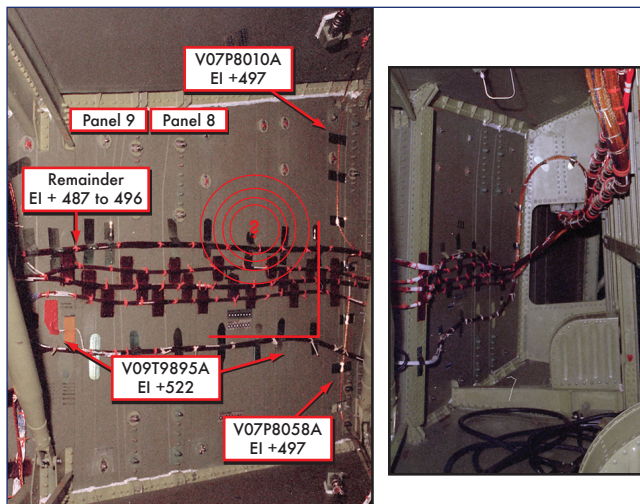
The first technique used the strain response, shown earlier in Figure 5-23. On this plot, the initial strain rise that began at about 8:49:09 EST (EI + 300 sec.) is due to thermal elastic strain. It appears that the spar structural softening occurs at approximately 8:50:09 EST (EI + 360 sec.), followed by loss of the structural integrity, or breach, at approximately 8:51:14 EST (EI + 425 sec.). This appears to be completed by approximately 8:52:00 EST (EI + 471 sec.). A detailed structural model that attempted to reproduce the thermal strain response observed during this timeframe confirmed this timing. This analysis determined that the location of the spar breach must be within about 15 inches of the spar strain measurement. This would locate the spar breach near the intersection of panel 8/9, as shown in Figure 5-29. The flow through the RCC breach maintained some directionality although it was influenced by the shape of the hole, remaining RCC structure, attach hardware, and leading edge insulators. Overall, this strain response is consistent with an RCC breach in the lower part of panel 8 as previously discussed in Section 5.3. Although it is difficult to pinpoint a precise location of the RCC breach, this analysis supports the argument that the breach was closer to the panel 8/9 intersection and Tee seal 8.

Figure 5-29. Cable routing on wing leading edge and wheel well wall.

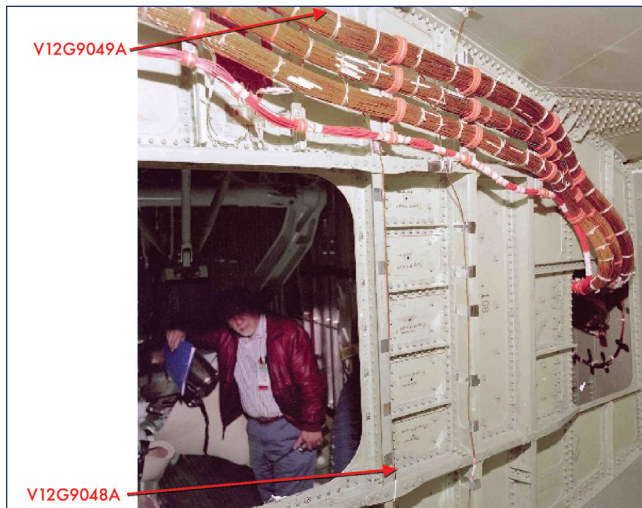
wheel well spar. The fact that these measurements are available until loss of data are important indicators that the RCC breach could not be forward on the panel 6 area since these measurements would have been lost as well (see Figure 5-32). These measurements also record key changes in strain that help indicate some of the changes that the left wing underwent as the remainder of the entry events unfolded.

Figure 5-36. Strain measurements on 1040 spar.

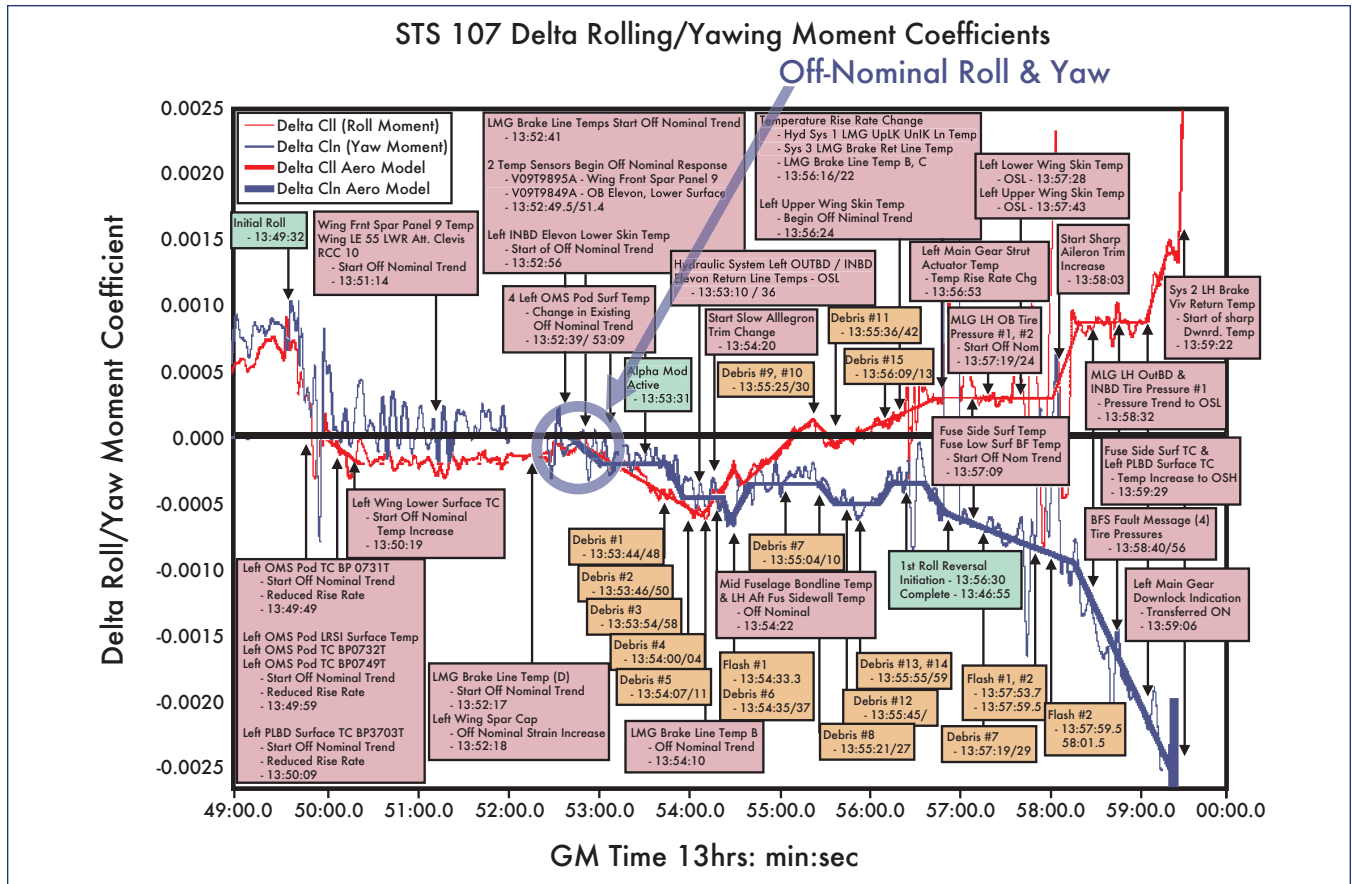
Figure 5-43. First noted off-nominal aero event.

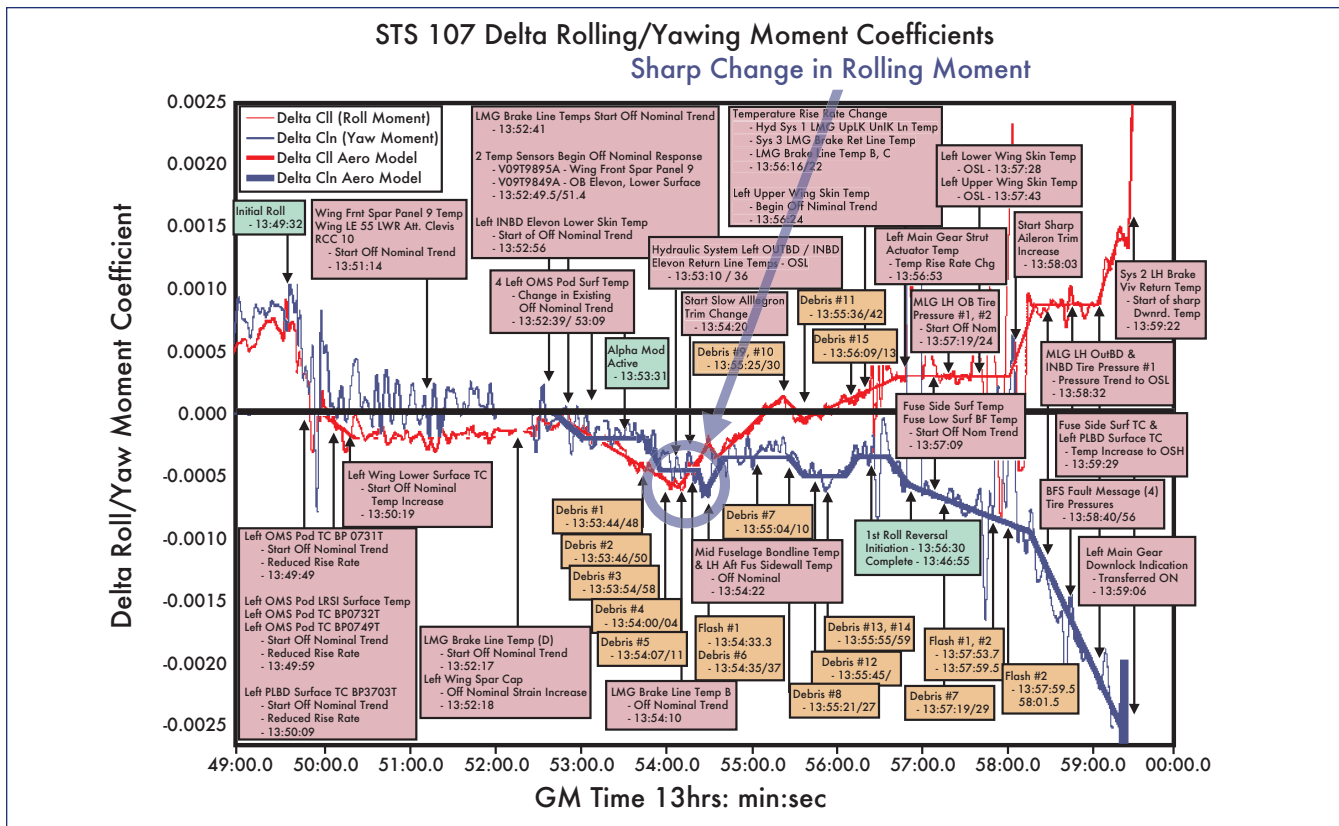
There are several theories that attempt to explain this response including a change in the wing camber or shape due to deformation and a lower wing recession, caused by the loss of much of the support structure internal to the wing. Wing recession here is in reference to structural deformation of the wing surface. In this case, one or more areas on the lower wing form a more concave shaped depression of wing skin and tiles as a result of the structural support in those areas being weakened or lost. A structural analysis of both wing deformation due to the loss of three ribs internal to the wing, and the wing recession concept was performed.

Figure 5-44. Sharp change in rolling moment.

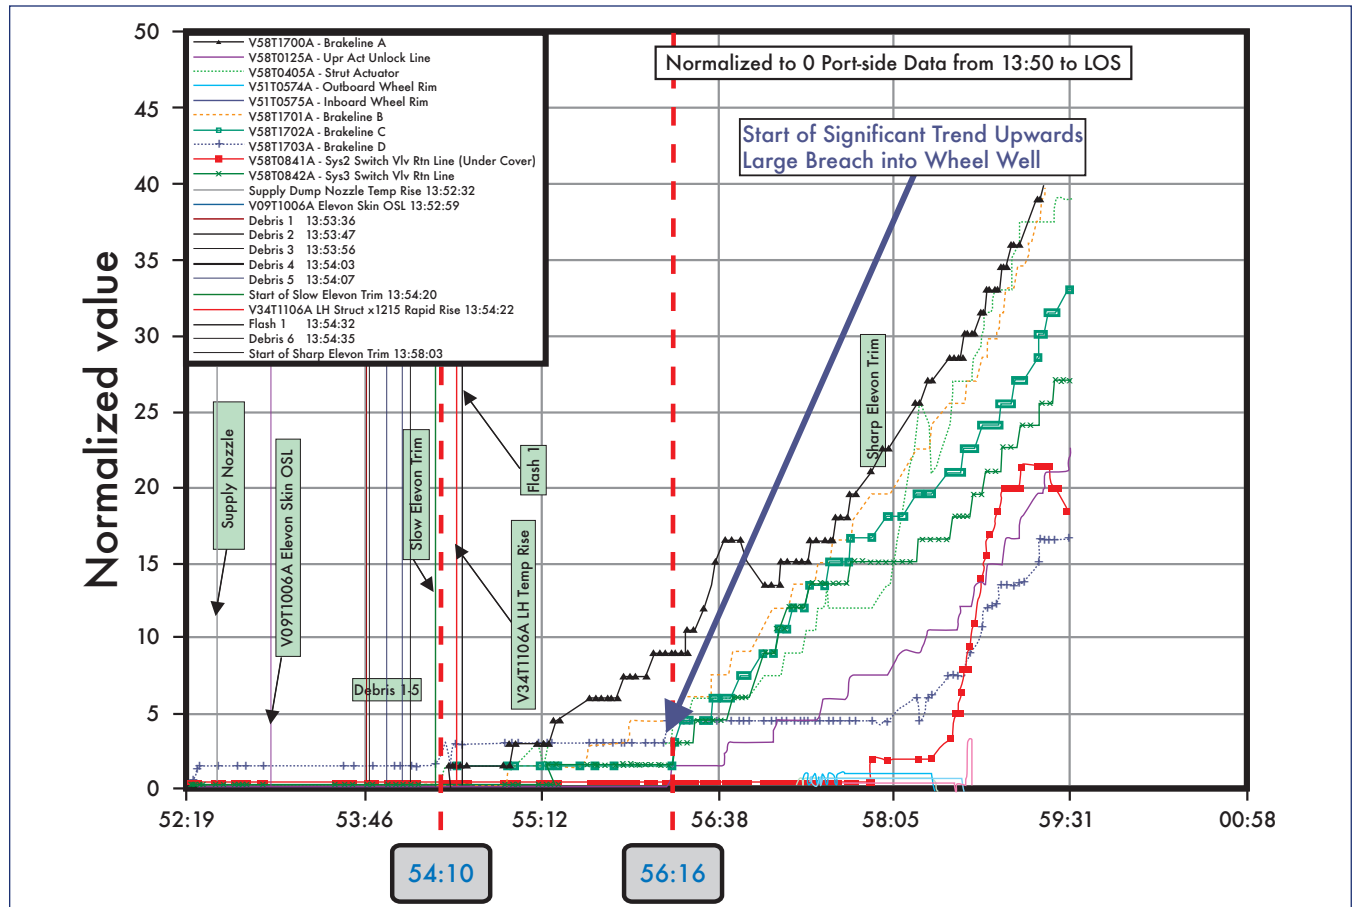
Immediately after the wheel well wall was breached, a hot gas plume began to flow on to the left main gear strut (depicted in Figure 5-47), leading to excessive strut erosion. A wheel well wall breach in this area is consistent with the erosion pattern observed on the recovered left main gear strut. Even after damage had significantly progressed into the wheel well, the orbiter initiated the first roll reversal at 8:56:30 EST (EI+741 sec.). The maneuver was completed by 8:56:55 EST (EI+766 sec.), and the vehicle was in a normal left bank. The guid-

Figure 5-46. Temperature data in left wheel well trends up.

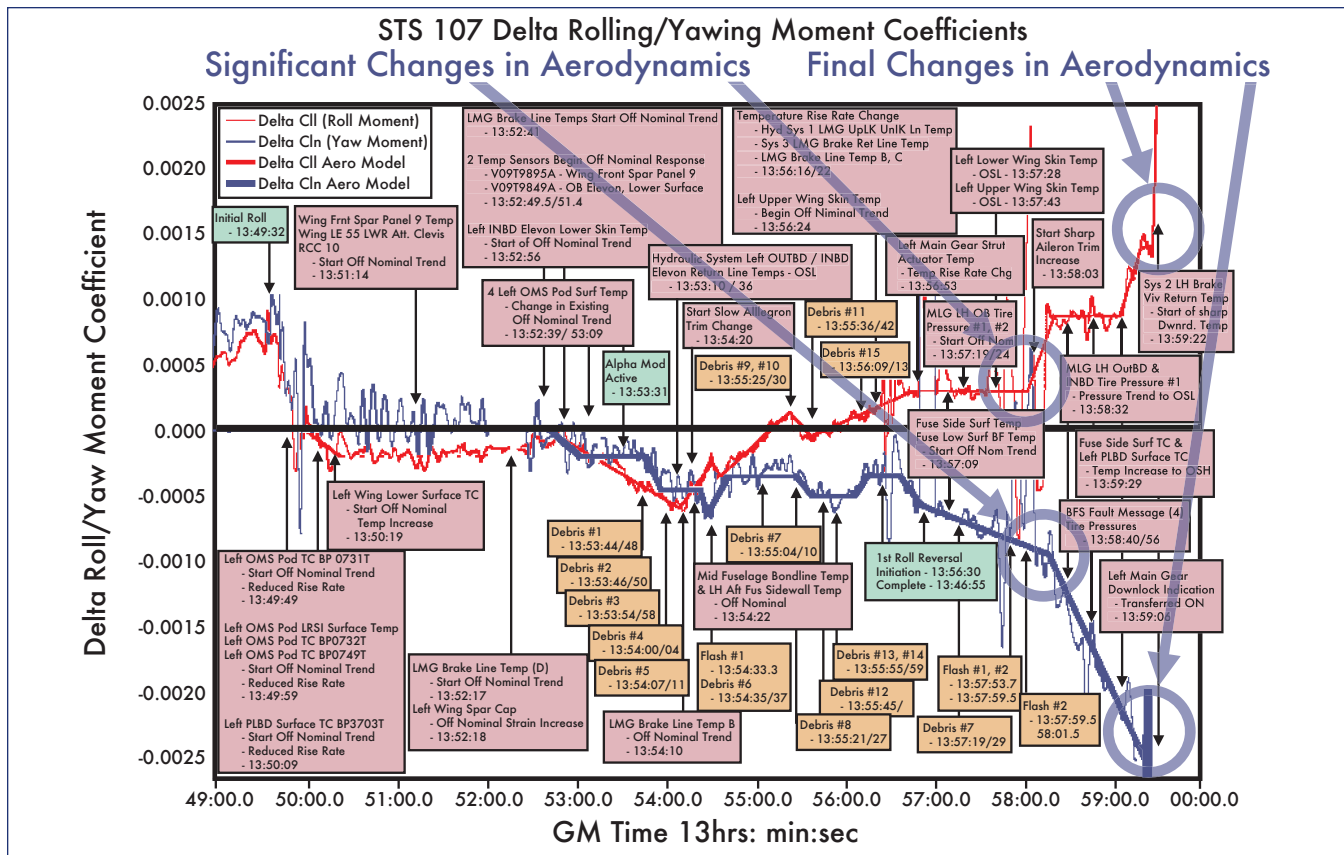
As shown in Figure 5-49, there was another abrupt change in the vehicle aerodynamics caused by the continued progression of left wing damage at 8:59:26 EST (EI + 917 sec.). This change was a significant increase in the positive delta roll moment and negative delta yawing moment, indicating increased drag and lift from the left wing. *Columbia* attempted to compensate for this by firing all four right yaw jets. By this point the MCC had lost all telemetry data at 8:59:23 EST (EI + 914 sec.). Even with all four right yaw jets and a maximum rate of change of the aileron trim, *Columbia* was unable to control the side-slip angle that was slightly negative (wind on the left side of the fuselage) during much of the entry. The side-slip angle changed sign at 8:59:36 EST (EI + 927 sec.) indicating that vehicle loss of control was imminent (side-slip angle is an aerodynamics term for the angle between the relative wind velocity and the vehicle direction of motion, or velocity vector).

Figure 5-49. Increased wing deformation and wing recession leads to significant vehicle aerodynamic changes.

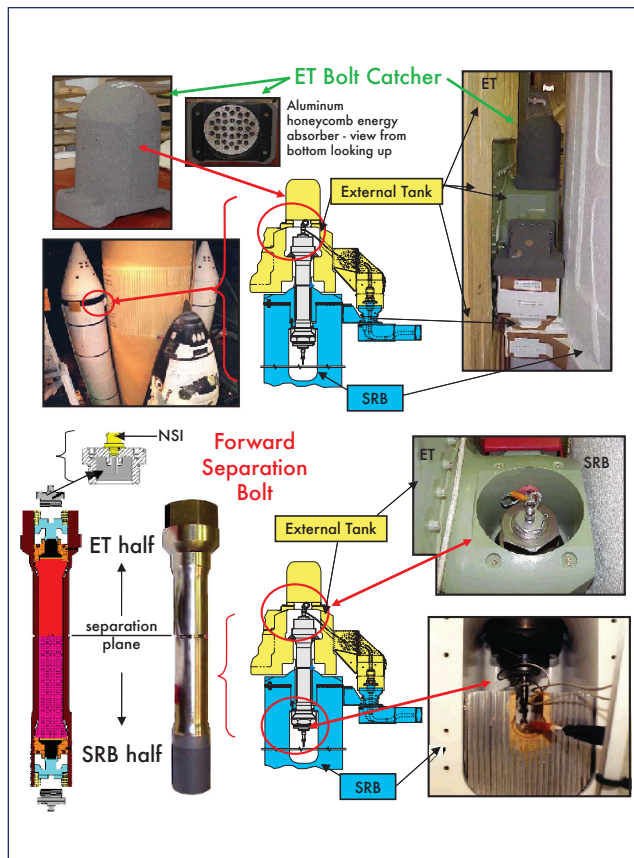
Four blocks on the STS-107 SRB fault tree remain open pending completion of forward bolt catcher testing. The bolt catcher, shown in Figure 7-1, was not qualified as an assembly, and structural qualification testing was not representative of the current flight configuration. The exact magnitude of loads transmitted to the bolt catcher housing cannot be determined based on available data. The SLA-561 thermal protection system (TPS) material on the bolt catcher was qualified by test and analysis for general ET application, but no pyrotechnic shock testing was performed. There is no test data available on the bolt catcher honeycomb dynamic crush strength versus separation bolt velocity, and random pressure loading from the NASA Standard Initiator (NSI) ejection was not included in the original qualification tests. Lastly, the running torque/break-away torque was not measured during STS-107 bolt catcher fastener and ET range safety system (RSS) fairing installation, which is used to verify the insert locking feature is in place. A review has determined that the bolt catchers and RSS fairings were installed and secured for flight with the correct bolts and final torque. Testing is in work to close the four remaining fault tree blocks, but initial static tests results show failure below the required safety factor of 1.4.

Figure 7-1. Details of SRB/ET forward separation bolt catcher assembly.

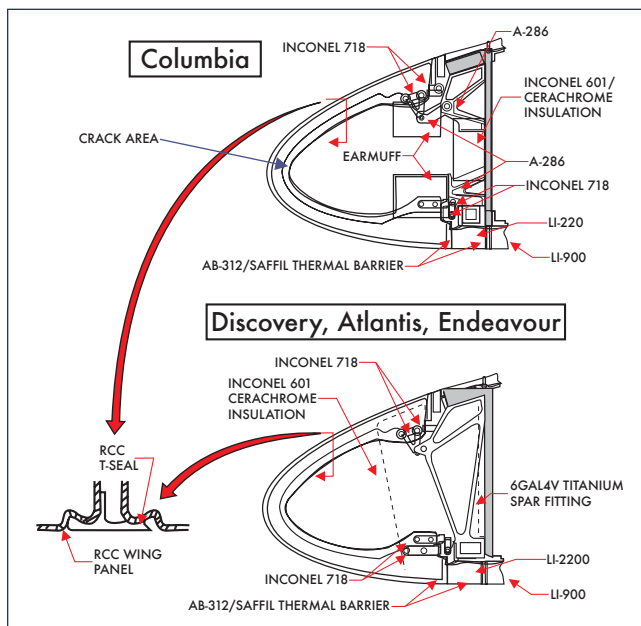
Figure 10-8. Tee seal crack location.

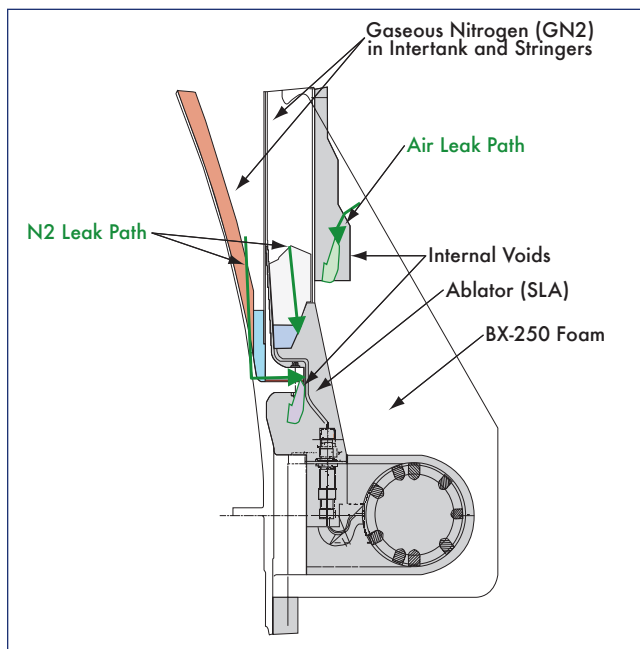
Figure 11-8. Schematic of bipod ramp - potential cryopumping.

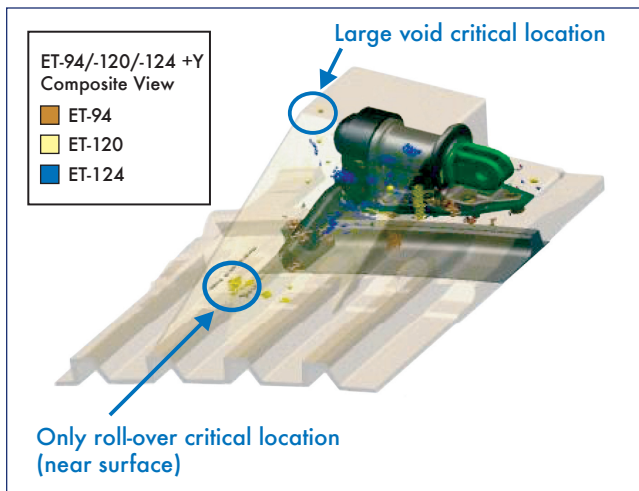
Figure 11-11. Defects found at critical locations.

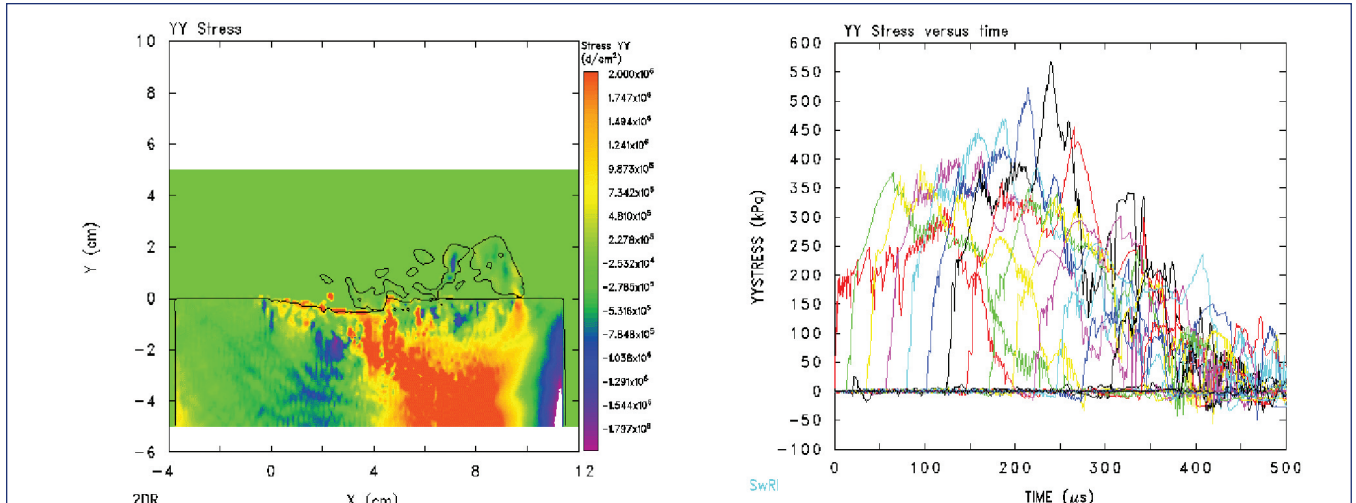
Figure 12.  $\sigma_{yy}$  (left) and normal stress ( $\sigma_{yy}$ ) histories (right) for 1" cube of foam insulation impacting thermal tile at 700 ft/s at 23° impact angle; damage occurs to the tile.

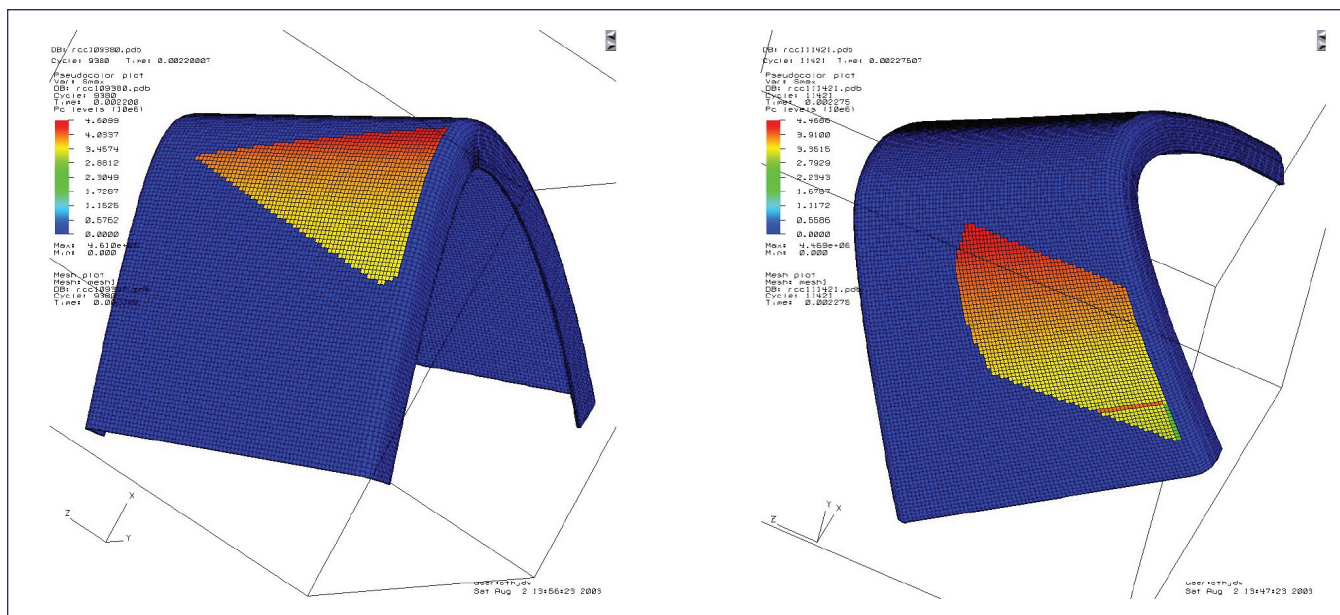
Figure 24. Footprints of impacts against RCC Panel #6 (left) and RCC Panel #8 (right).

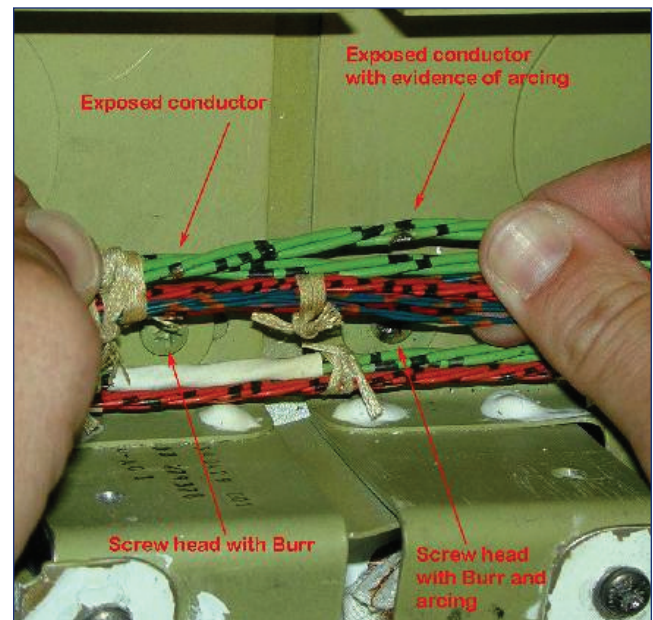
Figure 1.1.1. Picture of Kapton damage.

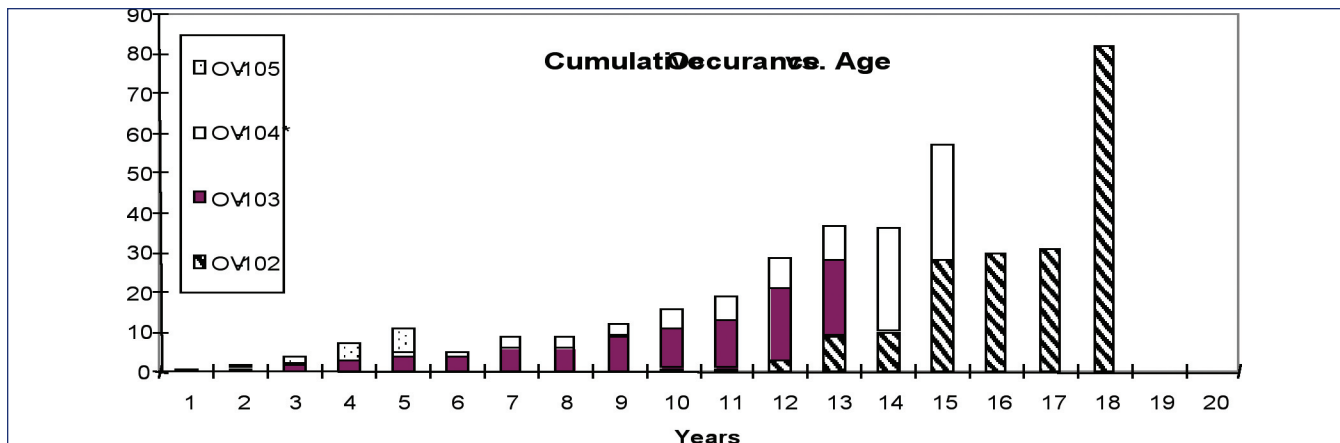
Figure 1.3.7. Fleet corrosion in body flap cove area.
