NASA TN D-7143

APOLLO EXPERIENCE REPORT - DESCENT PROPULSION SYSTEM

*by William R. Hammock, Jr., Eldon C. Currie,
and Arlie E. Fisher*

*Manned Spacecraft Center
Houston, Texas 77058*

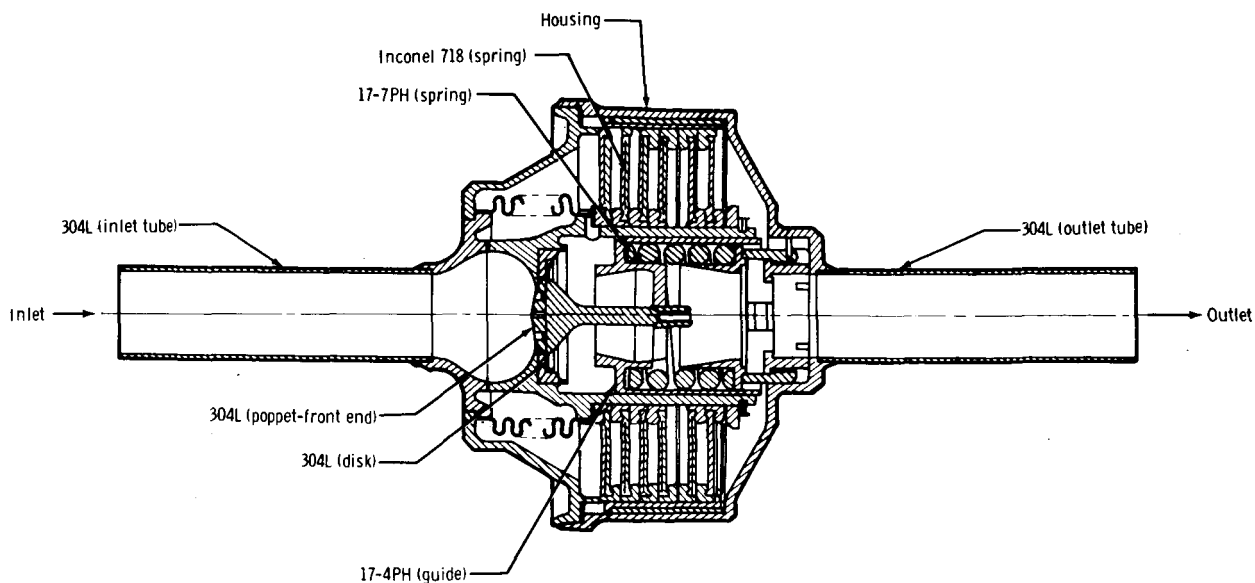
Figure 5. - The new burst-disk assembly.

reverse-pressure differentials (approximately 150 psid) without incurring damage. Before selection of the new design, many failures of the old burst disk occurred in checkout as a result of inadvertent reverse pressure.

A newly designed burst disk (fig. 5) with a burst-pressure setting of 267.5 ± 7.5 psia was selected to improve the design safety margins and pressure-cycling limitations on the propellant tanks. Another desirable feature of the newly designed burst disk was the ability to withstand

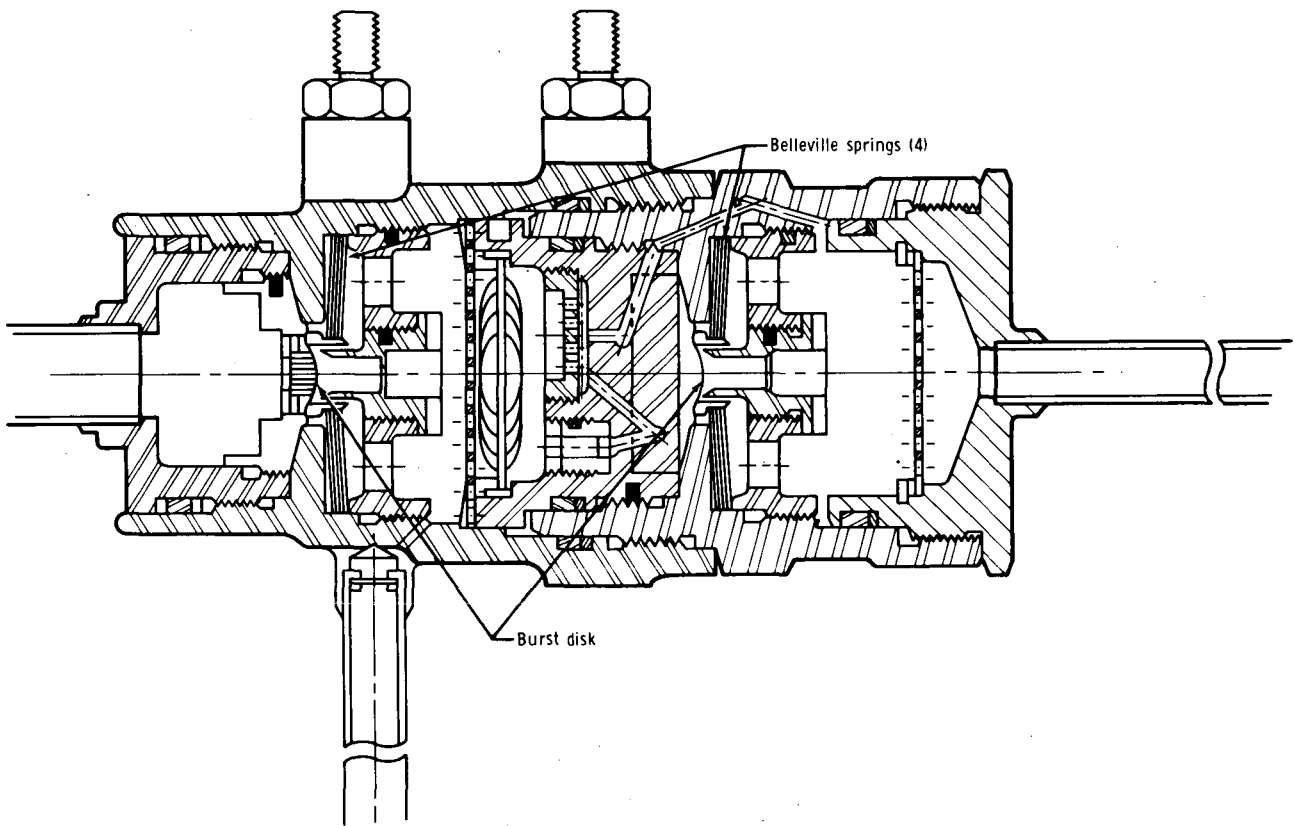
Figure 8. - The SHe tank burst disk.

The dual burst-disk assembly on the SHe tank was designed with stainless-steel belleville washer springs (17-7 PH) that controlled the burst-pressure setting of the burst disk. During certain vehicle checks on an SHe tank, the primary disk ruptured at approximately 300 psi below the set pressure of 1881 to 1967 psia. This rupture was traced to stress corrosion of the belleville springs caused by long-term exposure to moisture. One spring of the four-spring stack was cracked completely through; thus, the preload on the burst disk (fig. 8) was lowered. If moisture was detected by a vacuum-dryness check, a pressure-proof test was performed on all production burst disks. Also, desiccant bags were maintained on the outlet tube of all burst disks after the dryness check and the pressure-proof test. Subsequent to LM-5 (Apollo 11), on some vehicles the burst disk was modified to incorporate an Inconel belleville spring, which is resistant to stress corrosion.

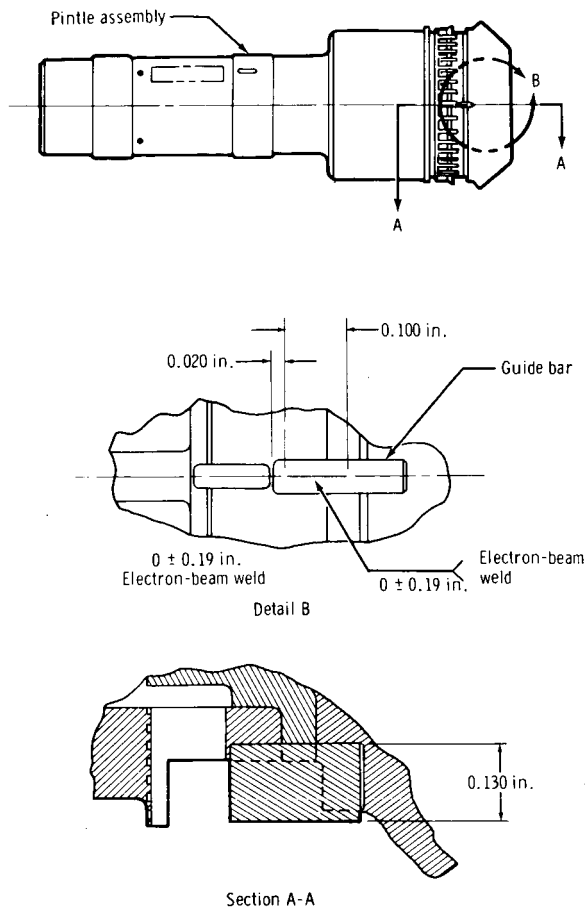
Figure 10. - Pintle-assembly diagram showing guide-bar installation.

The original injector pintle tip (figs. 9 and 10) was made of stainless steel, and it incurred severe erosion during engine operation because of inadequate cooling. As a result of the erosion, copper slugs were incorporated in the pintle tip to promote better

During the phase-B qualification test, gouging did occur on one engine. The gouging was traced to one of the fuel-barrier cooling orifices being plugged by room-temperature vulcanized (RTV) rubber, which was used as a seal around the tubes of the cooling orifice at the ablative faceplate. A process change was made to prevent plugging of the fuel-barrier cooling orifices during assembly. Also, during the phase-B qualification test, one engine incurred a failure of the electron-beam (EB) weld on the guide bar that positions the oxidizer sealing ring (fig. 10). This failure also occurred on several WSTF engines, and in some cases, the guide bar came completely out from under the oxidizer sleeve. Subsequently, an EB tack weld in the center of the guide bar was changed to a structural EB weld around the periphery of the guide bar.

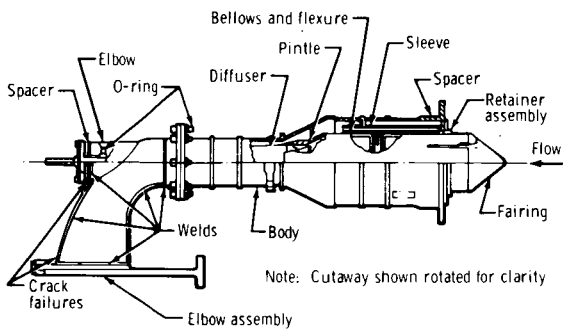
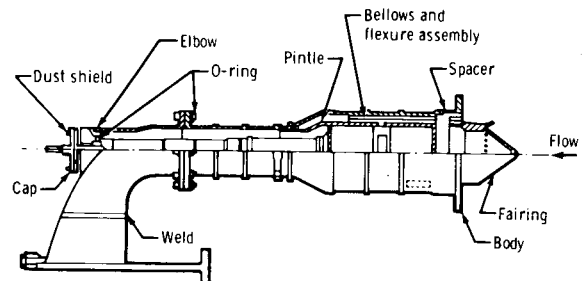
Figure 12. - Flow-control valve.

The original elbow of the flow-control valve (FCV) was made of stamped 6061 aluminum sheet metal and machined 6061 aluminum flanges (fig. 12(a)). The elbow was welded together as shown in figure 12(a). During qualification tests, cracks occurred in a weld near the flange; these cracks were caused by the closeness of the weld to the flange, which resulted in a stress concentration. Because of the design, the weld was very difficult to inspect. The elbow was redesigned to relocate the weld farther from the flange to improve the strength and inspectability. The redesigned elbow passed qualification; however, during production of elbows for flight engines, several elbows cracked during the proof-pressure test (540 psig). These cracks occurred in a weld adjacent to the throttle-linkage boss. An X-ray of the weld in this area showed that some elbows had a void in the weld caused by inadequate penetration from the welds made on the inner and outer surfaces of the elbow. Subsequently, all elbows were inspected by X-ray for voids in the welds. Because this inspection screened the inadequate welds, it resulted in a high rate of scrapage. A new two-piece elbow (fig. 12(b)) was designed and qualified for

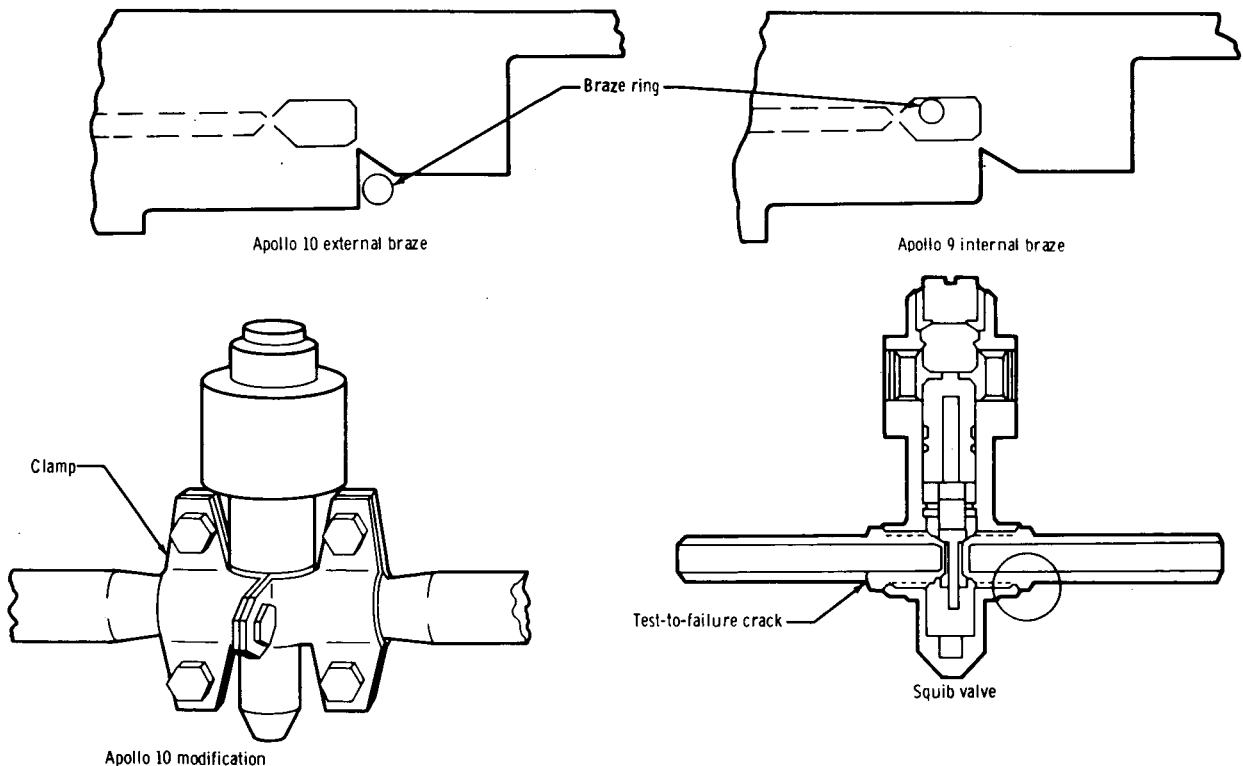
Figure 14. - The SHe squib-valve configuration.

The LM-3 SHe squib valve was similar to the LM-2 squib valve in that the valve fittings were internally brazed, which prevented inspection of the joint. The leak experienced during Apollo 9 probably was caused by a defective braze that was internal to the squib valve and could not be inspected.

The mission criticality of external leakage was evaluated for each of the squib valves on the Apollo 10 vehicle. On the DPS, the oxidizer-compatibility squib valve was determined to be of the internal-braze configuration; thus, if external leakage developed, it could have been hazardous to the mission. Therefore, this valve was modified to incorporate RTV potting reinforced with an external clamp (fig. 14) to contain any leakage if the brazes cracked. This configuration was thoroughly tested before the flight. The valves on all vehicles subsequent to Apollo 10 were of the external-braze configuration.

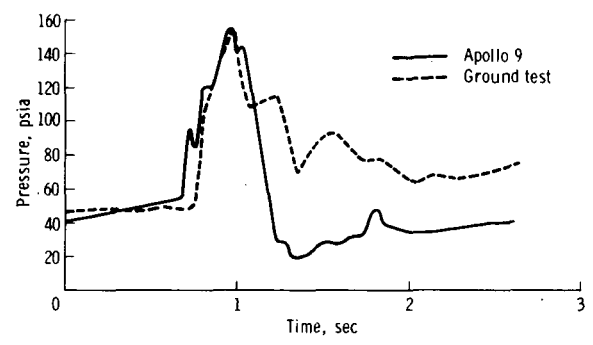
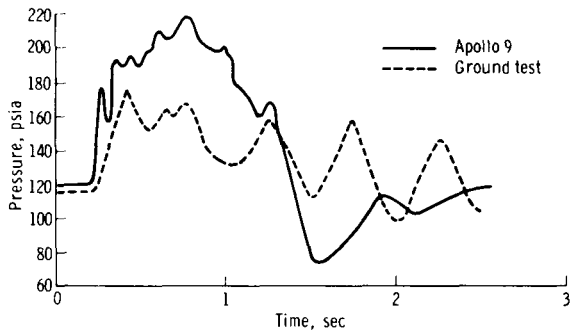
Figure 15.- Comparison of roughness during second descent-engine firing and ground test.

Engine roughness: During the second descent-engine firing, rough combustion was encountered at approximately 27-percent thrust as the engine was being manually throttled from 12 to 40 percent. This roughness lasted for approximately 2.5 seconds, during which time the crew delayed increasing the throttle. The resultant transients in propellant-injector pressures and chamber pressure are shown in figure 15.

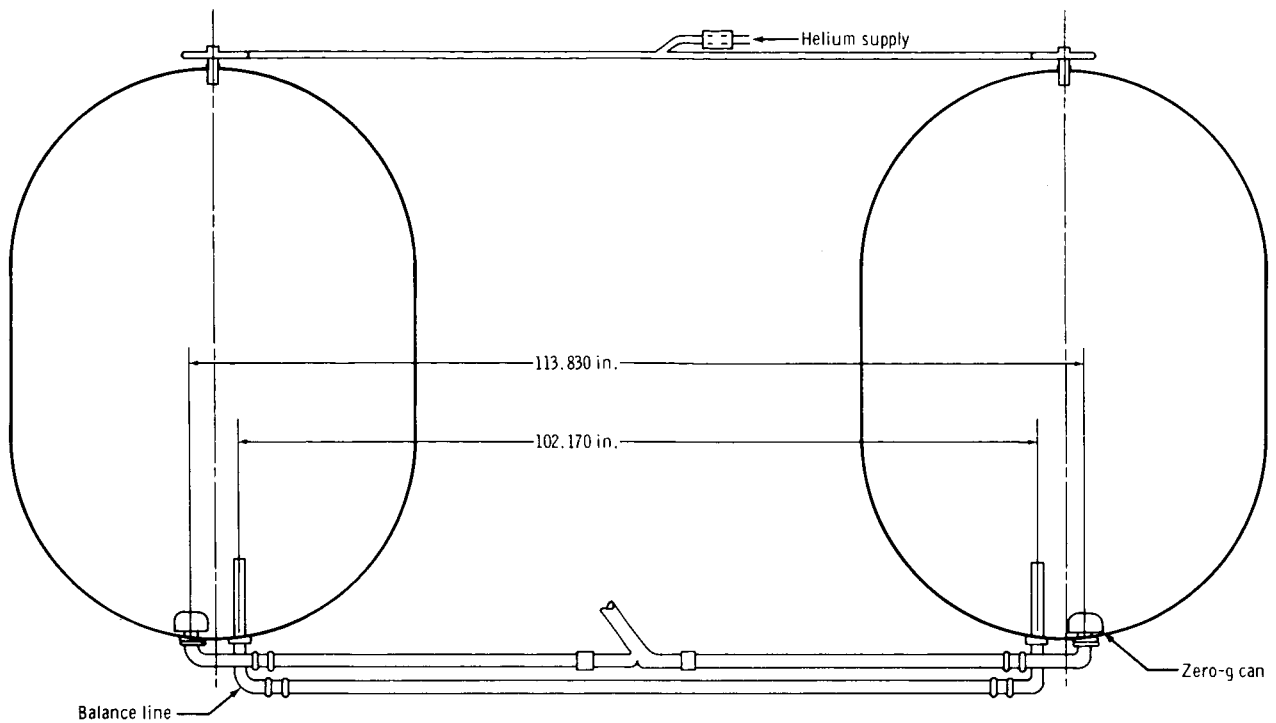
Figure 16. - Tanks and plumbing of the DPS.

that the zero-g-can retention screen was not capable of holding propellants at the 114-inch head between identical propellant tanks (fig. 16).

Helium ingestion requires that the zero-g can be uncovered and that lateral or rotational accelerations be present. This condition was highly probable with the 60-percent ullage volume present in Apollo 9 propellant tanks before the second descent-engine firing. Tests have demonstrated that ingestion of helium into the engine in this manner has no detrimental effect on the system.

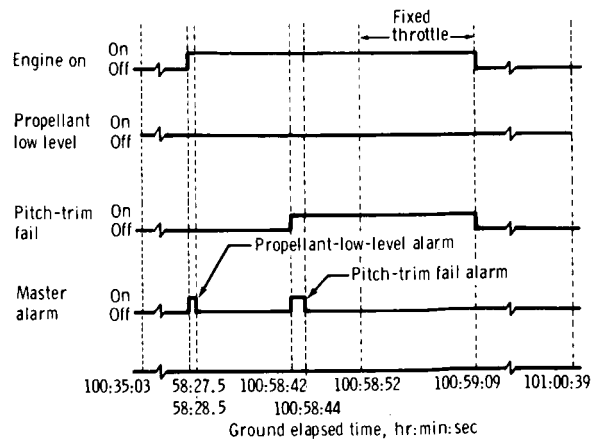
Figure 17. - Master alarms during Apollo 10 phasing maneuver.

The low-level indication probably was caused by a gas bubble in the unsettled propellant uncovering the low-level sensor before the burn but after turning on the PQGS. Once the low-level sensor was uncovered, the indication was latched on by a latching relay and remained on until the PQGS was turned off again after completion of the burn. The crew display of low quantity was inhibited until the engine "on" command was given, thus explaining the master alarm at the time of engine ignition. This

fact was verified by the telemetry recording of the low-level indication during the phasing burn (fig. 17). The second alarm (immediately after throttle up) could not be verified by telemetry data nor explained by normal system operation. On subsequent missions, the low-level indication was removed from the master alarm because a visual indication by the low-level warning light was considered adequate warning for the crew. Also, if the low-level indication occurred at engine ignition, a contingency crew procedure was instituted to reset the low-level indication by cycling the PQGS off and on.

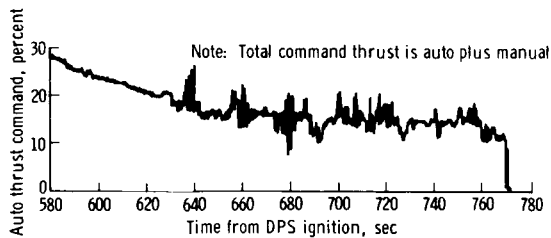
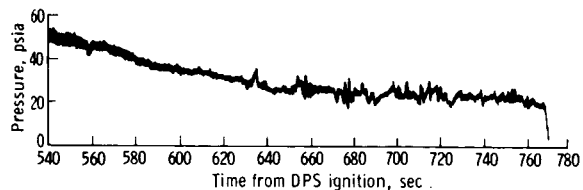
Figure 18. - Apollo 11 hover-phase throttle profile.

During the last 140 seconds of the PDI burn (hover phase), a series of large oscillating-throttle changes occurred (fig. 18). These changes were approximately 15 percent peak-to-peak about a nominal throttle setting of approximately 26 percent. Large and rapid changes in vehicle attitude (as much as 15° at $10^\circ/\text{sec}$) in pitch during the final phases of landing caused centrifugal accelerations on the inertial-measurement-unit accelerometers located at the top of the ascent stage high above the vehicle c.g., thereby giving a false indication of vertical acceleration. This false indication caused the lunar guidance computer to command a throttle change to compensate for an unreal change in vertical acceleration. Later, this problem was investigated under the analysis of the guidance and control system.

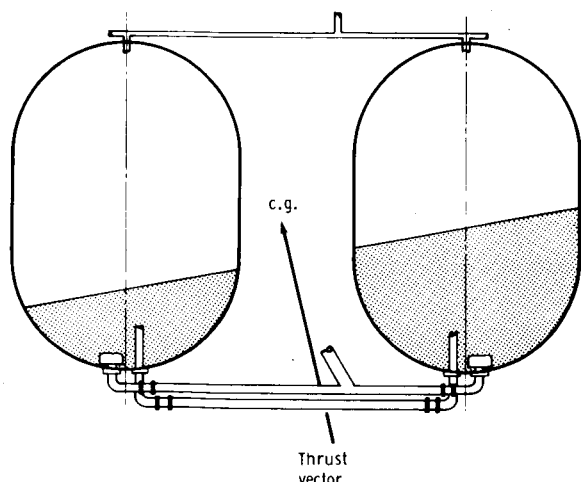
Figure 19. - Schematic of propellant unbalance.

During the PDI burn, the oxidizer quantity in tank 1 and tank 2 diverged, as observed by the PQGS readings, until, at 360 seconds into the burn oxidizer, tank 2 was approximately 3.4 percent less than oxidizer tank 1. This divergence in remaining oxidizer quantity was attributed to propellant transfer from one oxidizer tank to the other through the propellant balanceline during the burn. The offset in the vehicle c.g. from the centerline between the oxidizer tanks (on Z axis) resulted in the tilting of the vehicle in that axis to put the thrust vector through the vehicle c.g. (fig. 19). This tilt caused preferential feeding from the tank that was highest with respect to vehicle c.g. Although the observed magnitude was less than the calculated magnitude, calculation of propellant transfer between the two tanks, based on the known geometric head difference, confirmed the transfer of propellant from oxidizer tank 2 to oxidizer tank 1. Adjustments were made to the propellant margin to account for this difference.

At 685 seconds into the PDI burn, the propellant-low-quantity warning light was triggered by the sensor in one of the four propellant tanks. Based on remaining calculated quantities and corrected PQGS indications, the occurrence of the propellant-low-quantity warning was discovered to be premature by 36 seconds. The early warning was the result of propellant slosh waves created by sudden vehicle maneuvers and by attitude changes. These slosh waves caused the propellant level in the PQGS probe to oscillate about a negatively biased level. At the lowest point of the oscillation, the low-level sensor was momentarily uncovered, thus latching a relay to the warning light.

Before the flights of Apollo 11 and 12 (during which the anomaly was observed) a ground-test program was conducted in which the critical slosh modes were identified and potential modifications to eliminate or reduce the error were evaluated. From this test program, the lateral-mode and ring-mode slosh were found to produce the most errors in PQGS readings. Slosh baffles were incorporated on Apollo 14 and subsequent vehicles to minimize the slosh in the tanks.

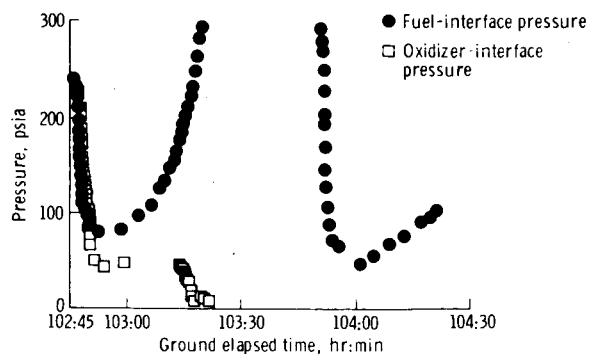
Figure 20. - The Apollo 11 descent-propellant and helium venting.

Venting of the propellant and the SHe tanks after lunar landing resulted in the freezing of the fuel-to-helium heat exchanger. Fuel and oxidizer interface pressures as compared to time during the postlanding venting are presented in figure 20. Venting of the SHe tank through the lunar-dump valves resulted in the flow of residual cold helium into the SHe tank through the heat exchanger, thereby freezing the fuel in the fuel passages and blocking flow of fuel through the heat exchanger. During the subsequent hour, the engine experienced a peak in heat soakback from the ablative chamber, which caused the fuel trapped in the line between the heat exchanger and engine SOV to expand thermally; therefore, the pressure rose rapidly. After 30 minutes, the fuel pressure was relieved by thawing of the heat exchanger, failure of the line-bellows linkage, or failure of the seals in the prevalue. The exact cause of relief was not determined. On subsequent flights, the venting procedure was modified to isolate the SHe tank by the latching solenoid valves during venting of the propellant tanks and to delay SHe venting until immediately before launch from the lunar surface. Based on autoignition tests of the fuel at various pressure levels, the final-vent fuel-pressure level was revised from 20 to 40 psia to 8 psia to prevent any autoignition hazards in the aerazine-50 fuel during engine peak periods of heat soakback. On LM-7 and subsequent vehicles, a bypass line around the heat exchanger was incorporated as an added safety feature to relieve the trapped fuel pressure if freezing of the heat exchanger should occur.
