# Shuttle Liquid Hydrogen (LH2) Engine Cut-Off (ECO) System Anomaly

**Presenter:**

**Michael D Stirling**

**NASA Electrical Systems**

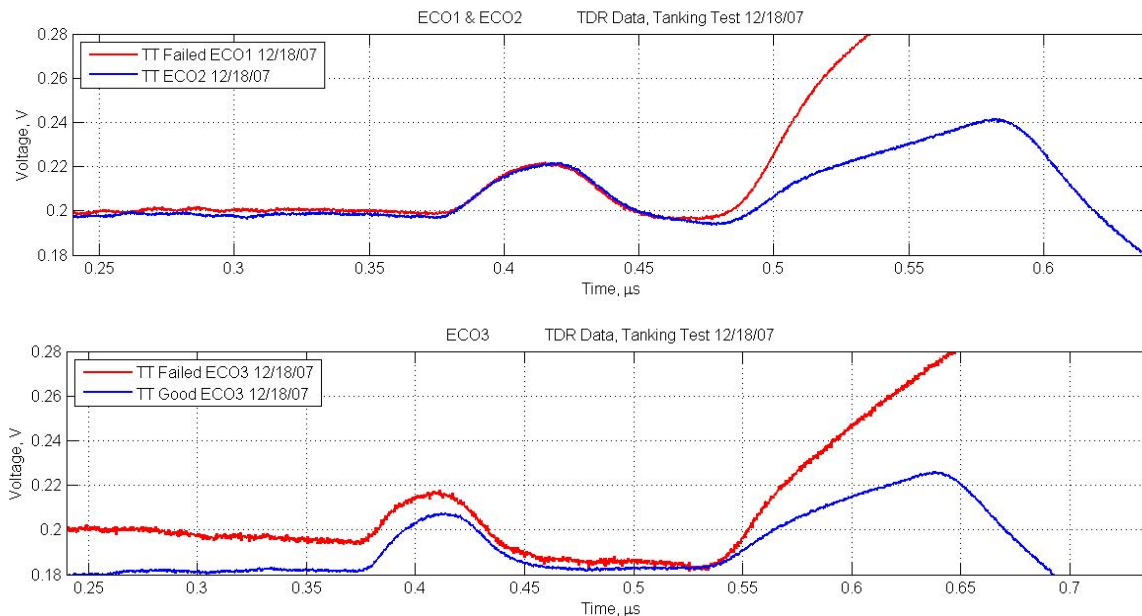
- A tanking, or fueling, test at Kennedy on Dec. 18, 2007, revealed that open circuits in the external tank's external electrical feed through connector were the most likely cause of false readings in the ECO sensor system during launch attempts on Dec. 6 and Dec. 9. NASA formed a combined troubleshooting team involving multiple NASA centers to find the root cause and develop plans to fix the system. A parallel team also was established to develop a forward plan of action to support the earliest possible launches STS-122 and STS-123.

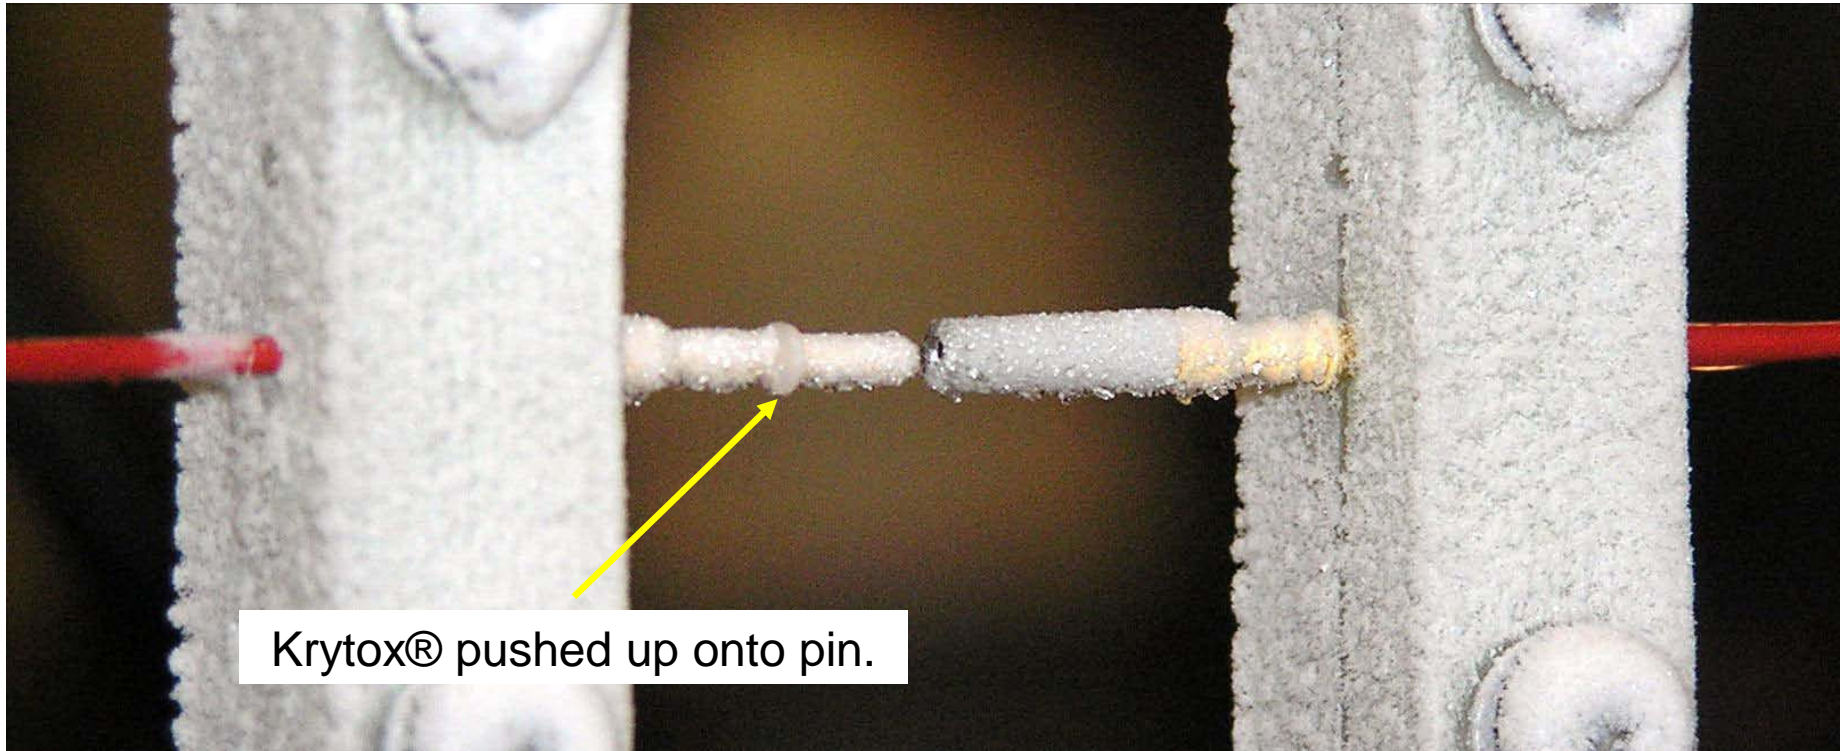
Frost formation on Krytox® 240 AC coated pin/socket after immersion in LN2 for at least 3 minutes beginning to melt.
