VEHICLE ENGINEERING

STS-112 FLIGHT READINESS REVIEW

Presenter:
	Organization/Date: Orbiter/09-17-02

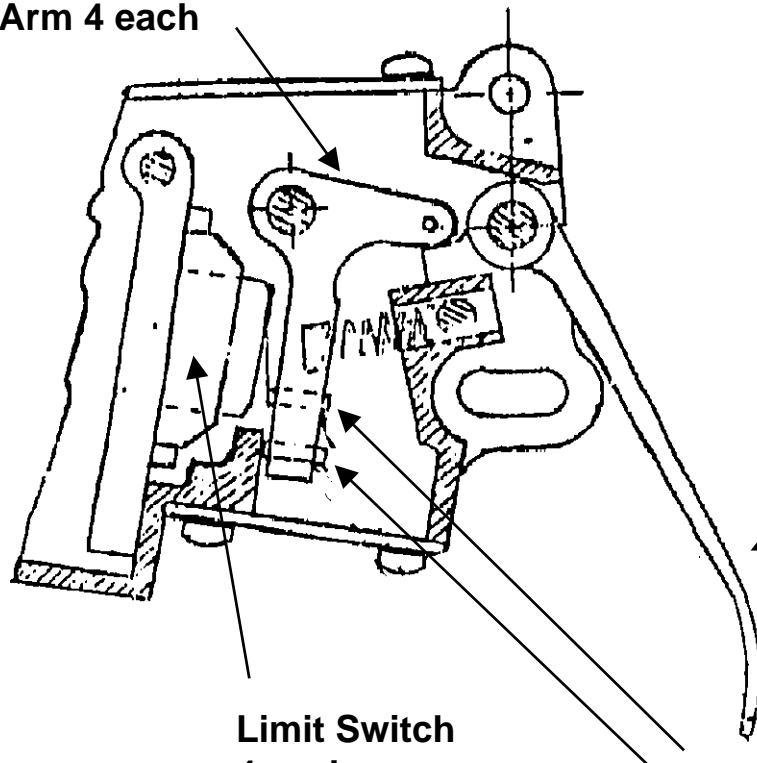
- The switch module was inspected for debris/damage - no visible defects/debris
- A small amount of isopropyl alcohol was used to flush the actuation paddle area to free up any debris - no contamination was found
- The switch module was removed and routed to NSLD for TT&E
- Four previous flight anomalies related to switch module RTL indications remaining “on”
 - All anomalies attributed to either:
 - Thermal conditions affecting the operation of the arm or the individual switch levers
 - Marginal switch rigging
 - Switches re-rigged and returned to the field for unrestricted usage

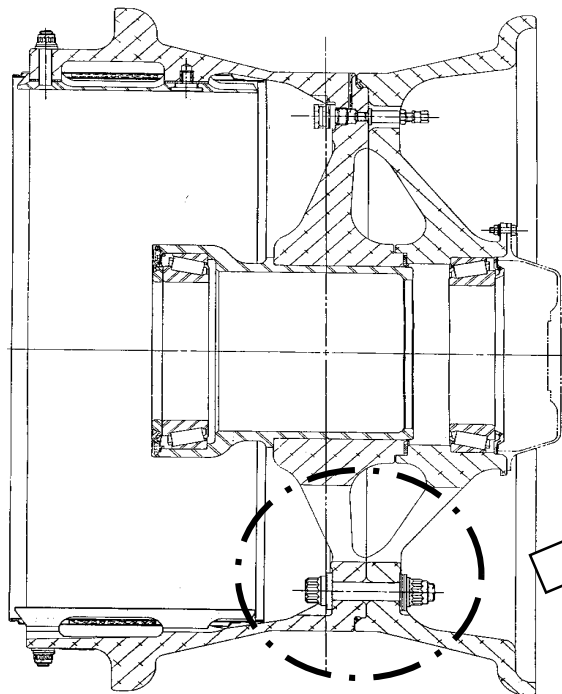
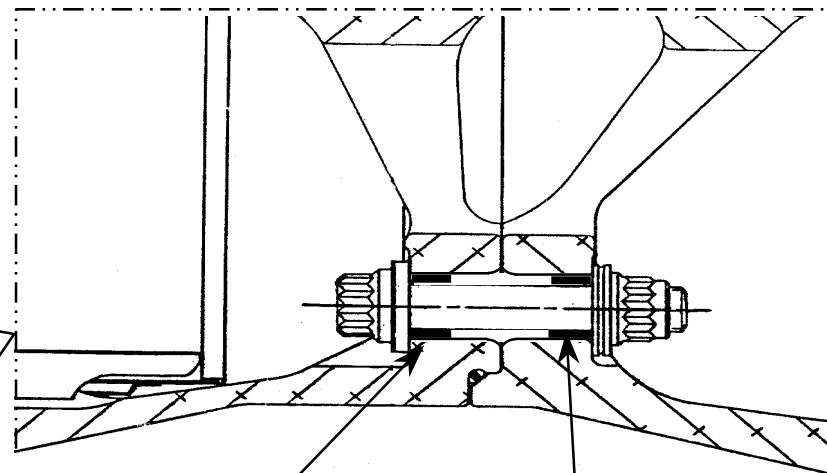
Typical Tie Bolt Attachment with Sleeves Installed on Inboard and Outboard Wheel Halves

- Repair procedure developed at Goodrich installed sleeves in tie-bolt holes after machining to remove corrosion
 - All 36 holes (18 per wheel half) fitted with sleeves to maintain tie-bolt clearances at assembly
- Fatigue test program completed at WPAFB demonstrated ten-mission life (details in back-up)
- The sleeved test wheel was fluorescent penetrant inspected prior to, during, and after completion of all tests
 - No flaws were detected at any of the sleeved hole locations
- MR dispositions for ten-mission usage of each repaired wheel were processed through PMRB and Fracture Control Board
 - Final MR will be processed for each wheel after the tenth mission for “scrap” disposition

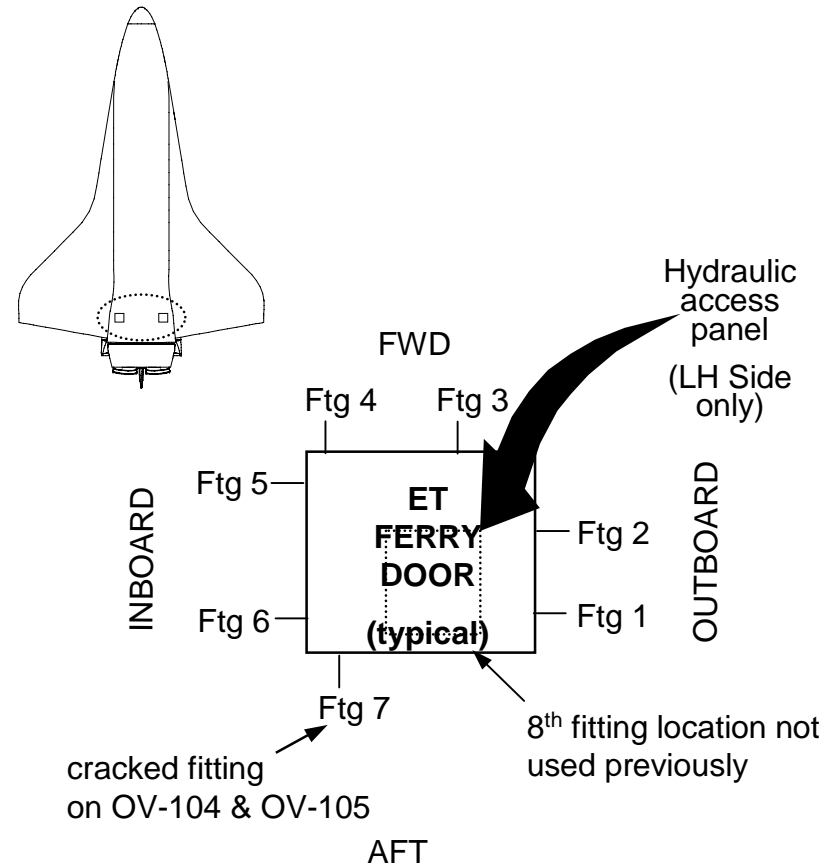
MCR 23070 ET Cavity Ferry Door Attach Fitting Redesign

- STS-98 post-flight inspection found a fatigue crack on the ferry door at attach point #7
- Modification installs a fitting at the unused location, attach point #8 (LH & RH)
 - Reduces unsupported span of the ferry door
 - Reduces stress levels at attach point #7
- Also adds a hydraulic access panel in the LH ferry door

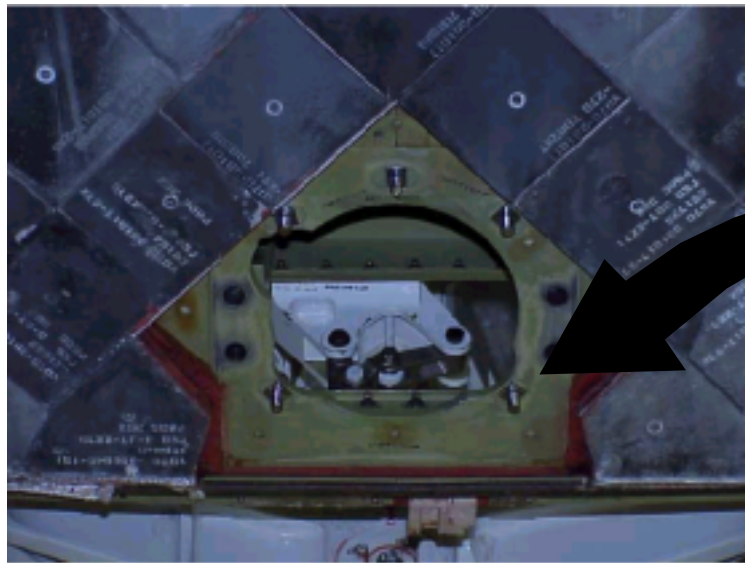
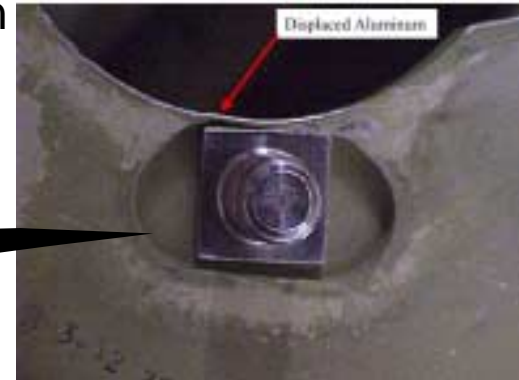
MCR 23077 Forward Orbiter ET Attach Fitting Stud Redesign

- STS-102 on OV-103 post-flight inspection found a crack in the attach fitting of the forward ET attach point
 - Current design can result in cracking during ground installation
 - Stud redesigned to alleviate concern

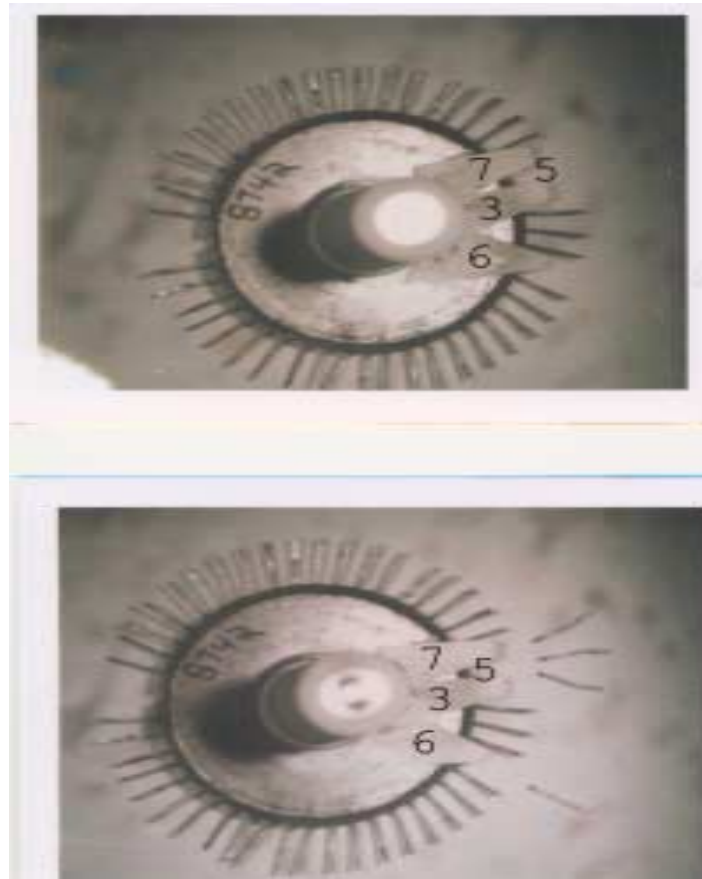
Photos of HAINS S/N 207 Broken Slip Ring Wires

- X-ray analysis of the 42-wire azimuth slip ring found breaks in fan-out wires 3, 5, 6 & 7
 - Wire 3 carried the 90 degree phase of the azimuth gyro motor power
- SEM analysis indicates fatigue failure from up/down flexure
- Slip ring misalignment is a phenomenon observed to be present and variable between IMUs
 - A side load on the slip ring shaft from the brush block tape cable is the major contributor to slip ring misalignment
 - Slip ring misalignment varies among IMUs

Most probable cause of wire failures appears to be a combination of the degree of slip ring misalignment and the number of times it is flexed (usage related)

- Kearfott searched IMU platform build records
 - One assembly technician built all but two platforms
 - There is no pattern in build dates of failed IMUs
- Kearfott is actively developing a re-design of azimuth slip ring mounting to prevent fracture of fan-out wires
 - Replacement slip rings are on order
 - IMU PRT developing fleet-wide retrofit plan
- As for the vertical gyro lubrication problem, this was recognized early in the HAINS program
 - Sufficient spare gyros (without this problem) are on the shelf
 - Gyros replaced when platform opened for repairs
 - Impending gyro failure has been identified by high gyro drift rates that can be compensated

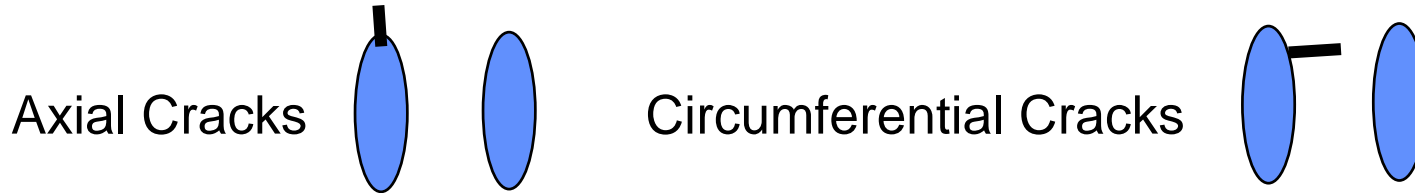
Crack Inspection Summary

Engine 1 LH2	Engine 2 LH2
MPTA	1 Circumferential, Downstream	None
OV-102	None	3 Circumferential, Downstream
OV-103	1 Axial, Upstream 2 Axial, Downstream	None
OV-104	1 Axial, Downstream 2 Circumferential, Downstream	None
OV-105	1 Axial, Downstream	1 Axial, Upstream

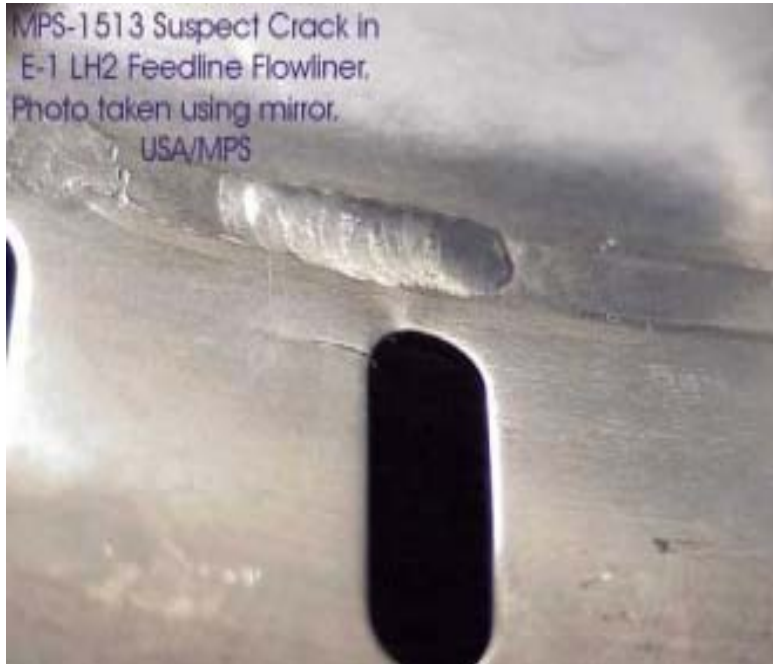
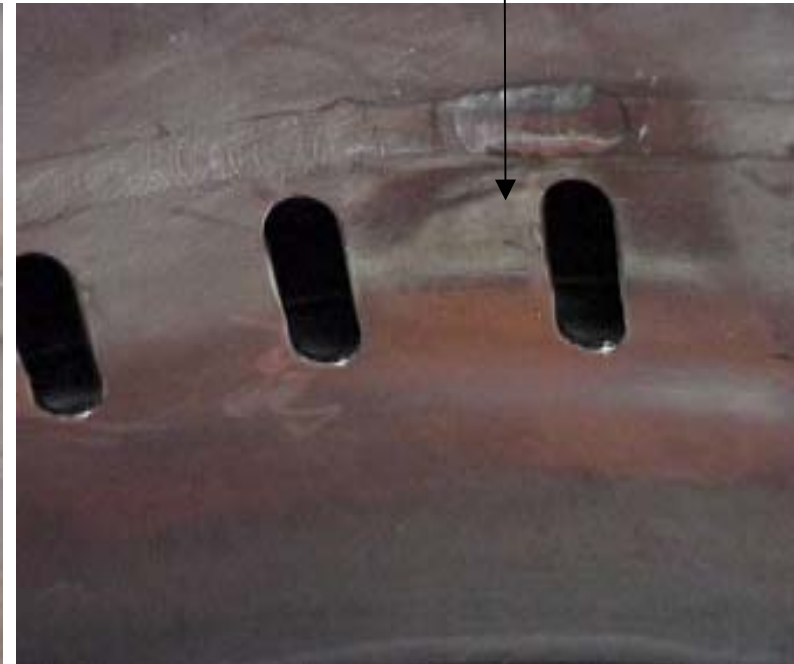
Repair area

- Inspections of MPS LH2 engine feedline flowliners found cracks in the gimbal assembly flowliners near the SSME interface

- Weld all detectible cracks and polish slots
 - Complete
- Test coupons to crack initiation
 - Plot test data
 - Evaluate for scatter
- Determine minimum weld life relative to parent material (i.e., knockdown factor)
- Use reverse fracture bounding analysis to estimate:
 - Equivalent damage, constant amplitude stress level
 - Life to “initiation”
 - Life to critical length - i.e., slot-to-slot crack (circumferential), detrimental length (axial)
 - Apply appropriate scatter factors
 - 4 for crack initiation in weld repaired area
 - 2 for crack growth from undetected damage

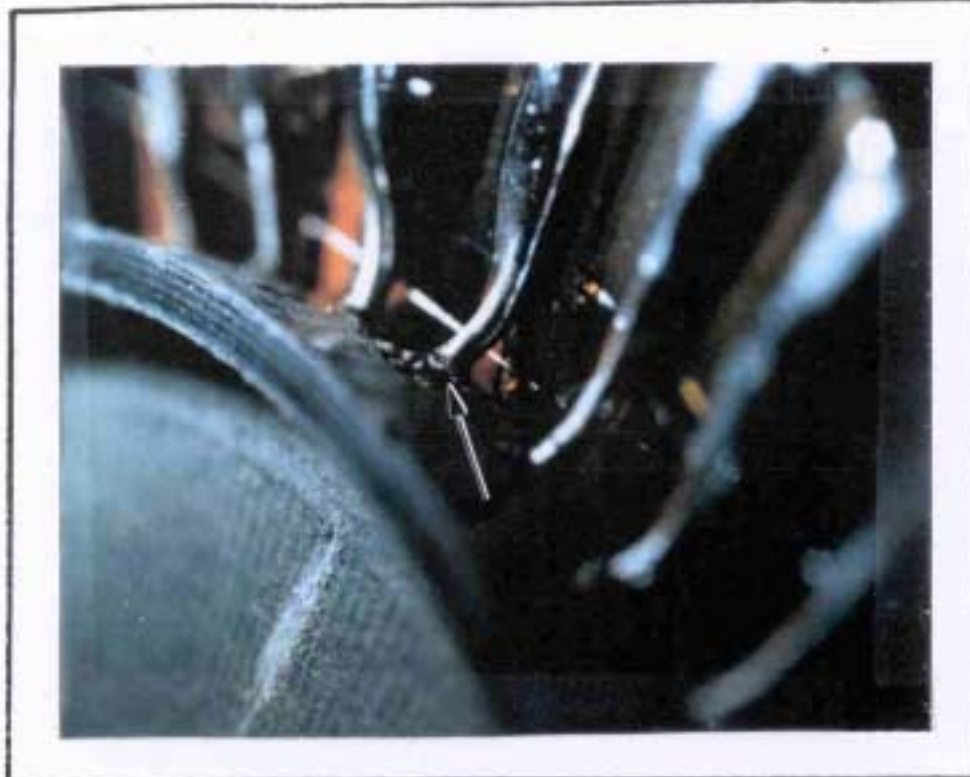
COMMENTS: ARROW SHOWING LOCATION OF
BROKEN PIN 8 EXIT LEAD WIRE ON 46
SLIPRING.
