COLUMBIA

ACCIDENT INVESTIGATION

**REPORT VOLUME IV** OCTOBER 2003

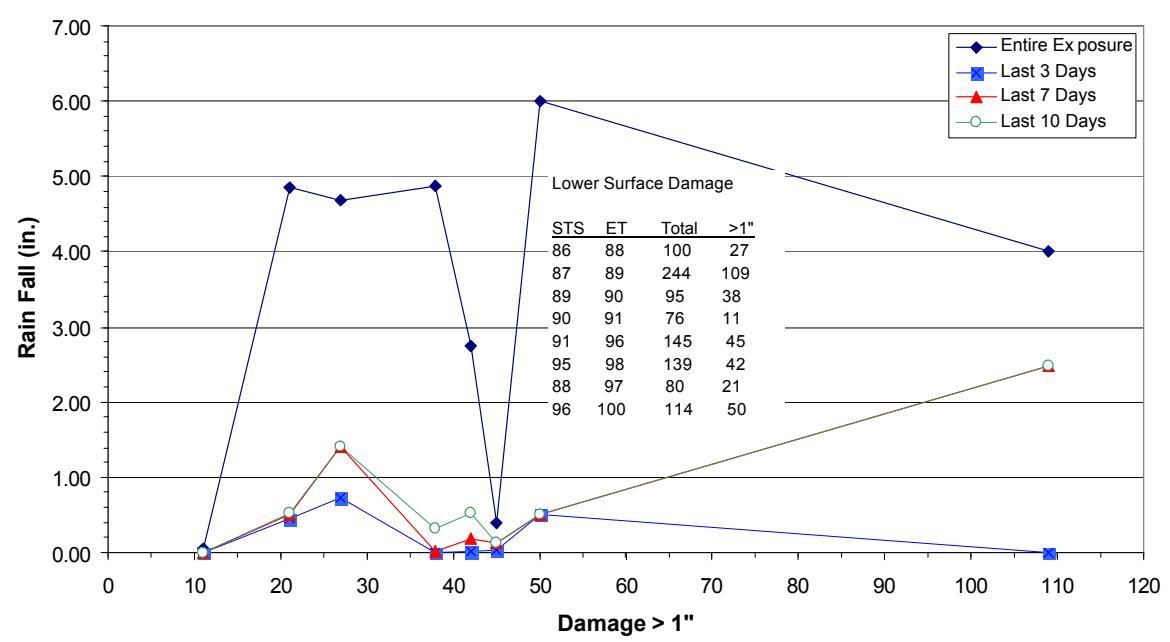
Figure 6. Correlation of On-Pad Rainfall to Orbiter Lower Surface Tile Damage.

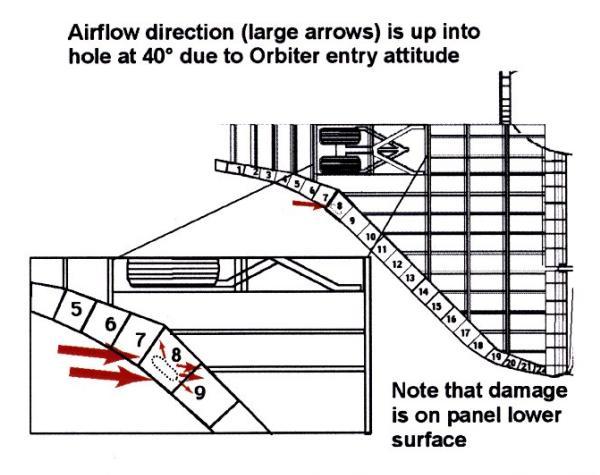
Figure 6: Hypothesized Entry Damage and Initial Entry Heating at Entry Interface.

Testing at Southwest Research Institute and associated analysis has shown (Reference 3) that a strike of debris on the RCC from the ET bipod (briefcase-sized, weighing about 1.7 lbs) striking the WLSS at speeds of 770 ft/sec can cause severe damage. Damage observed included RCC panel cracking, cracking of T-Seals, displacements of both panels and seals and the formation of holes as large as 16 inches by 16 inches.

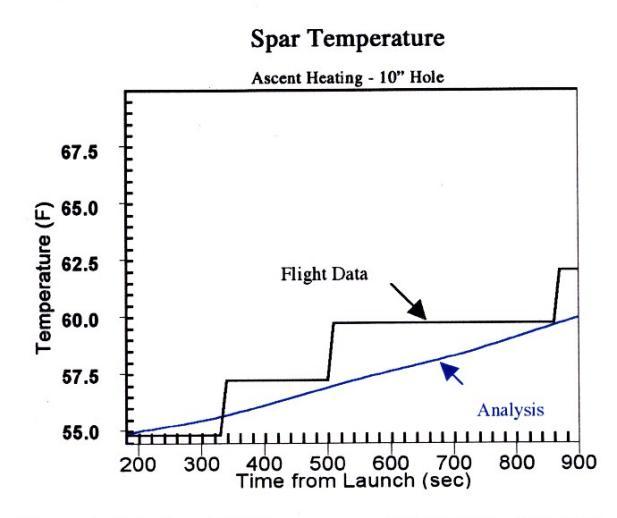
Figure 7: Data from OEX Thermocouple VO 9T9895 and Thermal Analysis by NASA (Reference 12).

One piece of evidence that corroborates that there was a breach in the wing at EI comes from the MADS/OEX thermocouple located behind the spar at the Panel 9 location. As discussed in References 4 and 12, there was "out-of-family" heating at this location during the STS 107 ascent. Figure 7 shows the time history of the measured thermocouple signal and the comparison of NASA's thermal analysis (Reference 12) of the ascent event. As indicated on the figure, the "stepped" curve is the flight data while the blue-colored, smooth curve is the result of the NASA analysis. Note that the temperature readings are not large, owing to the facts that ascent heating is small, relative to that for entry, and that the thermocouple locations will be discussed later.

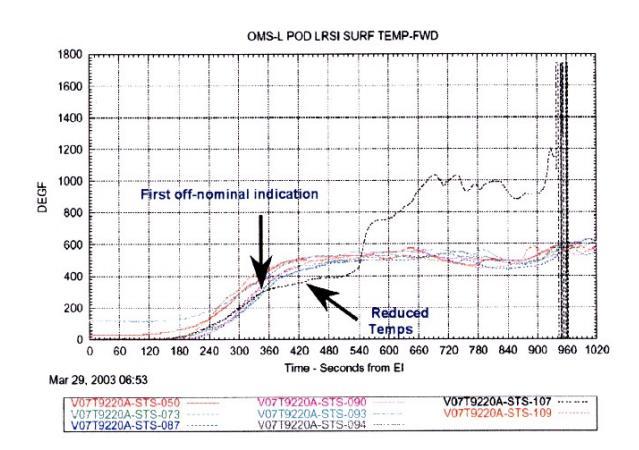
Figure 13: Off-nominal OMS Pod Temps.

Figure 13 shows temperature histories from the left-hand Orbital Maneuvering Systems (OMS) Pod. Again, data from other, similar flights is shown. As can be seen, below nominal temperatures were recorded, starting at about 340 seconds after EI. The following figure explains that this is likely due to a modification to the normal flow field by damage in the wing leading edge. Note also from this figure that at about 540 seconds from EI, the temperature abruptly <u>increases</u>, to values well beyond that for a normal entry.

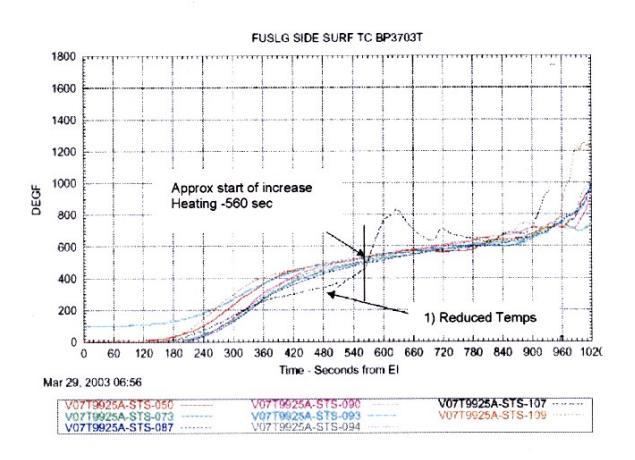
Figure 17: Representative Fusalage Sidewall Thermocouple Data.

Figure 17 displays the left fuselage sidewall thermal profile for thermocouple VO7T9925A in the standard MADS/OEX format wherein the data for STS 107 are compared to those from other, similar entries of Columbia. As can be seen, there is an out-of-family lower temperature trend at EI + 360 seconds, correlating to GMT 13:50:09. This early below nominal, and later, above nominal temperature observation on the fuselage sidewall, for a number of thermocouples has been explained by the NASA team led by J. Caram (Reference 16) to arise from flow disturbances propagated from the wing leading edge. The study depends upon a combination of hypersonic wind tunnel data and CFD analysis. The reader interested in detail is referenced to this report and the Aerothermodynamics section of the CAIB report (Reference 17).

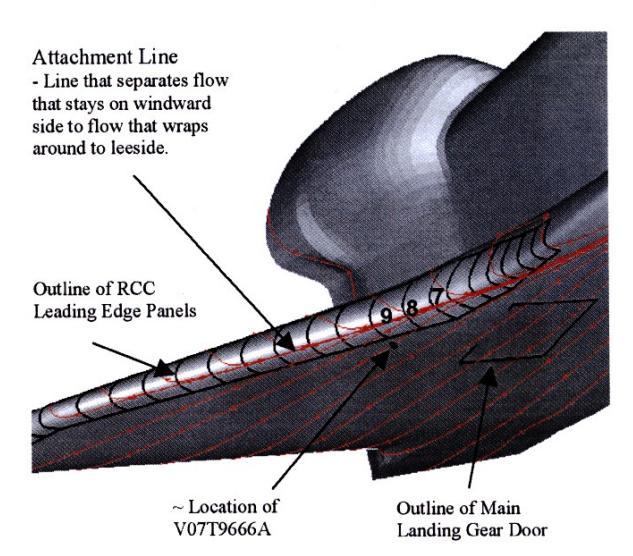
Figure 19: Orbiter Surface Streamlines. 13:50:53 (EI + 404), Mach: 24.9, Altitude: 243 k ft and Location of Thermocouple in Tile. CFD Solution from NASA (Reference 18).

As shown in Figure 19, thermocouple V07T9666A is in the flow area affected by Panel 8 (Reference 18). Specifically, as shown in the figure, the streamline, which passes over the junction of the lower Panel 8/9, also intersects the approximate location of this thermocouple. As will be discussed below, the forensic analysis shows compelling evidence that there was an outflow from the aforementioned 8/9 RCC lower panel junction that probably caused the above nominal readings of V07T9666A that started at EI + 370 seconds and continued till the spar breach occurred. This CFD solution by Gnoffo, Alter and Thompson (Reference 18), was the starting point of studies of flow into the breach, as will be discussed below.

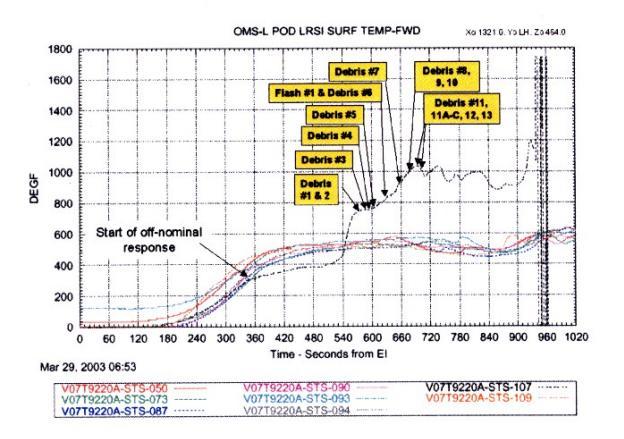
Figure 24: Left OMS Surface Temp Response Indicating the Progression of Damage.

Figure 24 displays the time history of thermocouple V07T9220A located on the OMS Pod. The observation made by NASA (Reference 16) is that from  $13:53:29 \rightarrow 13:55:29$  (EI + 560 -> 680 seconds), there are continual off-nominal increases in OMS Pod temperatures that correlates with the timing of debris sightings 1-13 during the flight. This correlation clearly suggests increasing damage is occurring to the left wing, specifically to the TPS and its substructure.

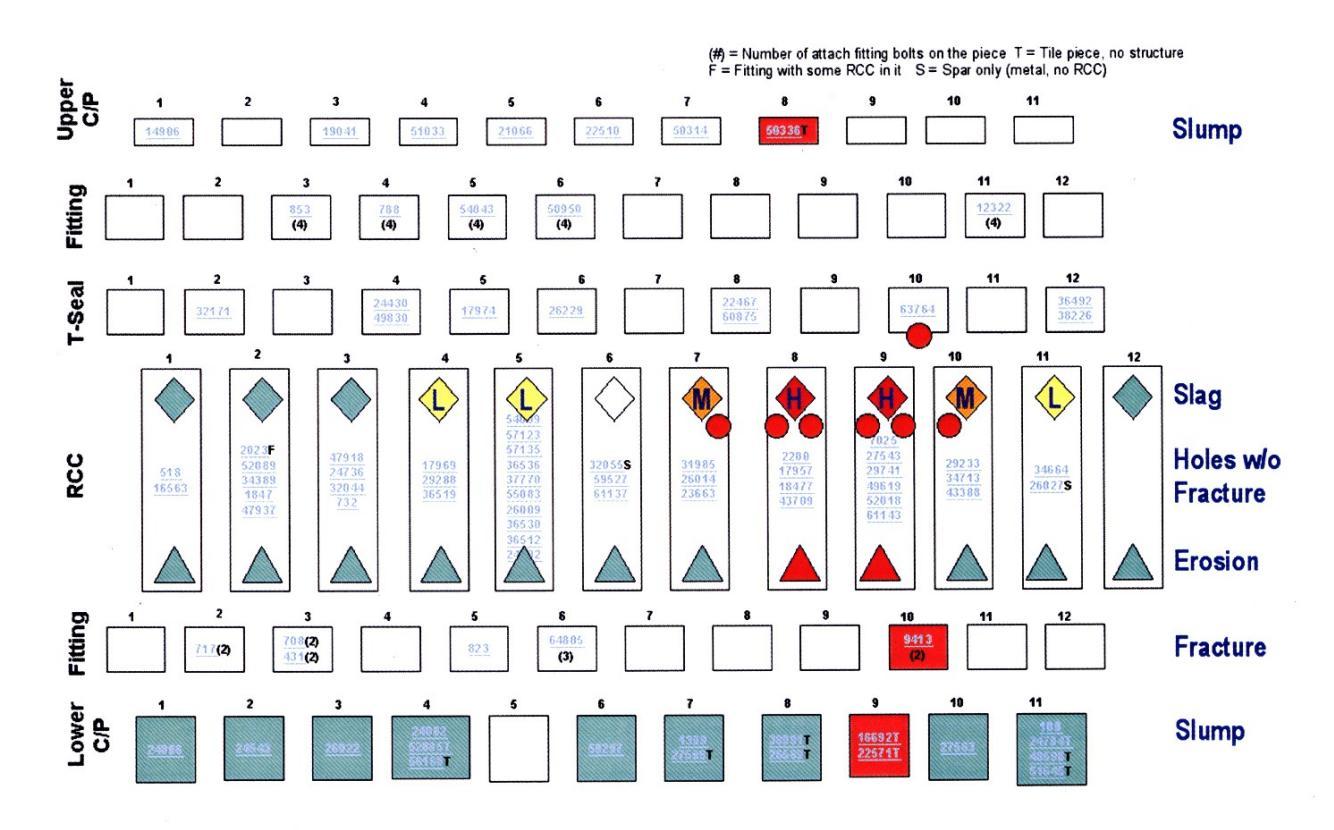
Figure 27: Left Hand Wing Debris Points to Breach in RCC Panel 8/9 Area (Reference 20).

For "Slag" the diamond symbol was used: Red (H) means heavy slag, Orange (M) means medium slag, Yellow (L) means light slag, Green (no letter) means none or very light slag. "Holes without fractures" refers to the unbroken holes in the RCC, interpreted as evidence that the Inconel fasteners melted out. Here, red circles indicate that prolonged heating occurred. Red triangles depict significant RCC erosion. Green triangles indicate no RCC erosion. "Fractures" indicate the possible evidence of hotshortcracking of the A286 carrier panel attach bolts (as evidenced by intergranular fracture) as an indicator of prolonged high temperature exposure (Reference 20/Appendix, by L. Korb). The red square represents the only such finding among these debris.

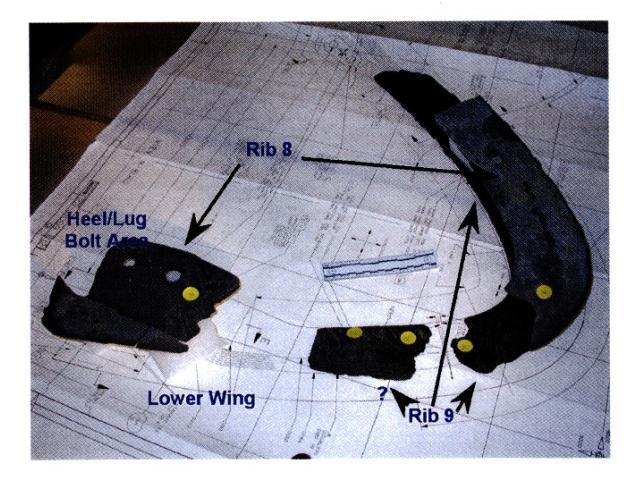
Figure 28: RCC Panel 8/9 Ribs (Outboard View).

The photograph in Figure 28 is an outboard view of recovered parts of RCC ribs from Panels 8 and 9. For perspective, four recovered parts of the outboard rib of Panel 8 are shown sitting on white foam blocks: one upper part of rib 8, and three parts from the lower part of the rib 8 heel/lug bolt area. Two recovered parts from the inboard, upper rib of Panel 9 are shown laying on their full-scale drawing. A third part, placed on the drawing, not identifiable, is likely also from the inboard rib 9 in the location shown. Lack of positive identification of this part is indicated by the ? mark written on the yellow tag. These parts show heavy ablation, and the RCC LW LESS Panel 8/9 area is the only location found with this feature. Ablation features are labeled using yellow tags with the letter "A." The ablation patterns facing the camera on this side of the rib parts strongly suggests that superheated air had been flowing inside the wing, in a generally outboard direction. This indicates significant and prolonged flow from the Panel 8 area into the Panel 9 and outboard regions of the wing inside the RCC-LESS channel. Edges of the ribs are sharpened to a near "knife-edge" (0.05 inches compared to undamaged thickness of 0.365 inches), with a flat side away from the flow direction. Because of the durability of RCC and the extent of the ablation, this flow probably was sustained inside the RCC-LESS cavity area for hundreds of seconds. This type of damage is the result of oxidation (ablation) of the RCC carbon substrate. The following figure shows the same parts from an inboard view.

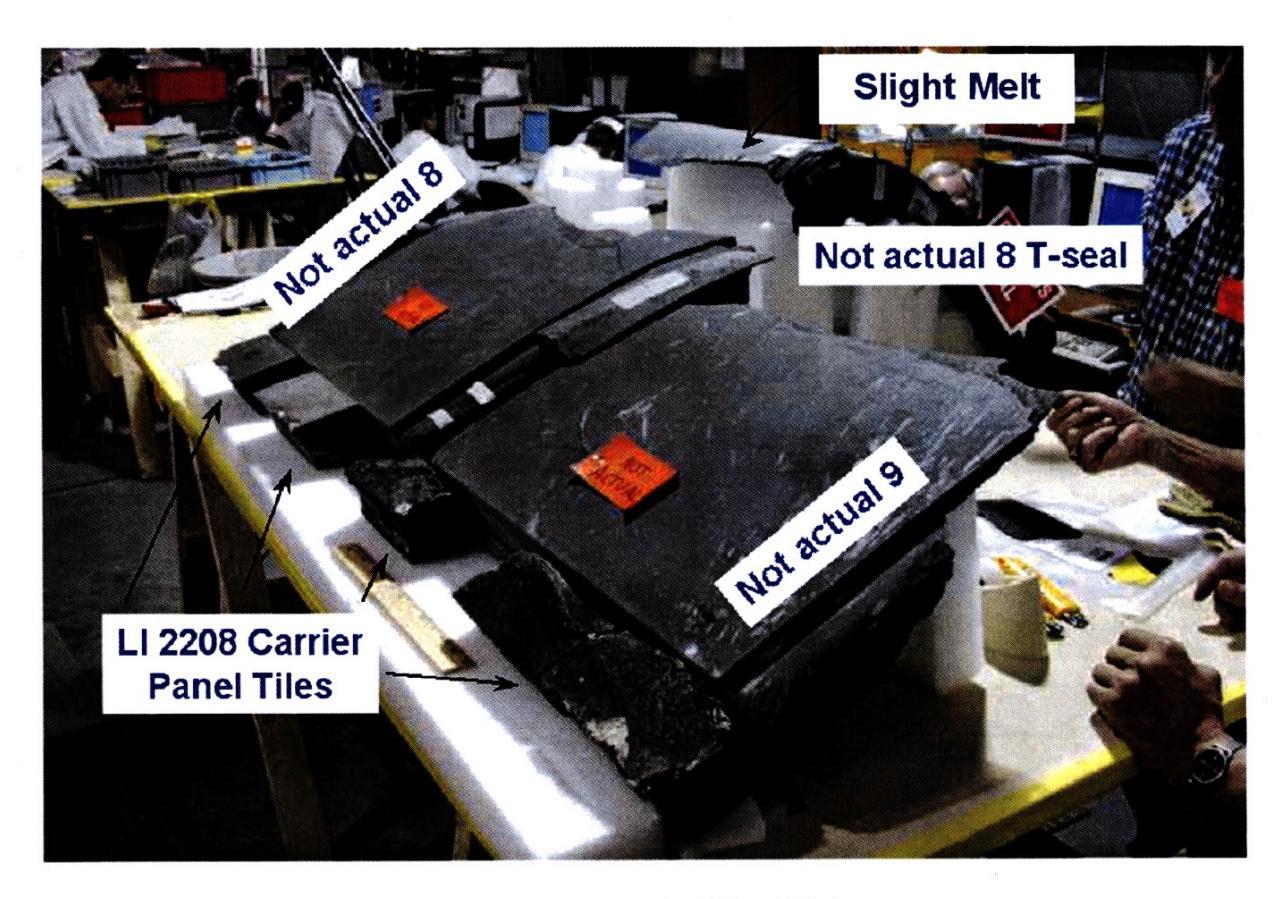
Figure 30: Reconstructed RCC Panel 8/9 Area.

As discussed earlier in describing Figure 19, streamline patterns determined by CFD show that flow out of this lower RCC Panel 8/9 juncture area directly affect the thermocouple V07T9666A, located in the lower tile field, close behind RCC Panel 9. This flow relationship, strongly suggests the above nominal temperatures recorded by this thermocouple were caused by the flow out of the lower Panel 8/9 juncture, which also eroded the lower Panel 9 carrier panel tiles. The flow out of this slot, into a relatively high-pressure area (but below the pressure at the inlet breach) was probably the only outlet available to the large volume of ingested gases once the flow-through of the RCC vent slots was choked. The traces in Figure 18 suggest that this started at EI + 370 seconds and persisted until spar burn-through at approximately EI + 487 seconds.

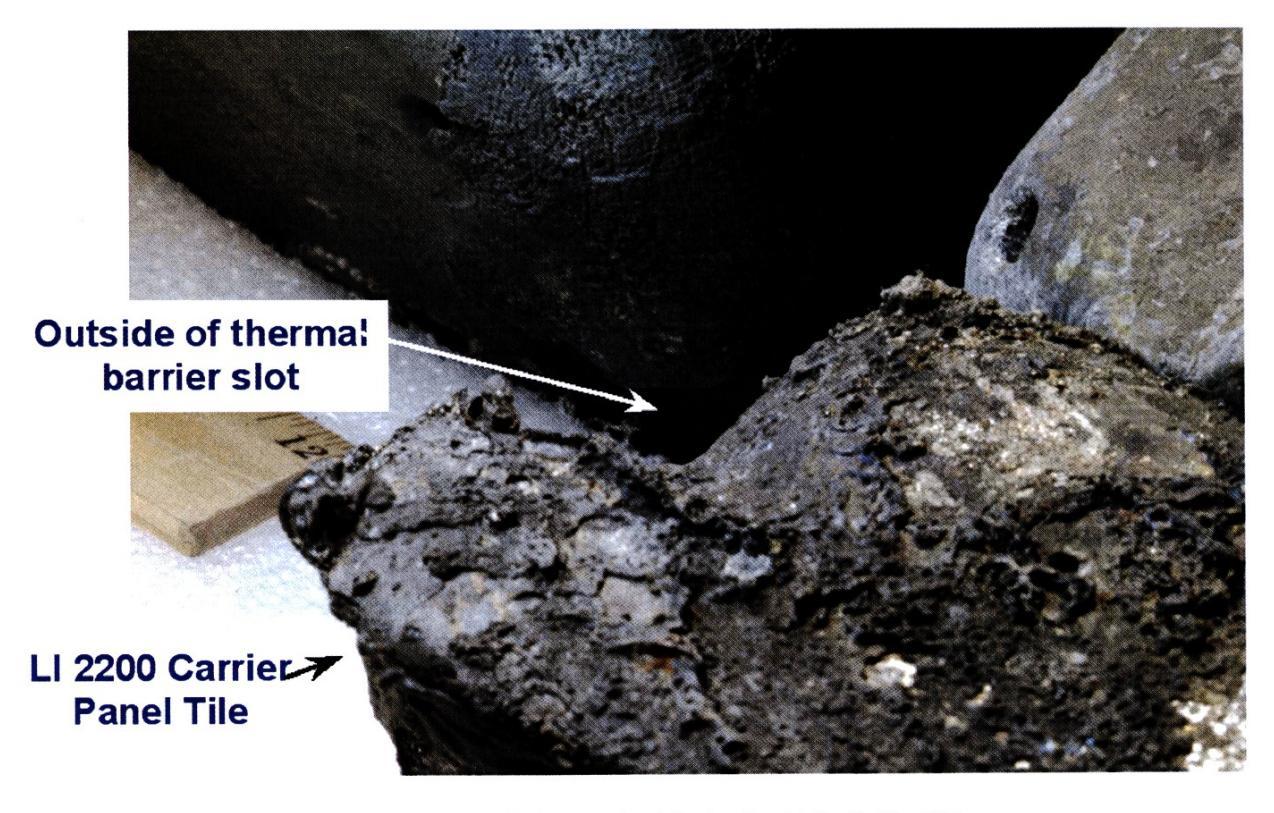
Figure 31: Close-up of Flow Location Affecting Panel 9 Carrier Panel Tiles

The authors believe that in addition to a breach in Panel 8, the upper part of the T-seal between Panels 8 and 9 must have been missing or severely misaligned for a major part of the entry. This is required to account for the severe erosion of the upper RCC Panel 8 outboard and Panel 9 inboard ribs shown in Figures 28 and 29 and discussed above. Flow patterns of the recovered upper Panel 8, suggest this happened as discussed in Reference 20.

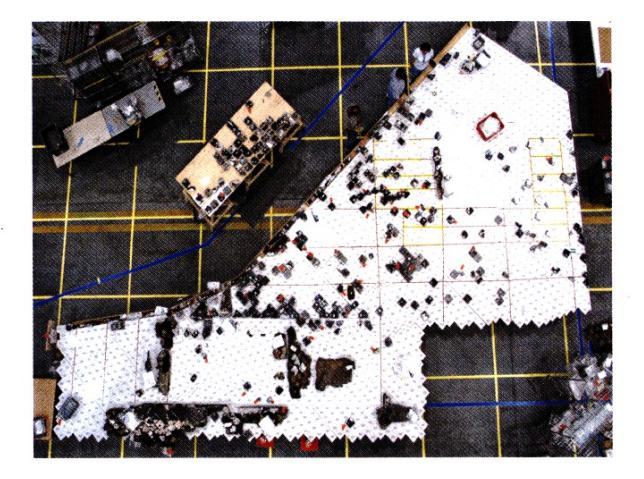
Figure 35: Overview of Tile Table. Left Wing, Lower Surface Tiles.

There is a distinct pattern of RCG coated tiles, in the general X-direction downstream of Panels 8 and 9, outboard of the wheel well where the tiles appear to have little of the dark metal deposit (aluminum - rich) generally seen on the recovered tiles. These normal-appearing tiles all have been identified to have failure at the tile/Koropon bond line and departed from the wing surface prior to a major outflow of molten aluminum. This is indicative of extreme heat, inside the wing behind Panel 8. It then seems probable from this observation that the breach in the wing spar occurred at the Panel 8 location, and this is consistent with the observations discussed above. Ballistic analyses of the trajectories and the geographic location of the recovered tiles (both those detached owing to bond failure and those that did not) suggest they came off from about 100 nautical miles west of their recovery location in Texas.

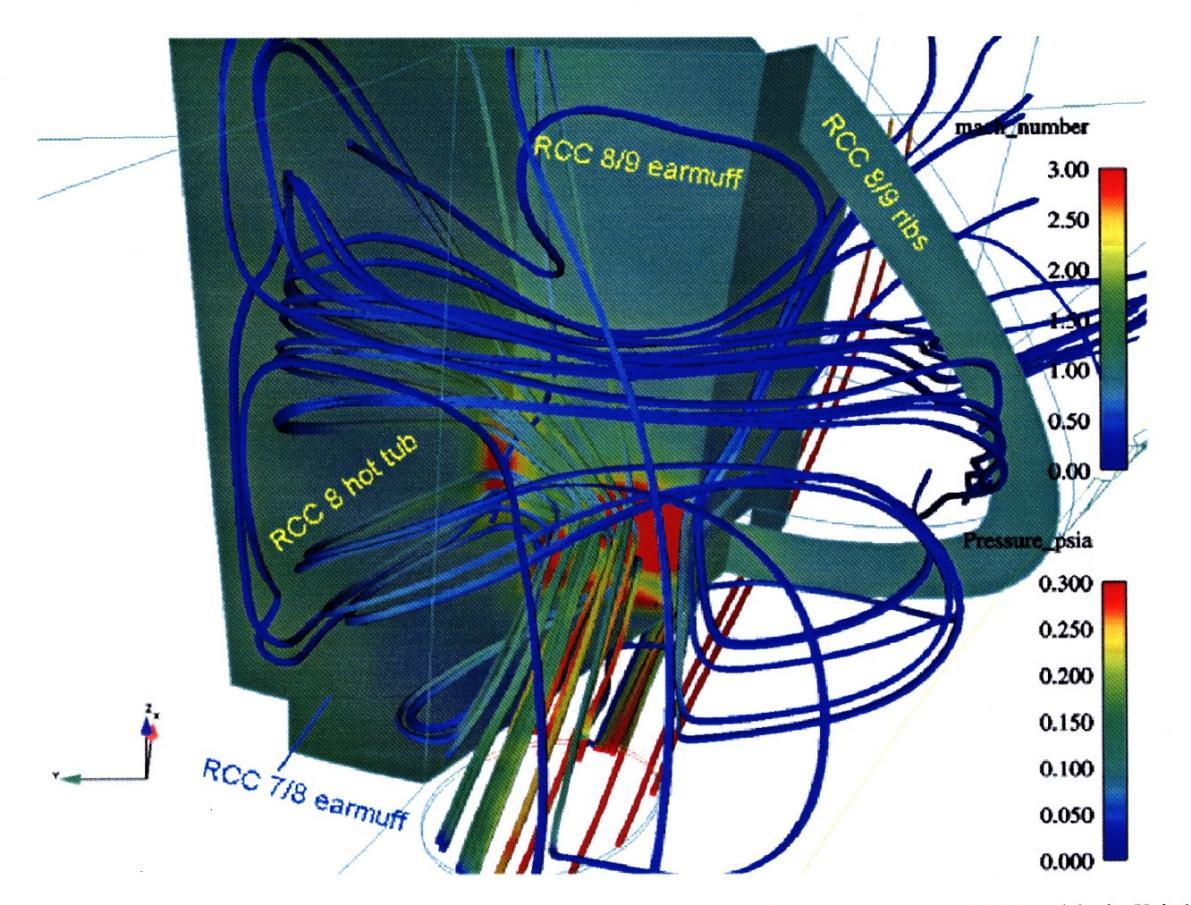
Figure 37 depicts a view of the CFD results (Reference 22) from the front of the leading edge with the acreage of the panels rendered transparent. The hole in RCC Panel 8 is outlined on the lower left corner of the figure. Streamlines are color coded by Mach number and pressures on the earmuff and spar insulation "hot tub" are displayed by the color-coding shown in the figure. As can be seen, the subsonic flow is complex and the jet creates a significant high-pressure zone on the RCC 8/9 earmuff.

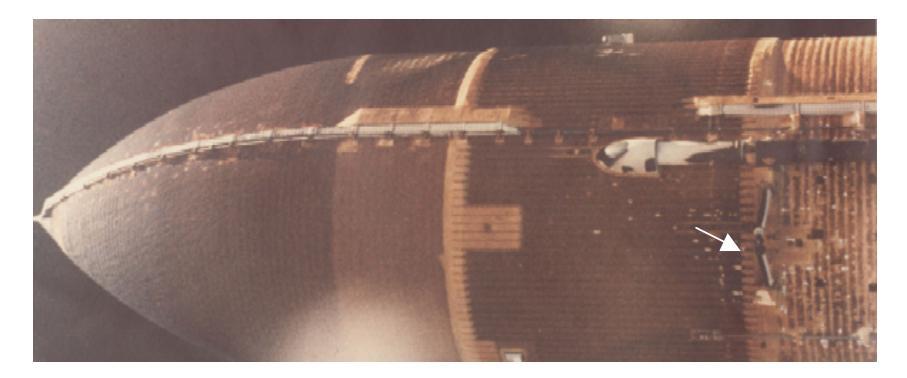
Figure 5.3.3.2-1. STS-7/ET-6

<ul> <li>STS-7/ET-6 (launched 06/18/83)</li> <li>Post separation film showed a large portion of the -Y (LH) bipod ramp missing</li> <li>Lower surface Orbiter tile damage locations = 151 with 40 &gt;1*</li> </ul>
	<ul> <li>STS-32/ET-32 (launched 01/09/90)</li> <li>Post separation film showed two divots measuring 12 to 14 inches between bipod and just above the flange and a third divot 14" in diameter centered between between ramps and extending into the flange area measuring 28" wide. The third divot surrounded the forward part of the -Y (LH) bipod ramp</li> <li>Lower surface Orbiter tile damage locations = 111 with 13 &gt;1"         <ul> <li>Largest damage: 2.0" x 3.0" x 0. 5"D (Right side of Orbiter, aft of the forward Main Landing Gear)</li> </ul> </li> </ul>
Nie.	<ul> <li>STS-35/ET-35 (launched 12/02/90)</li> <li>Ten circular TPS divots in the Intertank to Hydrogen tank flange doseout (ranging 8 to 10")</li> <li>Lower surface Orbiter tile damage locations = 132 with 15 &gt;1"         <ul> <li>Largest damage: 5.75" x 3.75" x 0.25"D (Right side of Orbiter, aft of forward Main Landing Gear)</li> </ul> </li> </ul>
