NAME P/N QTY	CRIT	FAILURE MODE & CAUSES	FAILURE EFFECT	RATIONALE FOR ACCEPTANCE
COMMON MULTIPLE CONNECTOR, ITEM 410 SY778872-18 (1)	2/2	410FH01: External leakage, coupled, oxygen.  CAUSE: Failure, coupling O-seal bypass leakage, defective interfacing dynatube hose or hose fitting leakage.	END ITEM: Leakage of vehicle oxygen supply to ambient. Unable to charge the PLSS primary O2 bottles if the leakage is excessive.  OPE INTERFACE: Excessive consumption of vehicle oxygen.  MISSION: Unable to use one EMU during IV activity if leakage is excessive.  CREW/VEHICLE: None.	A. Design - The coupled oxygen supply fitting has three potential external leakage paths. One path is blocked by a single static radial O-Seal. The second leakage path contains a radial O-seal which slides axially along a sealing surface provided by the SCU connector plunger coupling and uncoupling.  The O-ring seal design configurations, dimensions and rigidness of assembly, provide squeeze under all loading conditions.  The third leakage path is by a dynatube fitting joint at the flex hose to SCU connector oxygen elbow. These fittings are required to have a 32 micro-inch maximum circular top surface finish to preclude

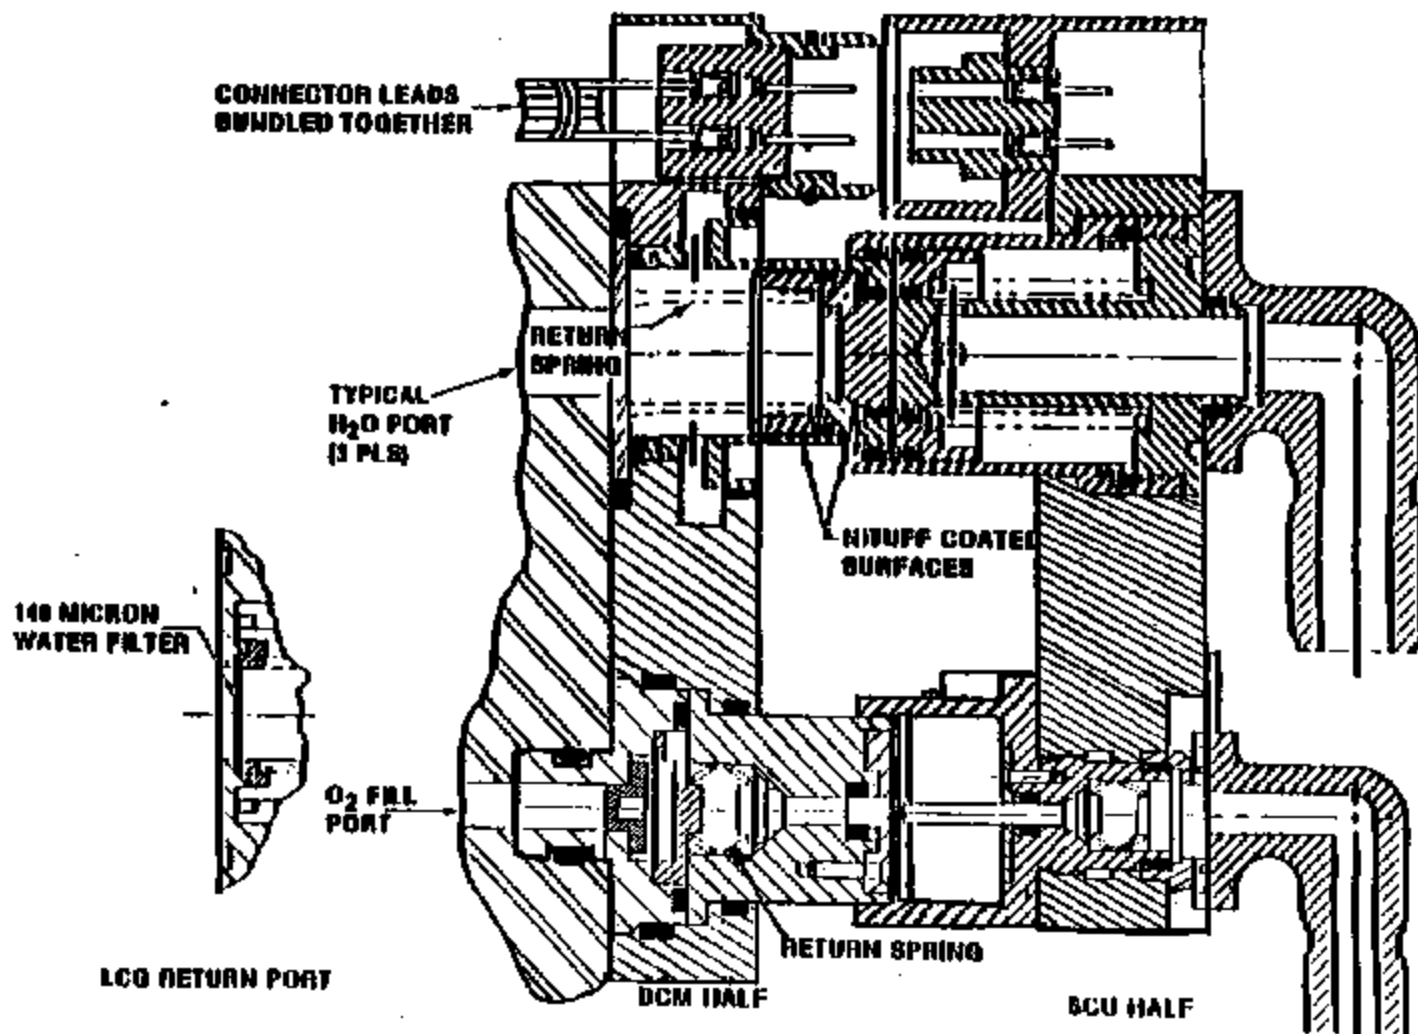
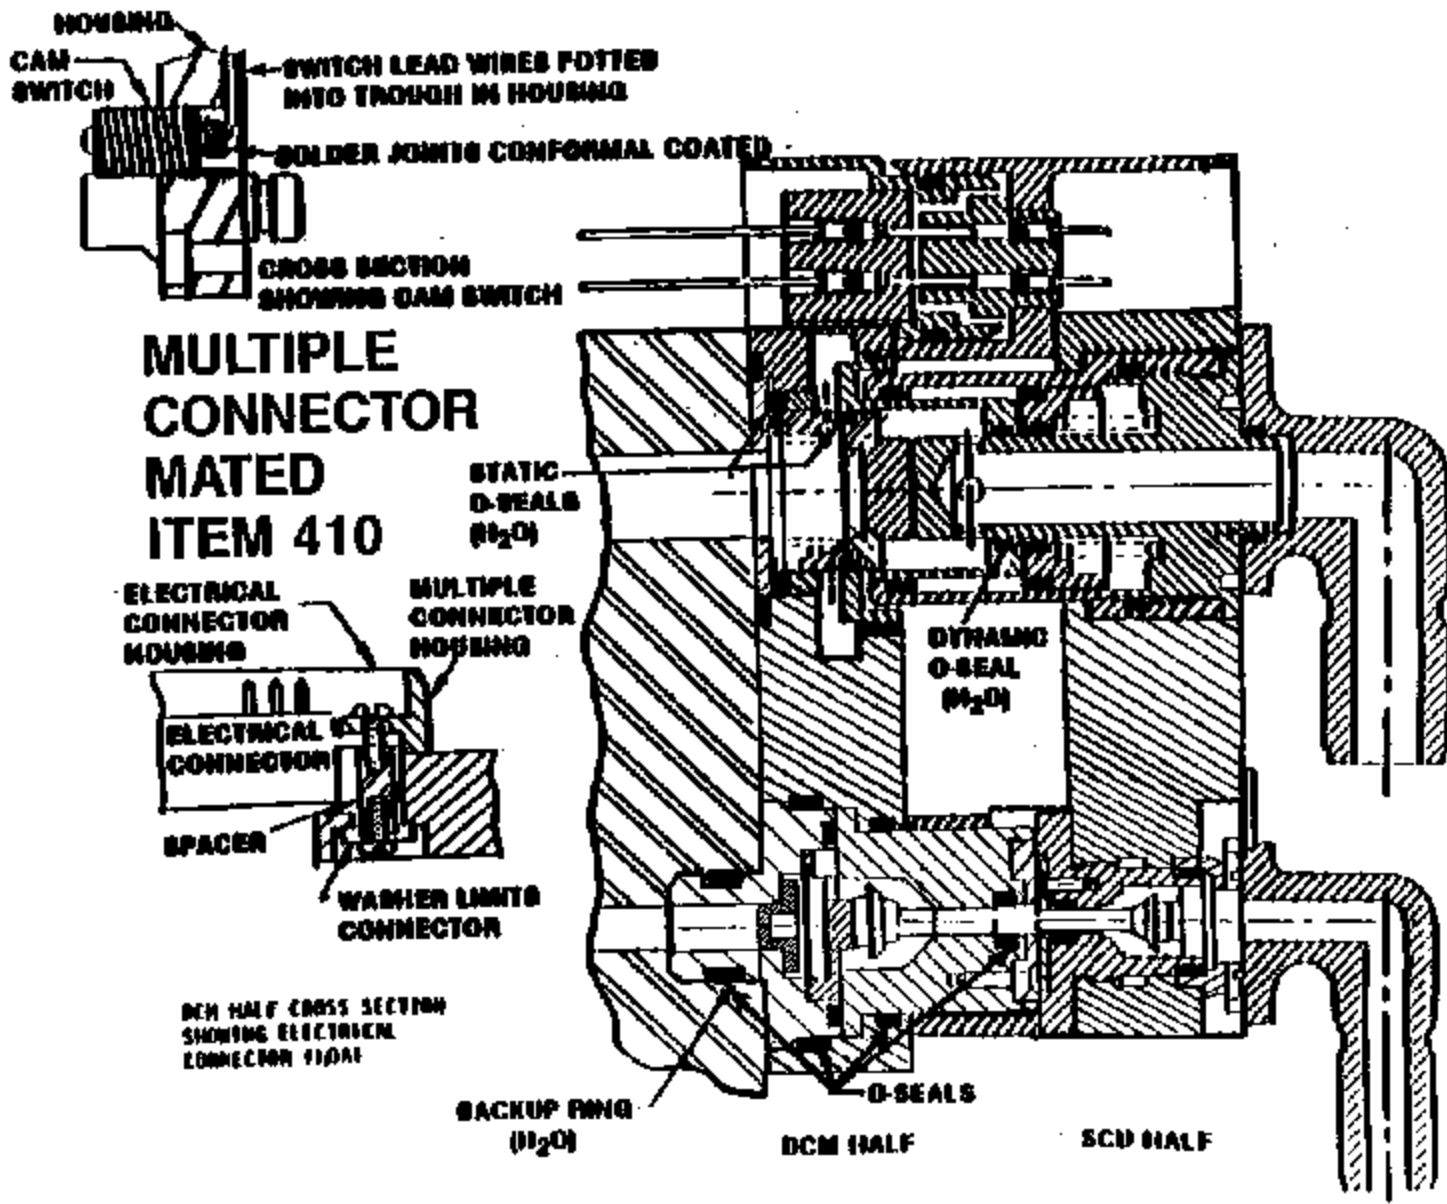
H-EMU-410-0001 (9/12/90) - Excessive leakage of SCU-side MWC O2 port due to cracks in the teflon impregnated hardcoat at the O-ring sealing surface. Leakage was initially masked by braycote lubrication which effectively provided a fluid seal at the O2 port O-rings until the braycote deteriorated over time. Per Call Task LSS-139, the O2 housing material was changed to Nitronic 60 to eliminate the hardcoat in new builds. Ref EC 163402-454-001.
