SPACE TRANSPORTATION SYSTEM
Johnson Space Center, 2101 NASA Parkway
Houston
Harris County
Texas

HAER TX-116
HAER TX-116

SPACE TRANSPORTATION SYSTEM HAER No. TX-116

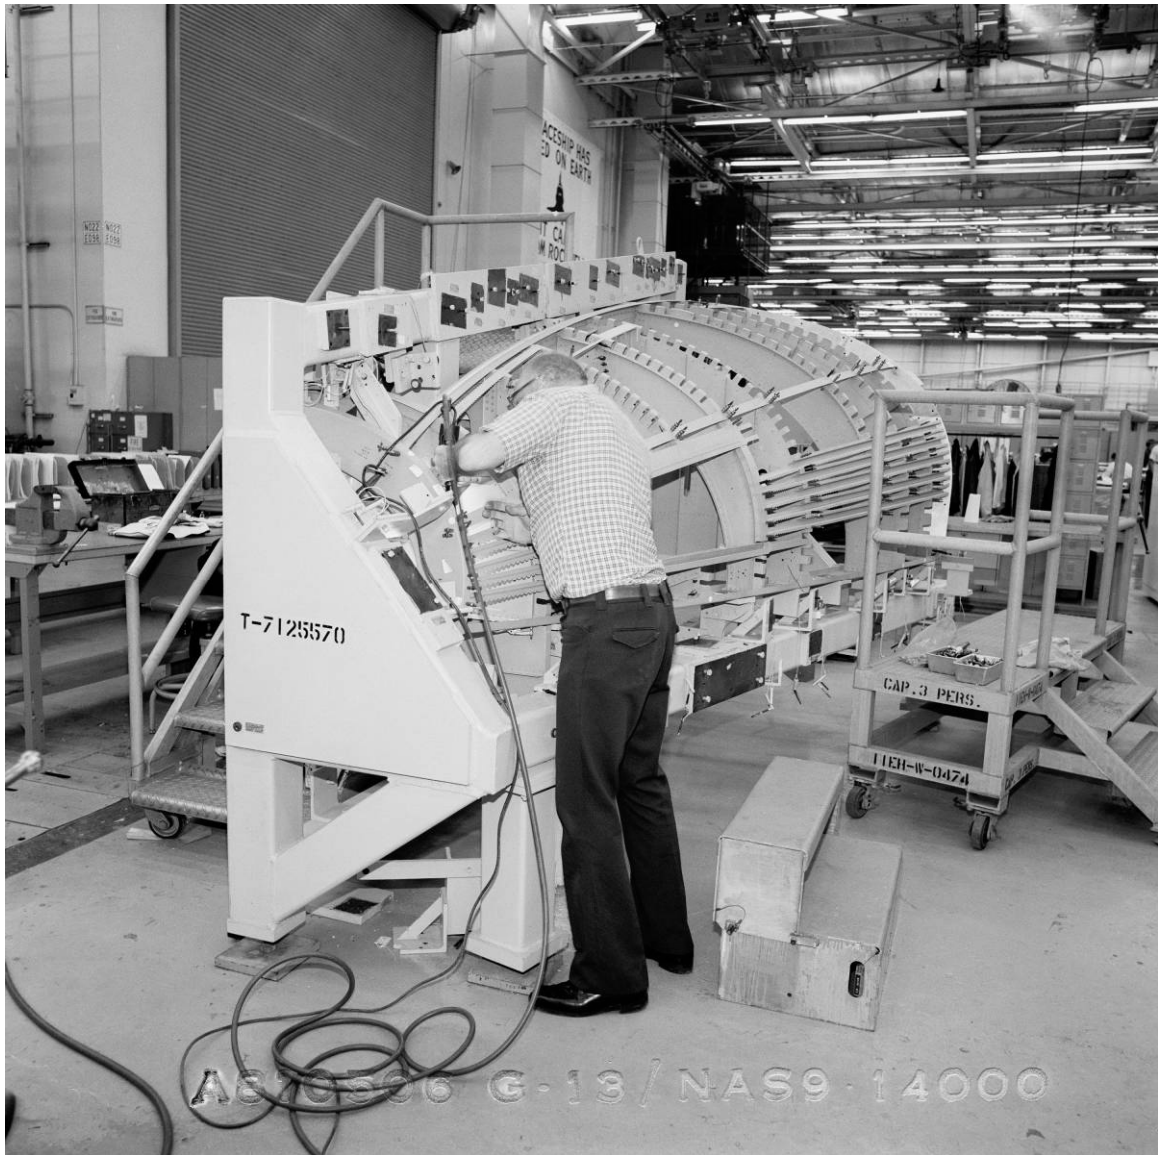
Figure B-1. Manufacturing of *Discovery's* lower forward fuselage, NAR Building 290, Downey, California, May 6, 1981.
Source: NASA, Johnson Space Center Image Repository, JSC2010-03096.

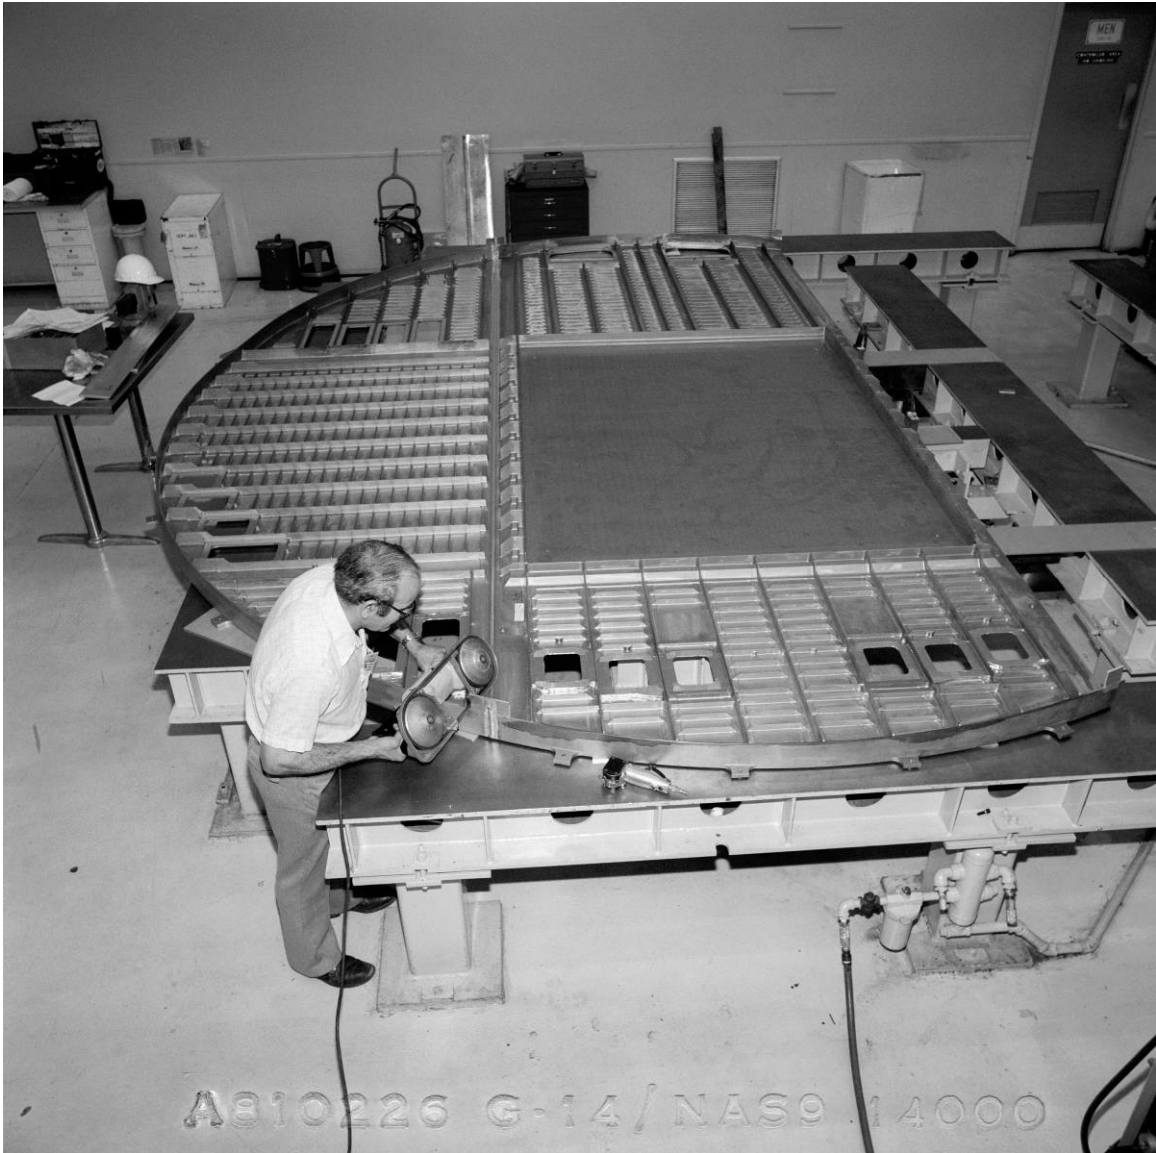
Figure B-5. Manufacturing of *Discovery's* crew module aft bulkhead, NAR Building 290, Downey, California, February 26, 1981.
Source: NASA, Johnson Space Center Image Repository, JSC2010-03081.

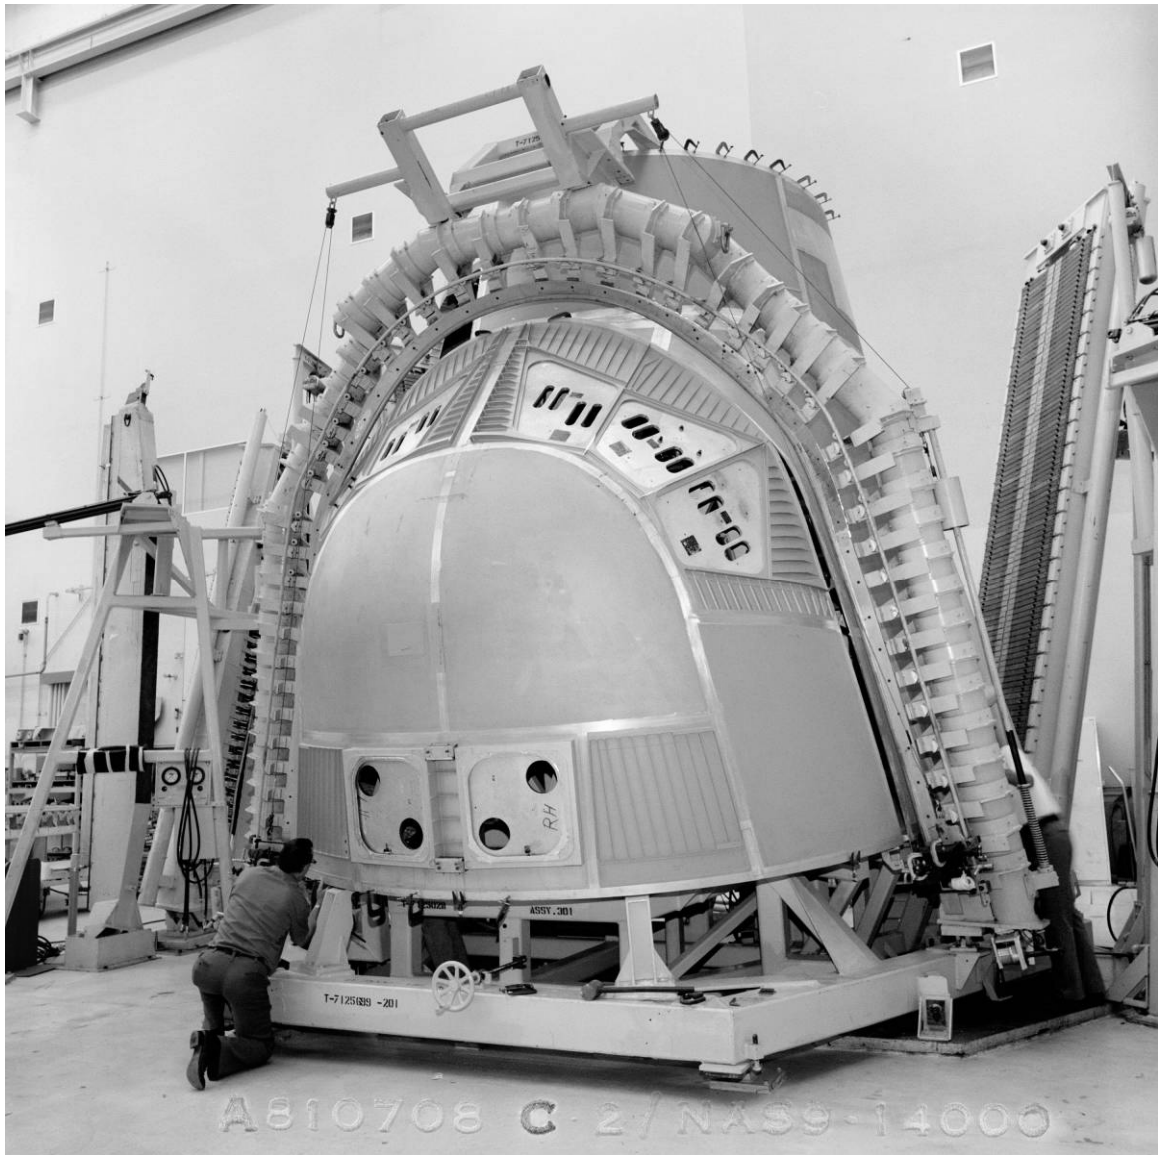
Figure B-8. Primary structure assembly for *Discovery's* crew module in weld tool, NAR Building 290, Downey, California, July 8, 1981.
Source: NASA, Johnson Space Center Image Repository, JSC2010-03119.

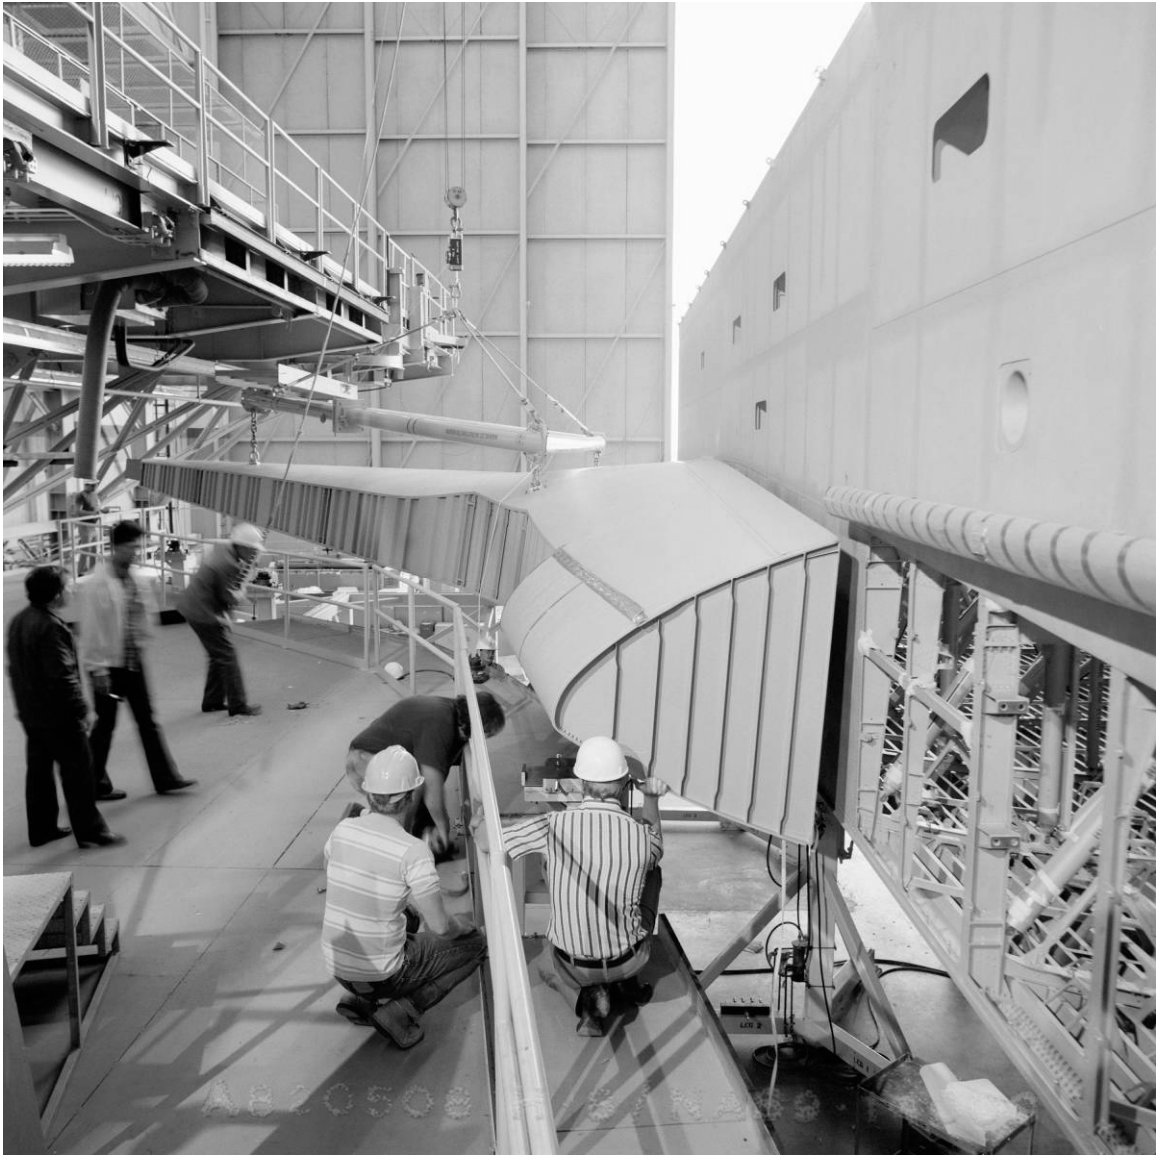
Figure B-23. *Discovery's* starboard wing being attached to the midfuselage in High Bay 2, AFP 42, May 8, 1982.
Source: NASA, Johnson Space Center Image Repository, JSC2010-03270.

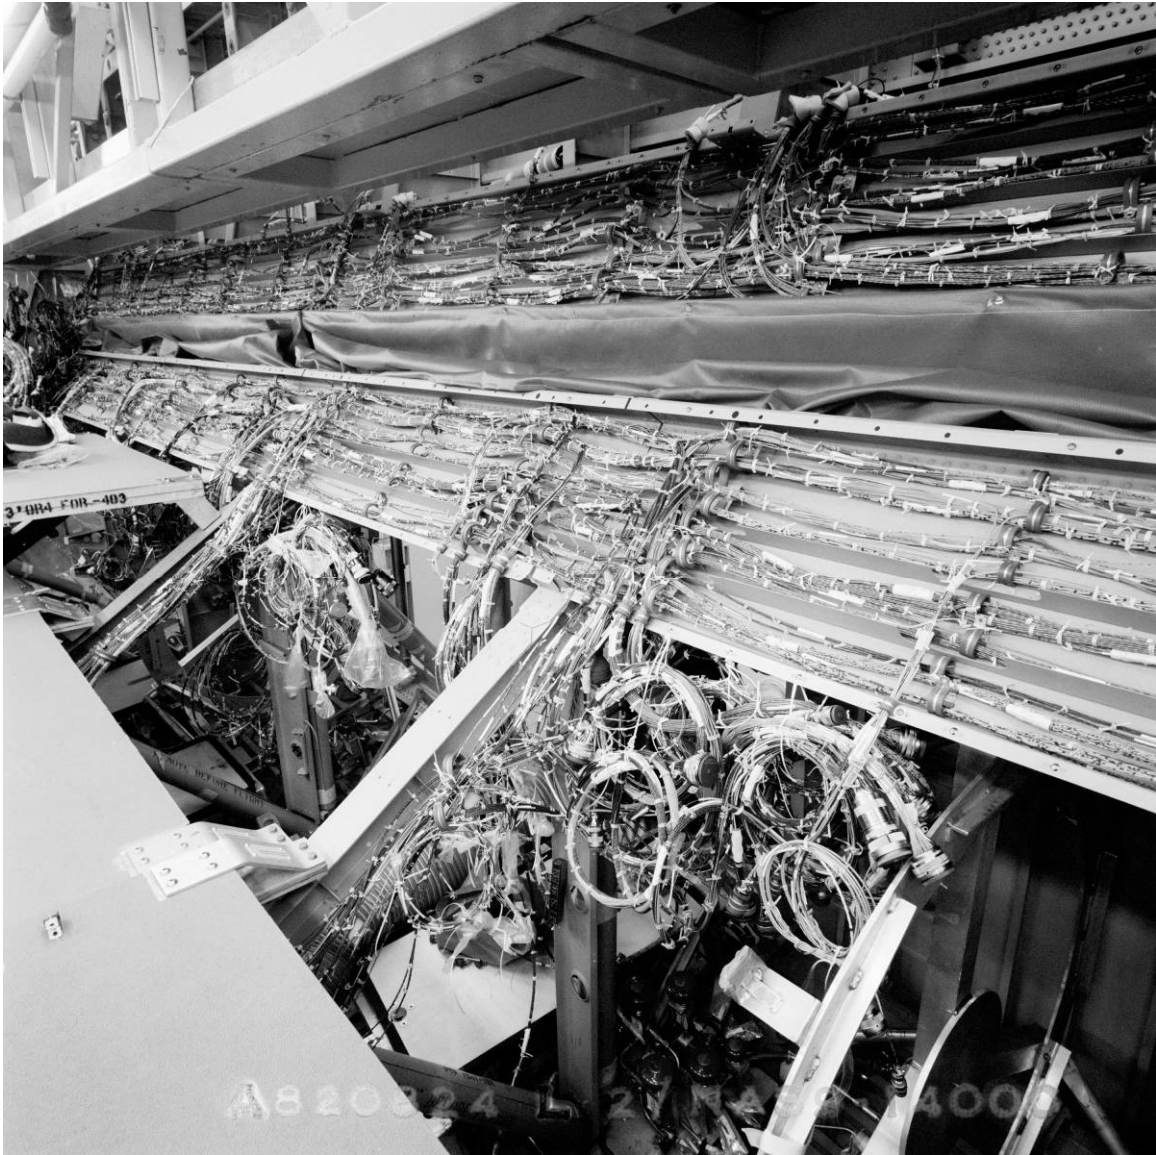
Figure B-25. Starboard wire harness being installed in *Discovery's* midfuselage in High Bay 2, AFP 42, August 24, 1982.
Source: NASA, Johnson Space Center Image Repository, JSC2010-03330.

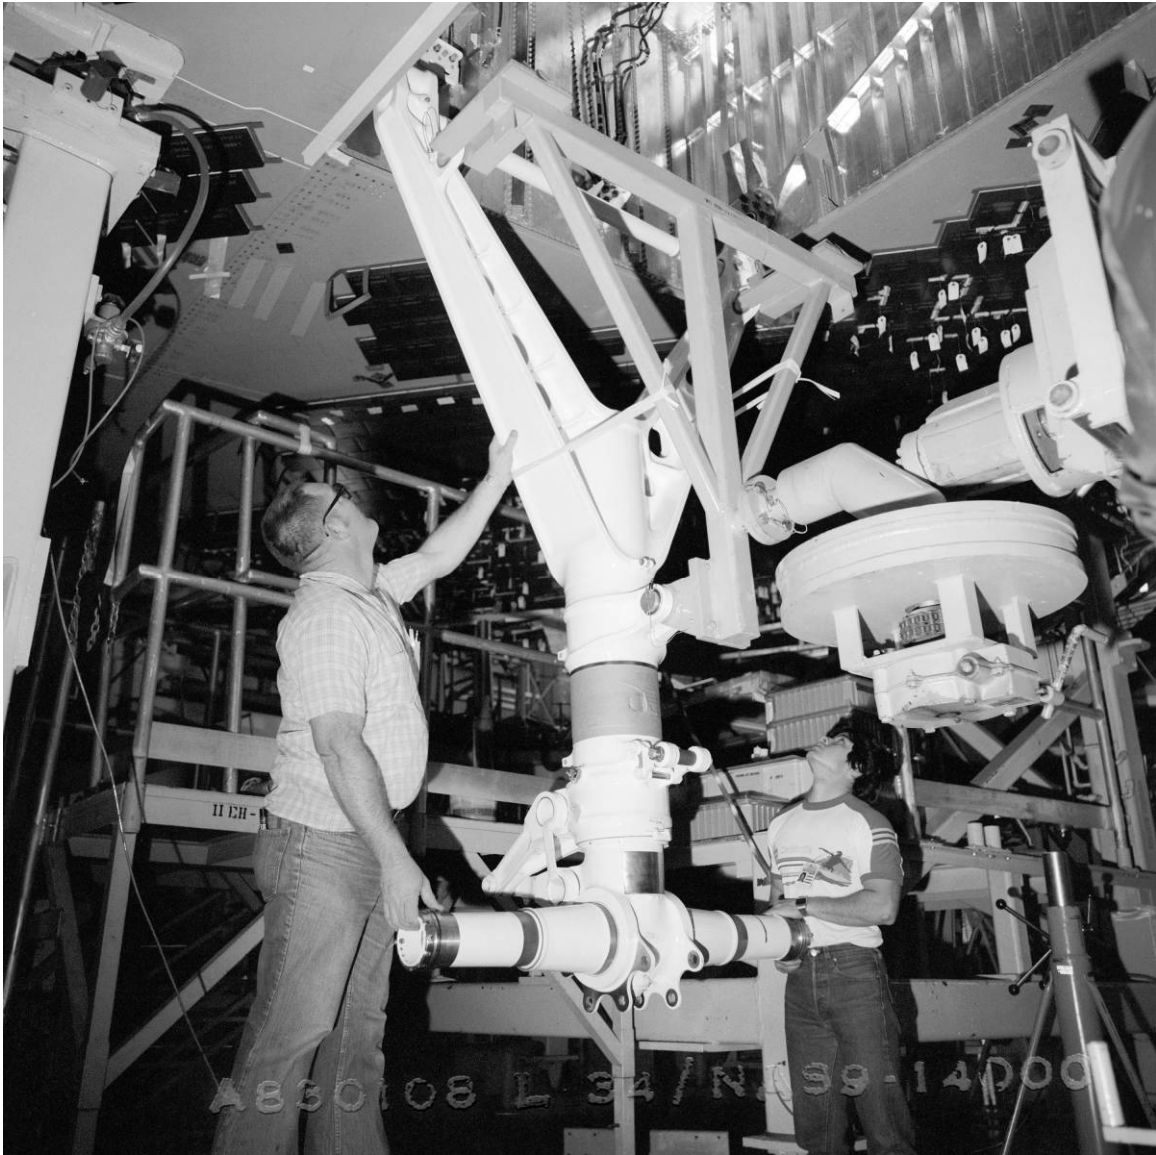
Figure B-35. Installation of *Discovery's* port side main landing gear in High Bay 2, AFP 42, January 8, 1983.
Source: NASA, Johnson Space Center Image Repository, JSC2010-03396.

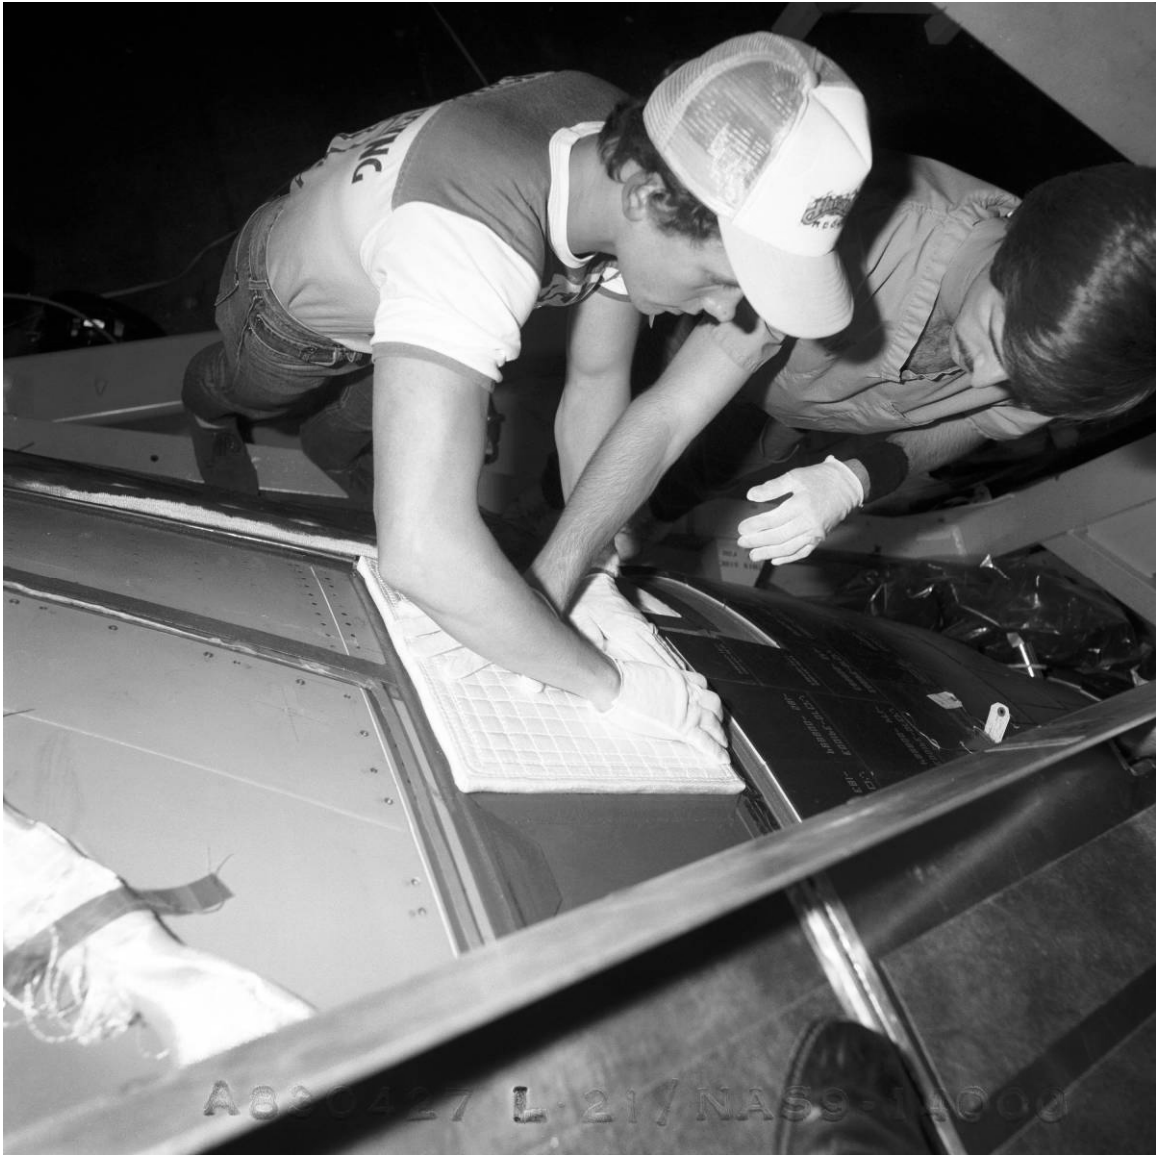
Figure B-49. Installation of AFRSI on *Discovery's* FRCS module in High Bay 2, AFP 42, April 27, 1983.
Source: NASA, Johnson Space Center Image Repository, JSC2010-03445.

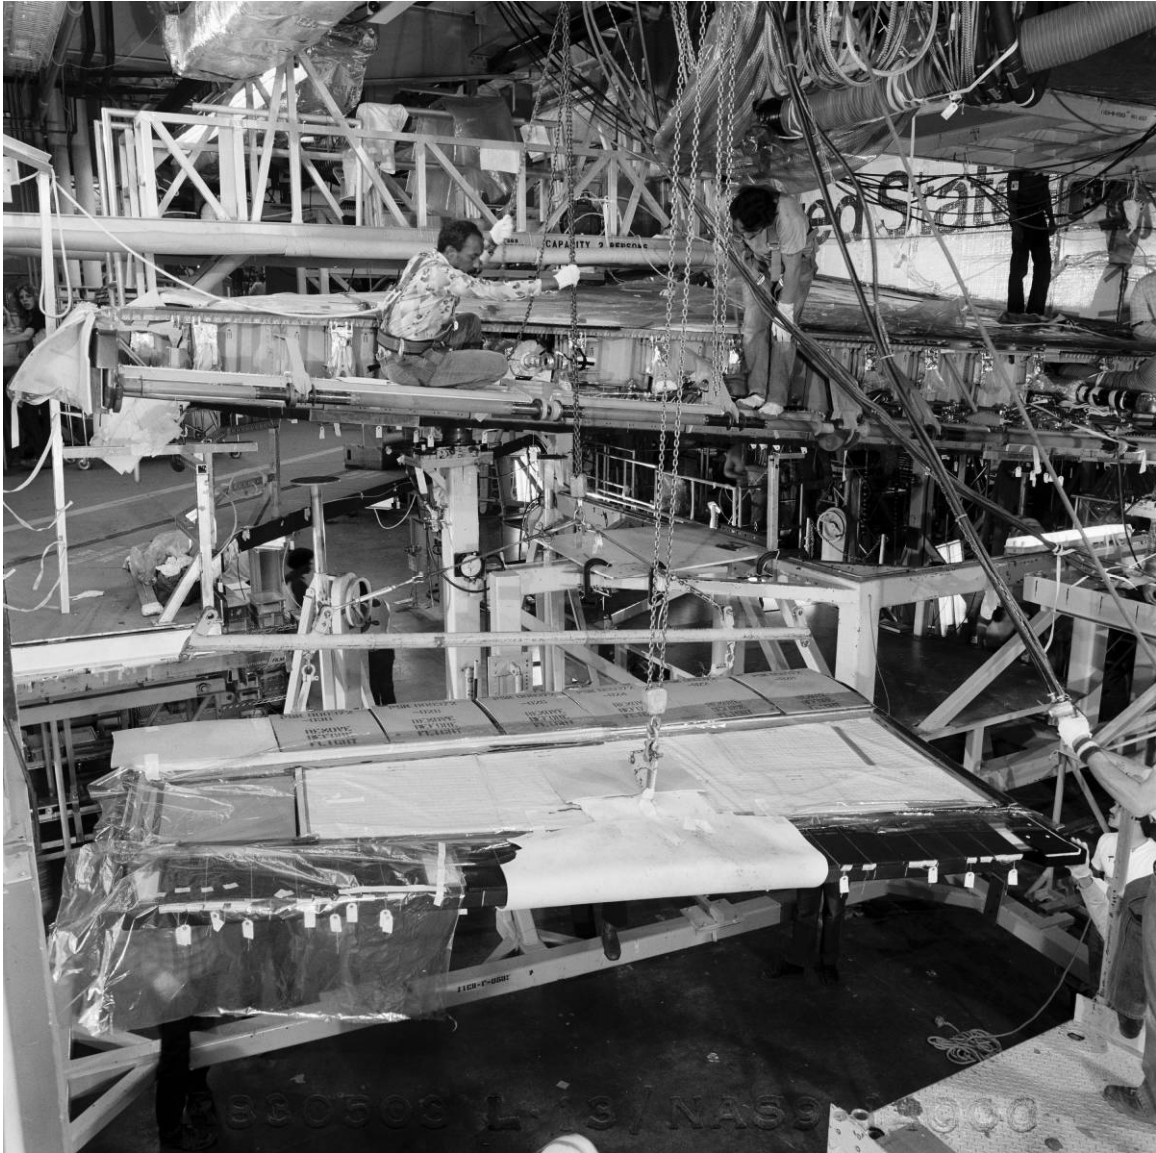
Figure B-50. Installation of outboard elevator to *Discovery's* port wing in High Bay 2, AFP 42, May 3, 1983.

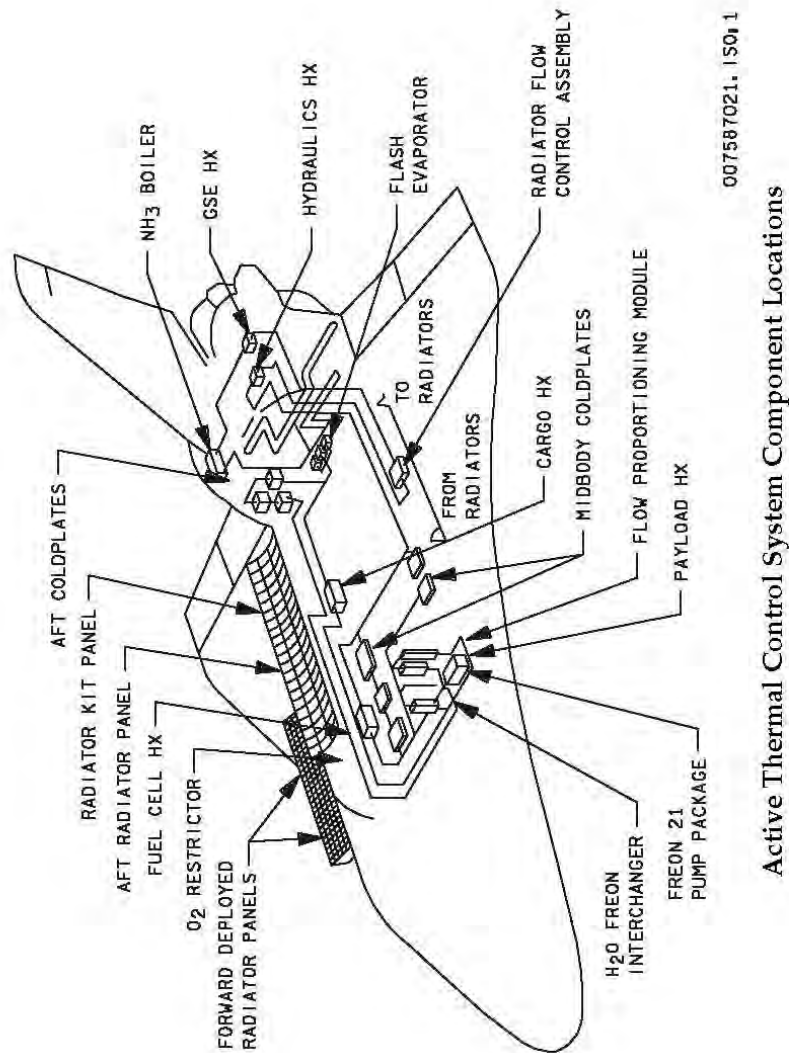
Figure B-121. Diagram of the ECLSS, active thermal control system.
 Source: USA, *Shuttle Crew Operation Manual*, 2.9-23.

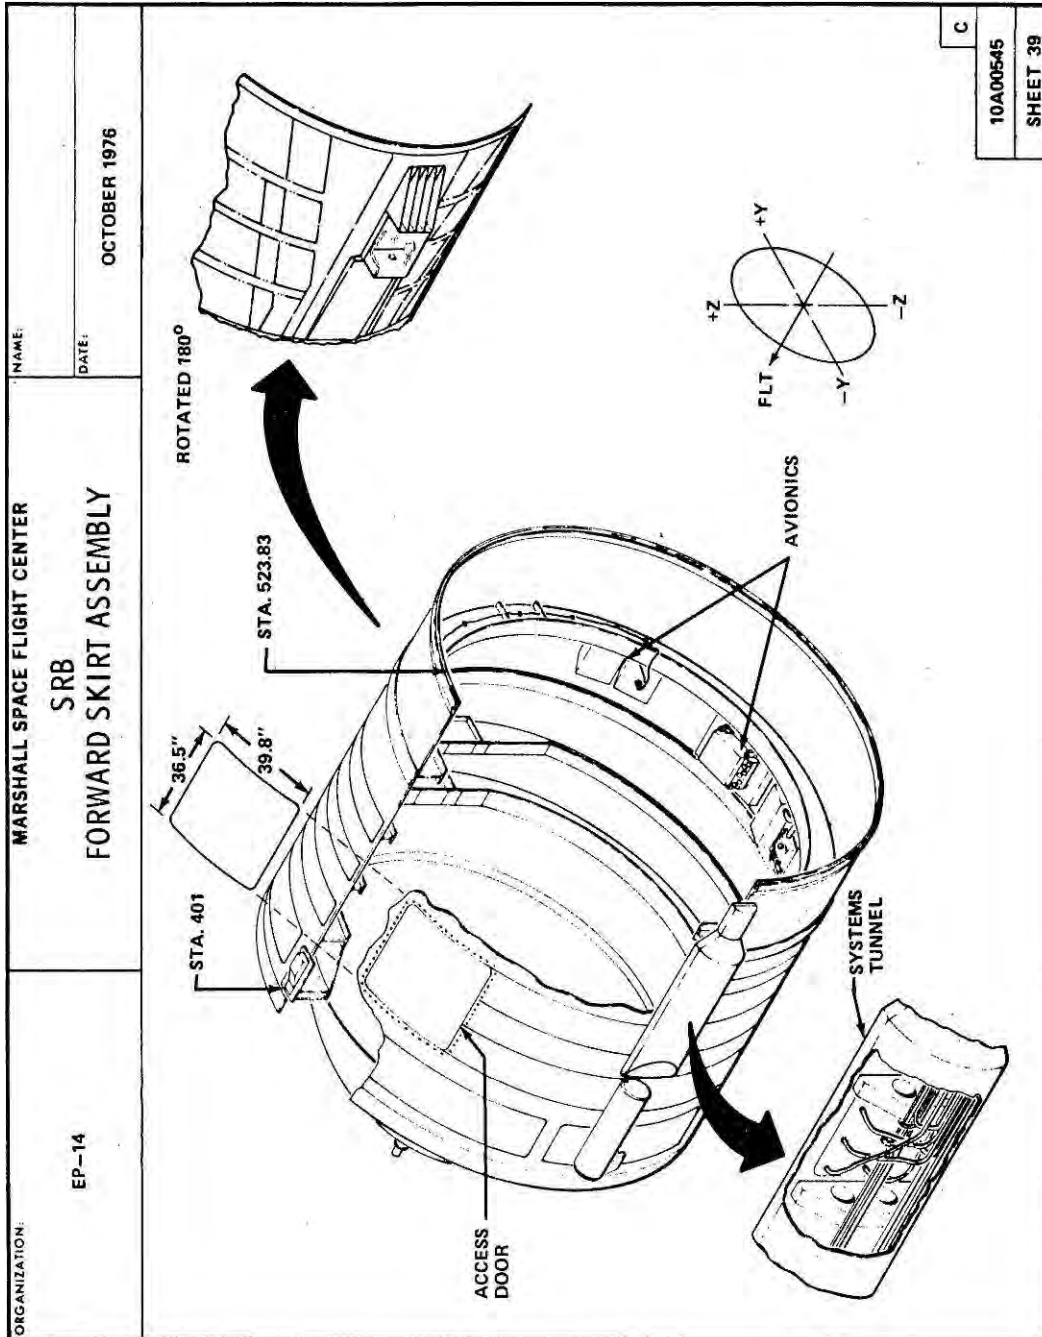
Figure No. E-16. Diagram of SRB forward skirt.
Source: Griner, et al., *Space Shuttle Solid Rocket Booster Pictorial Representations*, sheet 39.

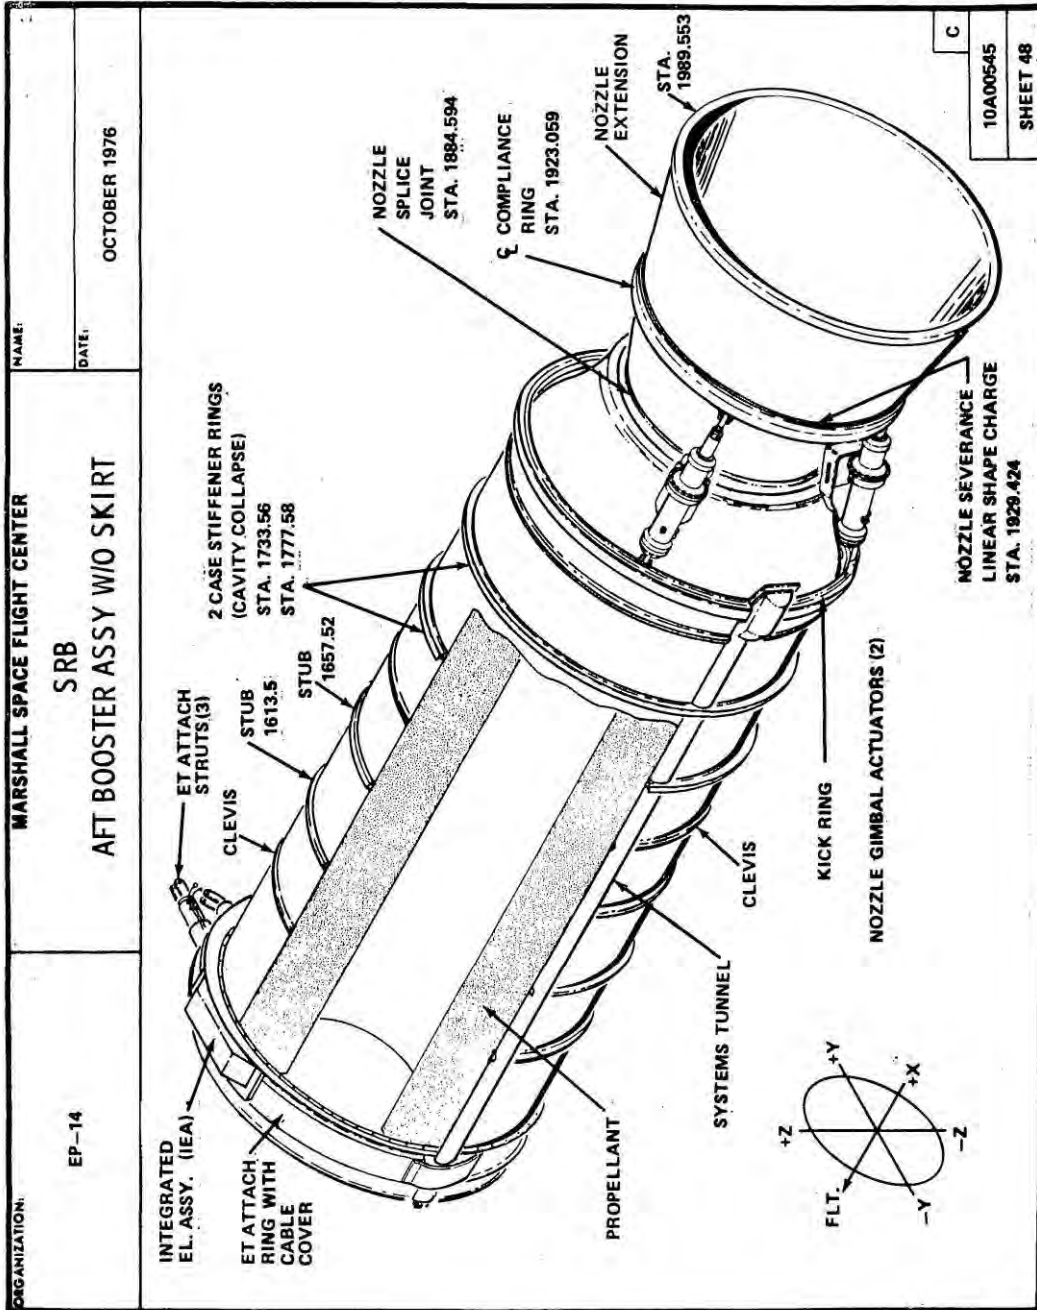
Figure No. E-23. Diagram of SRB aft booster assembly without skirt.
 Source: Griner, et al., *Space Shuttle Solid Rocket Booster Pictorial Representations*, sheet 48.

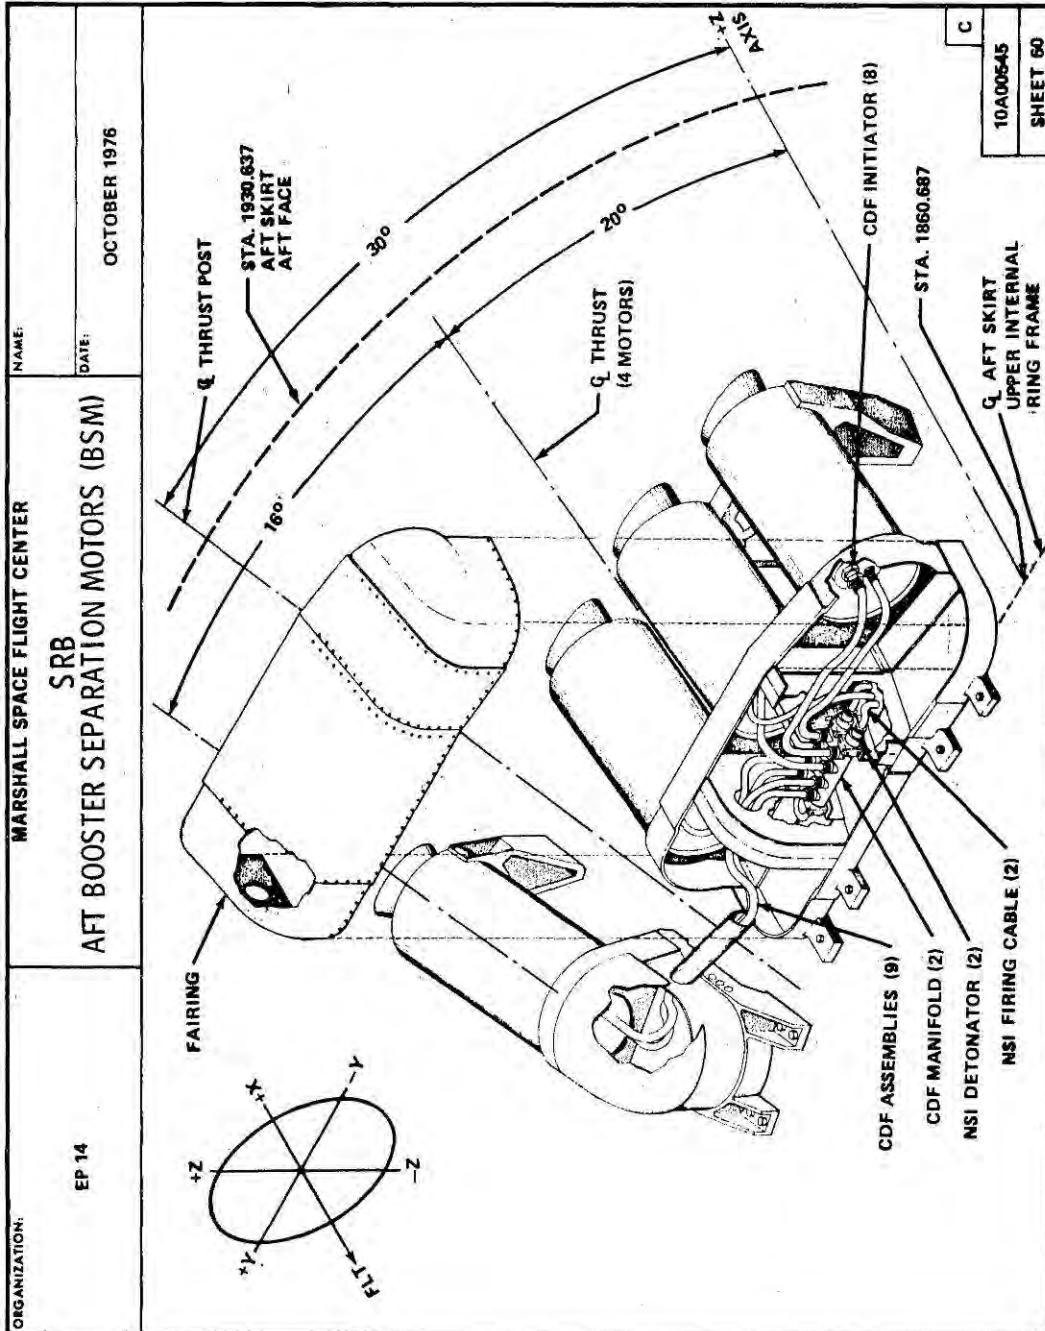
Figure No. E-26. Diagram of SRB aft booster separation motors.
 Source: Griner, et al., *Space Shuttle Solid Rocket Booster Pictorial Representations*, sheet 60.
