COLUMBIA

ACCIDENT INVESTIGATION BOARD

REPORT VOLUME I
AUGUST 2003

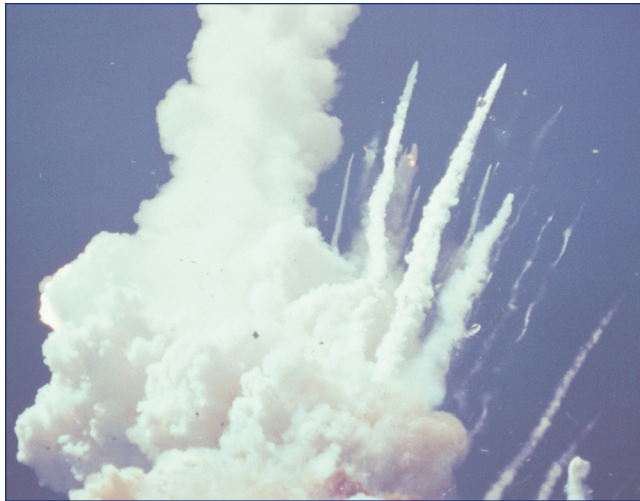
Figure 1.5-1. the Space Shuttle Challenger was lost during ascent on January 28, 1986, when an O-ring and seal in the left Solid Rocket Booster failed.

The Rogers Commission report, issued on June 6, 1986, recommended a redesign and recertification of the Solid Rocket Motor joint and seal and urged that an independent body oversee its qualification and testing. The report concluded that the drive to declare the Shuttle operational had put enormous pressures on the system and stretched its resources to the limit. Faulting NASA safety practices, the Commission also called for the creation of an independent NASA Office of Safety, Reliability, and Quality Assurance, reporting directly to the NASA Administrator, as well as structural changes in program management.²⁰ (The Rogers Commission findings and recommendations are discussed in more detail in Chapter 5.) It would take NASA 32 months before the next Space Shuttle mission was launched. During this time, NASA initiated a series of longer-term vehicle upgrades, began the construction of the Orbiter *Endeavour* to replace *Challenger*, made significant organizational changes, and revised the Shuttle manifest to reflect a more realistic flight rate.

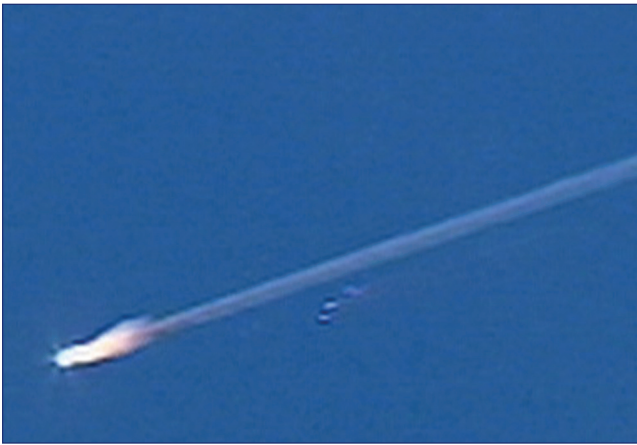
The Orbiter has a large glowing field surrounding it in this view taken from Mesquite, Texas, looking south.

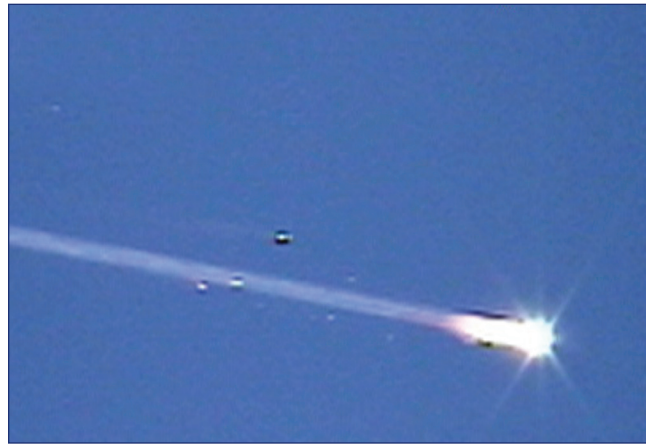
Taken at the same time as the photo at left, but from Hewitt, Texas, looking north.

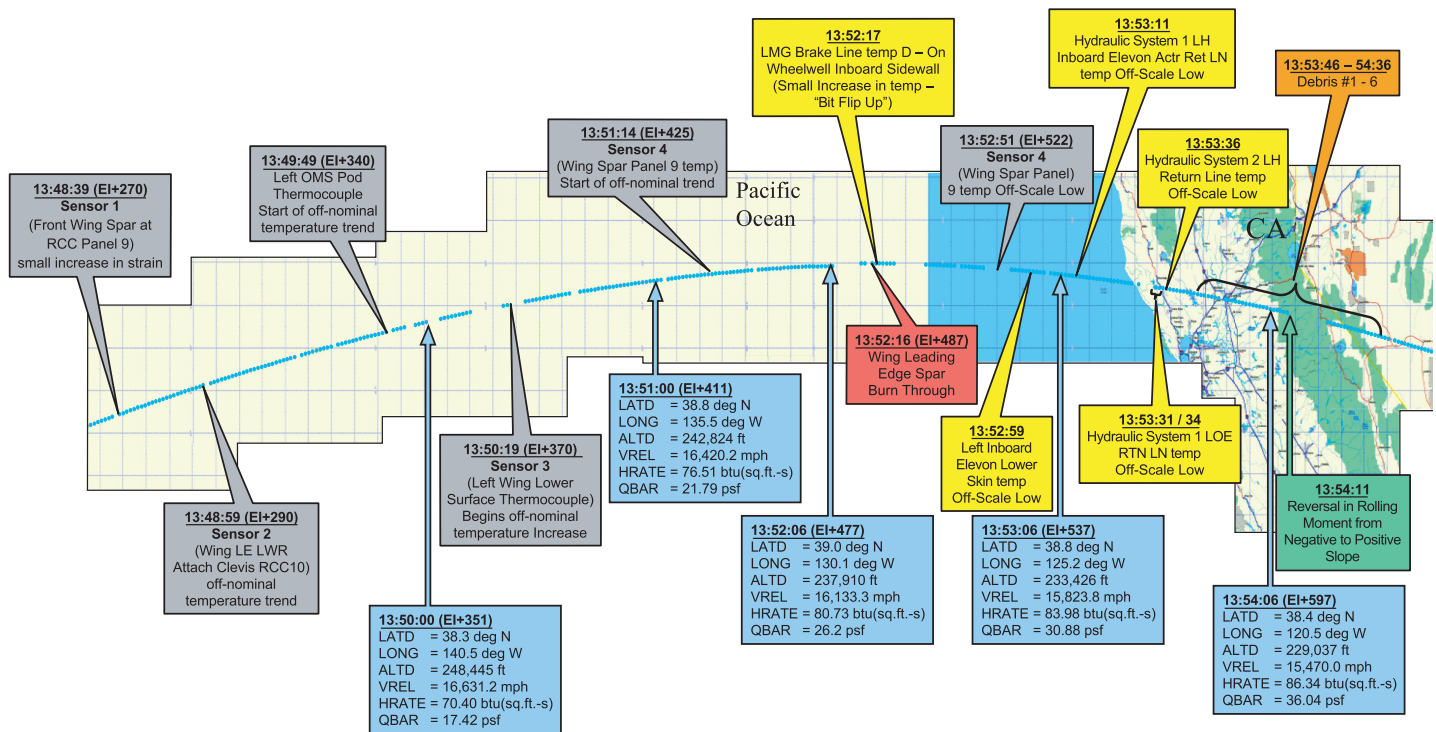
At 8:48:39 a.m. (EI+270), a sensor on the left wing leading edge spar showed strains higher than those seen on previous *Columbia* re-entries. This was recorded only on the Modular Auxiliary Data System, and was not telemetered to ground controllers or displayed to the crew (see Figure 2.6-1).

Figure 2.6-1. This simplified timeline shows the re-entry path of Columbia on February 1, 2003. The information presented here is a composite of sensor data telemetered to the ground combined with data from the Modular Auxiliary Data System recorder recovered after the accident. Note that the first off-nominal reading was a small increase in a strain gauge at the front wing spar behind RCC panel 9-left. The chart is color-coded: blue boxes contain position, attitude, and velocity information; orange boxes indicate when debris was shed from the Orbiter; green boxes are significant aerodynamic control events; gray boxes contain sensor information from the Modular Auxiliary Data System; and yellow boxes contain telemetered sensor information. The red boxes indicate other significant events.

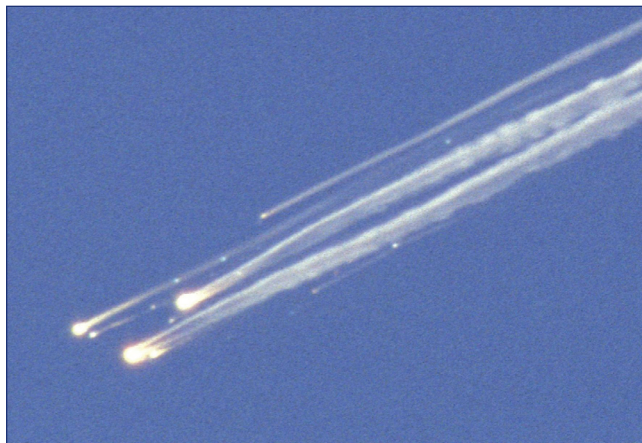
This view was taken from Dallas. (Robert McCullough/© 2003 The Dallas Morning News)

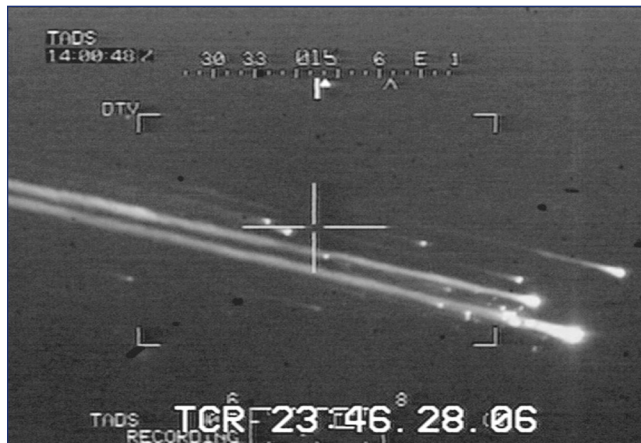
This video was captured by a Danish crew operating an AH-64 Apache helicopter near Fort Hood, Texas.

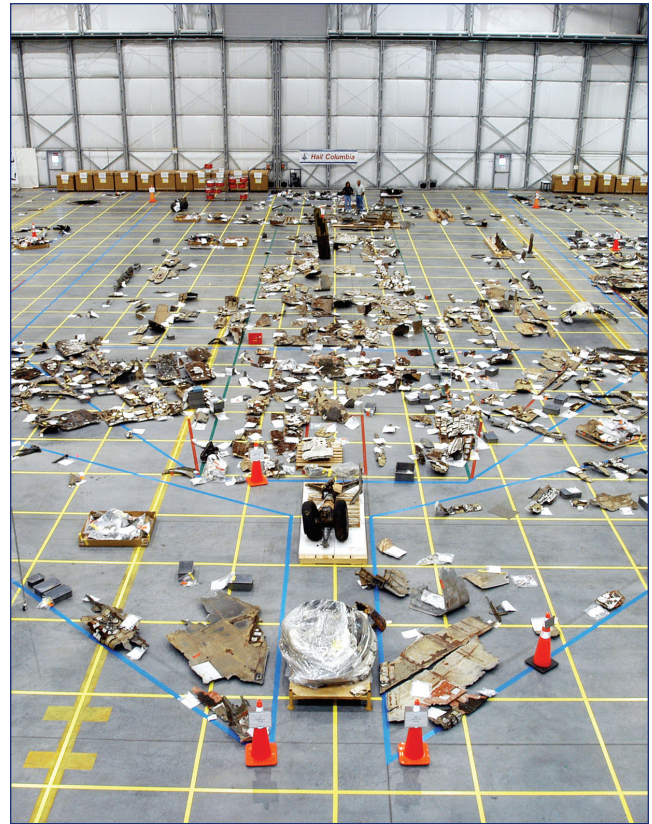
Figure 2.7-4. Recovered debris was returned to the Kennedy Space Center where it was laid out in a large hangar. The tape on the floor helped workers place each piece near where it had been on the Orbiter.

The debris collected (see Figure 2.7-4) by searchers aided the investigation in significant ways. Among the most important finds was the Modular Auxiliary Data System recorder that captured data from hundreds of sensors that was not telemetered to Mission Control. Data from these 800 sensors, recorded on 9,400 feet of magnetic tape, provided investigators with millions of data points, including temperature sensor readings from *Columbia's* left wing leading edge. The data also helped fill a 30-second gap in telemetered data and provided an additional 14 seconds of data after the telemetry loss of signal.

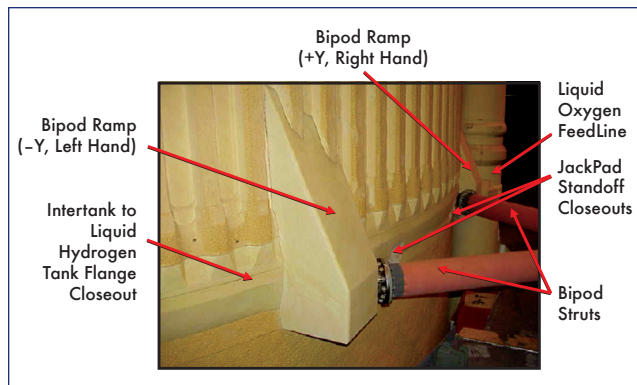
Figure 3.2-2. The exterior of the left bipod attachment area showing the foam ramp that came off during the ascent of STS-107.

A combination of factors, rather than a single factor, led to the loss of the left bipod foam ramp during the ascent of STS-107. NASA personnel believe that testing conducted during the investigation, including the dissection of as-built hardware and testing of simulated defects, showed conclusively that pre-existing defects in the foam were a major factor, and in briefings to the Board, these were cited as a necessary condition for foam loss. However, analysis indicated that pre-existing defects alone were not responsible for foam loss.

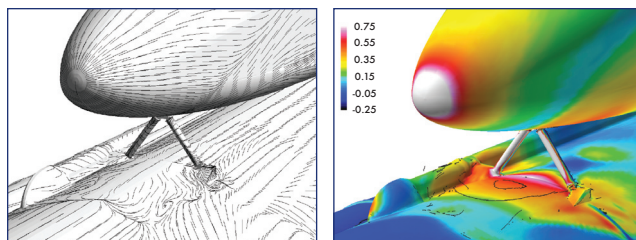
Significant analytical advancements have been made since the External Tank was first conceived, particularly in computational fluid dynamics (see Figure 3.2-5). Computational fluid dynamics comprises a computer-generated model that represents a system or device and uses fluid-flow physics and software to create predictions of flow behavior, and stress or deformation of solid structures. However, analysis must always be verified by test and/or flight data. The External Tank and the bipod ramp were not tested in the complex flight environment, nor were fully instrumented External Tanks ever launched to gather data for verifying analytical tools. The accuracy of the analytical tools used to simulate the External Tank and bipod ramp were verified only by using flight and test data from other Space Shuttle regions.

Figure 3.2-5. Computational Fluid Dynamics was used to understand the complex flow fields and pressure coefficients around bipod strut. The flight conditions shown here approximate those present when the left bipod foam ramp was lost from External Tank 93 at Mach 2.46 at a 2.08-degree angle of attack.

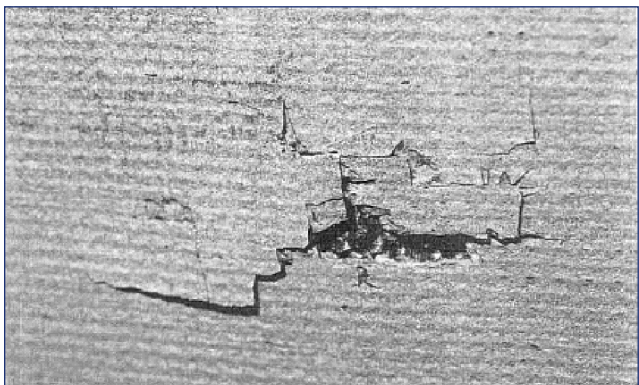
RCC components have been struck by objects throughout their operational life, but none of these components has been completely penetrated. A sampling of 21 post-flight reports noted 43 hypervelocity impacts, the largest being 0.2 inch. The most significant low-velocity impact was to *Atlantis*' panel 10-right during STS-45 in March and April 1992. The damaged area was 1.9 inches by 1.6 inches on the exterior surface and 0.5 inches by 0.1 inches in the interior surface. The substrate was exposed and oxidized, and the panel was scrapped. Analysis concluded that the damage was caused by a strike by a man-made object, possibly during ascent. Figures 3.3-2 and 3.3-3 show the damage to the outer and inner surfaces, respectively.

Figure 3.3-3. Damage on the inner surface of RCC panel 10-right from *Atlantis* after STS-45.

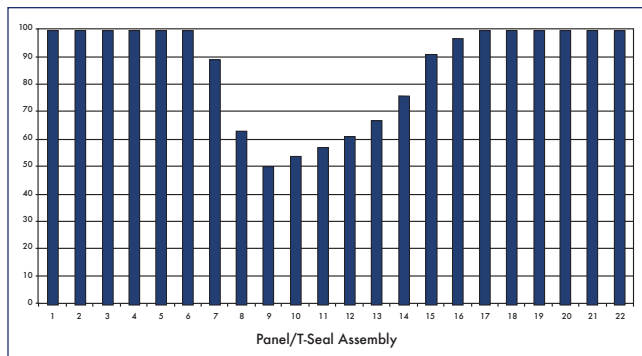
For the first five missions of *Columbia*, the RCC components were not coated with Type A sealant, and had shorter mission service lives than the RCC components on the other Orbiters. (*Columbia*'s panel 9 has the shortest mission service life of 50 flights as shown in Figure 3.3-4.) The predicted life for panel/T-seals 7 through 16 range from 54 to 97 flights.⁷

Figure 3.3-4. The expected mission life for each of the wing leading edge RCC panels on Columbia. Note that panel 9 has the shortest life expectancy.

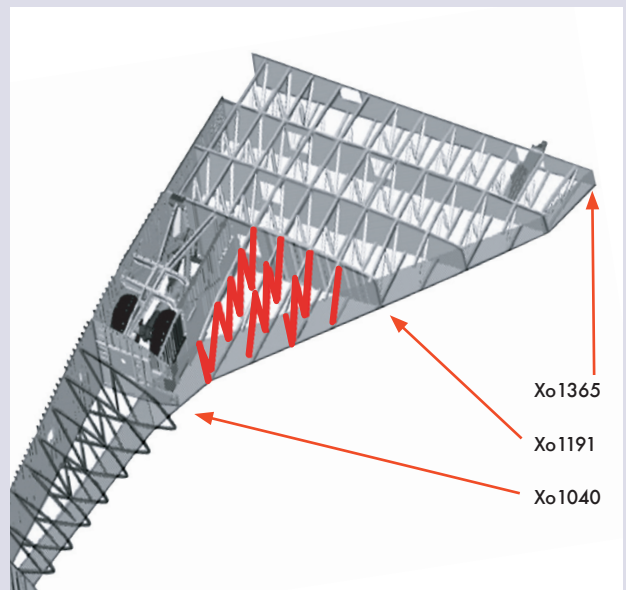
The major internal support structures in the mid-wing are constructed from aluminum alloy. Since aluminum melts at 1,200 degrees Fahrenheit, it is likely these truss tubes in the mid-wing were destroyed and wing structural integrity was lost.

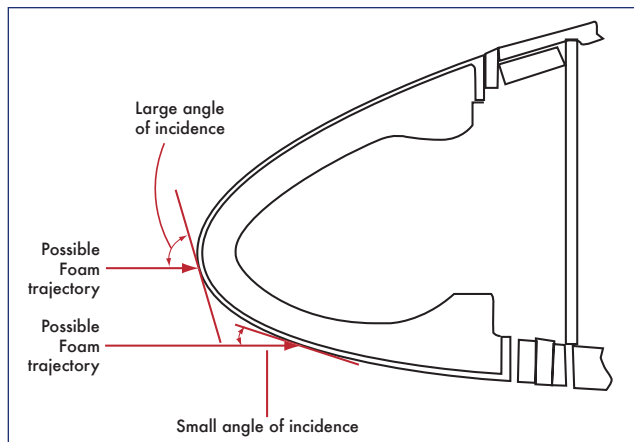
Image analysis determined that the foam was moving almost parallel to the Orbiter's fuselage at impact, with about a five-degree angle upward toward the bottom of the wing and slight motion in the outboard direction. If the foam had hit the tiles adjacent to the leading edge, the angle of incidence would have been about five degrees (the angle of incidence is the angle between the relative velocity of the projectile and the plane of the impacted surface). Because the wing leading edge curves, the angle of incidence increases as the point of impact approaches the apex of an RCC panel. Image and transport analyses estimated that for impact on RCC panel 8, the angle of incidence was between 10 and 20 degrees (see Figure 3.4-4).⁹ Because the total force delivered by the impact depends on the angle of incidence, a foam strike near the apex of an RCC panel could have delivered about twice the force as an impact close to the base of the panel.

Figure 3.4-4. This drawing shows the curve of the wing leading edge and illustrates the difference the angle of incidence has on the effect of the foam strike.

The precise impact location of the foam determined the impact angle because the debris was moving almost parallel to the Orbiter's fuselage at impact. Tile areas would have been hit at very small angles (approximately five degrees), but the curvature of the leading edge created angles closer to 20 degrees (see Figure 3.4-4).

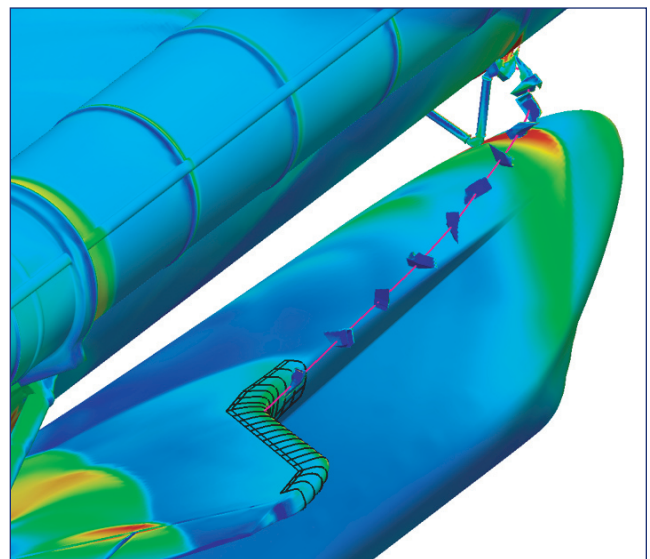
Figure 3.4-6. These are the results of a trajectory analysis that used a computational fluid dynamics approach in a program called CART-3D, a comprehensive (six-degree-of-freedom) computer simulation based on the laws of physics. This analysis used the aerodynamic and mass properties of bipod ramp foam, coupled with the complex flow field during ascent, to determine the likely position and velocity histories of the foam.

The undetermined and yet certainly irregular shape of the foam introduced substantial uncertainty about its estimated aerodynamic characteristics. Appendix D.8 contains an independent analysis conducted by the Board to confirm that the estimated range of ballistic coefficients of the foam in Figure 3.4-6 was credible, given the foam dimension results from the image analyses and the expected range of the foam density. Based on the results in Figure 3.4-7, the physical dimensions of the bipod ramp, and the sizes and shapes of the available barrels for the compressed-gas gun used in the impact test program described later in this chapter, the Board and the NASA Accident Investigation Team decided that a foam projectile 19 inches by 11.5 inches by 5.5 inches, weighing 1.67 pounds, and with a weight density of 2.4 pounds per cubic foot, would best represent the piece of foam that separated from the External Tank bipod ramp and was hit by the Orbiter’s left wing. See Section 3.8 for a full discussion of the foam impact testing.

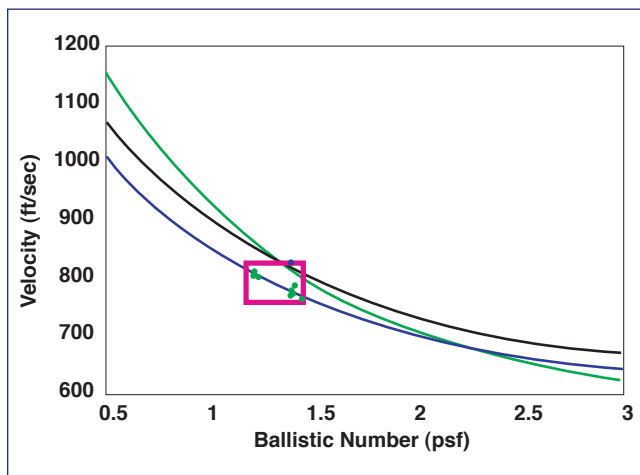
Figure 3.4-7. The results of numerous possible trajectories based on various assumed sizes, shapes, and densities of the foam. Either the foam had a slightly higher ballistic coefficient and the Orbiter struck the foam at a lower speed relative to the Orbiter, or the foam was more compact and the wing struck the foam at a higher speed. The “best fit” box represents the overlay of the data from the image analysis with the transport analysis computations. This data enabled a final selection of projectile characteristics for impact testing.

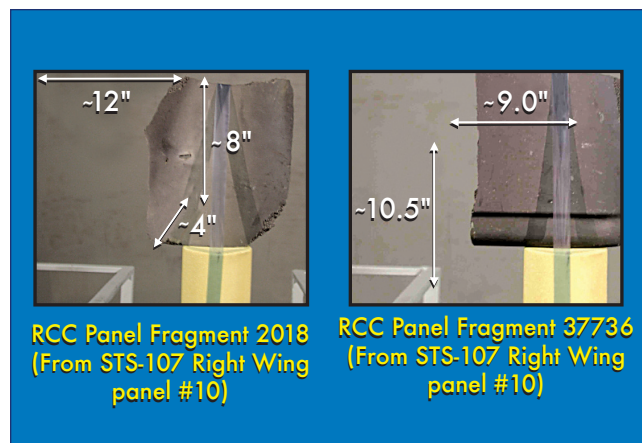
Figure 3.5-1. These representative RCC acreage pieces matched the radar cross-section of the Flight Day 2 object.

In the Advanced Compact Range at the Air Force Research Laboratory in Dayton, Ohio, analysts tested 31 materials from the Orbiter's exterior and payload bay. Additional supercomputer radar cross-section predictions were made for Reinforced Carbon-Carbon T-seals. After exhaustive radar cross-section analysis and testing, coupled with ballistic analysis of the object's orbital decay, only a fragment of RCC panel would match the UHF radar cross-section and ballistic coefficients observed by the Space Surveillance network. Such an RCC panel fragment must be approximately 140 square inches or greater in area to meet the observed radar cross-section characteristics. Figure 3.5-1 shows RCC panel fragments from *Columbia*'s right wing that represent those meeting the observed characteristics of object 2003-003B.¹⁰

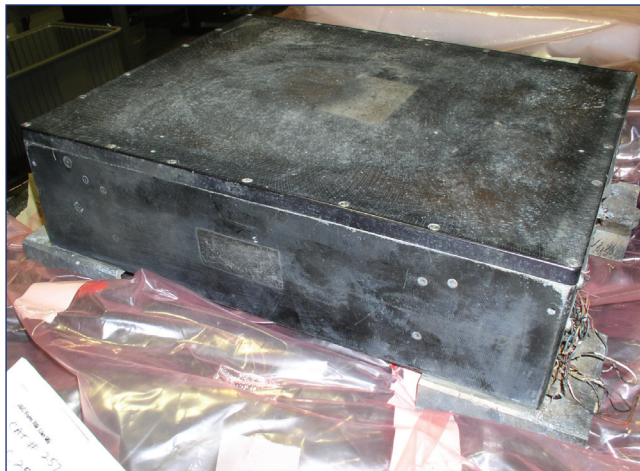
Figure 3.6-1. The Modular Auxiliary Data System recorder, found near Hemphill, Texas. While not designed to withstand impact damage, the recorder was in near-perfect condition when recovered on March 19, 2003.

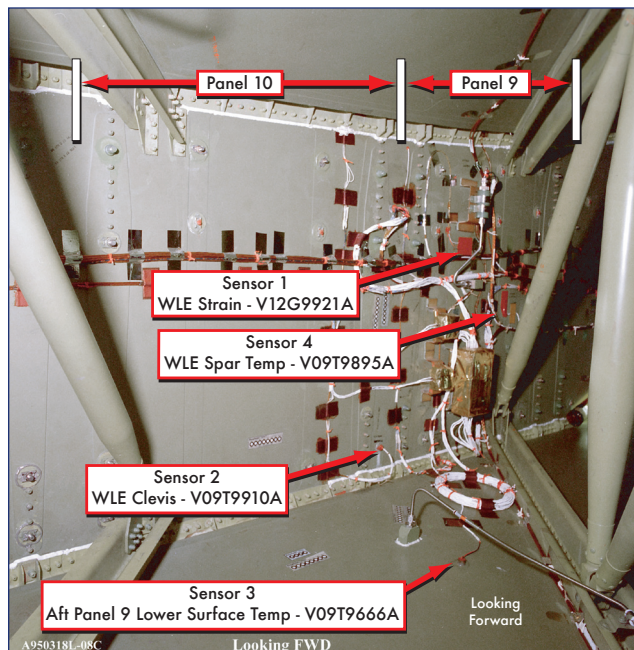
Figure 3.6-2. Location of sensors on the back of the left wing leading edge spar (vertical aluminum structure in picture). Also shown are the round truss tubes and ribs that provided the structural support for the mid-wing in this area.

or outside the wing leading edge spar near Reinforced Carbon-Carbon (RCC) panel 9-left, helped tell the story of what happened on the left wing of the Orbiter early in the re-entry. These four sensors were: strain gauge V12G9921A (Sensor 1), resistance temperature detector V09T9910A on the RCC clevis between panel 9 and 10 (Sensor 2), thermocouple V07T9666A, within a Thermal Protection System tile (Sensor 3), and resistance temperature detector V09T9895A (Sensor 4), located on the back side of the wing leading edge spar behind RCC panels 8 and 9 (see Figure 3.6-2).

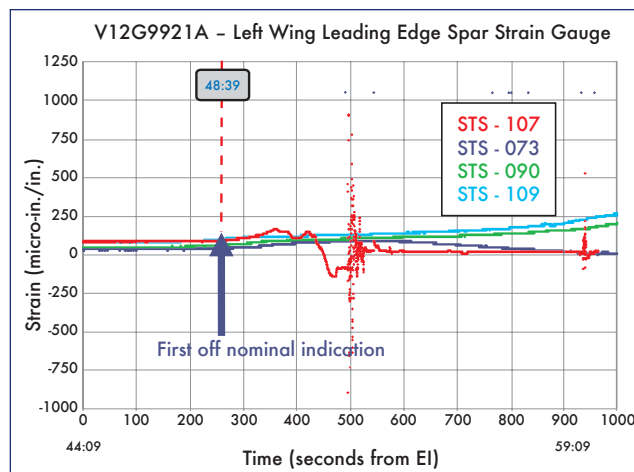
Figure 3.6-3. The strain gauge (Sensor 1) on the back of the left wing leading edge spar was the first sensor to show an anomalous reading. In this chart, and the others that follow, the red line indicates data from STS-107. Data from other *Columbia* re-entries, similar to the STS-107 re-entry profile, are shown in the other colors.

Sensor 1 provided the first anomalous reading (see Figure 3.6-3). From EI+270 to EI+360, the strain is higher than that on previous *Columbia* flights. At EI+450, the strain reverses, and then peaks again in a negative direction at EI+475. The strain then drops slightly, and remains constant and negative until EI+495, when the sensor pattern becomes unreliable, probably due to a propagating soft short, or “burn-through” of the insulation between cable conductors caused by heating or combustion. This strain likely indicates significant damage to the aluminum honeycomb spar. In particular, strain reversals, which are unusual, likely mean there was significant high-temperature damage to the spar during this time.

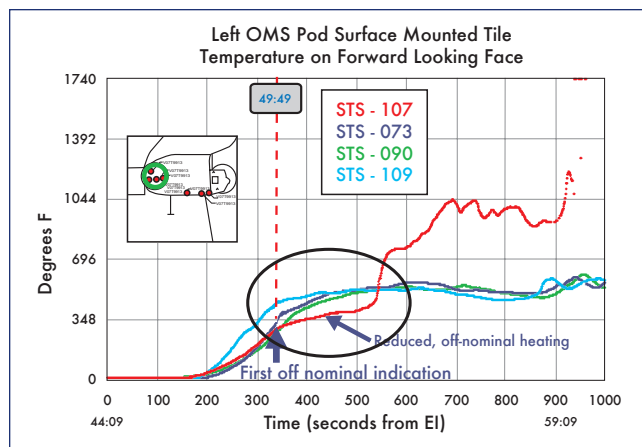
Figure 3.6-9. Orbital Maneuvering System (OMS) pod heating was initially significantly lower than that seen on previous Columbia missions. As wing leading edge damage later increased, the OMS pod heating increased dramatically. Debris recovered from this area of the OMS pod showed substantial pre-breakup heat damage and imbedded drops of once-molten metal from the wing leading edge in the OMS pod thermal tiles.

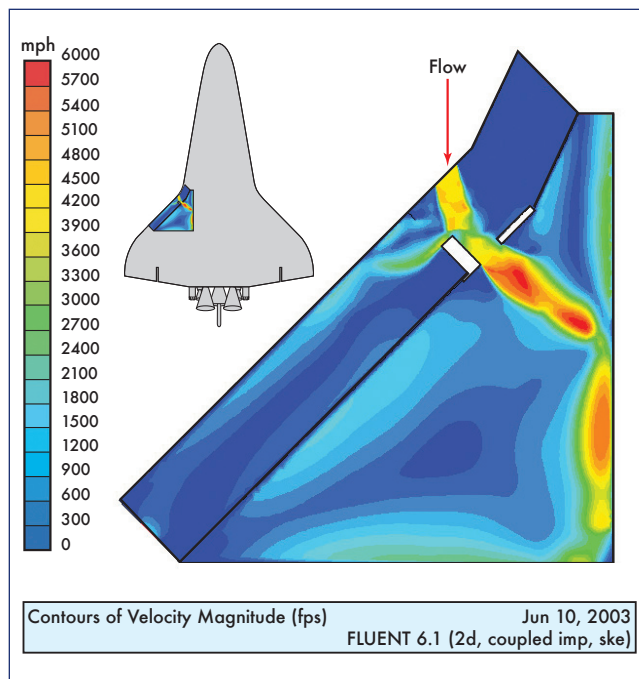
Later computational fluid dynamics analysis of the mid-wing area behind the spar showed that superheated air flowing into a breached RCC panel 8 and then interacting with the internal structure behind the RCC cavity (RCC ribs and spar insulation) would have continued through the wing leading edge spar as a jet, and would have easily allowed superheated air to traverse the 56.5 inches from the spar to the outside of the wheel well and destroy the cables (Figure 3.6-11). Controllers on the ground saw these first anomalies in the telemetry data at EI+613, when four hydraulic sensor cables that ran from the aft part of the left wing through the wiring bundles outside the wheel well failed.

Figure 3.6-11. The computational fluid dynamics analysis of the speed of the superheated air as it entered the breach in RCC panel 8 and then traveled through the wing leading edge spar. The darkest red color indicates speeds of over 4,000 miles per hour. Temperatures in this area likely exceeded 5,000 degrees Fahrenheit. The area of detail is looking down at the top of the left wing.

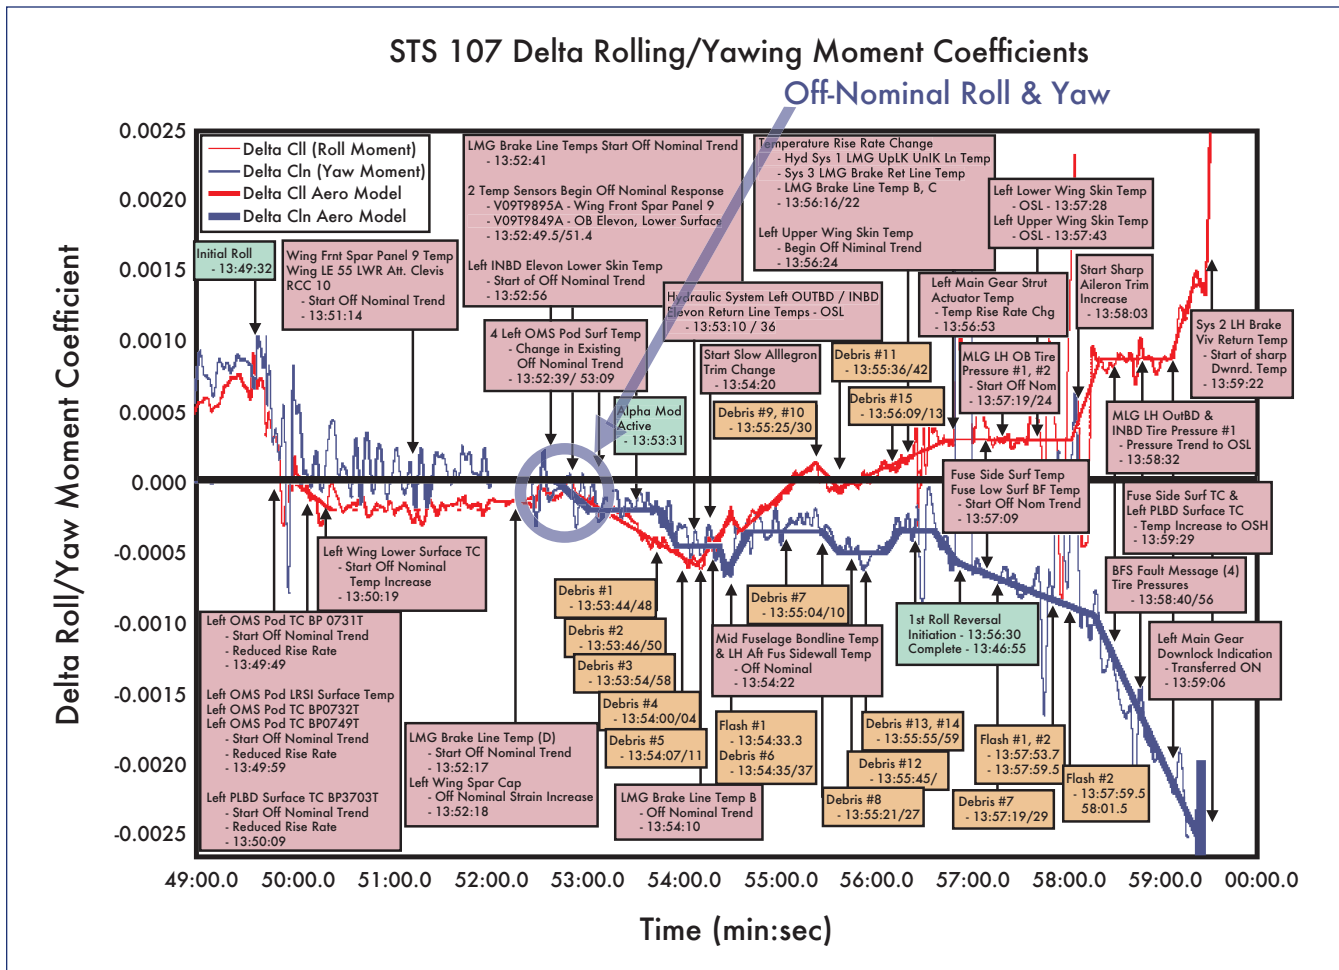
Aerodynamic roll and yaw forces began to differ from those on previous flights at about EI+500 (see Figure 3.6-12). Investigators used flight data to reconstruct the aerodynamic forces acting on the Orbiter. This reconstructed data was then compared to forces seen on other similar flights of *Columbia*

Figure 3.6-12. At approximately EI+500 seconds, the aerodynamic roll and yaw forces began to diverge from those observed on previous flights. The blue line shows the Orbiter's tendency to yaw while the red line shows its tendency to roll. Nominal values would parallel the solid black line. Above the black line, the direction of the force is to the right, while below the black line, the force is to the left.

and to the forces predicted for STS-107. In the early phase of flight, these abnormal aerodynamic forces indicated that *Columbia's* flight control system was reacting to a change in the external shape of the wing, which was caused by progressive RCC damage that caused a continuing decrease in lift and a continuing increase in drag on the left wing.

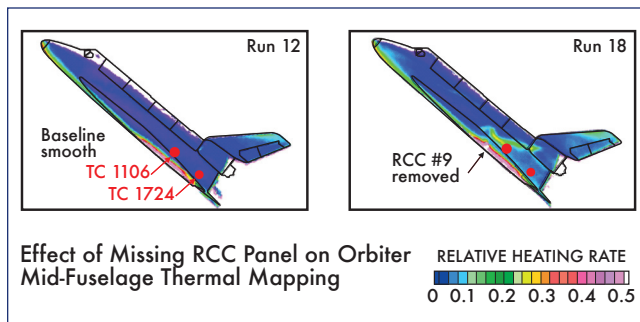
Figure 3.6-13. The effects of removing RCC panel 9 are shown in this figure. Note the brighter colors on the front of the OMS pod show increased heating, a phenomenon supported by both the OMS pod temperature sensors and the debris analysis.

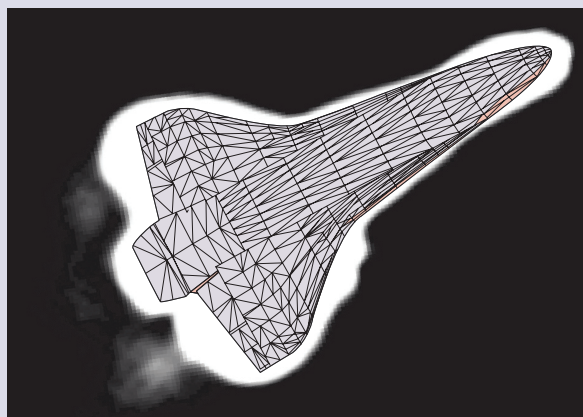
The image shows an unusual condition on the left wing, a leading-edge disturbance that might indicate damage. Several analysts concluded that the distortion evident in the image likely came from the modification and interaction of shock waves due to the damaged leading edge. The overall appearance of the leading-edge damage at this point on the trajectory is consistent with the scenario.

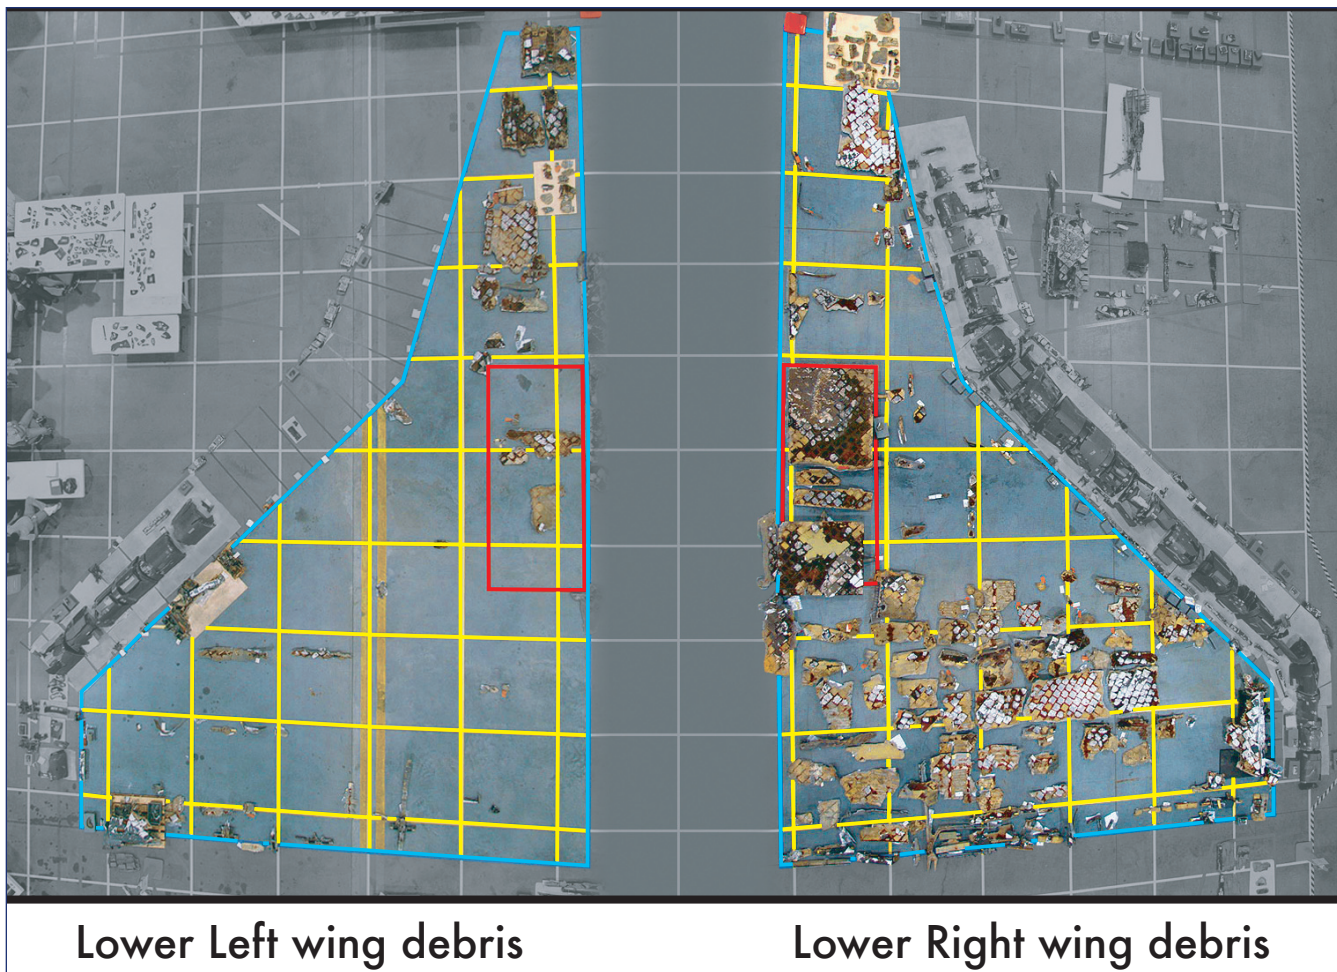
Figure 3.7-1. Comparison of amount of debris recovered from the left and right wings of Columbia. Note the amount of debris recovered from areas in front of the wheel well (the red boxes on each wing) were similar, but there were dramatic differences in the amount of debris recovered aft of each wheel well.

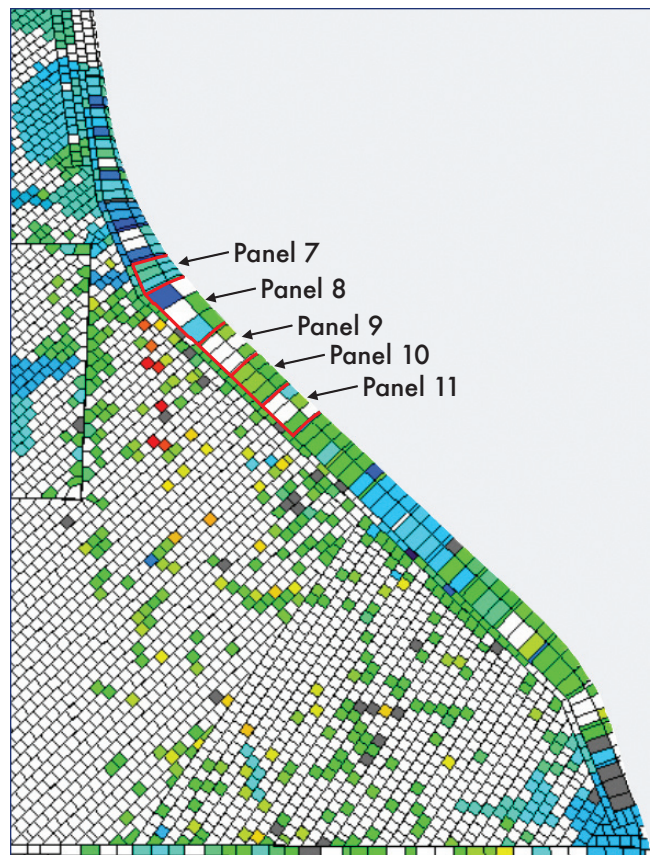
Figure 3.7-6. The tiles recovered farthest west all came from the area immediately behind left wing RCC panels 8 and 9. In the figure, each small box represents an individual tile on the lower surface of the left wing. The more red an individual tile appears, the farther west it was found.

An analysis of where tiles were found on the ground also yielded significant evidence of the breach location. Since most of the tiles are of similar size, weight, and shape, they would all have similar ballistic coefficients and would have behaved similarly after they separated from the Orbiter. By noting where each tile fell and then plotting its location on the Orbiter tile map, a distinctive pattern emerged. The tiles recovered farthest west all came from the area immediately behind the left wing RCC panel 8 and 9 (see Figure 3.7-6), which suggests that these tiles were released earlier than those from other areas of the left wing. While it is not conclusive evidence of a breach in this area, this pattern does suggest unique damage around RCC panels 8 and 9 that was not seen in other areas. Tiles from this area also showed evidence of a brown deposit that was not seen on tiles from any

other part of the Orbiter. Chemical analysis revealed it was an Inconel-based deposit that had come from inside the RCC cavity on the left wing (Inconel is found in wing leading edge attachment fittings). Since the streamlines from tiles with the brown deposit originate near left RCC panels 8 and 9, this brown deposit likely originated as an outflow of superheated air and molten metal from the panel 8 and 9 area.

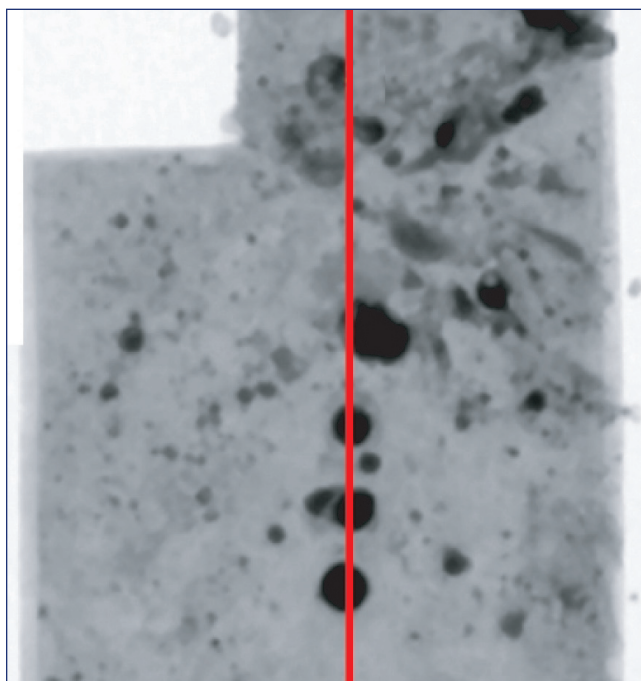
The X-ray analysis of left wing RCC panel 8 (see Figure 3.7-7) showed a bottom-to-top pattern of slag deposits. In some areas, small spheroids of heavy metal were aligned vertically on the recovered pieces, which indicated a superheated airflow from the bottom of the panel toward the top in the area of RCC panel 8-left. These deposits were later determined by chemical analysis to be Inconel 718, probably from the wing leading edge attachment fittings on the spanner beams on RCC panels 8 and 9. Computational fluid dynamics modeling of the flow behind panel 8 indicated that the molten deposits would be laid down in this manner.

Figure 3.7-7. X-ray analysis of RCC panel 8-left showed a bottom-to-top pattern of slag deposits.

The layered deposits on panel 8 were also markedly different from those on all other left- and right-wing panels. There was much more material deposited on RCC panel 8-left. These deposits had a much rougher overall structure, including rivulets of Cerachrome slag deposited directly on the RCC. This indicated that Cerachrome, the insulation that protects the wing leading edge spar, was one of the first materials to succumb to the superheated air entering through the breach in RCC panel 8-left. Because the melting temperature of Cerachrome is greater than 3,200 degrees Fahrenheit, analysis indicated that materials in this area were exposed to extremely

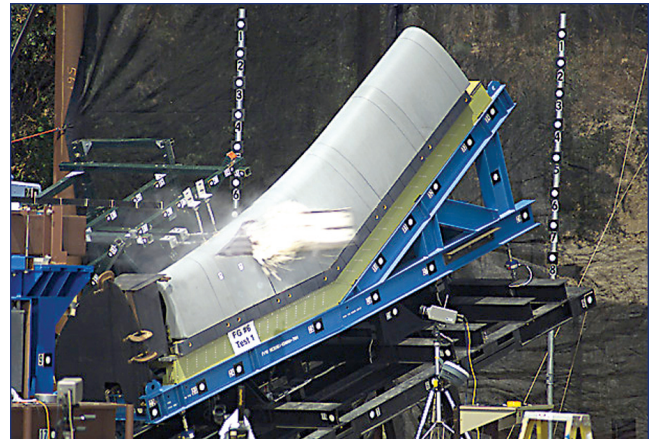
Figure 3.8-5. A typical foam strike leaves impact streaks, and the foam projectile breaks into shards and larger pieces. Here the foam is striking Panel 6 on a fiberglass test article.

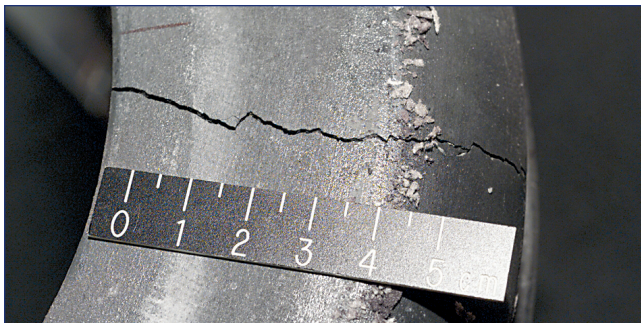
RCC panel 6 was tested first to begin to establish RCC impact response, although by the time of the test, other data had indicated that RCC panel 8-left was the most likely site of the breach. RCC panel 6 was impacted using the same parameters as the test on fiberglass panel 6 and developed a 5.5-inch crack on the outboard end of the panel that extended through the rib (see Figure 3.8-6). There was also a crack through the "web" of the T-seal between panels 6 and 7 (see Figure 3.8-7). As in the fiberglass test, the foam block deflected, or moved, the face of the RCC panel, creating a slit between the panel and the adjacent T-seal, which ripped the projectile and stuffed pieces of foam into the slit (see Figure 3.8-8). The panel rib failed at lower stresses than predicted, and the T-seal failed closer to predictions, but overall, the stress pattern was similar to what was predicted, demonstrating the need to incorporate more complete RCC failure criteria in the computational models.

Without further crack growth, the specific structural damage this test produced would probably not have allowed enough superheated air to penetrate the wing during re-entry to cause serious damage. However, the test did demonstrate that a foam impact representative of the debris strike at 81.9 seconds after launch could damage an RCC panel. Note that

Figure 3.8-6. A 5.5-inch crack on the outboard portion of RCC Panel 6 during testing.

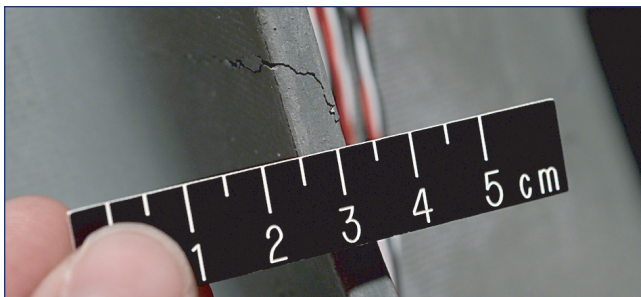
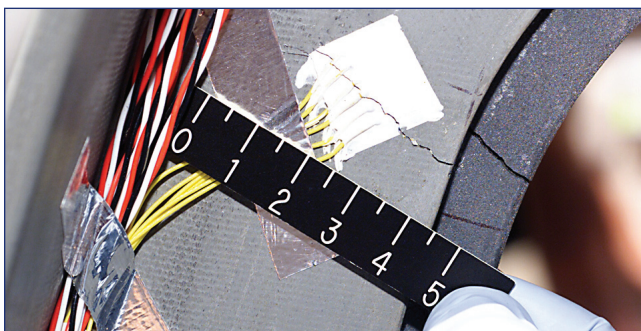
Figure 3.8-7. Two views of the crack in the T-seal between RCC Panels 6 and 7.

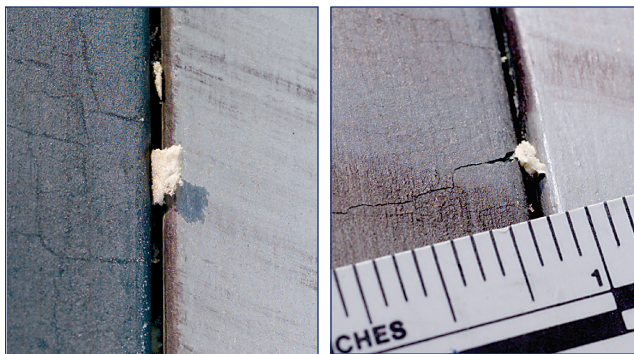
Figure 3.8-8. Two views of foam lodged into the slit during tests.

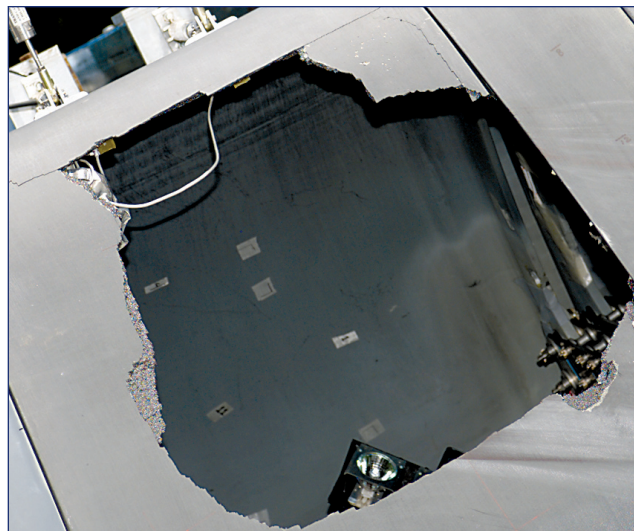
The second impact test of RCC material used panel 8 from *Atlantis*, which had flown 26 missions. Based on forensic evidence, sensor data, and aerothermal studies, panel 8 was considered the most likely point of the foam debris impact on *Columbia*.

Figure 3.8-9. The large impact hole in Panel 8 from the final test.

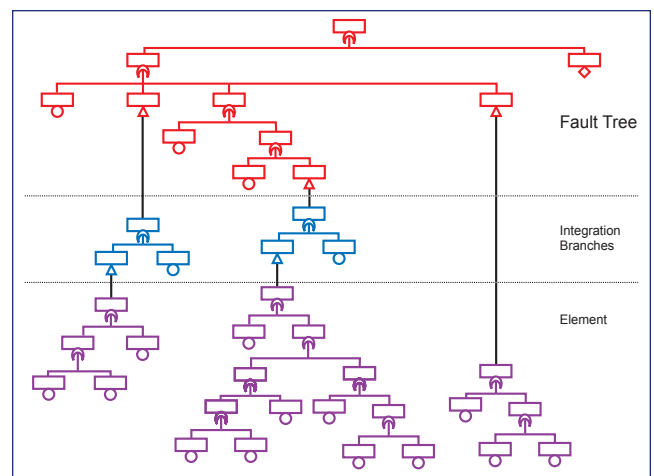
Figure 4.1-1. Accident investigation fault tree structure.

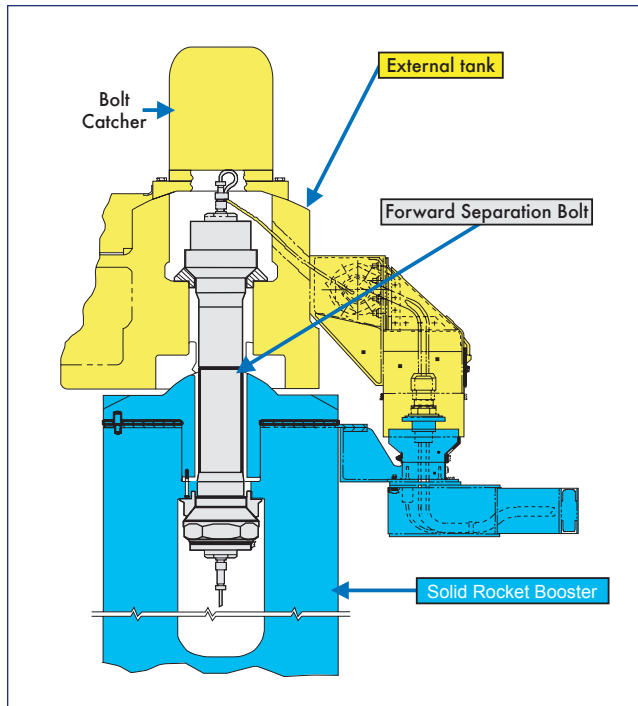
If one of the bolt catchers failed during STS-107, the resulting debris could have damaged *Columbia's* wing leading edge. Concerns that the bolt catchers may have failed, causing metal debris to ricochet toward the Orbiter, arose because the configuration of the bolt catchers used on Shuttle missions differs in important ways from the design used in

Figure 4.2-1. A cutaway drawing of the forward Solid Rocket Booster bolt catcher and separation bolt assembly.

initial qualification tests.¹ First, the attachments that currently hold bolt catchers in place use bolts threaded into inserts rather than through-bolts. Second, the test design included neither the Super Lightweight Ablative material applied to the bolt catcher apparatus for thermal protection, nor the aluminum honeycomb configuration currently used. Also, during these initial tests, temperature and pressure readings for the bolt firings were not recorded.

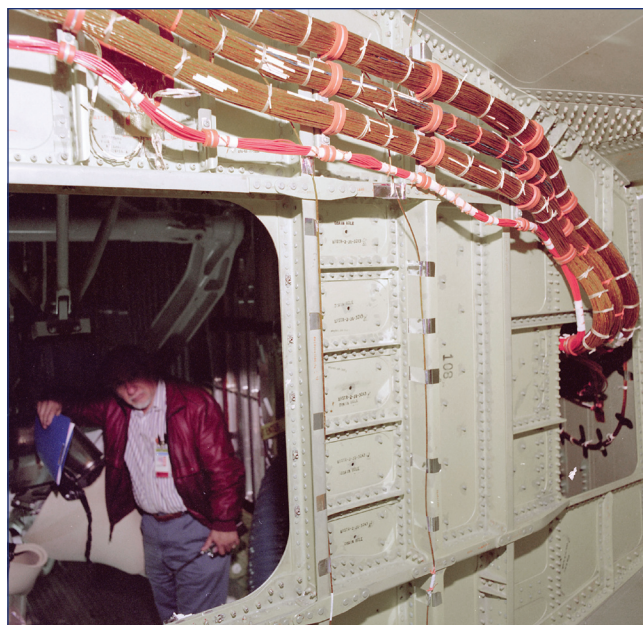
Figure 4.2-3. Typical wiring bundle inside Orbiter wing.

A typical wiring bundle is shown in Figure 4.2-3. Wiring nonconformances are corrected by rerouting, reclamping, or installing additional insulation such as convoluted tubing, insulating tape, insulating sheets, heat shrink sleeving, and abrasion pads (see Figure 4.2-4). Testing has shown that wiring bundles usually stop arc tracking when wires are physically separated from one another. Further testing under conditions simulating the Shuttle's wiring environment demonstrated that arc tracking does not progress beyond six inches. Based on these results, Boeing recommended that NASA separate all critical paths from larger wire bundles and individually protect them for a minimum of six inches beyond their separation points.⁴ This recommendation is being adopted through modifications performed during scheduled Orbiter Major Modifications. For example, analysis of telemetered data from 14 of *Columbia's* left wing sensors (hydraulic line/wing skin/wheel temperatures, tire pressures, and landing gear downlock position indication) provided failure signatures supporting the scenario of left-wing thermal intrusion, as opposed to a catastrophic failure (extensive arc tracking) of Kapton wiring. Actual NASA testing in the months following the accident, during which wiring bundles were subjected to intense heat (ovens, blowtorch, and arc jet), verified the failure signature analyses. Finally, extensive testing and analysis in years prior to STS-107 showed that, with the low currents and low voltages associated with the Orbiter's instrumentation system (such as those in the left wing), the probability of arc tracking is commensurately low.

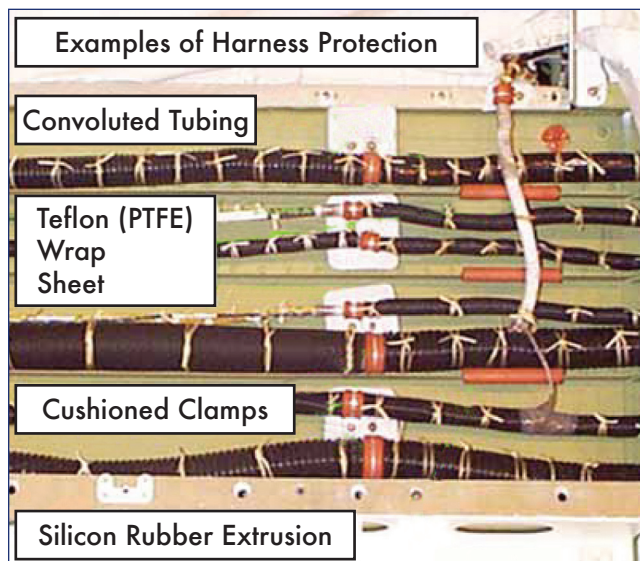
Figure 4.2-4. Typical wiring harness protection methods.

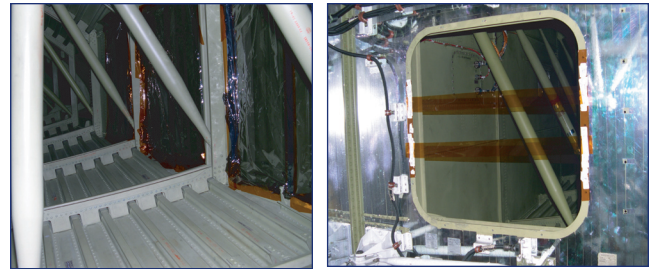
Figure 4.2-5. At left, a wing section open for inspection; at right, wing access closed off after inspection.

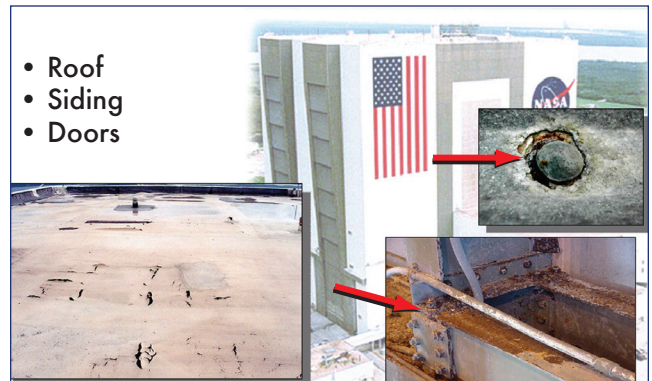
Board investigators have identified deteriorating infrastructure associated with the launch pads, Vehicle Assembly Building, and the crawler transporter. Figures 5.5-5 and 5.5-6 depict some of this deterioration. For example, NASA has installed nets, and even an entire sub-roof, inside the Vehicle Assembly Building to prevent concrete from the building’s ceiling from hitting the Orbiter and Shuttle stack. In addition, the corrosion-control challenge results in zinc primer

on certain launch pad areas being exposed to the elements. When rain falls on these areas, it carries away zinc, runs onto the leading edge of the Orbiter’s wings, and causes pinholes in the Reinforced Carbon-Carbon panels (see Chapter 3).

Figure 5.5-5 and 5.5-6. Examples of the seriously deteriorating infrastructure used to support the Space Shuttle Program. At left is Launch Complex 39A, and at right is the Vehicle Assembly building, both at the Kennedy Space Center.

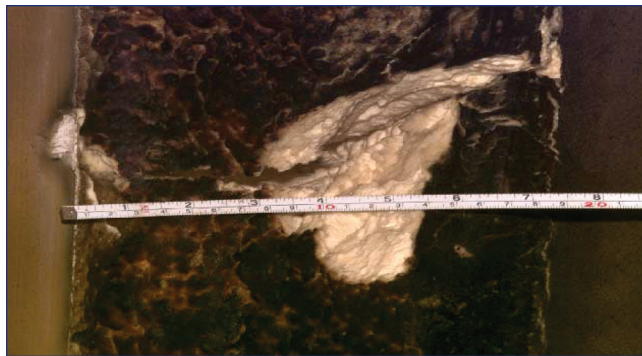
The sixth and final bipod ramp event before STS-107 occurred during STS-112 on October 7, 2002 (see Figure 6.1-3). At 33 seconds after launch, when *Atlantis* was at 12,500 feet and traveling at Mach 0.75, ground cameras observed an object traveling from the External Tank that subsequently impacted the Solid Rocket Booster/External Tank Attachment ring (see Figure 6.1-4). After impact, the debris broke into multiple pieces that fell along the Solid Rocket Booster exhaust plume.¹⁵ Post-mission inspection of the Solid Rocket Booster confirmed damage to foam on the forward face of the External Tank Attachment ring. The impact was approximately 4 inches wide and 3 inches deep. Post-External Tank separation photography by the crew showed that a 4- by 5- by 12-inch (240 cubic-inch) corner section of the left bipod ramp was missing, which exposed the super lightweight ablator coating on the bipod housing. This missing chunk of foam was believed to be the debris that impacted the External Tank Attachment ring during ascent. The post-launch review of photos and video identified these debris events, but the Mission Evaluation Room logs and Mission Management Team minutes do not reflect any discussions of them.

Figure 6.1-4. On STS-112, the foam impacted the External Tank Attach ring on the Solid Rocket Booster, causing this tear in the insulation on the ring.
