COLUMBIA

ACCIDENT INVESTIGATION BOARD

REPORT VOLUME I
AUGUST 2003

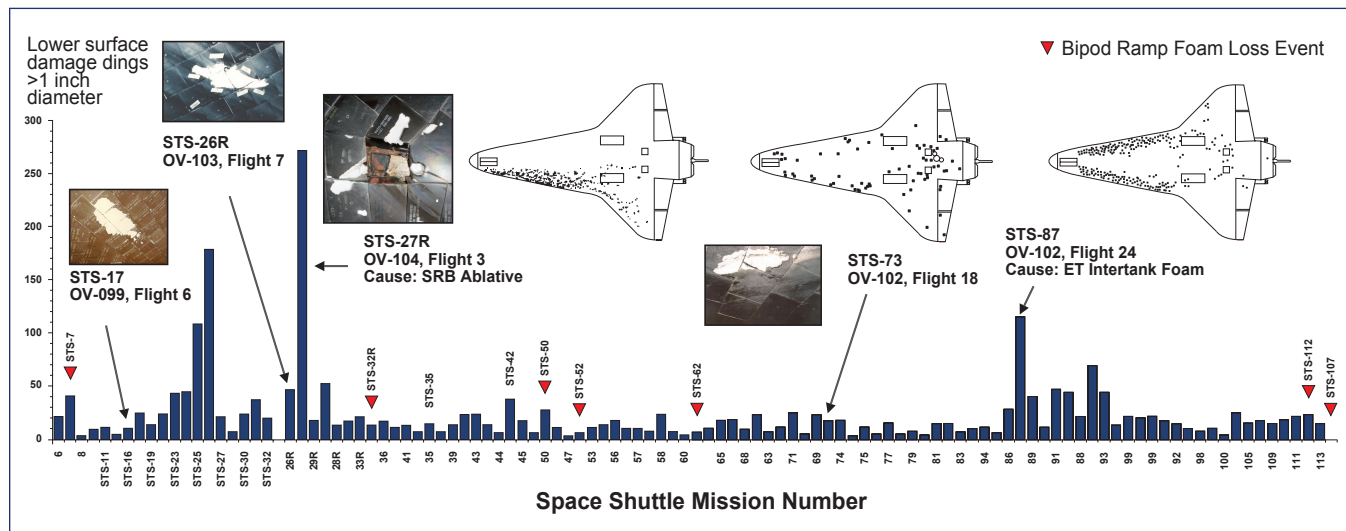
Figure 6.1-6. This chart shows the number of dings greater than one inch in diameter on the lower surface of the Orbiter after each mission from STS-6 through STS-113. Flights where the bipod ramp foam is known to have come off are marked with a red triangle.

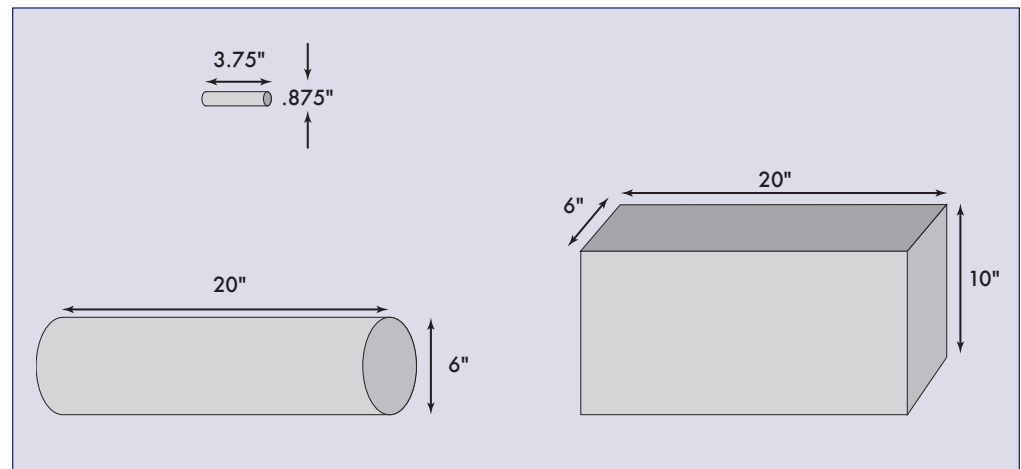
Until STS-107, Crater was normally used only to predict whether small debris, usually ice on the External Tank, would pose a threat to the Orbiter during launch. The use of Crater to assess the damage caused by foam during the launch of STS-107 was the first use of the model while a mission was on orbit. Also of note is that engineers used Crater during STS-107 to analyze a piece of debris that was at maximum 640 times larger in volume than the pieces of debris used to calibrate and validate the Crater model (the Board’s best estimate is that it actually was 400 times larger). Therefore, the use of Crater in this new and very different situation compromised NASA’s ability to accurately predict debris damage in ways that Debris Assessment Team engineers did not fully comprehend (see Figure 6.3-1).

Figure 6.3-1. The small cylinder at top illustrates the size of debris Crater was intended to analyze. The larger cylinder was used for the STS-107 analysis; the block at right is the estimated size of the foam.

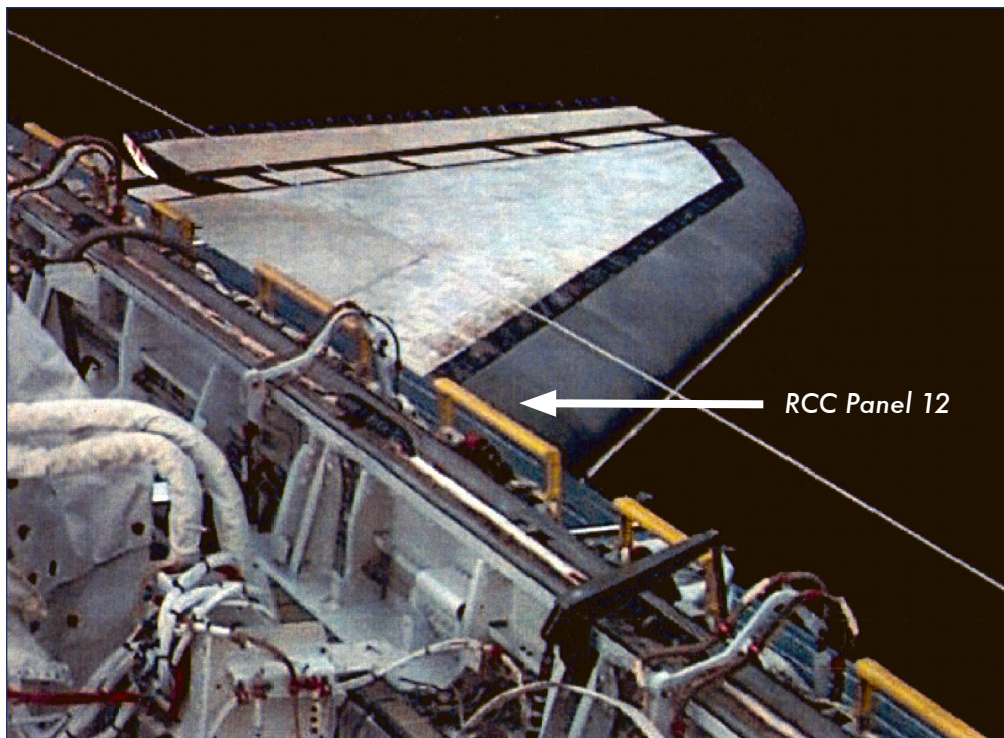
This photo from the aft flight deck window of an Orbiter shows that RCC panels 1 – 11 are not visible from inside the Orbiter. Since Columbia did not have a manipulator arm for STS-107, it would have been necessary for an astronaut to take a spacewalk to visibly inspect the inboard leading edge of the wing.

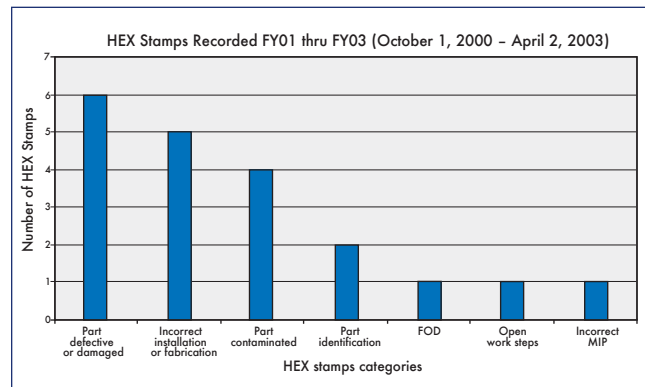
Figure 10.4-4. Rejection, or "Hex" stamps issued from October 2000 through April 2003.

Of the 141,127 inspections subject to rejection from October 2000 through March 2003, only 20 rejections, or "hexes," were recorded, resulting in a statistically improbable discrepancy rate of .014 percent (see Figure 10.4-4). In interviews, technicians and inspectors alike confirmed the dubiousness of this rate. NASA's published rejection rate therefore indicates either inadequate documentation or an underused system. Testimony further revealed incidents of quality assurance inspectors being played against each other to accept work that had originally been refused.

- F10.4-1 Shuttle System industrial safety programs are in good health.
- F10.4-2 The Quality Planning Requirements Document, which defines inspection conditions, was well formulated. However, there is no requirement that it be routinely reviewed.
- F10.4-3 Kennedy Space Center's current government mandatory inspection process is both inadequate and difficult to expand, which inhibits the ability
