# COLUMBIA

## ACCIDENT INVESTIGATION BOARD

REPORT  
VOLUME II

OCTOBER  
2003

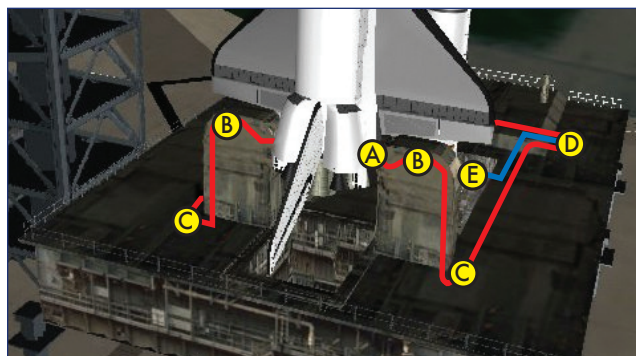
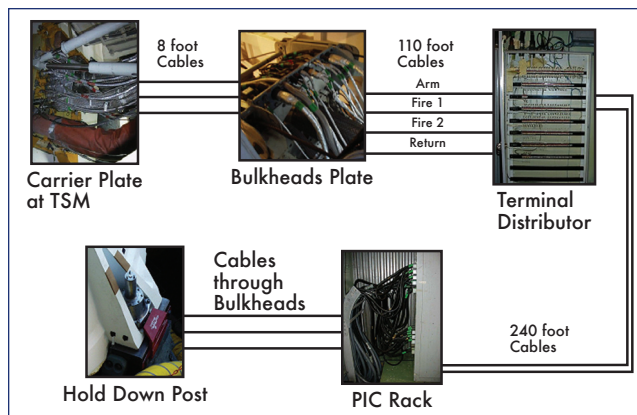
*Figure S-1: Hold-Down Post/External Tank Vent Arm Systems diagram with nomenclature below (Note: This figure was not included in the final report Section 10.9; it is provided here for clarity.)*

The signal to fire the HDP/ETVAS begins in the General Purpose Computers and goes to both of the Master Events Controllers (MECs). (See Figure S-1 for system routing.) MEC 1 communicates this signal to the A system cable, and MEC 2 feeds the B system. The cabling then goes through the Mobile Launch Platform mast to the Pyrotechnics Initiator Controllers (PICs; there are 16 PICs for A and B Hold-Down Posts, and 4 for A and B External Tank Vent Arm Systems); it then goes to each Solid Rocket Booster and Hold Down Post External Tank Vent Arm System. The A system is hard-wired to one of the initiators on each of the four nuts (eight total) that hold the Solid Rocket Booster to the Mobile Launch Platform. The B system cabling is hard-wired to the secondary initiator on each nut. The A and B systems also send a duplicate signal to the External Tank Vent Arm System. Either Master Events Controller will operate if the other or the intervening cabling fails. To verify cabling integrity, a continuity and ohms check is performed before each launch.

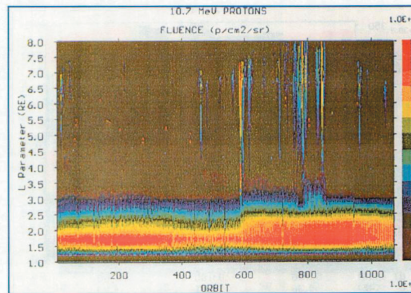
### Recommendation:

Figure 5 shows the most extreme compressional effect of a CME ever observed in the magnetosphere detected by the Combined Release and Radiation Effects Satellite (CRRES) at the onset of the great magnetic storm of March 24, 1991. CRRES flew in a geostationary transfer orbit with perigee at ~390 km and apogee at ~6.6  $R_E$ . Figure 5 is a plot of the distribution of protons with energies of ~10.7 MeV in distance from the Earth as a function of orbit number. Attention is directed to the sudden increase in the flux of protons during orbit #537 at radial distances between 2 and 2.5  $R_E$  from the center of the Earth.

CRRES measurements show that the injected high-energy particles were trapped in the magnetosphere and did not have access to the ionosphere. A sudden increase in flux was observed during the inbound pass at ~03:45 UT. This was the first sign of shock-accelerated protons. CRRES then passed through the inner radiation belt, behind the Earth and crossed the spatially extended new radiation belt. The initial injection was narrowly confined in energy to near 40 MeV. During the outbound pass the energies of newly trapped protons filled the 10 to 70 MeV range. These protons were observed continuously for the next seven months (Figure 5) until the spacecraft's battery failed.

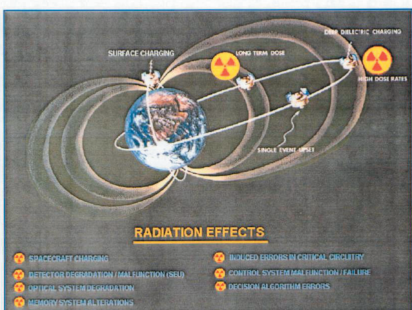
analysis of anomalies such as single event upsets and deep dielectric charging. Other methods include improved prediction and monitoring of space environment hazards and developing practical ways to accelerate the loss of trapped particles from the radiation belts. Figure 6 summarizes the main radiation hazards to which space systems are exposed. The first, called a single event upset, occurs when MeV protons pass through the shielding of microelectronic components leaving trails of ionization and currents that can trigger false commands or altered memory states. Long exposure to doses of energetic protons degrades and destroys the functionality of microelectronic devices.

Figure 6. Primary radiation hazards to space systems.

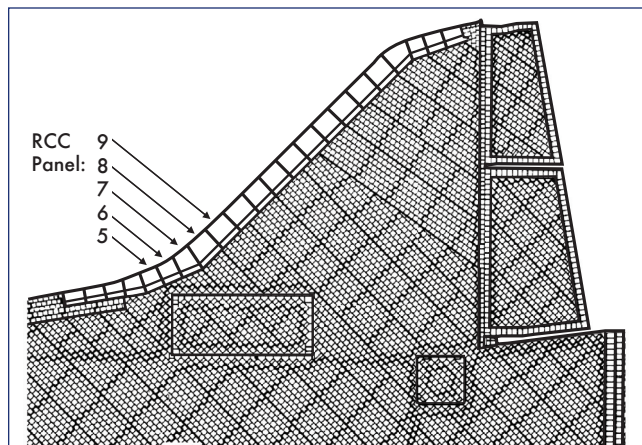
Several approaches were taken to assess the area of left wing damage. The efforts included launch video and photograph analysis, review of launch MADS data, debris transport analysis, forensic analysis of debris found in Texas, wire bundle burn through analysis, and aero/thermal modeling of the entry. The data indicate that the area of the highest probability of damage to the left wing was between RCC panels 5 and 9, with the most likely damage occurring on the lower side of RCC panel 8 or an adjacent Tee seal. The damage was most likely equivalent in size to a 6 to 10 inch diameter hole or area broken from the RCC panel or an adjacent Tee seal. Figure 3-4 shows the area of highest probability of wing damage and Table 3-1 shows the methods used to determine the damage.

Figure 3-4. Area of most likely wing damage.

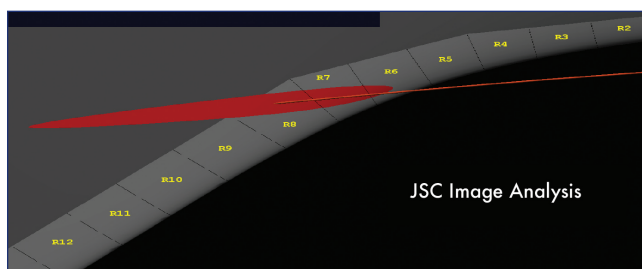
Video and Computer-Aided Design (CAD) analysis determined that the most likely impact location was leading edge RCC panels 6 through 8 (Figure 3-5). Due to the foam size, RCC panels 5 and 9 must also be included in this impact zone. The best estimate of the foam size, based on imagery measurements, is 21 to 27 inches long and 12 to 18 inches

Figure 3-5. Multiple analyses determine foam impacted lower RCC panels 6 through 8 area.

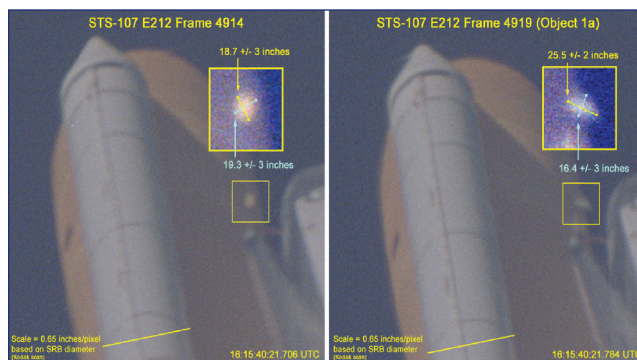
wide. The precise foam shape and thickness cannot be determined from the available imagery; however, a reasonable estimate is that it was a plate-like shape and several inches thick. The foam tumbled at a minimum rate of 18 times per second based on the imagery, although the actual rate may never be known more accurately. Figure 3-6 illustrates a portion of the photographic analysis techniques used to determine the size of the foam.

Figure 3-6. Photographic analysis techniques determined foam size: debris appears almost circular in frame 4914 and elongated in frame 4919.

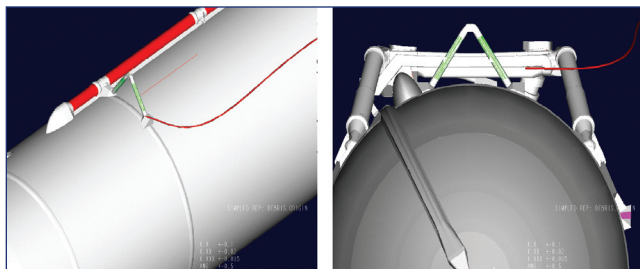
There is significant visual and debris trajectory information to implicate the left bipod ramp area as the source of debris. In Figure 3-9, the red line depicts the estimated foam trajectory as it moved from the bipod ramp area toward the left wing. In addition to locating the impact in the RCC panels 6 through 8 region, the video analysis has also shown that the impact was below the apex of the RCC panels since no foam or post impact debris was observed to traverse over the top of the wing. This is indicative of an impact below the wing leading edge aerodynamic stagnation line (Figure 3-10). The stagnation line, or dividing streamline, is the line along the leading edge of the wing where the airflow comes to rest; above this line, airflow moves over the upper wing surface and below this line, the airflow moves over the lower wing surface.

Figure 3-9. Multiple analyses indicate foam is from ET left bipod area. Red line depicts the estimated foam trajectory as it moved from the bipod ramp area toward the left wing.

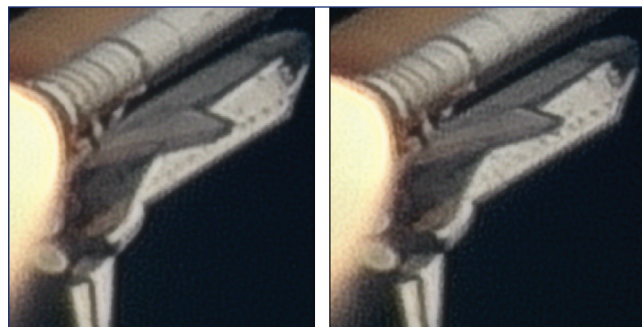
Enhancements of the ascent video indicated there was no discernable damage to the orbiter wing leading edge or lower tile surface. Figure 3-11 is a sample of these video enhancements. The figure compares 30 pre-impact integrated video fields with 21 post-impact integrated video fields. Based on these enhancements, photo experts have been unable to determine or quantify any damage to any portion of the orbiter vehicle as a result of the impact.

Figure 3-11. Pre-impact vs. post-impact shows no observable damage within the resolution limits.

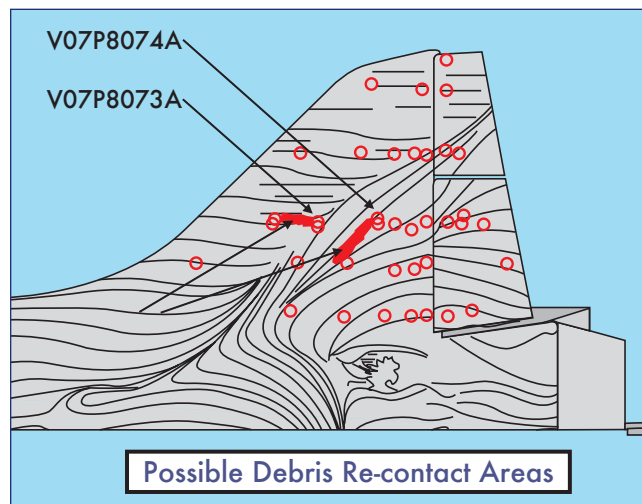
There are two other indications that the foam impact occurred in the panels 6 through 8 area. Two Modular Auxiliary Data System (MADS) lower surface pressure measurements behaved anomalously immediately after the time of the impact. Figure 3-13 shows the location of these measurements along with possible areas for post-impact debris re-contact in the vicinity of the sensors. The unusual behavior of one of the sensors is shown in Figure 3-14.

Figure 3-13. CFD surface flow with lower left wing pressure sensors.

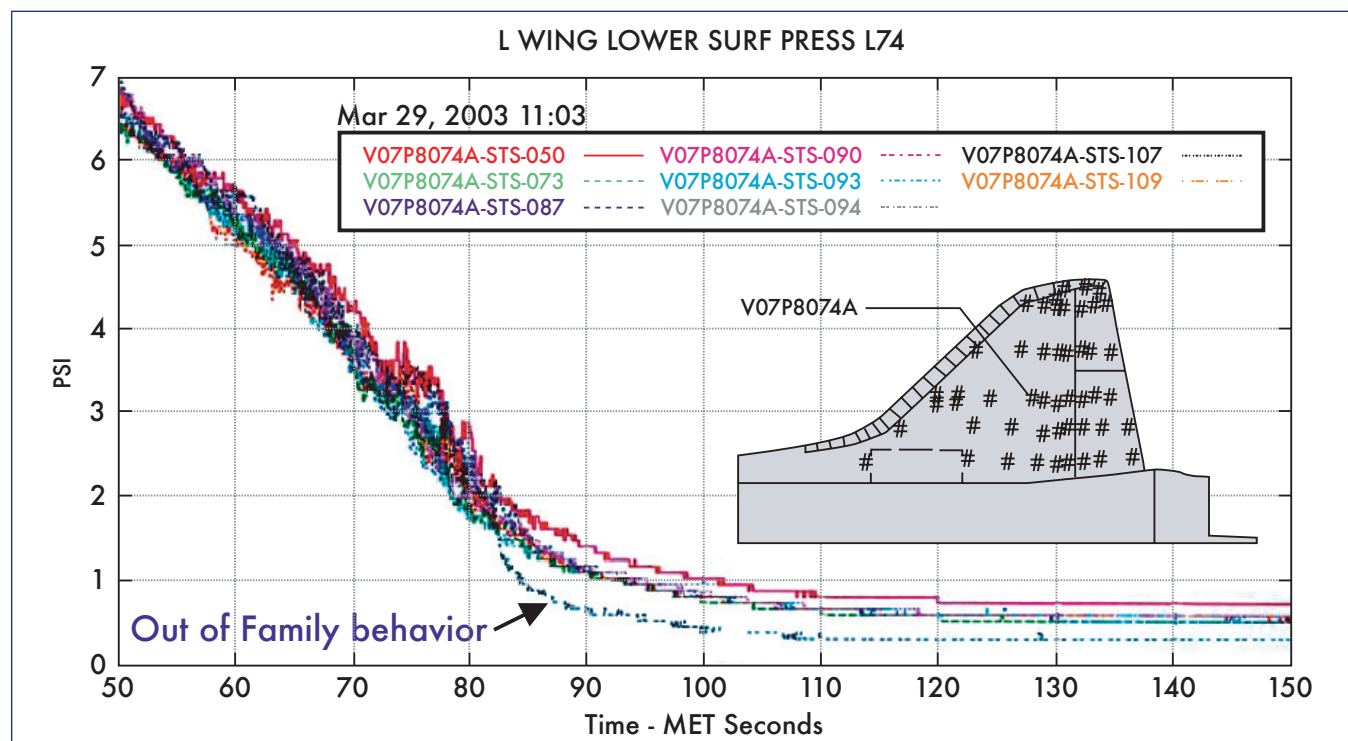
Figure 3-14. Unusual behavior of pressure sensor V07P8074A.

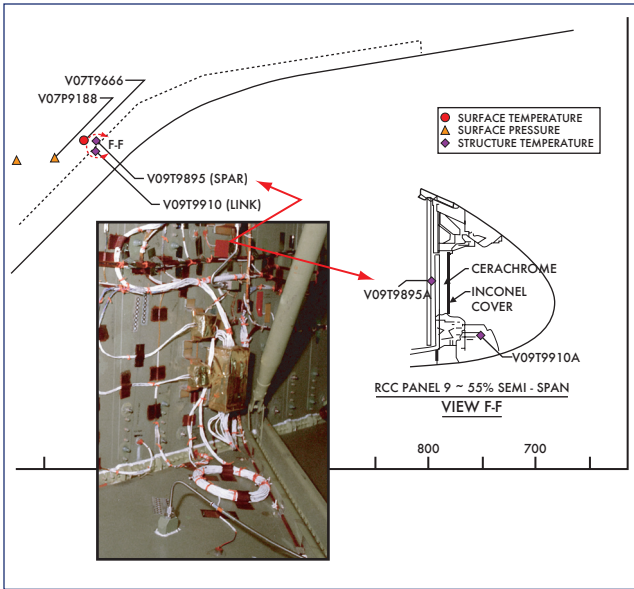
Additionally, there is another MADS measurement that had an off-nominal signature during the ascent timeframe. The temperature sensor on the leading edge spar behind RCC panel 9 showed a slightly higher temperature rise than seen on any previous *Columbia* flight. Figure 3-15 shows the location of the temperature sensor behind the wing leading edge spar inside the wing. The slight temperature rise can be seen in Figure 3-16. Note that most flights show a small rise in this temperature during ascent due to aerodynamic heating.

Figure 3-15. Close-up photo shows RCC panel 9 wing leading edge temperature measurement.

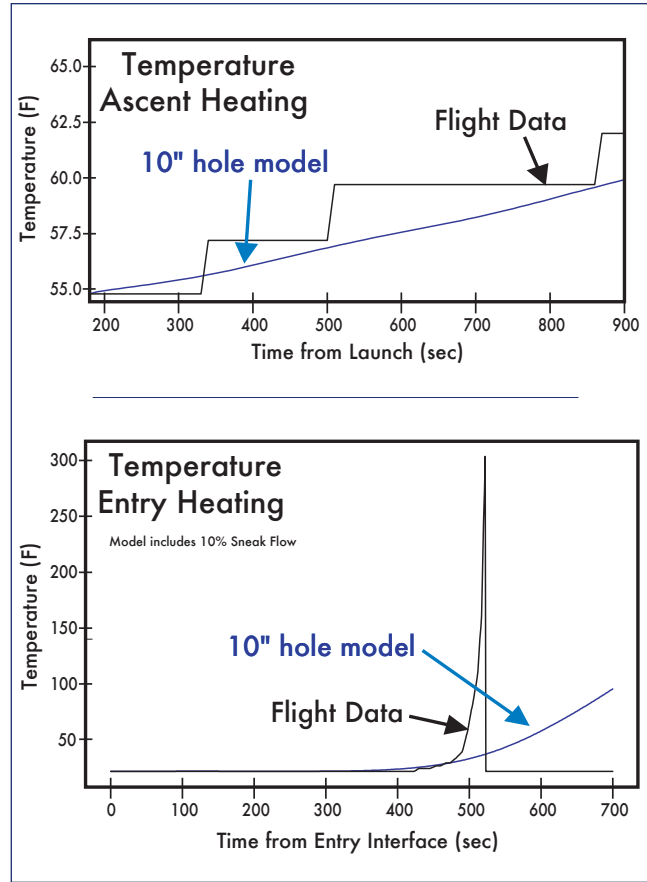
Figure 3-17. Correlation between simplified thermal math model and STS-107 ascent and entry flight data.

STS-107 had a 7.5 degree Fahrenheit rise that started very early during ascent (five to six minutes after launch). Although the data do not prove that the RCC was breached during ascent, the data are consistent with a possible flow path into the RCC cavity via damage in the RCC panels 6 through 8 area. A simplified thermal math model was constructed and verified with flight data from STS-5. The model was then correlated to the flight data from STS-107. Assuming the equivalent heating from a 10 inch diameter hole in RCC panel 8, this model nearly predicts both the ascent and entry temperature profiles for the wing leading edge spar temperature sensor. Figure 3-17 compares the model with

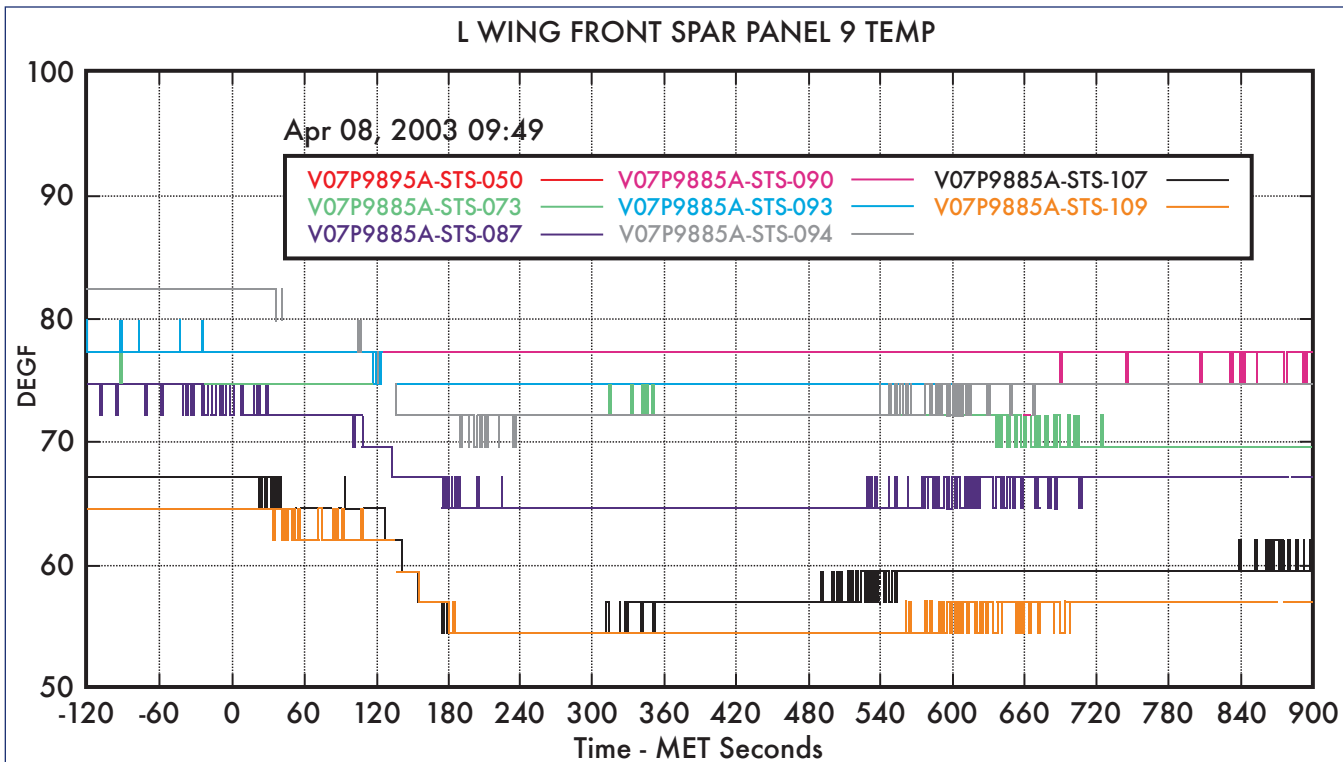
Figure 3-16. Three-bit rise (7.5 degrees F) on MADS wing leading edge spar temperature measurement (V09T9895A) during ascent.

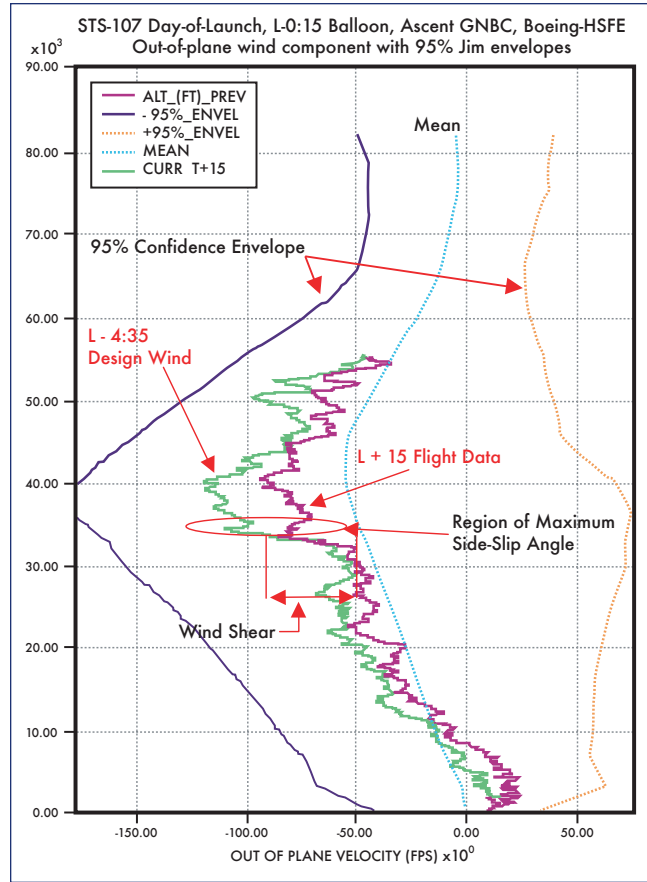
STS-107 experienced a wind shear during the period of maximum dynamic pressure starting at 57 seconds MET (Mach 1.27). The wind shear was due to a rapid change in the out-of-plane wind velocity of -37.7 feet per second over a 1200 foot altitude range starting at approximately 32,000 ft (as shown in Figure 3-21). Immediately after the vehicle flew through this altitude range, its side-slip angle began to increase in the negative direction, reaching a value of approximately -1.75 degrees at 60 seconds. This value of side-slip angle is a new flight experience value for MET 60 seconds (as shown in Figure 3-22). Post-flight data indicates that the new flight experience side slip event was not the result of the wind shear itself. Instead, it was the direct result of a difference in the L - 4:35 minutes balloon measurement, upon which orbiter guidance commands were updated on launch day, and the actual winds flown through by the orbiter during launch and ascent. Figure 3-21 highlights the difference in these two winds in this altitude region (a 25 foot per second increase in out-of-plane magnitude pre-launch compared to a 12 foot per second reduction in magnitude as experienced by the vehicle).

Figure 3-21. Out-of-plane wind velocity.

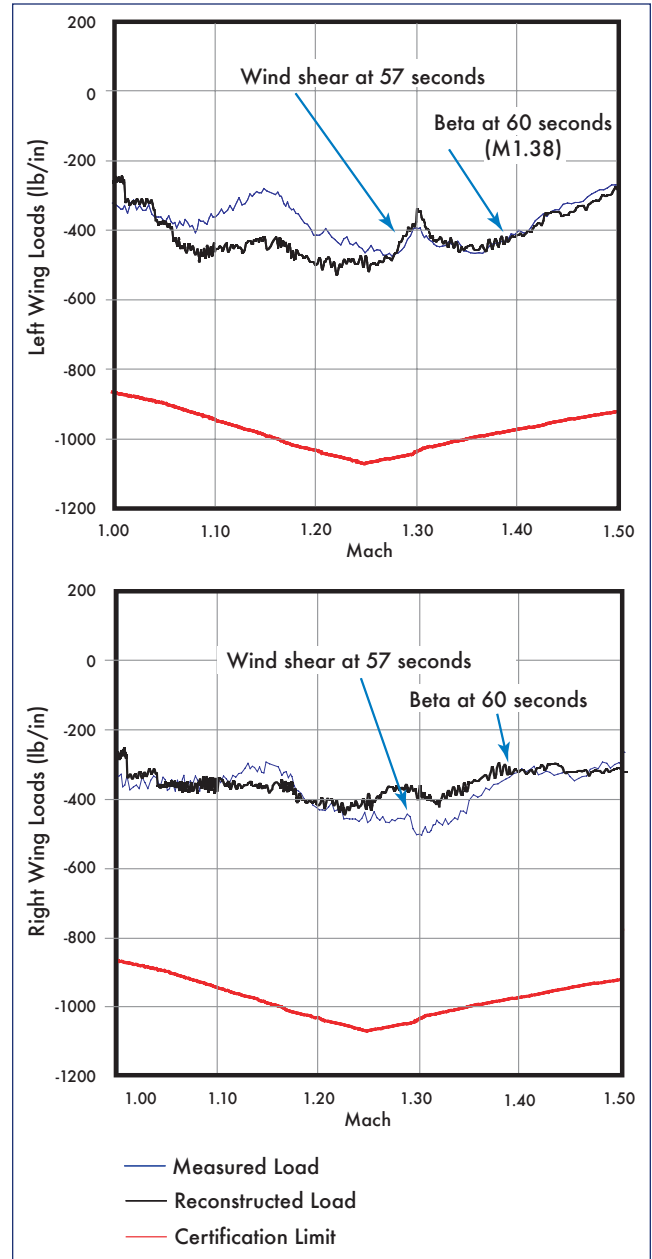
generate the loads on the orbiter wings during ascent. The assessment demonstrated that all orbiter wing loads were 50 to 60% of their design limit, or less, throughout the ascent. This includes the wind shear event at 57 seconds MET, and subsequent side-slip angle at 60 seconds MET (as shown in Figure 3-23).

Figure 3-23. Wing loads during wind shear and side-slip angle.

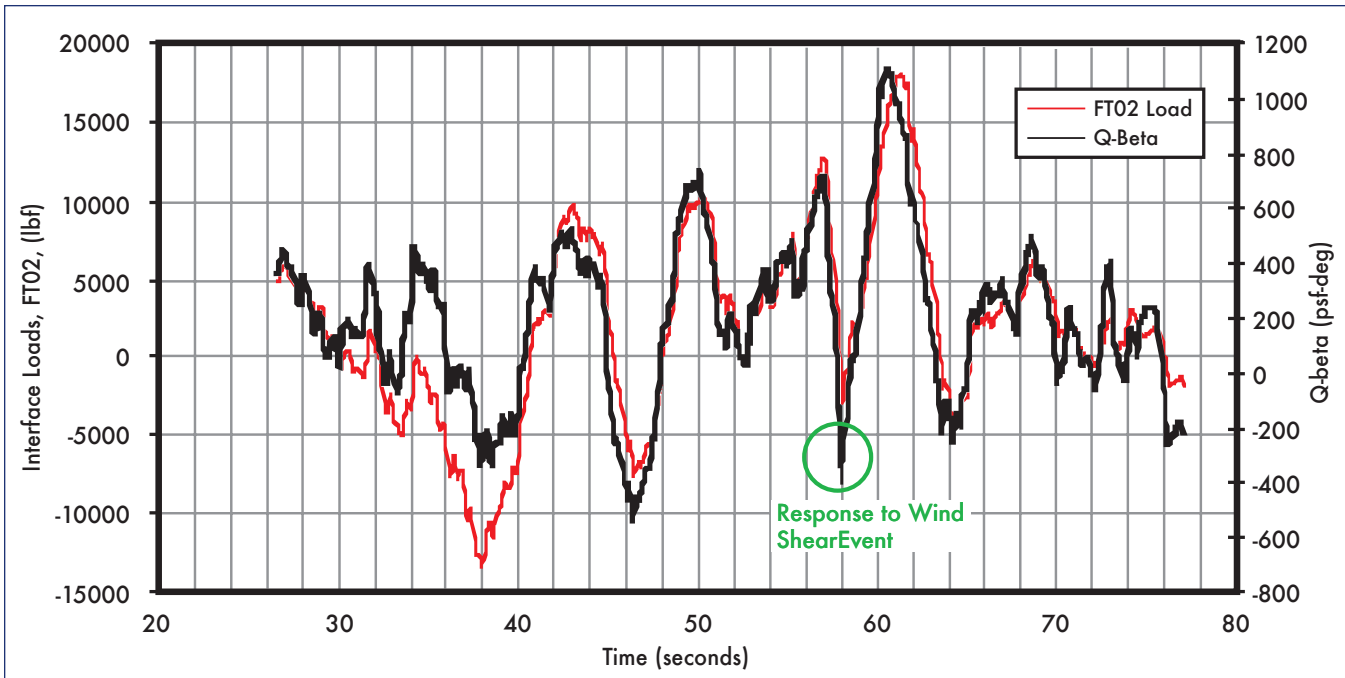
The ET/orbiter interface loads were generated using reconstructed trajectory parameters that included the effects of wind shear/crosswind, side-slip angle, and ET liquid oxygen (LOX) slosh. The loads analysis demonstrated that the ET forward attach loads were within certification requirements at all times. The wind shear event had only a small effect on the overall ET loads relative to the required limits (as shown in Figure 3-24), as did the ET liquid propellant slosh

Figure 3-24. ET interface loads at forward attachment during wind shear and side-slip angle. Q-beta is side-slip angle multiplied by the dynamic pressure and represents the side-slip angle contribution of the interface load.

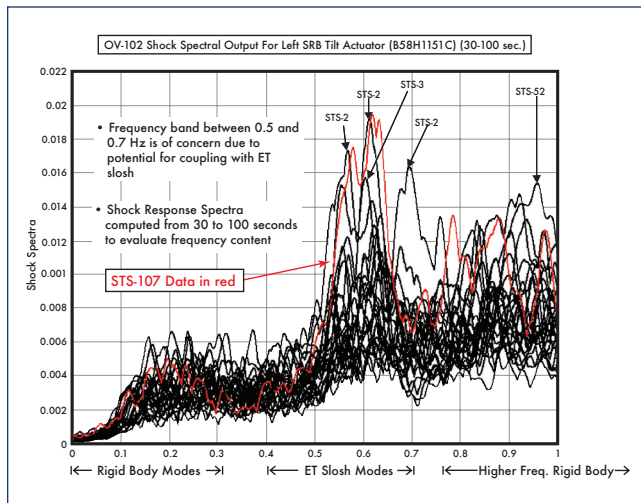
The STS-107 ascent data indicate a 0.6 Hz actuator oscillation frequency that peaks in amplitude at 55 seconds, and again at 77 seconds MET and continues through SRB separation. The peaks directly correlate to peaks in 0.6 Hz wind content. A 0.6 Hz oscillation in the Flight Control System output is of interest since it can couple with the ET Liquid Oxygen (LOX) slosh mode. Slosh refers to the repeated side-to-side movement of the center of gravity of the liquid oxidizer propellant in the external tank. The slosh mode frequency and amplitude cannot be measured directly through vehicle data. In order to determine if ET LOX slosh is present, a post-flight process of reviewing the vehicle SRB and SSME actuator frequency content must be conducted, as well as that of the launch wind. When this post-flight process was conducted for STS-107, it revealed that this flight experienced more than typical 0.6 Hz frequency content in the SRB tilt actuators with moderate content in the rock actuators. Figure 3-29 illustrates this point with the results of the SRB left tilt actuator frequency response as compared to previous *Columbia* flight history.

Figure 3-29. STS-107 SRB tilt actuators experienced more than typical 0.6 Hz content.

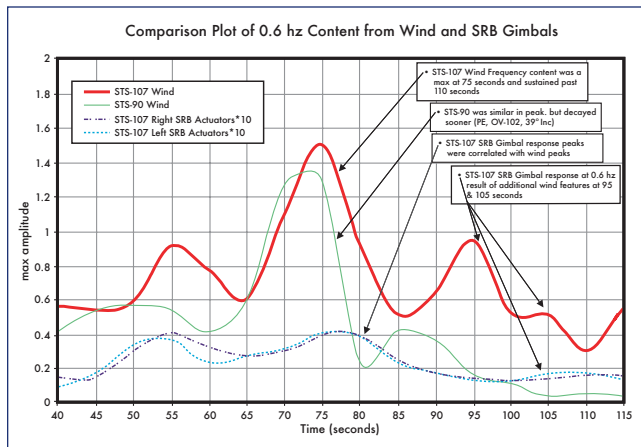
Figure 3-30 shows the relative time variation of amplitudes of the 0.6 Hz frequency content in wind and actuator data. The close correlation between the peaks in the 0.6 Hz content of the right and left actuator responses and the wind dynamics indicates that the actuators were responding primarily to wind rather than ET LOX slosh at this frequency through most of first stage (prior to SRB separation). As the 0.6 Hz content of the wind dynamics reduces in magnitude late in first stage, the remaining 0.6 Hz content in the actuator response may be attributed to a combination of the remaining wind dynamics and low-amplitude ET LOX slosh. STS-90 shows a similar wind frequency content.

Figure 3-30. STS-107 SRB gimbal responses at 0.6 Hz frequency correlated to wind.

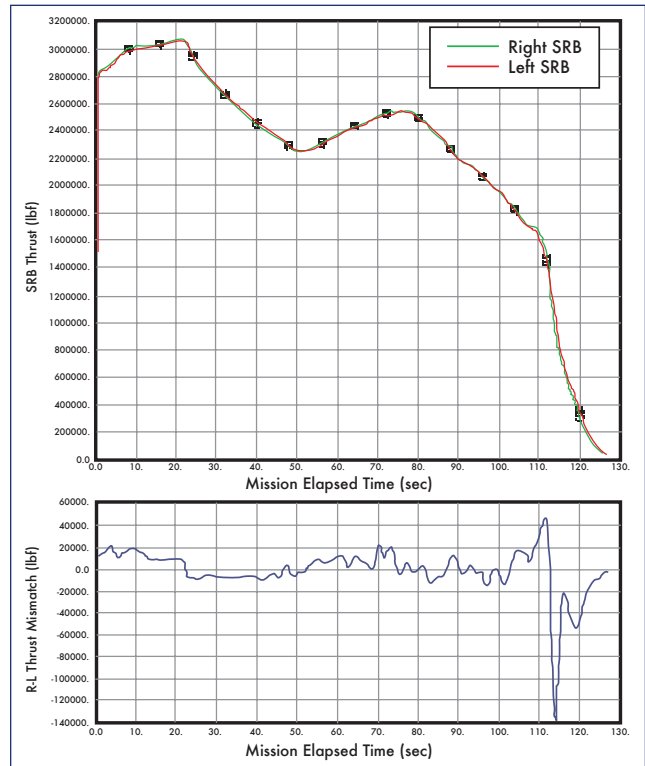
Figure 3-34. SRB thrust mismatch.

The SRB thrust mismatch observed during tail-off was well within the design margin of the flight control system, and similar occurrences have happened numerous times during previous flights.

The data indicate that the SRB thrust mismatch on STS-107 was a direct result of SRB burn rate differences between the left and right SRB. The thrust mismatch observed on STS-107 and the new flight experience nozzle positioning occurred after the foam shedding event. The SRB thrust mismatch occurred on the majority of flights in both families of flights, including those that did not shed foam.

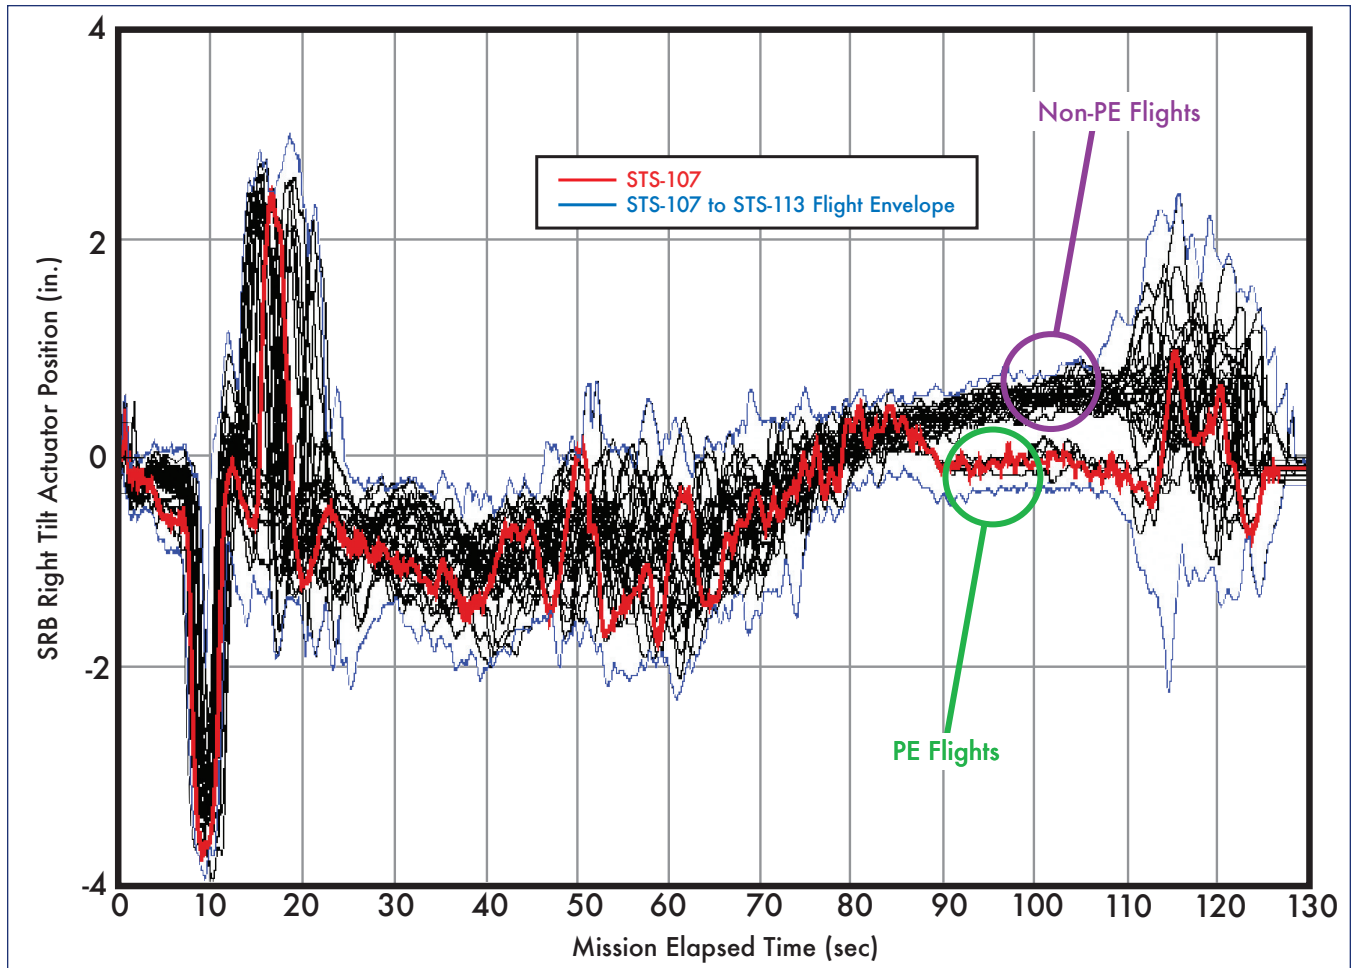
Figure 3-35. SRB nozzle position for PE flights versus non-PE flights.

The second nozzle motion event occurred when the SRB and SSME Thrust Vector Control (TVC) pitch and yaw deflections exceeded the previous flight experience envelope during SRB tail-off (as the SRB thrust diminished). The new flight experience envelope for the SSME and SRB nozzle positions was primarily due to (1) low Reusable Solid Rocket Motor (RSRM) performance that caused a time shift of the SRB tailoff events relative to previous flight experience, as indicated by a low burn rate shown in Figure 3-33, (2) a thrust mismatch between the left and right SRB caused by lower than normal thrust on the right SRB during tail-off, the final seconds of SRB burn (as shown in Figure 3-34), (3) a small bias in the left SRB pitch actuator that shifted the actuator positions farther toward the edge of the flight experience envelope, and (4) flight control trim characteristics unique to PE flights (as shown in Figure 3-35).

Due to flight control gain settings unique to PE flights, PE flights have a nozzle position closer to zero inches deflection from 85 to 110 seconds MET. The flight data that coincides with the STS-107 data are all from PE flights, seen clearly in the 85 to 110 seconds MET timeframe in Figure 3-35. The other grouping of flights in this same timeframe (85 to 110 seconds MET) are all non-PE flights and have larger pitch nozzle deflections.

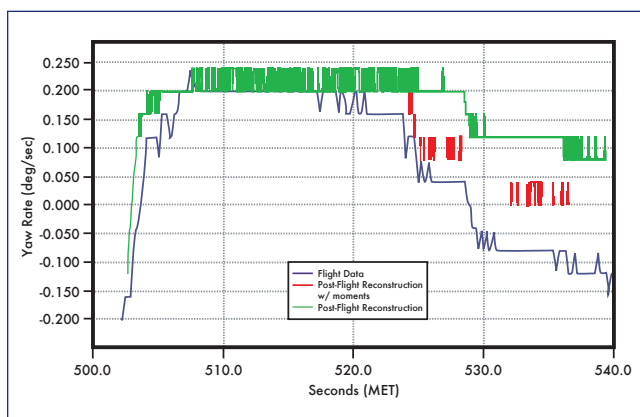
Figure 3-36. ET separation yaw rate.

A higher than typical negative yaw rate was observed at ET separation during STS-107. The yaw rate, shown in Figure 3-36, was approximately  $-0.12$  deg/sec and near the edge of the flight experience envelope. The negative yaw rate is noteworthy because it does not correspond to the flight control system's thruster activity, known vent forces, or any other explained mission activity. Furthermore, the rate appears at the time of physical separation between the orbiter and external tank, which indicates that it is related to the structural release between the two objects. Although the negative yaw rate was unusual, it was well within the design and certification envelope for ET separation. This rate was also well within the flight limits ( $\pm 0.7$  deg/sec) for ET separation to occur.

A fault tree analysis narrowed down the cause of the negative yaw rate to a release of strain energy at ET separation due to either (1) a misalignment of the orbiter and external

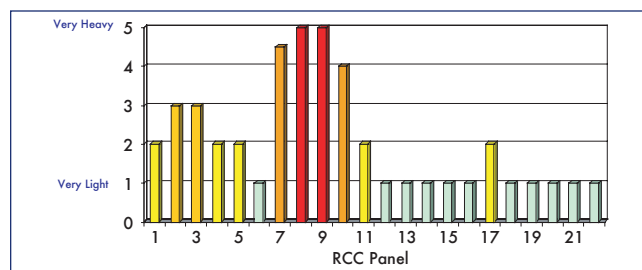
The forensic data indicate that the panel 8/9 area was subjected to extreme entry heating over a long period of time leading to RCC rib erosion, severely slumped carrier panel tiles, and a substantial slag deposition on the upper portion of RCC panels 8 and 9. Figure 5-2 shows the slag deposition (both metallic and oxide) in the RCC panel 8/9 area relative to the other parts of the wing leading edge, and Figure 5-3 shows samples of the severe slag deposition on the panel 8 rib. A review of all recovered debris indicates that this is the most probable area of a breach into the wing since there are no other debris pieces that exhibit the unique characteristics observed in this area.

Figure 5-2. Slag deposition in the RCC panel 8/9 area relative to the other parts of the left wing leading edge.

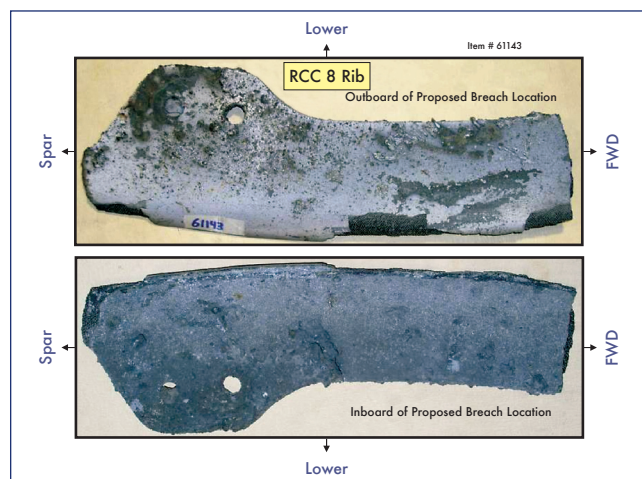
Figure 5-3. Samples of severe slag deposition on the panel 8 rib.

Based on the slag deposition on the upper RCC panel 8 and the rib erosion at the panel 8/9 interface, the most likely area of damage was the bottom portion of RCC panel 8. The outboard apex on the panel 8 upper inboard rib shows knife edge erosion, and the rib tapers from a design thickness of 0.365 inches to 0.05 inches. The surface of the panel 8 outboard rib and matching heel piece show a similar sign of erosion, as does the panel 9 upper inboard rib. The erosion on both the panel 8 and 9 rib is on the inboard side, indicating that flow is coming from the panel 8 location. Additionally, several lower carrier panel tiles in the RCC panel 9 area also show significant slumping and erosion that is consistent with a hole or breach in the lower part of RCC panel 8. Fig-

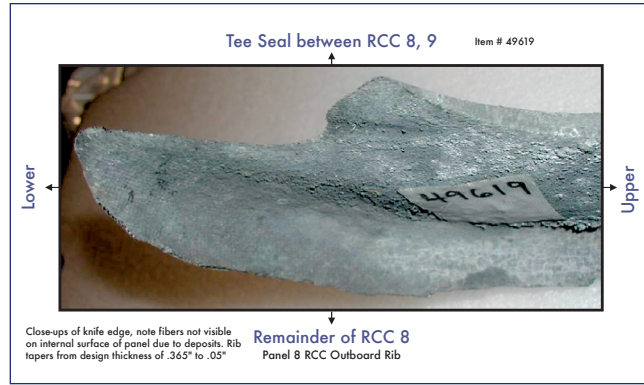
Figure 5-4. Example of rib erosion.

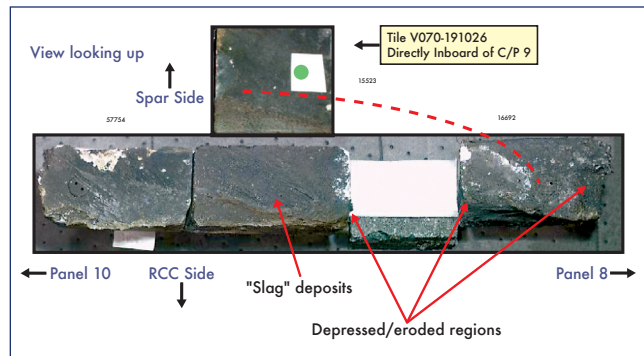
Analysis of the slag deposition on the lower carrier panel 9 tiles was also performed. Materials on these tiles are consistent with wing leading edge materials (Aluminum, Inconel, Nickel alloy, and Carbon) indicating an outflow from the panel 8 area across the tiles. Tile slumping in this area is indicative of temperatures in excess of 3000 °F. The upper carrier panel 8 tile was also analyzed and the results were similar to lower carrier panel 9 except that this tile appeared to have more Cerachrome and Nextel fiber deposits. These materials are consistent with the insulator that protects the wing leading edge spar and with flow moving toward the upper wing surface through the vent between the upper carrier panel and RCC.

Figure 5-5. Flow on the lower carrier panel 9 tiles.

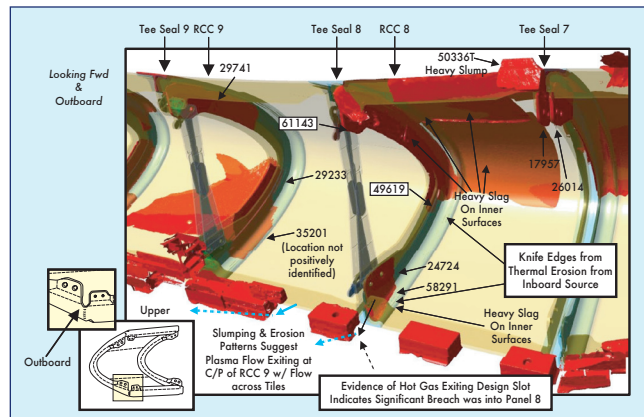
Figure 5-6 is a CAD drawing of the recovered debris showing overall slag deposition and erosion patterns. The drawing is a view from behind the RCC panels since this provides the best view of the erosion and slag deposition. Three full Tee seals can be seen in this drawing; the leftmost, Tee seal 9, divides panel 9 and 10; Tee seal 8 in the center divides panel 8 and 9; the rightmost, Tee seal 7, is the division between panel 7 and 8. The drawing shows the heavy slag deposition of the upper portion of panel 8 indicating that the probable breach area was the bottom of panel 8. The severely eroded RCC ribs are also visible near the RCC panel 8/9 Tee seal. The heavy slag on these inner surfaces indicate flow from the panel 8 direction toward panel 9. This is also consistent with the knife-edge erosion shown in Figure 5-4. The proposed flow direction leading to the erosion and slag deposition on the lower carrier panel 9 tiles can be seen in this view as well. The detailed flow, erosion, and deposition are best viewed in Figure 5-5. The last significant feature in Figure 5-6 is the heavy slumping that is observed on the upper carrier panel 8 tile (50336T) in the upper right portion of the drawing.

Figure 5-6. CAD drawing of the recovered debris showing overall slag deposition and erosion patterns.

patterns, the breach was in an area that caused the flow to impact the spanner beam associated with Tee seal 8 and create the knife edge erosion shown in this area in Figure 5-6.

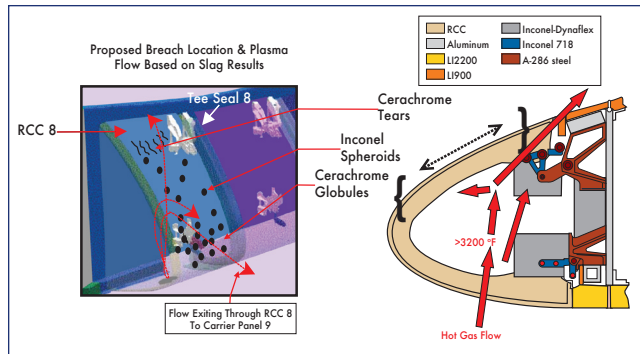
As time progressed, the Cerachrome and Inconel wing spar insulators were eroded, and eventually hot gas flow impinged on the wing leading edge, burning through the honeycomb spar. Figure 5-7 depicts the possible flow direction and deposition of various metals as determined by this analysis.

Figure 5-7. Analysis results show possible flow direction and deposition of metals.

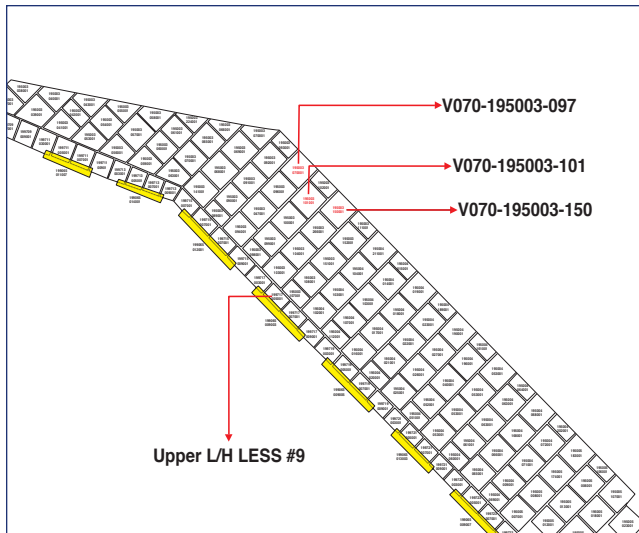
The tile departed the orbiter more than one minute prior to final break-up due to prolonged internal heating of the upper wing skin in the area shown in Figure 5-9. The tile shows indications of backside heating and an RTV debond. It was not a failure in the densification layer, which would have been caused by mechanical loading. This piece of recovered debris is not very significant on its own merit; however, it is consistent with the previously discussed forensics data (rib erosion, carrier panel 9 tile slumping, etc.) and other events that will be discussed later in Section 5.4.

Figure 5-9. Three possible orbiter locations of the Littlefield tile on left wing.

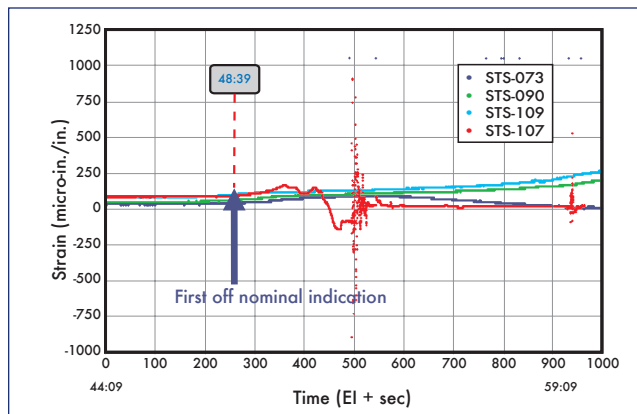
At approximately 8:48:39 EST (EI + 270 sec.), a left wing leading edge spar strain gauge began a small off-nominal increase. Figure 5-11 shows the STS-107 response of this

Figure 5-11. Left wing RCC panel 9 strain gauge is first measurement to indicate an off-nominal event. Note that EI was at 8:44:09 EST.

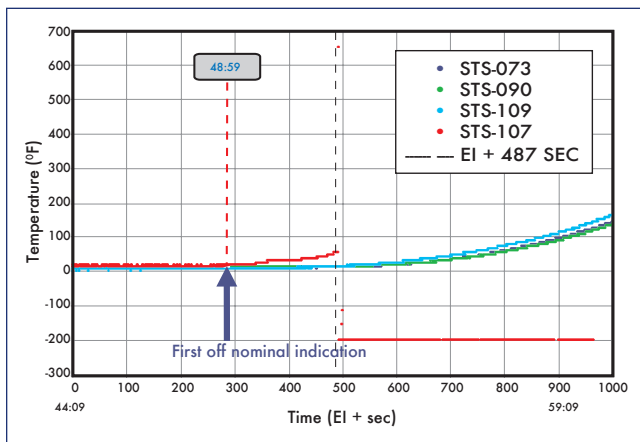
Twenty seconds later at 8:48:59 EST (EI + 290 sec.), the left wing lower attach clevis temperature sensor (between RCC panel 9 and 10) began an early off nominal temperature trend. Figure 5-13 shows the abnormal temperature response when compared to other *Columbia* missions. This temperature rise is consistent with an early entry of hot gas into the RCC cavity. This Modular Auxiliary Data System (MADS) measurement (V09T9910A) is the only temperature measurement located in the RCC cavity along the left wing leading edge. It is positioned on the lower attach fitting between panel 9 and 10 and is well protected thermally by Inconel foil insulation. The sensor is also thermally isolated since it sits on the attach fitting away from other structure as shown in Figure 3-12. In order to get an early temperature rise for this sensor, unlike that observed on any other flight, there must be a path in the RCC cavity to allow hot gas to reach the sensor.

A thermal analysis was performed with heating rates from various hole sizes in the bottom of RCC panel 8 in an attempt to match this temperature rise. The analysis used a thermal math model of the wing leading edge (Inconel Cerachrome insulation, Inconel 718 and A-286 steel attach fittings, and aluminum honeycomb spar). The results indicated that the heating equivalent of a 6 to 10 inch diameter hole with a 10 percent “sneak flow” around the insulation would be required to match the thermal response of the clevis temperature. In the same timeframe several MADS lower surface temperatures on the left wing showed a slight off nominal early temperature rise when compared to previous flights of *Columbia* of the same inclination.

Figure 5-13. Left wing RCC panel 9/10 clevis temp sensor is second measurement to indicate an off-nominal event.

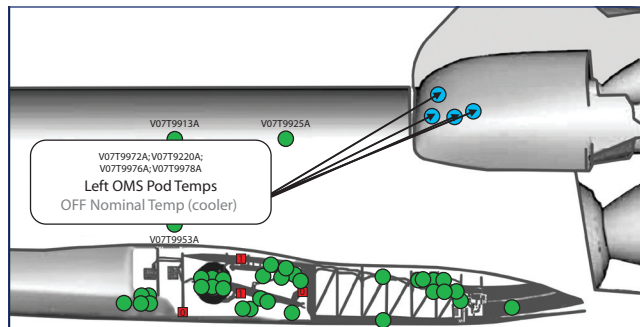
Figure 5-15. Location of OMS pod thermocouples off-nominal low.

The reduced heating is not completely understood since the weak aerodynamic flow field on the upper surface of the orbiter is difficult to model and is extremely sensitive to disturbances. The best explanation for this reduced heating is that flow into the RCC cavity was venting through to the upper surface of the wing through an existing 0.1-inch vent between the RCC and upper surface carrier panels. This vent exists all along the leading edge from RCC panel 1 through panel 22 and has an approximate area of 66 square inches. This upper surface RCC venting and the flow disturbance created by the panel 8 and upper carrier panel 8 damage caused the vortices from the canopy or area where the wing

meets the orbiter fuselage to move from their normal positions, thus reducing the heating on the OMS pod. Figure 5-16 depicts the change in the upper wing surface vortices and the weak upper surface flow.

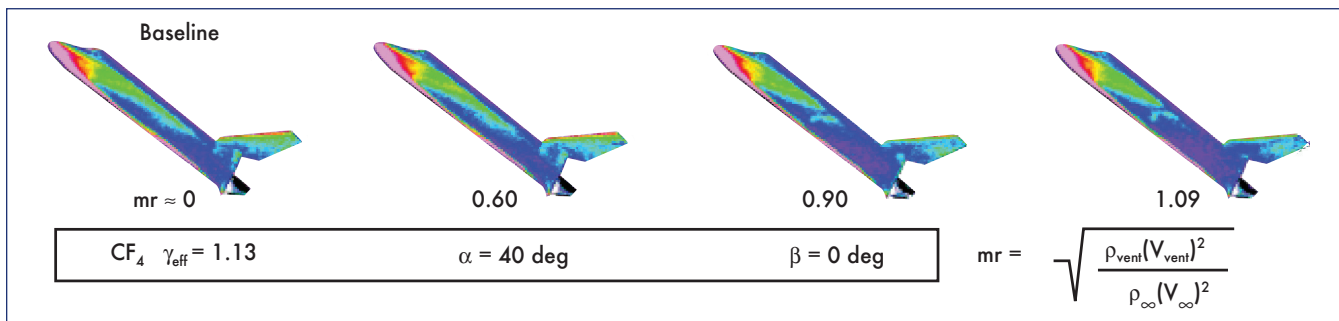
Figure 5-18. Wind tunnel model results for sensitivity of orbiter side fuselage and OMS pod heating patterns to mass addition along WLE leeside vent gap.

the RCC upper surface vent. Figure 5-18 shows the change in heating as the vent velocity is altered.

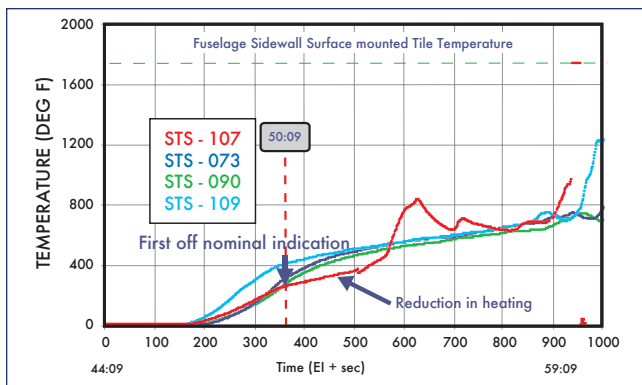
Figure 5-20. Off-nominal temperature indication on the left sidewall.

In the same timeframe, at 8:50:09 EST (EI + 360 sec.), a left payload bay fuselage MADS surface temperature measurement (Figure 5-19) showed an off-nominal temperature trend. This trend is a reduced rise rate when compared to other previous *Columbia* missions, as shown in Figure 5-20. The previously discussed theory of venting and or disturbed flow due to panel 8 damage, causing a shift in the vortices on the upper surface of the wing, is also believed to be the cause of this off-nominal behavior. The flow field and venting on the upper surface rate are constantly increasing since the mass flow rate into the RCC breach is increasing as the orbiter descends lower into the atmosphere.

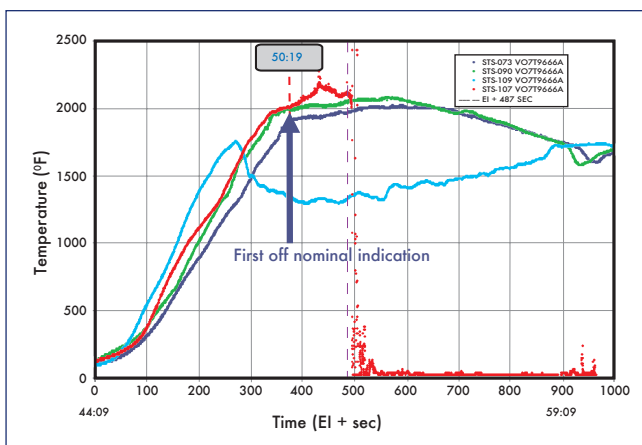
Figure 5-21. Temperature rise on tile surfaces aft of RCC panel 9.

panel 8 will cause increased heating to the lower wing surface. As previously discussed, the eroded lower carrier panel tiles on panel 9 indicate this strong flow from panel 8. This is consistent with flow patterns observed on many recovered lower surface wing acreage tiles along the flow lines aft of the RCC panel 8 area. Figure 5-21 shows this temperature response as compared to other *Columbia* missions. The location of the sensor can be seen in Figure 5-22.

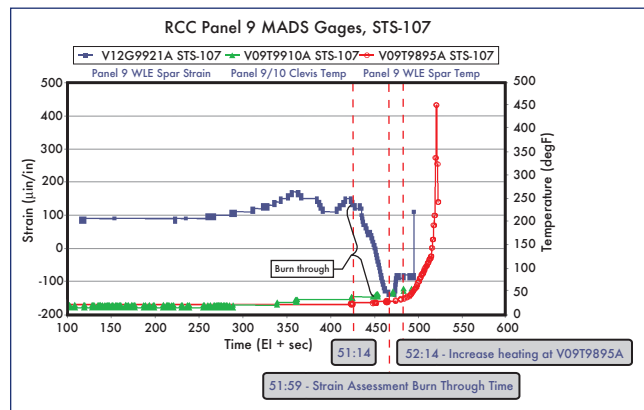
Figure 5-23. RCC panel 9 MADS strain and temperature measurements, STS-107.

By 8:51:14 EST (EI + 425 sec.), the wing leading edge spar temperature began an early, off-nominal rise, shown in Figure 5-23. At the same time, the clevis temperature in the RCC panel 9/10 region continued to increase. The initial spar temperature rise was relatively slow and was caused by

conduction since this measurement is on the backside of the spar in the wing cavity. Eventually, the rise rate increased dramatically as first the Inconel and Cerachrome insulation and later the aluminum honeycomb were destroyed. The exact time of the spar breach is unknown; however, it is estimated to have occurred between 8:51:14 to 8:51:59 EST (EI + 425 to 470 sec.) based on the observed wing leading edge linear decrease in strain during this timeframe. A more detailed discussion of the method used to bracket the time of the wing spar breach is contained in the following section.

The first technique used the strain response, shown earlier in Figure 5-23. On this plot, the initial strain rise that began at about 8:49:09 EST (EI + 300 sec.) is due to thermal elastic strain. It appears that the spar structural softening occurs at approximately 8:50:09 EST (EI + 360 sec.), followed by loss of the structural integrity, or breach, at approximately 8:51:14 EST (EI + 425 sec.). This appears to be completed by approximately 8:52:00 EST (EI + 471 sec.). A detailed structural model that attempted to reproduce the thermal strain response observed during this timeframe confirmed this timing. This analysis determined that the location of the spar breach must be within about 15 inches of the spar strain measurement. This would locate the spar breach near the intersection of panel 8/9, as shown in Figure 5-29. The flow through the RCC breach maintained some directionality although it was influenced by the shape of the hole, remaining RCC structure, attach hardware, and leading edge insulators. Overall, this strain response is consistent with an RCC breach in the lower part of panel 8 as previously discussed in Section 5.3. Although it is difficult to pinpoint a precise location of the RCC breach, this analysis supports the argument that the breach was closer to the panel 8/9 intersection and Tee seal 8.

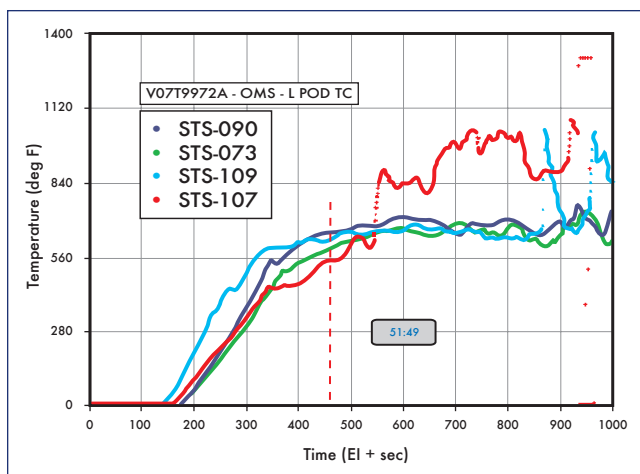
Figure 5-24. Off-nominal low OMS pod thermocouple (V07T9972A).

At 8:51:49 EST (EI + 460 sec.), one of the left OMS pod measurements (V07T9972A) began to show an increased temperature rise, indicating that the upper surface flow has changed again. This is shown in Figure 5-24 along with this measurement on other *Columbia* missions. It is evident that the measurement rises to a higher temperature and at a faster rate than has been observed on previous missions within the next few minutes. Figure 5-25 shows other left OMS pod and fuselage temperature measurements that exhibit an off-nominal rise later in time. The sensor locations on the left side of the orbiter are also shown in Figure 5-25.
