# COLUMBIA

## ACCIDENT INVESTIGATION BOARD

REPORT  
VOLUME II

OCTOBER  
2003

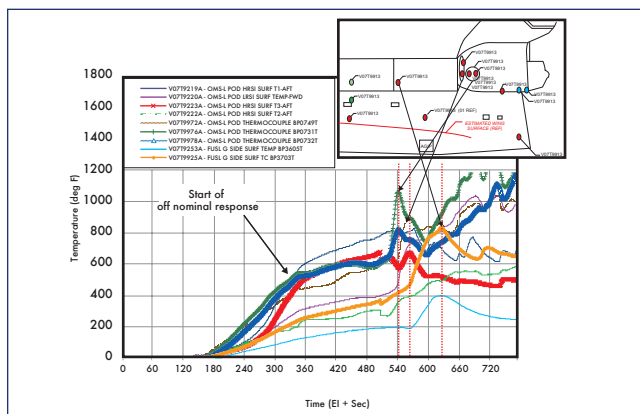
Figure 5-25. Left side fuselage/OMS pod off-nominal responses indicate increased heating.

At 8:51:49 EST (EI + 460 sec.), one of the left OMS pod measurements (V07T9972A) began to show an increased temperature rise, indicating that the upper surface flow has changed again. This is shown in Figure 5-24 along with this measurement on other *Columbia* missions. It is evident that the measurement rises to a higher temperature and at a faster rate than has been observed on previous missions within the next few minutes. Figure 5-25 shows other left OMS pod and fuselage temperature measurements that exhibit an off-nominal rise later in time. The sensor locations on the left side of the orbiter are also shown in Figure 5-25.

These off-nominal temperature rises were caused by a change in the flow field along the upper portion of the left wing as the wing leading edge (WLE) and wing spar damage progressed. The mechanism was a shift in the vortices due to venting on the upper portion of the wing and is similar to the previous discussions on lower than expected OMS pod temperatures. Wind tunnel testing and CFD analysis confirmed that WLE damage on RCC panels 8 and 9 could cause increased heating to the OMS pod due to disturbed upper surface flow or flow impingement caused by re-directed flow from the lower surface. Additionally, the molten Inconel 718 and A-286 spray onto this area are indications that this flow is the cause of these temperature rises. Figure 5-26 (from wind tunnel test results) is a representative example of increased heating on the left fuselage and OMS pod due to RCC panel 9 damage from wind tunnel test results. Figure 5-27 shows a similar picture of the left side as determined by CFD analysis. Note that neither the wind tunnel testing nor the CFD analysis accounts for increased heating that is likely due to molten metal contacting the OMS pod.

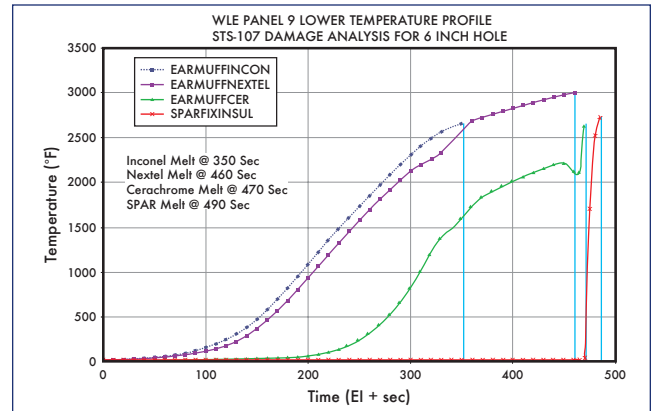
Figure 5-30. Thermal model prediction of wing spar burn through.

The second technique used a detailed thermal model to determine the time required to burn through the various insulations immediately in front of the wing leading edge spar (Inconel, Nextel, Cerachrome) and then the honeycomb spar. This model assumed the equivalent heating of a six-inch diameter hole in the bottom of RCC panel 8. Using the expected aero heating rate and the various material properties, the spar burn through occurred at 8:52:19 EST

(EI + 490 sec.). This time would be accelerated slightly for a larger diameter hole. The results of this thermal model are shown in Figure 5-30.

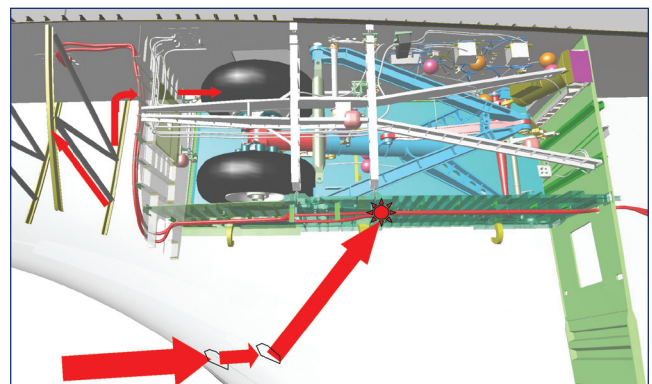
Figure 5-31. Hot gas begins to fill left wing.

Immediately after the breach, hot gas inside the wing began to heat the remaining wire bundles that contained real-time telemetry and the recorded MADS measurements. Figure 5-29 shows an inside-the-wing view of the approximate breach location based on this wire failure analysis. The view on the left is of the panel 8/9 spar location. This area is not visible in the right photo, which contains the transition spar and a view of the three wire bundles along the outside of the wheel well wall. Figure 5-31 shows the overall spar breach location with respect to the rest of the wheel well. The distance from the spar to the wheel well wall in this area is approximately 56 inches, as shown in Figure 5-32. Figure

5-33 shows a sketch of the venting of the left wing into the payload bay, driving the direction of the internal flow depicted in Figure 5-31. Note the 142 square inch vent into the midbody fuselage located forward of the wheel well.

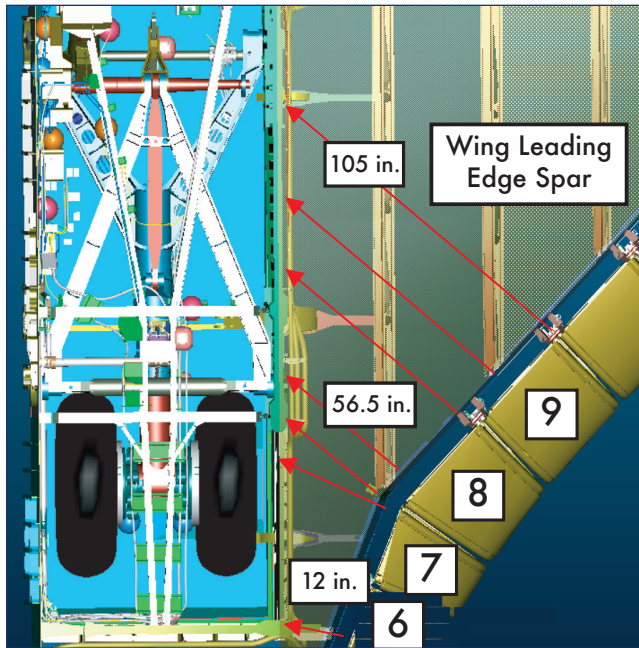
Figure 5-32. Columbia LH wing and wheel well geometry.

wheel well spar. The fact that these measurements are available until loss of data are important indicators that the RCC breach could not be forward on the panel 6 area since these measurements would have been lost as well (see Figure 5-32). These measurements also record key changes in strain that help indicate some of the changes that the left wing underwent as the remainder of the entry events unfolded.

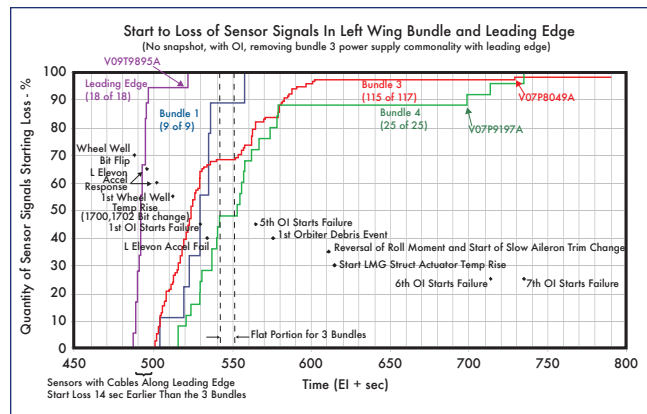
Figure 5-34. MADS data failure due to wire burning.

One hundred sixty-three other measurements failed very quickly over the next two minutes. Figure 5-34 is a plot of the percentage of measurements lost as a function of time from EI. The first measurements to fail are all located on the wing leading edge spar as shown by the purple line on the plot. Bundles 1, 3, and 4 along the wheel well (shown in Figure 5-35) began to fail about 14 seconds after the first spar measurements. This is indicative of a plume impinging on the wire bundles on the wheel well wall.

Four additional measurements failed after 8:54:16 EST (EI + 605 sec.) with the last starting to fail at 8:56:24 EST (EI + 735 sec.). This last measurement failure took over a minute to fail completely. Figure 5-34 and Figure 5-35 show the measurement loss timing and the wire bundle runs along the wheel well. Although almost all measurements internal to the wing failed, two strain measurements on the 1040 spar (forward of the wheel well) were unaffected and produced data until loss of all MADS data at 9:00:13 EST (EI + 964 sec.). Figure 5-36 shows the location of the sensors on the forward

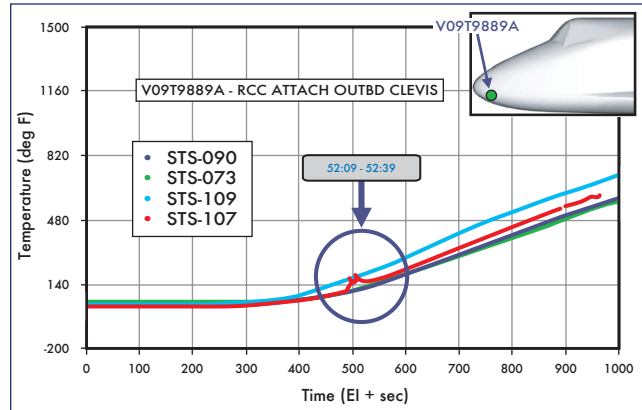
Figure 5-37. Off-nominal temperature rise rate in nose cap RCC attach clevis.

Coincident with the spar breach at approximately 8:52:09 EST (EI + 480 sec.), the nose cap RCC attach clevis temperature had an off-nominal change in rise rate when compared to previous missions. This rise rate was abnormal for approximately 30 seconds and ended at 8:52:39 EST (EI + 510 sec.). The exact cause of this abnormal temperature rise is not known, but the timing is coincident with the breach of the wing leading edge spar. An explanation is that the abnor-

mal rise is an instrumentation anomaly caused by multiple wire failures in this timeframe. This measurement response is shown in Figure 5-37 along with the same measurement for several other *Columbia* missions. This figure also shows the location of this internal nose cap measurement on the very forward portion of the left fuselage.

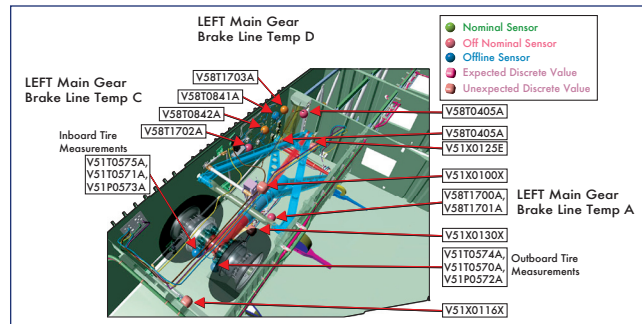
Figure 5-38. Location of sensors in the LH wing wheel well.

nominal. The first indication of any anomalous Operational Instrumentation (OI) was a small increase in the left main gear brake line temperature D measurement at this time (see Figure 5-38). Within one second of this time, there is a lower 1040 spar (forward wall of the wheel well) strain measurement that shows an off-nominal increase in strain (see Figure 5-39). These are both indications that the breach in the wing leading edge spar had allowed hot gas to reach the wheel well area, most likely through vent paths around the hinge covers, which allowed hot gas into the wheel well cavity.

At the same time as the stress was relieved on the lower 1040 spar, two left main gear outboard tire pressures began trending toward an off-scale low reading. This was preceded by a slight upward trend at 8:57:19 EST (EI + 790 sec.) for both pressure measurements. This is an indication of extreme heating of both the left outboard tire and the surrounding instrumentation. The tire has significant thermal mass and substantial heating would be required to produce the slight temperature rise. By 8:58:56 EST (EI + 887 sec.), all left main gear inboard and outboard tire pressure and wheel temperature measurements were lost indicating a rapid progression of damage or wire burning inside of the wheel well. Figure 5-38 shows the location of these pressure sensors.

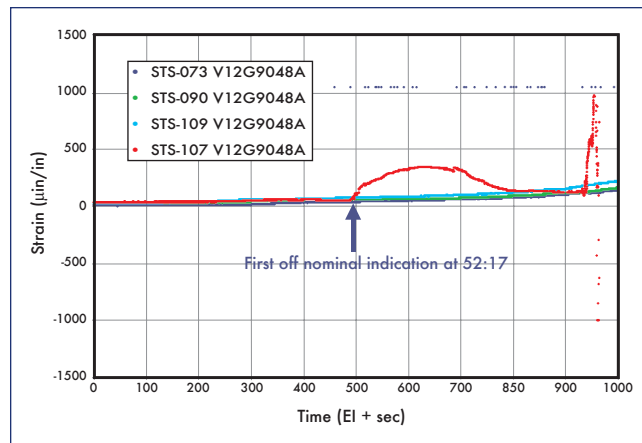
Figure 5-39. Strain rise in lower 1040 spar cap.

ous Figure 5-39). The upper strain measurement continued to increase during this timeframe indicating that the heating was different on the upper and lower portions of the wheel well and 1040 spar. Although the response of the 1040 spar strain is not completely understood, structural analysis indicates that the strain response can be completely explained by thermal stresses caused by severe heating of the wheel well wall and internal wing components.

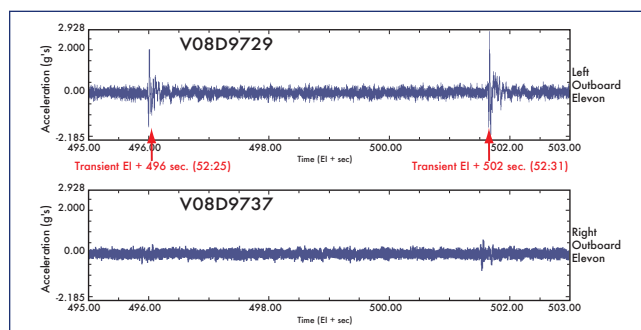
Figure 5-40. Outboard elevon accelerometer responses at 8:52:25 and 8:52:31 EST (EI + 496 and 502 sec.).

At approximately 8:52:25 EST (EI + 496 sec.), the left outboard elevon wideband accelerometer showed an unusual 2 g peak-to-peak acceleration (see Figure 5-40). This is consistent with the timing of the many wire failures within the left wing and the timeframe when the spar breach occurs. Additionally, there are two unexplained communication dropouts in this same timeframe. Another 3 g peak-to-peak acceleration anomaly was observed at 8:52:31 EST (EI + 502 sec.). Additional temperature measurements (left main gear brake line temp A and C) in the wheel well area (see Figure 5-38) began an off-nominal rise at 8:52:41 EST (EI + 512 sec.).

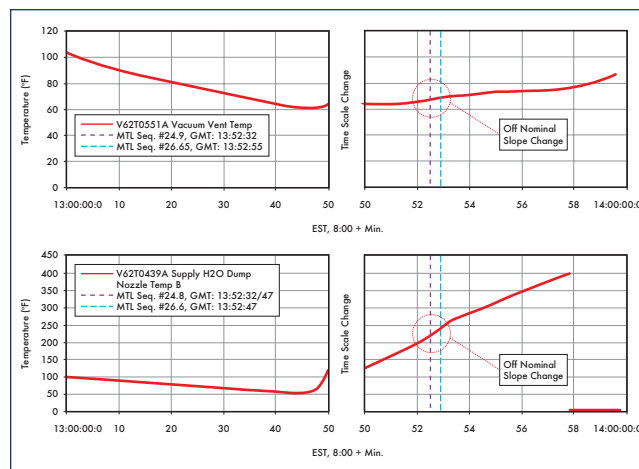
Figure 5-42. Off-nominal temperature for supply nozzle and vacuum vent nozzle.

The elevon response event was followed by a change in the rise rate for two supply nozzle temperatures and the vacuum vent nozzle temperatures at 8:52:32 EST (EI + 503 sec.). The off-nominal rise rate occurred for approximately 15 seconds for the supply nozzle temperatures and 23 seconds for the vacuum vent temperatures. The location of these nozzles on the left side of the fuselage is shown in Figure 5-41, and the arrow indicates that they could have been located along a line of disturbed flow. The short, abnormal rise rate is unexplained, has not been observed on any previous Shuttle missions, and may not be associated with the upper wing disturbed flow caused by the leading edge damage. Unlike the RCC nose cap clevis temperature, the instrumentation appears to have been valid for both nozzles. Plots of this off-nominal temperature rise for one of the supply nozzle temperatures and the vacuum vent nozzle are shown in Figure 5-42.

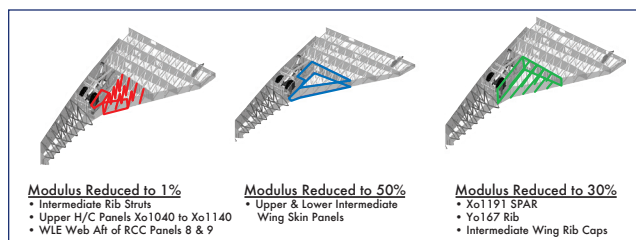
Structural and aerodynamic analysis of wing deformation was performed without any type of recession in the wing lower surface. An assumption of 70 pounds per square foot was used for wing loading. Heat transfer coefficients were updated from previous coupled venting and thermal models for the left wing. A structural model was used along with the heating equivalent of a 10 inch diameter breach in the wing spar beginning at 8:52:16 EST (EI + 487 sec.) assuming 100 percent of the energy from this hole was transferred to the wing interior. Two different cases were analyzed: one with no breach in the upper wing skin and another with a 5 inch diameter breach in the upper skin at 8:54:37 EST (EI + 628 sec.) when a significant visual flash event was observed. Both cases showed that the temperatures of the wing skins, wing spars, and the wheel well wall were high enough by 8:58:19 (EI + 850 sec) that significant damage to the wing structure would occur. Figure 5-45 shows the potential area of damage and that significant deformation of the intermediate wing area and/or a recession in the lower surface is possible.

Figure 5-45. Modeling results show potential area of damage and that significant deformation of the intermediate wing area and/or a recession in the lower surface are possible.

Based on the structural analysis, it appears feasible that a wing recession occurred and resulted in the large positive slope in the delta rolling moment. The recession was caused by severe prolonged heating internal to the left wing that melted many of the support struts. Once the struts were lost, the wing skin lost structural support, a concave cavity developed, and some lower surface tiles may have been lost.

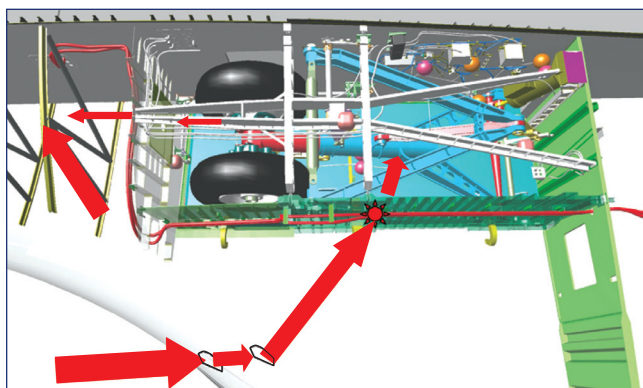
Immediately after the wheel well wall was breached, a hot gas plume began to flow on to the left main gear strut (depicted in Figure 5-47), leading to excessive strut erosion. A wheel well wall breach in this area is consistent with the erosion pattern observed on the recovered left main gear strut. Even after damage had significantly progressed into the wheel well, the orbiter initiated the first roll reversal at 8:56:30 EST (EI+741 sec.). The maneuver was completed by 8:56:55 EST (EI+766 sec.), and the vehicle was in a normal left bank. The guid-

Figure 5-47. Hot gas breaches the wheel well.

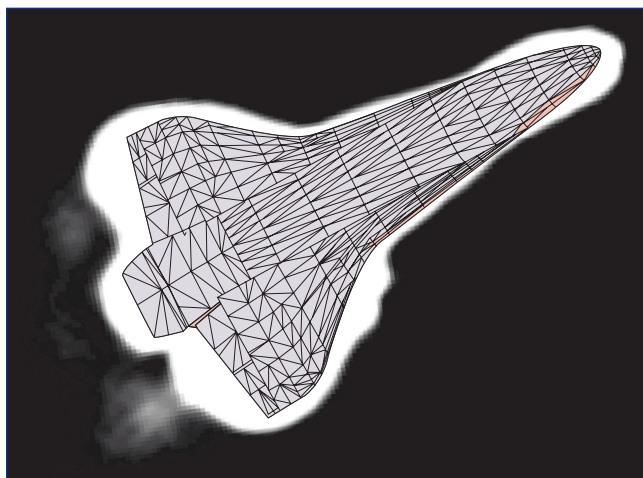
Imaged at 8:57:14 EST (EI + 785 sec.), the Kirtland photo could indicate a flow disturbance on the leading edge of the left wing and/or flow leaving the leading edge of the left wing (see Figure 5-48). It also appears to show a disturbed flow leaving the trailing edge of the left wing. Other images, not shown here, also show disturbed flow on the upper side of the left wing, indicating that the damage and venting through the upper RCC vent was deflecting the flow upward. The Kirtland photo is a digital still image taken by off-duty employees of the Starfire Optical Range at Kirtland Air Force Base, New Mexico, during the STS-107 entry using a 3.5 inch telescope through a computer controlled 1 meter rotating mirror.

Figure 5-48. Kirtland photo with superimposed Orbiter outline.

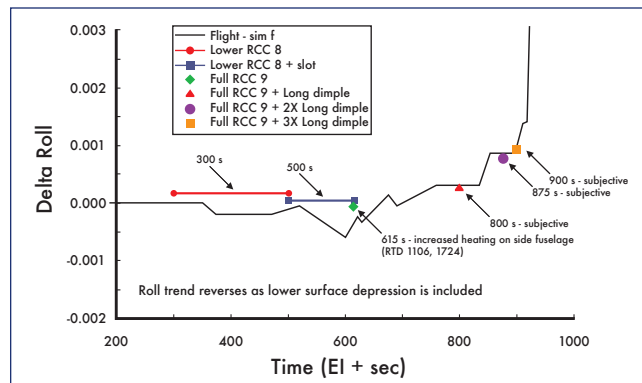
Figure 5-50. Wind tunnel testing configurations that match delta roll moment data.

the wing leading edge and flow through a slot onto the upper carrier panel is consistent with the first observed aerodynamic response, which occurs at 8:52:29 EST (EI + 500 sec.). This can be observed in Figure 5-50 and Figure 5-51 as a slow negative trend in delta roll and yaw. Figure 5-55 shows the wind tunnel test results for three different cases: missing lower RCC panel 8, missing panel 8 combined with a 4 inch diameter hole in the upper carrier panel 8, and missing RCC panel 8 with a slot through the upper carrier panel. The slot was shown to produce the increased delta yaw observed during flight as well as the upper surface flow disturbances on the OMS pod and left side fuselage, which were also observed during flight by abnormal temperature rise rates.

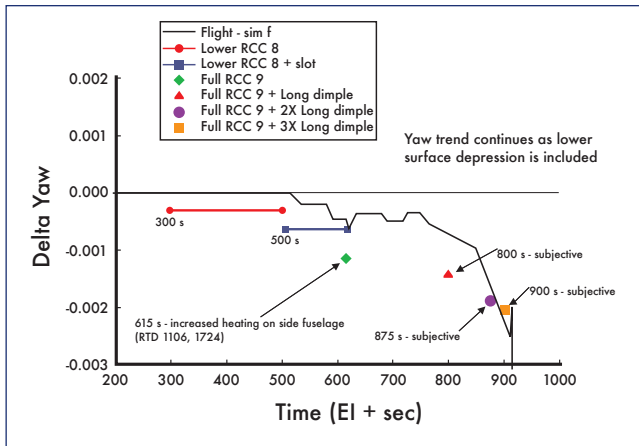
Figure 5-51. Wind tunnel configurations that match delta yaw moment data.

Initially, the recessed area would have been relatively small; however, it would gradually grow over time to cause the delta roll moment to increase. By 8:57:29 EST (EI + 800 sec.) wind tunnel testing showed that the depression has to be on the order of 20 feet long, two feet wide, and 5.3 inches deep along with panel 9 missing in order to duplicate the delta roll coefficient shown in Figure 5-50. This configuration provides a delta yaw moment that is slightly larger than was observed, but is consistent with a decreasing negative delta yaw moment observed in this timeframe (Figure 5-51).

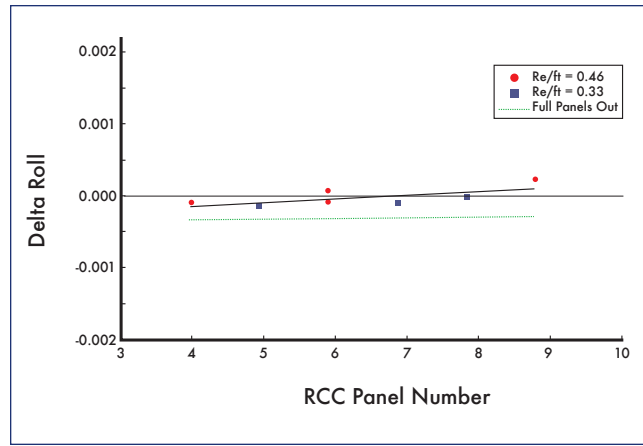
Figure 5-53. Delta roll for lower half and full panel RCC panel missing.

As discussed previously, the reconstructed aerodynamic moments showed little to no change due to damage through 8:52:29 EST (EI + 500 sec.). Based on the forensics data discussed in Section 5.3, the most likely region of initial damage was in the lower part of RCC panel 8. Wind tunnel testing in the Langley Research Center (LaRC) CF4 tunnel indicated that a missing bottom part of RCC panel 8 (from the apex to the lower carrier panel) matches the initial aerodynamic increments, which show a minimal effect on the overall vehicle aerodynamics. In fact, even a full missing panel 8 produces only a small change to the roll and yaw aero moments. Figure 5-53 and Figure 5-54 show the results of this LaRC evaluation.

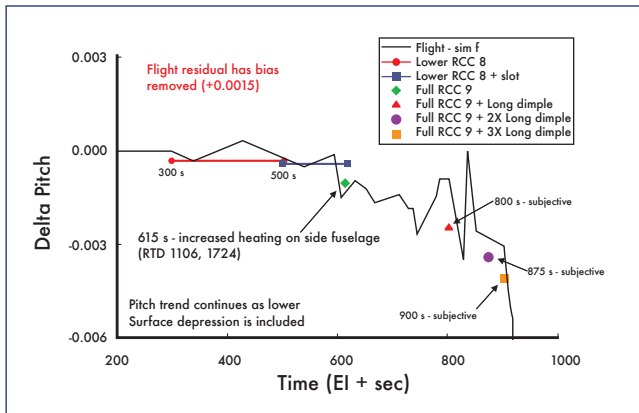
Figure 5-52. Wind tunnel configurations that match delta pitch moment data.

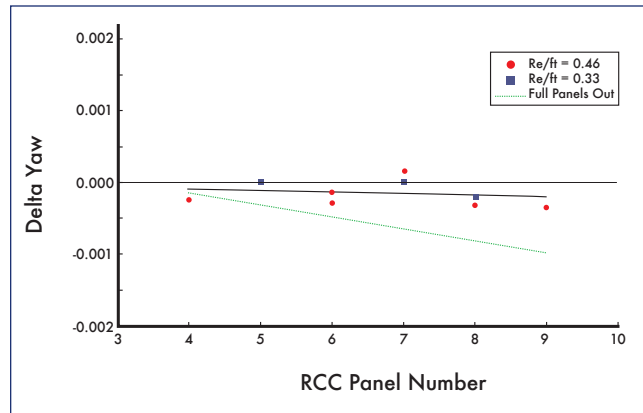
Figure 5-54. Delta yaw for lower half and full panel RCC panel missing.

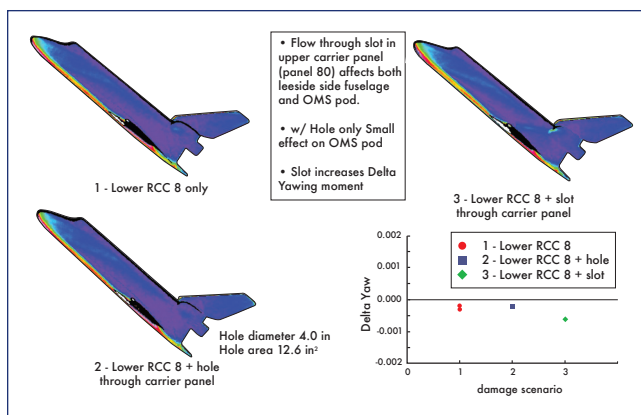
It is possible that a hole through the upper wing developed in the 8:54:11 EST (EI + 600 sec.) to 8:54:31 EST (EI + 630 sec.) timeframe. This is consistent with a lull in the measurement failure rate in the wire bundle along the wheel well that was discussed earlier in Section 5.4.3. Wind tunnel testing and CFD analysis have shown that sizable holes through the wing have little to no effect on the aerodynamics and heating on the left side of the fuselage and OMS pod. A representative sample of this work is shown in Figure 5-55 as damage scenario number 2.

Figure 5-55. Wind tunnel testing results for missing lower carrier panel 8 and a slot and hole through wing.

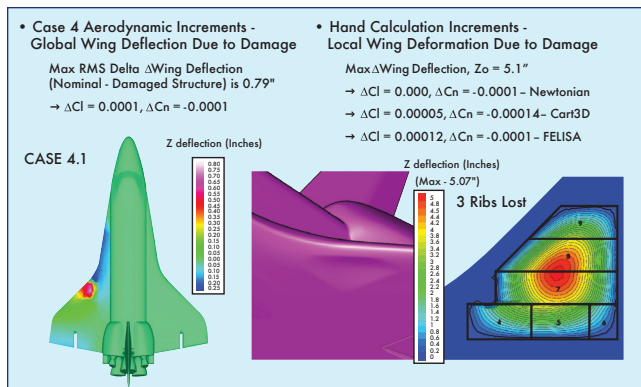
The next significant aerodynamic event occurred at 8:54:11 EST (EI + 602 sec.) when a dramatic reversal of the aero rolling moment trend occurs. By this time hot gas and an internal plume environment had severely degraded the structural integrity of some of the intermediate wing support structure leading to wing deformation. Three different configurations were tested to validate the theory of wing deformation. The first involved global wing deflection of up to 0.79 inches due to damage and is depicted in Figure 5-56. CFD analysis of this configuration showed extremely small aero moment response for yaw and roll that does not match the flight derived data. More substantial local wing skin deformation with a maximum deflection of 5.1 inches due to three ribs missing along with other internal wing damage was examined using CFD tools. Again, these results produced only small aerodynamic moment changes, which did not match the flight-derived data.

Figure 5-56. CFD analysis of wing deformation.

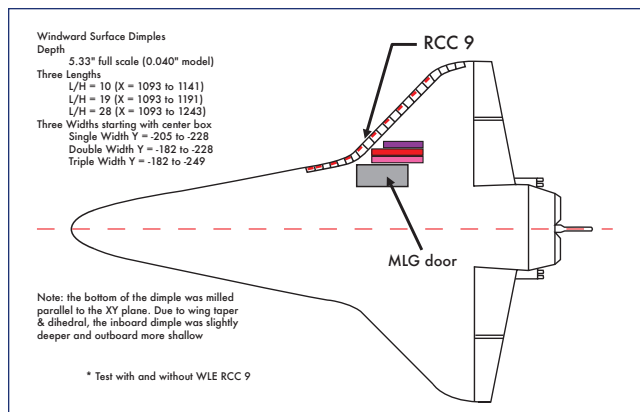
The third and final configuration that was tested was a depression in the lower surface of the wing caused by the significant structural damage caused by the hot gas plume environment internal to the wing. A previous section (5.4.5) discussed the internal structural damage that was most probable in this timeframe. LaRC wind tunnel testing and CFD analysis were performed for several different configurations of lower surface recessions shown in Figure 5-57. The data shows that it is feasible for a recession to cause

Figure 5-57. LaRC wind tunnel testing of lower surface depressions.

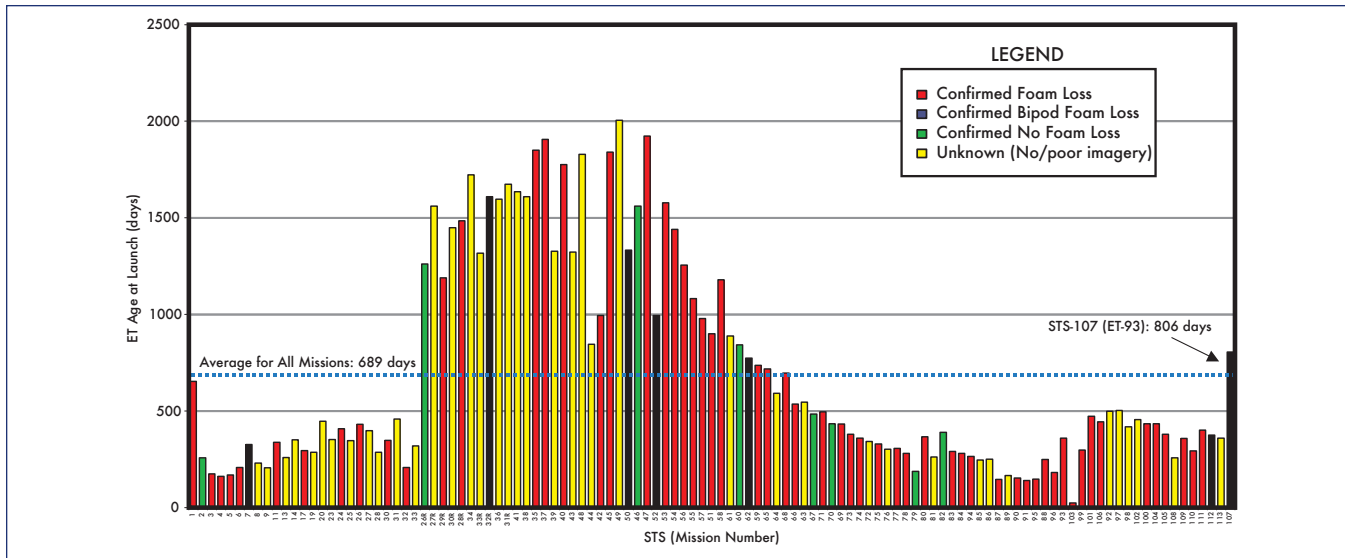
Figure 9-1. ET age for all STS missions.

The ET age was compared for various flights, presented in Figure 9-1. As shown in Figure 9-2, the ET age for STS-107/ET-93, 806 days, falls above the 95% confidence interval upper limit for the average age of all tanks, mean value 689 days, as well as the average age for all tanks with known bipod foam loss. STS-107/ET-93 also falls within the 95% confidence limit for missions with known bipod foam loss. Although the upper bound of the 95% confidence interval of the age of missions with bipod foam loss appears to be greater than the other groups in Figure 9-2, the 95% confidence interval limits of the different groups overlap each other. Therefore, data are inconclusive as to whether a correlation can be drawn about ET age and bipod foam loss.

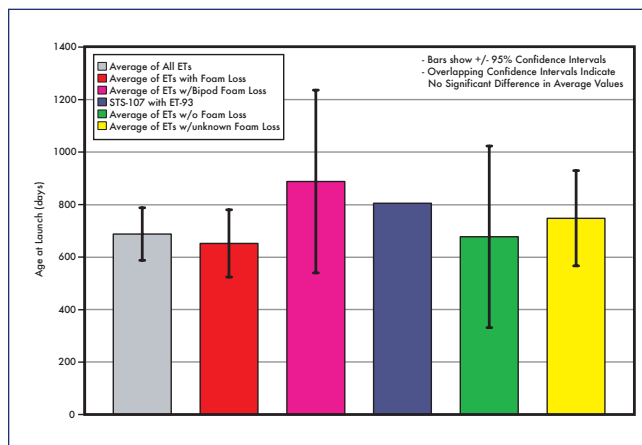
Figure 9-2. ET age for STS-107 compared to ET age for missions with and without bipod foam loss.

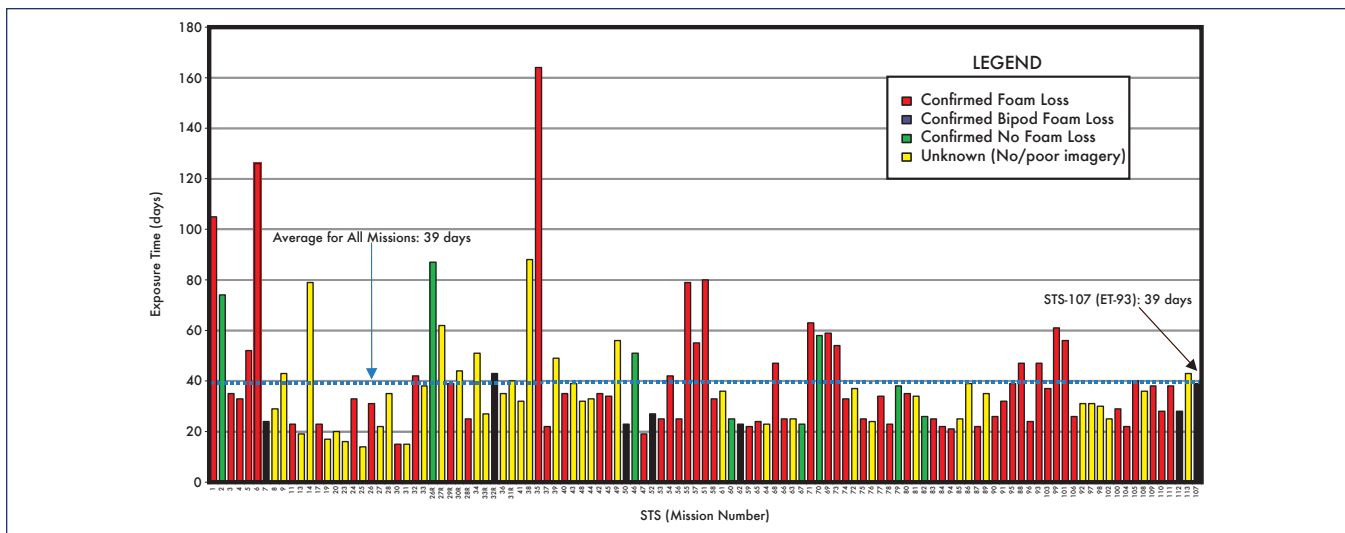
Figure 9-3. ET exposure time (to weather) prelaunch for all STS missions.

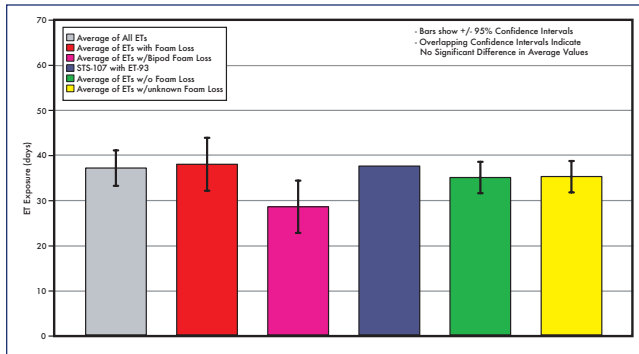
Note that the STS-107/ET-93 exposure time, 39 days, is the same as the mean value for all STS flights. As shown in Figure 9-4, the STS-107/ET-93 exposure time falls within the 95% confidence limit of all missions' ET exposure time, as well as the time confidence limits for flights with or without known bipod foam loss. The STS-107/ET-93 exposure time is larger than the 95% confidence upper bound for missions with known bipod foam loss. However, as stated above when discussing ET age, the 95% confidence limits of the different groups in Figure 9-4 overlap each other, and data are inconclusive as to whether ET exposure time and bipod foam loss can be correlated.

Figure 9-4. ET exposure time (to weather) for STS-107 compared to ET exposure time for missions with and without bipod foam loss.

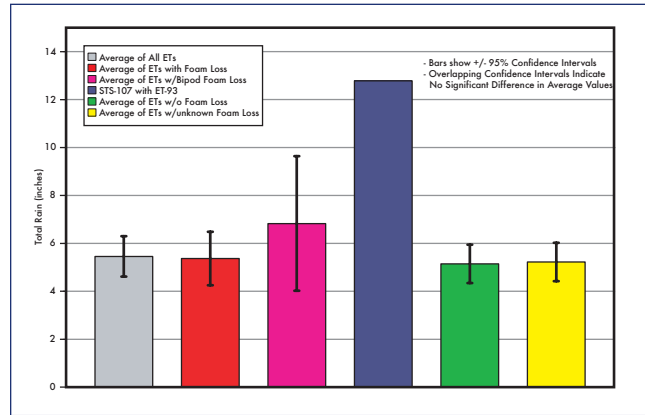
examined total rainfall, maximum one-day rainfall, average daily rainfall, launch day rainfall, and L-5 days through lift-off total rainfall. Figure 9-5 shows the total prelaunch rainfall for all STS missions. As shown in Figure 9-6, although the STS-107 value for total prelaunch rainfall, 12.78 inches, is greater than the mean value for all mission, 5.45 inches, the data are inconclusive as to whether a correlation can be

Figure 9-6. Total rainfall for STS-107 compared to total rainfall for missions with and without bipod foam loss.

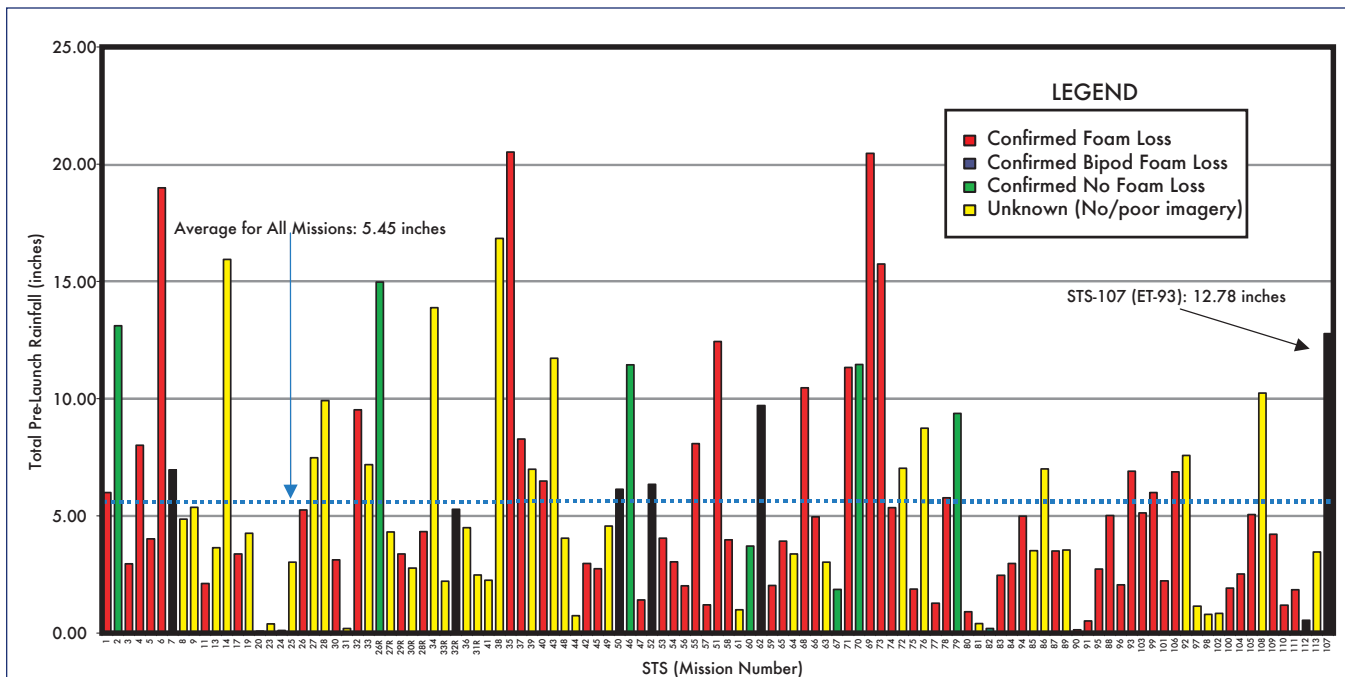
Figure 9-5. Total prelaunch rainfall for all STS missions.

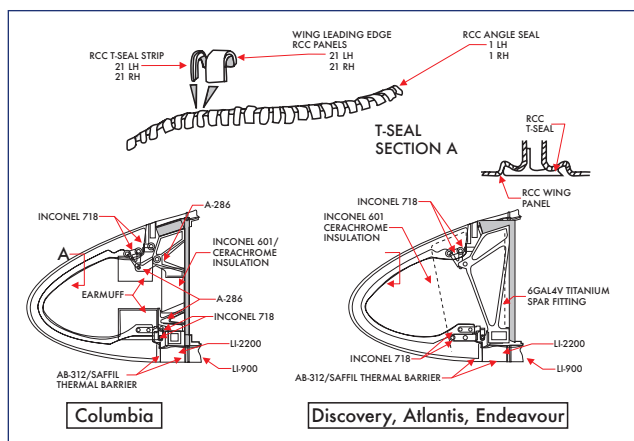
The angle seal at RCC panel 1 on the left wing leading edge (see Figure 10-4) was removed to support the evaluation of the horse collar gap filler between the adjacent tiles. During the removal attempt, the upper bushing remained bound with the shipside clevis. During subsequent attempts, the angle seal was manually manipulated to try and remove the preload. During the KSC paper review, structures engineers realized that the load applied to the angle seal was specified to be kept below 20 pounds, but was never recorded in the

Figure 10-4. Wing leading edge RCC.

paper. The RCC specification requires that RCC panel loads be kept below 30 pounds. Subsequent tests at KSC verified that the angle seal load was below the 30-pound requirement. The LESS prevention and resolution team is addressing the issue of how to measure the load and how to support the seal in future operations. Work continued on the elevon flipper doors. Flipper door 1 blade seal was not making contact with the rub channel, potentially leading to excessive venting from the elevon cove area. This issue surfaced twice during this flow and was Material Review (MR) accepted to fly as is. Modification was made to the Inconel trailing edge seal and bulb seal on the elevon. Additional work was performed on the elevon cove corrosion protection again to reduce the excessiveness of the application.

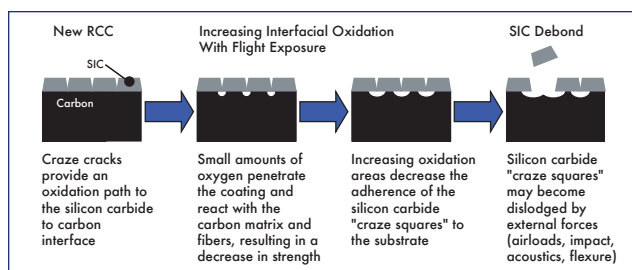
Figure 10-7. RCC corrosion process.

Subsurface oxidation has been discovered beneath the silicon carbide surface cracks in the sealant and coating which allow the oxidation process to thrive. This process is considered to be an impact to RCC mission design life, but is not generally considered to be a safety of flight issue. This oxidation process (Figure 10-7) starts with the breakdown of

the coating due to entry heating. Surface craze cracks allow oxygen to migrate to the subsurface carbon fibers and react with them. This increase in oxidation develops into larger crazed areas, which eventually allow pieces to become dislodged due to vibration, aerodynamic, or thermal loads. Once the pieces dislodge, they leave a large path for the oxidation process to continue.

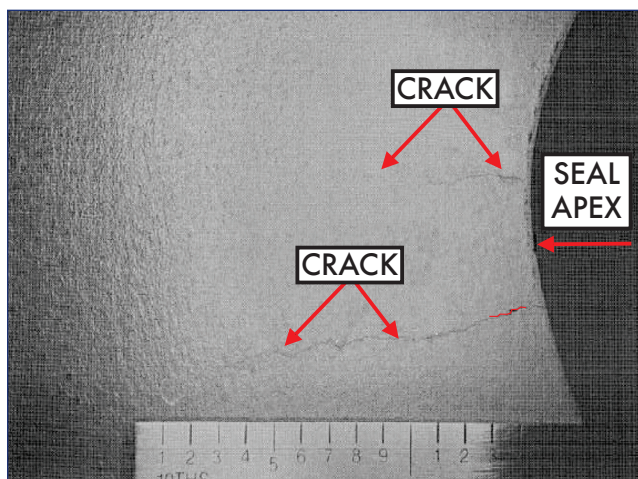
Figure 10-9. Tee seal cracking.

Each wing leading edge RCC panel shares a Tee seal that is used to close the gap between adjacent RCC panels. Following STS-43 (*Atlantis*) in August 1991, routine inspections identified cracks in the web of a Tee seal. The cracks were in the silicon carbide coating and occasionally in the substrate, and were due to normal shrinkage. They were typically less than 1/2 inch long, were not visible to the naked eye, and usually occurred in the web of the seal, on the backside of the seal (Figure 10-8) near the apex rather than on the leading edge. Further examination of the remainder of the shuttle fleet identified 20 (of 132) cracked Tee seals. *Columbia* had 11 Tee seals identified with possible cracks. Detailed inspections determined that all the cracks were typical of the surface craze cracks in the coating. The Tee seal cracks were determined to be caused by warping of the substrate fabric during lay-up during the original build. The Tee seal cracking (Figure 10-9) leads to a reduction in mission life and loss of oxidation protection. All the seals were refurbished with new coating and sealant and were reinstalled. Failure analysis showed that cracks would form after excessive wishbone loading (bending) caused the brittle coating to crack. Crack testing was performed in 1991 on Tee seal 10 (attached to RCC panel 9) from the left wing of *Columbia* to try to determine the crack mechanism. The Tee seal was cycled 400 times in bending up to 70% of its ultimate load and no dis-

cernable damage was noted. After an engineering evaluation was performed on the health and strength of the Tee seal, it was subsequently reinstalled on *Columbia*.

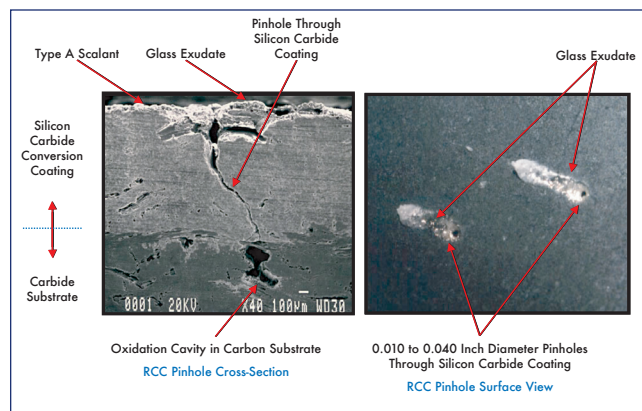
Figure 10-10. RCC pinholes.

Another phenomenon, discovered first on *Columbia* after STS-50 landed, was the existence of pinholes (Figure 10-10) in the RCC panels. The pinholes were found primarily in the wing leading edge RCC and were subsequently identified on all orbiters. Testing has shown that the pinholes are most likely the result of the accelerated oxidation process involving zinc oxide and the silicon carbide coating. The reaction of the zinc oxide and the silicon carbide produces a silica (glass) exudate that flows out of the pinhole area. The presence of zinc oxide is theorized to originate from the paint primer used to recondition the launch pad after each mission and is considered an accelerator to the oxidation process. The zinc-based contamination accumulates on the wing leading edge RCC as rainwater drips off of the launch pad.

This contamination rests on the RCC without reacting to the surface material while at ambient conditions at the pad. All of the damaging oxidation occurs once the RCC is exposed to the high temperatures, pressures, and excess oxygen of re-entry. Only a few pinholes have been observed on the nose cap RCC, most likely because the nose cap remains under a protective cover while at the launch pad. It is also believed that sodium chloride contributes to the oxidation process, but to a much lesser extent than the zinc oxide.

In 1997, pinhole acceptance criteria were established. Pinholes with surface dimensions less than 0.040 inches discovered during routine processing flows are acceptable to fly as is for up to 16 missions unless the carbon substrate is exposed, in which case the panel must be repaired. Pinholes discovered at OMM greater than 0.040 inches are unacceptable. Although the pinholes themselves constitute only a small mass loss, they are not considered to be a safety-of-flight issue by themselves. Analysis has identified that the sustainable thru-hole size in-flight due to orbital debris is 0.25 inches in the lower surfaces of RCC panels 5-13. A hole under 1 inch in diameter anywhere else in the RCC is considered survivable for a single mission.

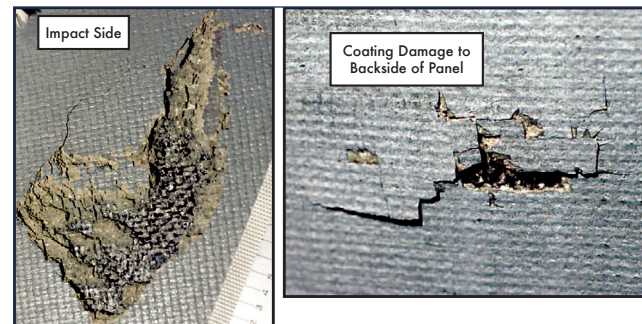
Figure 10-11. RCC impact damage.

There have been damaged RCC panels that were discovered after the vehicle returned from space on various missions. Some of the impact damage was only to the surface, but some even caused damage to the coating on the backside of the panel. In 1992, after STS-45, significant impact damage (overall length of ~1.75 inches) was noted on RCC panel

10R on *Atlantis*. The damage (Figure 10-11) was theorized to come from orbital debris or micrometeorite impacts during the mission. This type of RCC damage is of particular concern in that a significant impact could cause a hole in the RCC large enough to lead to wing spar burn through and subsequent loss of crew and vehicle. At that time, the maximum acceptable hole size (0.040”) criterion was established for processing flows and advanced wing leading edge internal insulation was modified to reduce the risk should hot gas penetrate the RCC.

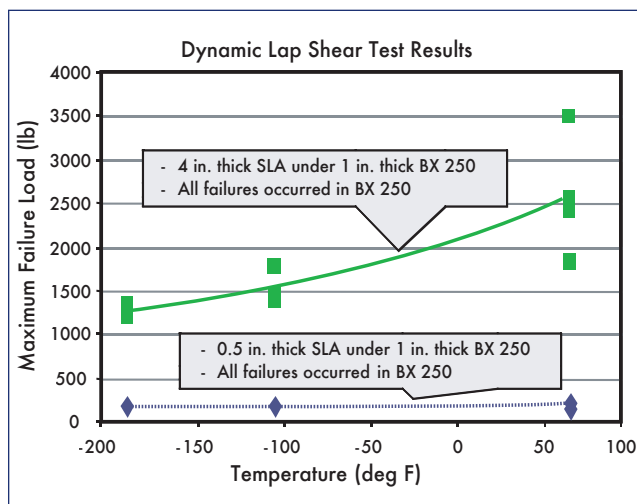
Figure 11-9. Critical test results in debris assessment.

Testing shows that the potential loss of BX-250 does not liberate hand packed SLA due to impulse loading for cryogenic applications; the BX-250 fails before the SLA. For shear, testing shows BX-250 fails before SLA at all test temperatures. For tension, testing shows BX-250 fails before SLA when SLA temperatures are less than or equal to  $-100^{\circ}\text{F}$  (see Figure 11-9).

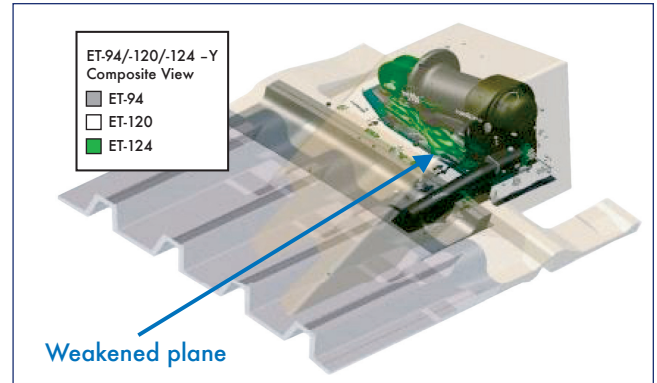
Figure 11-12. Weakened plane defect found.

The dissection of six bipod ramps indicated similar patterns for geometry-induced defects in all ramps. Roll-overs were observed at complex substrate elements, and the majority of observations were associated with spraying over complex details at the substrate. Sporadic voids were also observed. One internal delamination and one weak plane at the knit line were observed. Critical locations, or areas at-risk for producing debris, were identified near the edge of the machined foam surface for both voids and roll-overs (see Figure 11-11). Vacuum pressure is the primary driver for divot formation; however, wind shear also contributes to flight loads. A combination of multiple large voids, geometry-induced defects, and critical locations is needed to produce significant foam loss. For example, a large interconnected void at close proximity to the surface plus a “weakened plane” (see Figure 11-12) may produce foam loss.

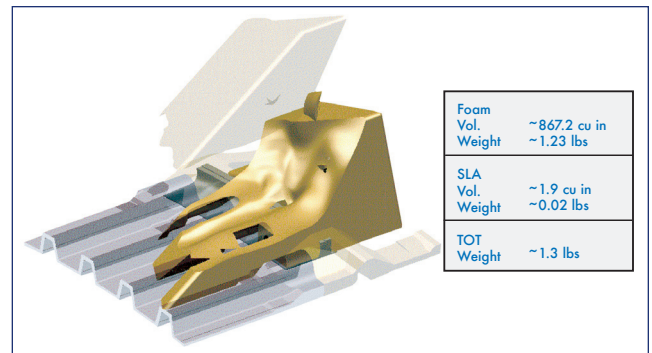
Figure 11-13. Multi-failure mode bipod TPS debris estimated by the ET Working Group. Note that this size and weight were not used in the RCC impact testing as part of the STS-107 investigation.

The ET Working Group conducted an analysis coupled with test data to estimate a multi-failure mode TPS bipod debris size and weight. The ET Working Group scenario includes seven simultaneous and interactive adverse events: A large rollover occurs at the inboard stringer interface immediately below the machined foam surface, side-to-side thermal crack/weak knit line, a large void near the topmost surface one inch below machined foam surface, warm SLA environment, and foam machined to minimum tolerances (not a failure). The specific results are shown in Figure 11-13.

The determination of the STS-107/ET-93 bipod TPS debris is based on evaluation of fault tree findings, possible TPS failure modes and contributors, and results to date from TPS debris test programs including dissection, foam loss secondary effects assessment (SLA/BX-250), and bipod TPS debris size analysis. The TPS bipod debris size was determined by the ET Working Group to be approximately 870 cubic inches and 1.3 pounds.

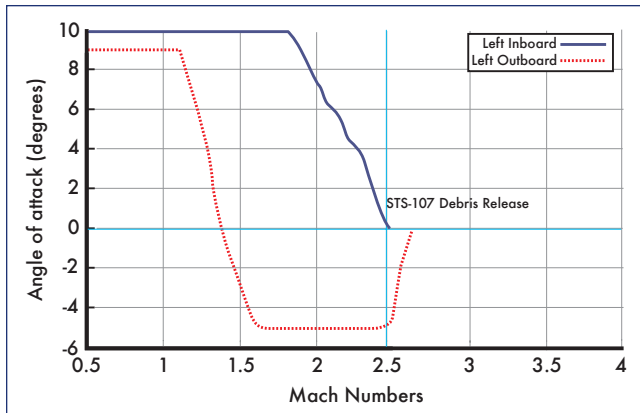
Figure 2-3. STS-107 ascent elevon schedule.

Figure 2-3 shows that the elevons were moving to their neutral or 0°/0° deflection position during the debris event.

Negative elevon deflections indicate that the elevons are rotated upward, away from the External Tank. The elevon deflection at this point in the ascent trajectory makes debris impacts on the outboard elevon lower surface unlikely.

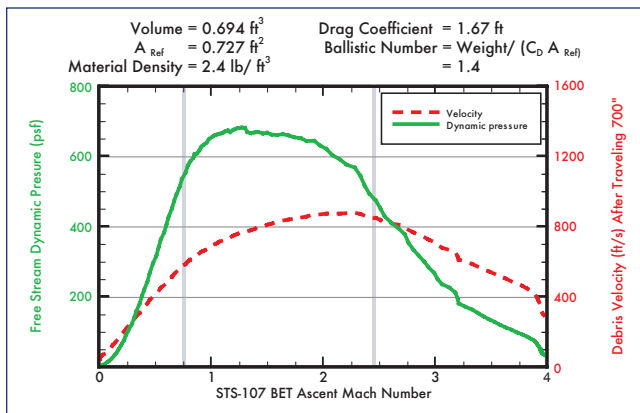
Figure 2-4. Impact velocity vs. Mach number (based on freestream conditions).

Figure 2-4 illustrates the importance of freestream density and velocity on the impact velocity. This figure is based on a constant drag coefficient and does not account for local variations in the flowfield.

Dynamic pressure produces the acceleration force applied to the debris and the freestream velocity determines the maximum relative velocity that the debris can attain. The maximum potential acceleration coincides with the maximum dynamic pressure or max q, which occurred at Mach number = 1.28, however this does not produce the worst case impact velocity. As shown in the previous figure, Mach 2.46 is near the worst case combination of dynamic pressure and freestream velocity in terms of impact velocity potential.

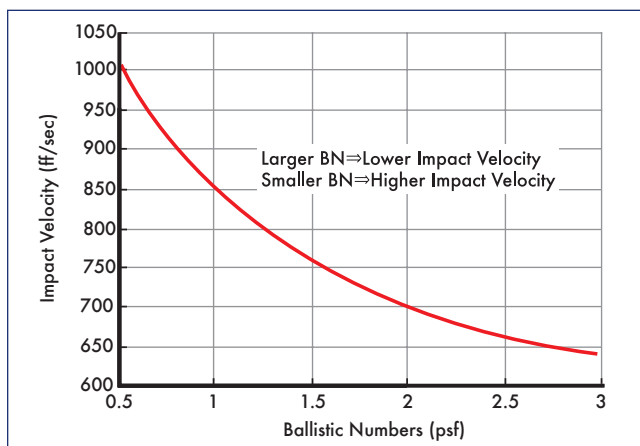
Figure 2-5. Impact velocity vs. ballistic number at STS-107 conditions.

aerodynamic acceleration is a function of BN. As the ballistic number decreases the drag force and resultant impact velocity increases and as the ballistic number increases the drag decreases and the resultant impact velocity decreases. The Figure 2-5 shows estimated impact velocity vs. ballistic number for a Mach 2.46 flowfield for debris from the bipod region impacting the wing leading edge on RCC panel 8.

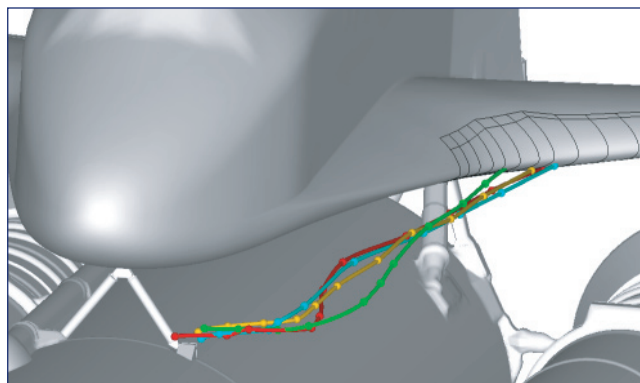
Figure 3-1. Sample set of 3-dimensional trajectories from various members of the Image Analysis Team.

One of the most important inputs from this group were 3-dimensional trajectories and view vectors extracted from the launch camera film and videos. Four of the trajectories are shown in Figure 3-1. These trajectories provided the reference information needed to narrow the estimated range of the weights and velocities for the debris released from the External Tank. This refinement was required due to the limited number of test articles available for impact testing and the critical nature of these impact tests to determine the foam damage potential.

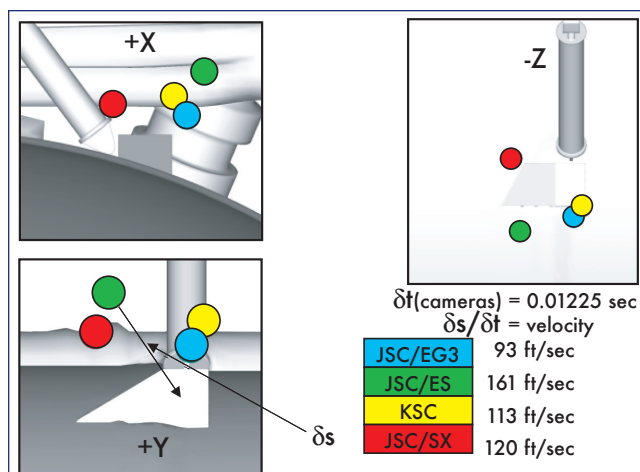
Figure 3-2. Initial trajectory points from Image Analysis Team.

Based on the initial positions of each of these trajectories and the camera frame rates an initial average velocity can be calculated for each of these trajectories. Figure 3-2 shows the initial positions of four of the 3-dimensional trajectories relative to the bipod ramp. These points are assumed to represent the debris locations 1/2 of a frame (12.25 milliseconds) after release.

Note that two of the initial trajectory points shown in the +Y view of Figure 3-2 are actually ahead of the ramp. This implies that the debris somehow moved forward, against the oncoming flow, initially and then traveled aft towards the Orbiter wing. This would require some force acting on the aft edge of the foam ramp that could overcome the aerodynamic forces acting on the ramp at the time of the debris release. Flaws in the bipod ramp shown in Reference 3-2 are in an area where this force could have been applied. However, there is no data on the STS-107 ramp to confirm the existence of similar defects in the STS-107 foam ramps.

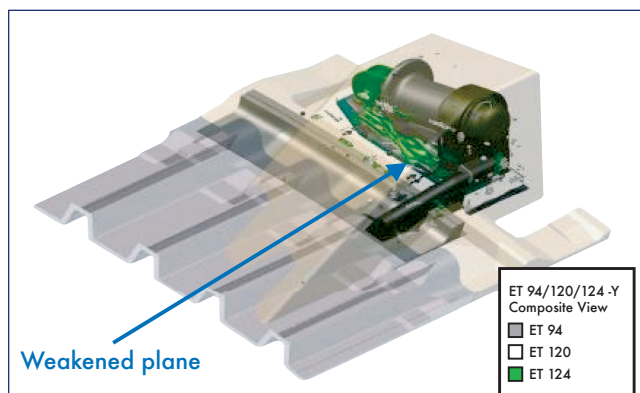
Figure 3-3. Weakened plane in bipod ramp foam.

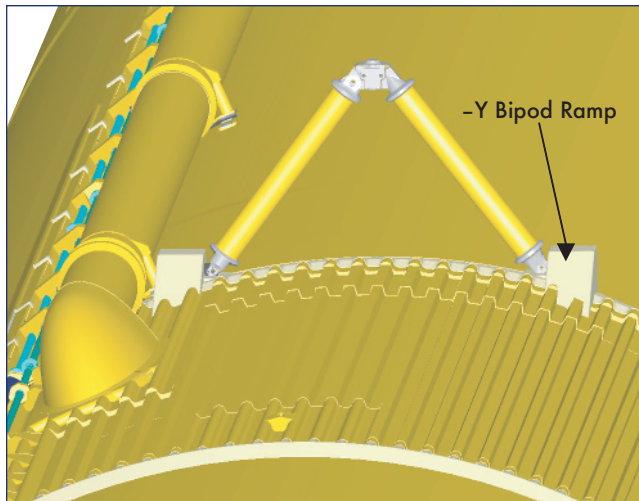
Figure 4-1. ET-93 CAD model detail.

Figure 4-1 includes the bipod struts, LO2 Feedline, cable trays and the stringer geometry ahead of the bipod ramp. These details were not available during the early part of the investigation and most analyses were carried out with simplified geometries that did not include the stringers on the ET Intertank and included simplified representations of the feedline geometry.
