# COLUMBIA

## ACCIDENT INVESTIGATION BOARD

REPORT  
VOLUME II

OCTOBER  
2003

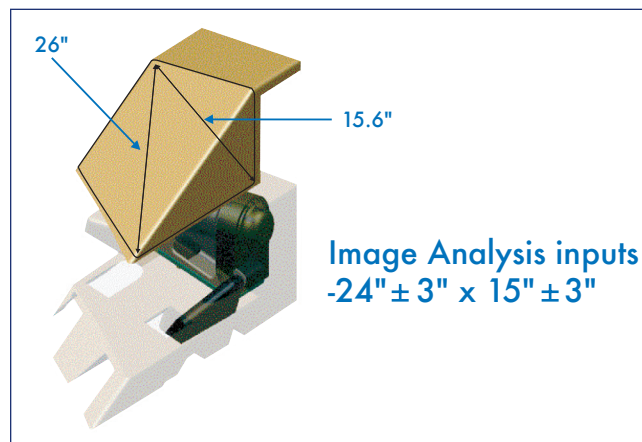
Figure 4-2. Initial maximum estimated foam loss.

An estimate was made of the maximum potential foam loss based on this ramp angle. The original estimated maximum foam loss was 855 in<sup>3</sup>. Later in the investigation this estimate was increased to 867 in<sup>3</sup>. The initial estimate assumed that the thin region aft of the ramp would break off during the debris separation. At a foam density of 2.4 lb/ft<sup>3</sup> these volumes of foam would weigh approximately 1.2 pounds. These estimated volumes are shown in Figures 4-2 and 4-3.

The dark outline in Figure 4-2 represents the initial 855 in<sup>3</sup> estimated worst case foam loss. Note that the diagonal dimensions are similar to those reported by the Image Analysis Team. The final estimate included a small amount of Super-Lightweight Ablator SLA.

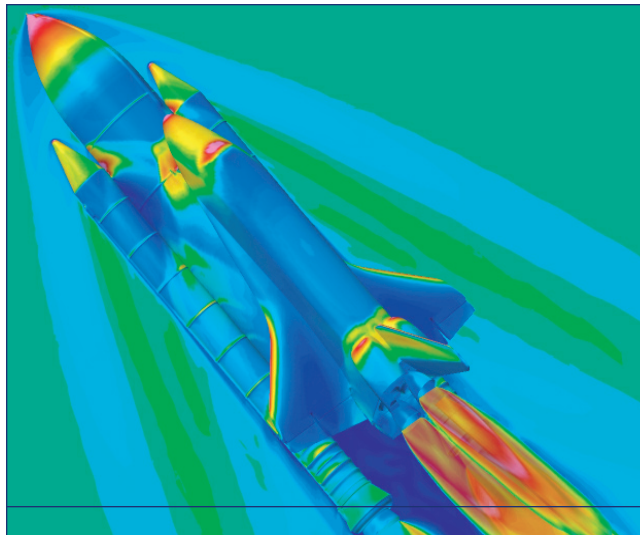
Figure 5-1. Pressure coefficient on the Space Shuttle surface and Mach number in the surrounding flowfield at the STS-107 debris release conditions.

The flowfield in the bipod ramp region, at the STS-107 debris release conditions, has a number of interesting features. Each of the SSLV elements generates a bow shock and the Orbiter and SRB shocks intersect just ahead of the bipod ramp. The left hand SRB shock effect on the local surface pressures is visible as a light blue area in Figure 5-1 on the ET between the SRB nose and the Orbiter nose. These shock-shock interactions with the boundary layer cause the boundary layer

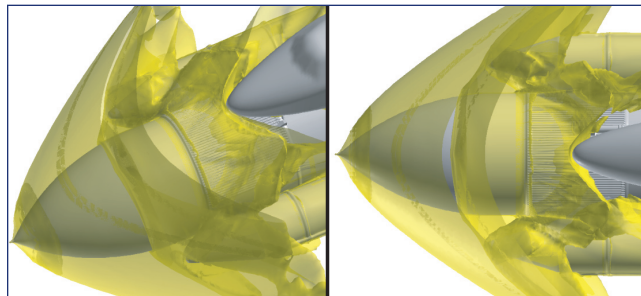
Figure 5-2. Mach number isosurfaces at Mach number = 2.46.

ahead of the bipod ramp to separate. Figure 5-2 shows Mach number isosurfaces, colored yellow, at the debris release conditions. These images show the bow shock ahead of the ET as well as the SRB shocks intersecting with the shock off of the Orbiter nose just ahead of the bipod ramps.

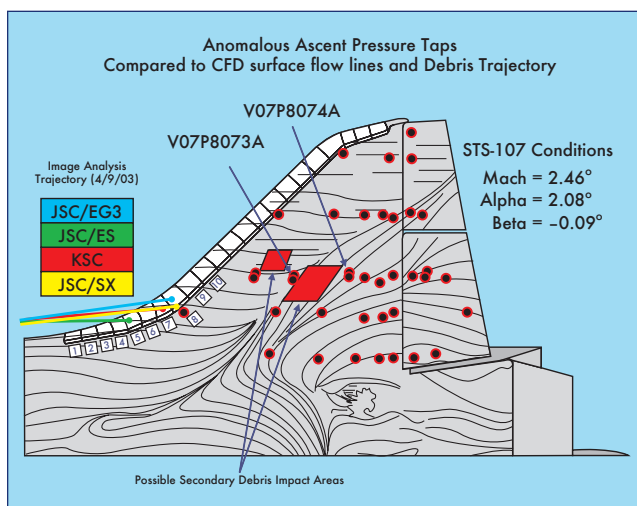
Figure 5-3. Surface flow lines and possible secondary impact locations.

Surface constrained flow lines, extracted from the static CFD solution, were used to estimate areas where secondary debris strikes may have been detected by the vehicle pressure sensors. Figure 5-3 shows flow lines on the Orbiter lower surface at the debris release freestream conditions the red regions indicate possible secondary impact locations that might have resulted in anomalous pressure measurements during the vehicle ascent. These locations were determined based on their positions relative to the anomalous pressure tap measurements, the local flow direction and further any damage should not affect any other down stream or adjacent pressure instruments which behaved nominally.

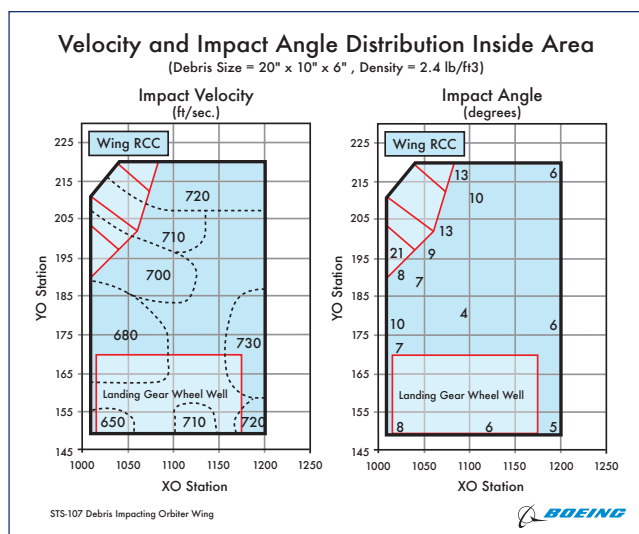
Figure 6-1. STS-107 debris impact results.

During the STS-107 three different foam debris sizes were analyzed. One of the debris sizes, a 20" x 10" x 6" volume, is within the final estimated range of foam volumes predicted by detailed ballistic number estimates in Section 7. The original predicted impact velocity on RCC Panel 8 was 710 ft/sec with an impact angle of up to 21° as shown in Figure 6-1. These analyses were performed using relatively coarse grid CFD solutions at a Mach number of 2.5 and at angles of attack of 1.5° and 3.0°. These values compare well with the Mach 2.46 and angle of attack of 2.08° values determined by the post STS-107 ascent reconstruction.

Using a high fidelity flowfield at the STS-107 debris release conditions and a 1200 in<sup>3</sup> debris volume, along with the updated/corrected ADT, resulted in an impact velocity of 830 ft/sec. This result is within 55 ft/sec of the final estimated velocity used in the impact testing performed at the

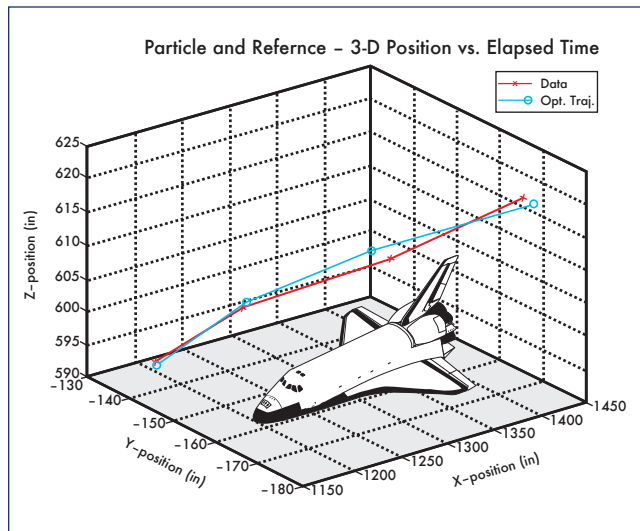
Figure 7-3. Three-dimensional view of foam debris trajectory as compared to KSC reference data for index range (5-8). Note: Shuttle diagram is for attitude reference only and is not to scale.

The KSC data set (see Table 7-1) for ranges (4-8, 4-9, 5-8, and 5-9) produced the most consistent BN values. Trajectory optimization using the KSC reference data set resulted in a BN ranging from 1.2317 – 1.4516 lb/ft<sup>2</sup> and an associated projected velocity range (at X=1800 inches) of 763 – 803 ft/s. These ranges represent approximately an 18% variation in BN and a 5% variation in predicted velocity at X = 1800 in. (near impact location). The minimum sum square error of all assessed data sets is 15.55 in<sup>2</sup> per interval in the index interval range 5-8. A 3-dimensional plot of the trajectory positions and the reference data set positions for this portion of the debris trajectory (Figure 7-3) reflects the low sum square

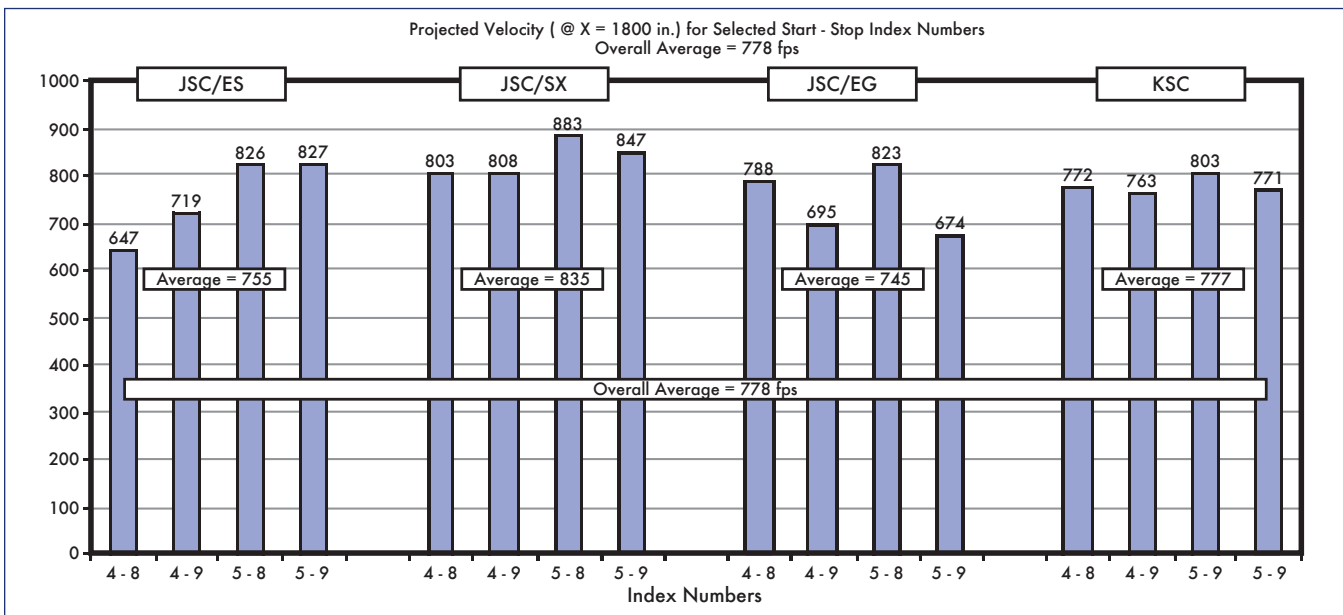
Figure 7-5. Projected velocity of foam debris to position X = 1800 inches, for reference data sets JSC/ES, JSC/SX, JSC/EG, and KSC. The KSC data provides the most consistent projected velocity results.

A plot of the projected velocities at X = 1800 inches (Figure 7-5) shows the consistent velocity results for the KSC based data. The JSC/SX velocities appear to be almost as consistent as the KSC data and are uniformly higher than the KSC data. The results for the JSC/ES and JSC/EG are a bit more "choppy". In contrast to the lower sum square error of the KSC data for index interval range 5-8, the JSC/EG carries a higher sum square position error and associated larger differences between the trajectory and the reference data set (see Figures 7-6 and 7-7).

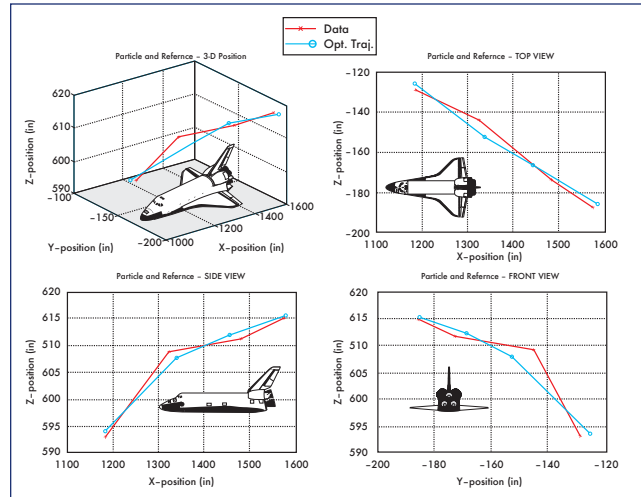
Figure 7-7. Composite view of foam debris trajectory as compared to JSC/EG reference data for index range (5-8) including top, side and "front" views. Note: Shuttle diagram is for attitude reference only and is not to scale.

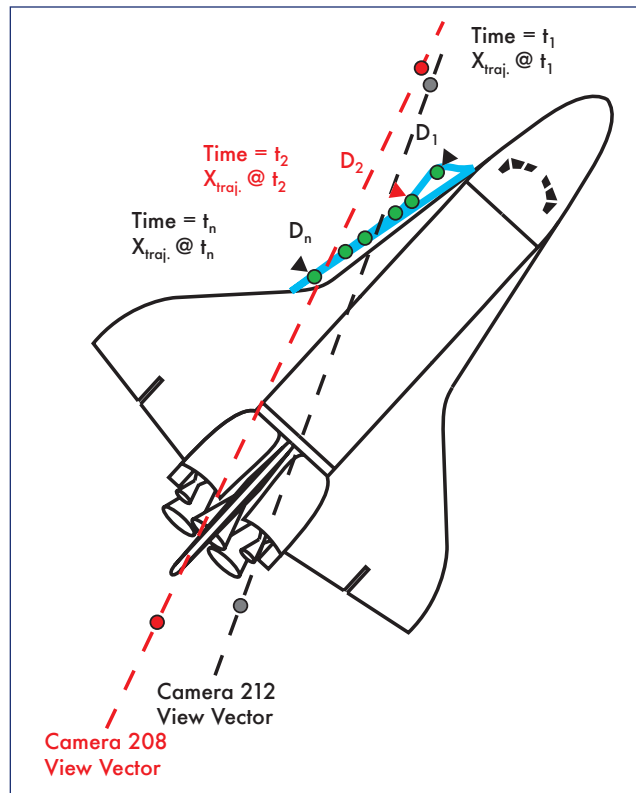
As mentioned in the previous section, comparisons between an integrated trajectory and pre-processed reference data sets may possess inherent errors due to the nature of these data sets (e.g., curve fitting of imagery data, unknown assumptions made by analysts, etc.). A second approach option employing trajectory comparison directly to camera view vector data attempts to generate the most realistic values for BN and projected velocity. This approach minimized the sum square error (in the ET coordinate frame) between an integrated trajectory and view vector data for cameras 208 and 212, obtained from Marshall Space Flight Center. The diagram and equations of motion in Figure 7-1 also apply to this approach. In fact the overall approach for this trajectory vs. view vector data comparison (part 2) is the essentially the same as that of the trajectory vs. reference data sets (part1). The approaches differ in that the sum square error objective (optimization) function in this approach (part 2) is obtained by comparing the integrated trajectory to the perpendicular distance from the camera view vectors for two ground cameras 208 and 212 (see Figure 7-8).

Figure 7-8. Illustration of time-dependent position differences between view vectors for ground cameras 208 and 212 and an integrated trajectory (solid curve) employing a flight-based local velocity flow field. The objective (minimized) function is the sum of the squares of the distances between some or all eleven of these time-dependent position points ( $\sum D_n^2$ ).

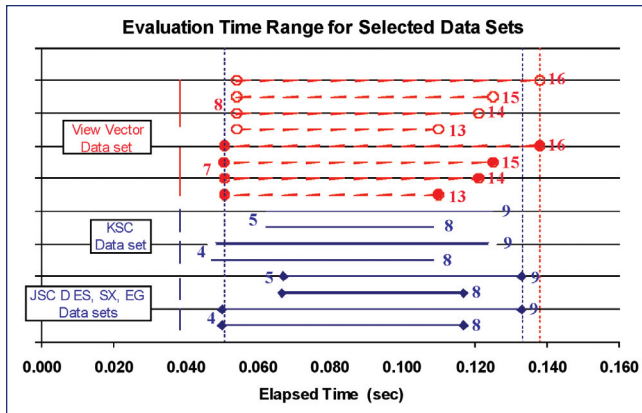
Figure 7-9. The index intervals for the comparison of an integrated trajectory with the view vectors from cameras 208 and 212 are designed to provide similarity to the intervals using in the reference data set comparisons in the previous section. The index ranges used to generate the most probable estimates of key parameters (BN, projected impact velocity, etc.) were 7-13, 7-14, 7-15, 7-16, 8-13, 8-14, 8-15, and 8-16.

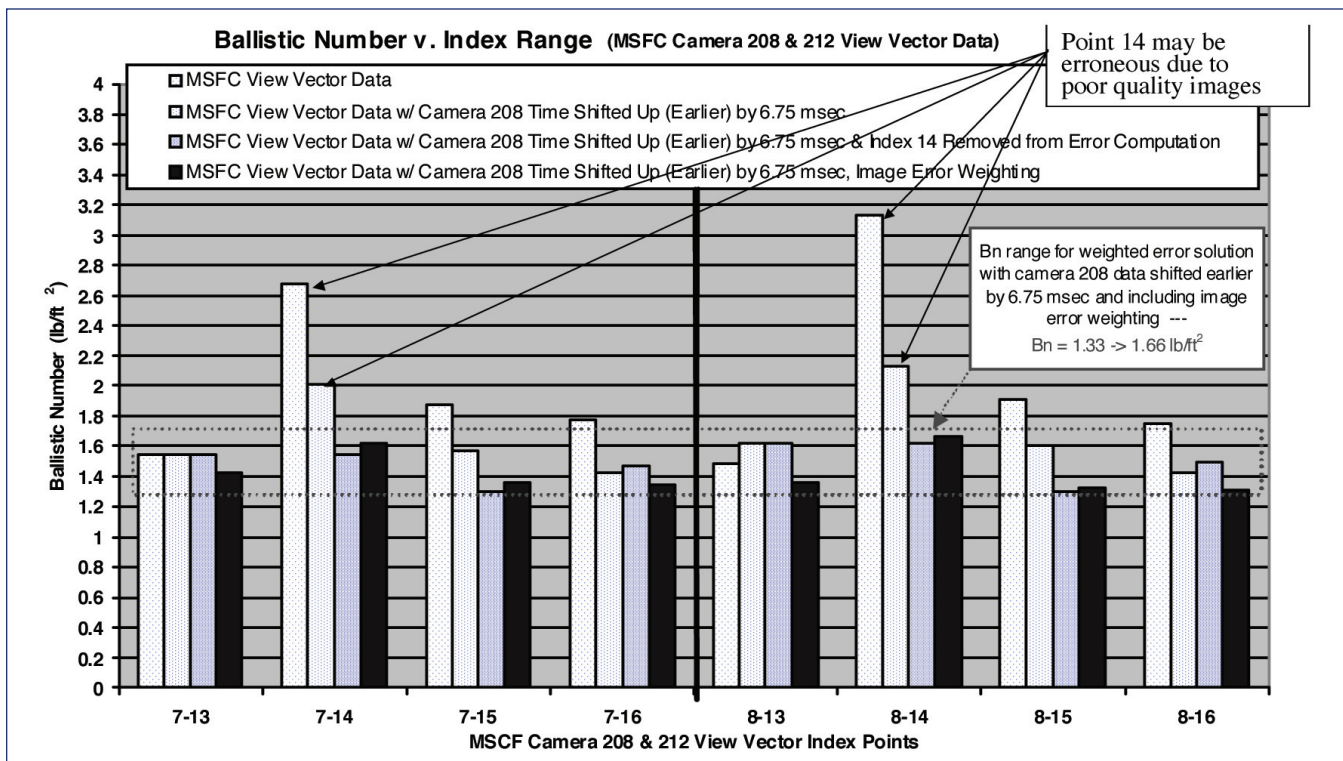
Figure 7-10. BN vs. index range for selected view vector data comparisons.

For the index intervals evaluated, the resulting BN ranged from 1.314 to 1.661 lb./ft<sup>2</sup> and the projected impact velocity of the foam debris at X-position of 1817.45 inches ranged from 742 to 814 fps.

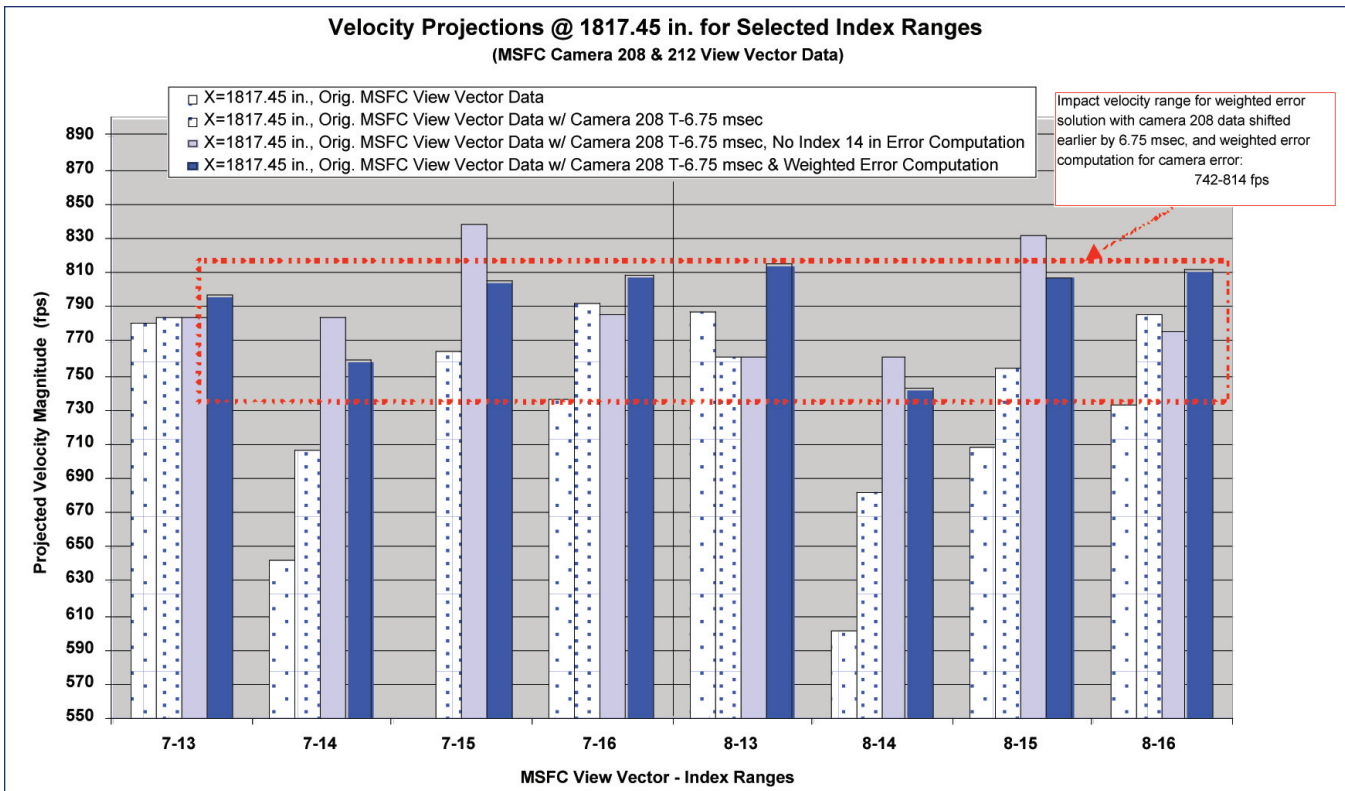
Figure 7-11. Projected impact velocity at X-position = 1817.45 inches vs. index range for selected view vector data comparisons.

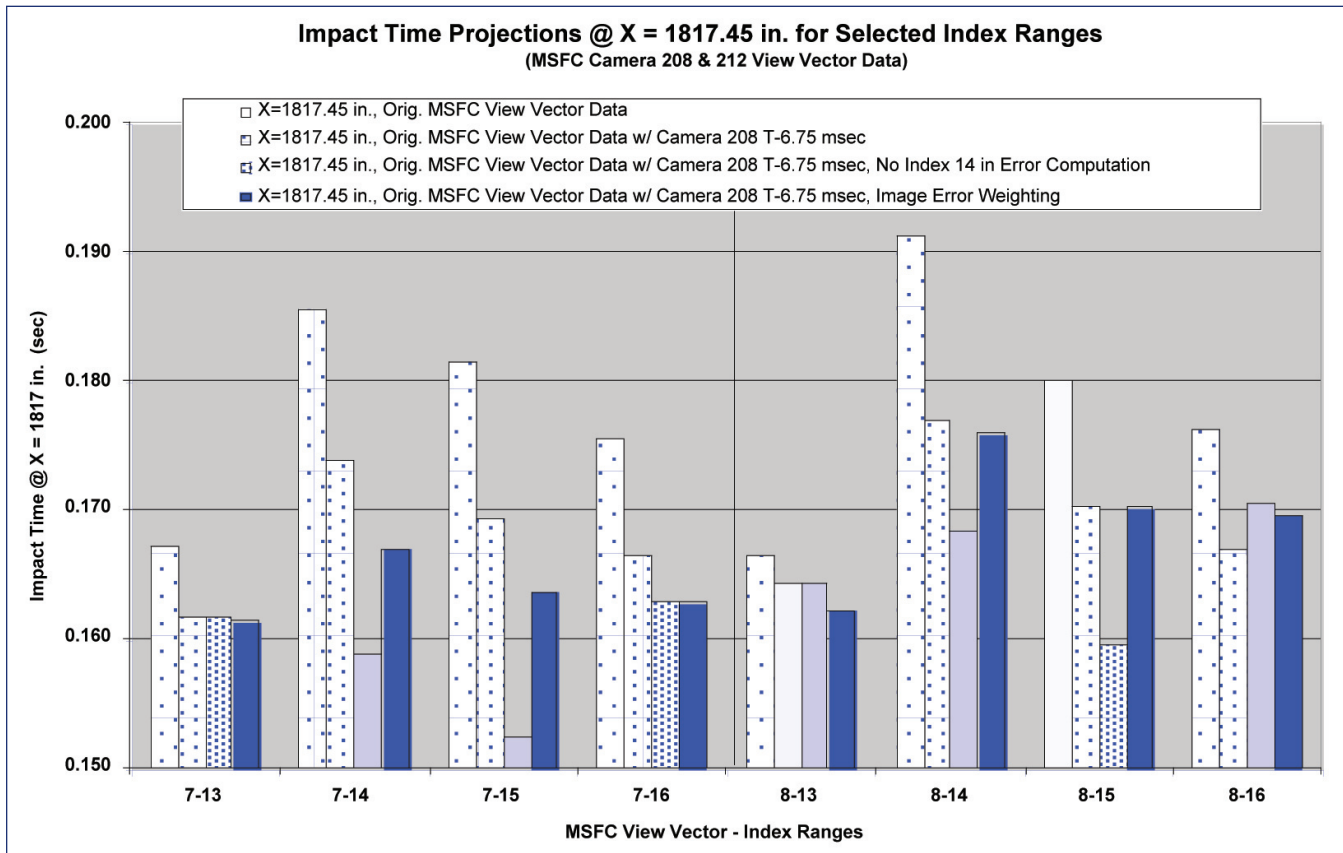
Figure 7-12. Projected time of impact at X-position = 1817.45 inches vs. index range for selected view vector data comparisons.

An enhanced view of the impact locations (Figure 7-12) shows the projected impact locations on the leading edge of the Shuttle wing. While all eight selected index interval trajectories were projected to hit the wing, several appeared to hit high on the wing leading edge (trajectories 8-13 and 8-14, possibly 7-13 and 7-14). Imagery data showing debris emerging from under the wing suggest a debris impact on the lower leading edge. A grouping of four trajectories (7-15, 7-16, 8-15, 8-16) appears on RCC panels 7 & 8 on the lower leading edge. A top view of the Shuttle with these tra-

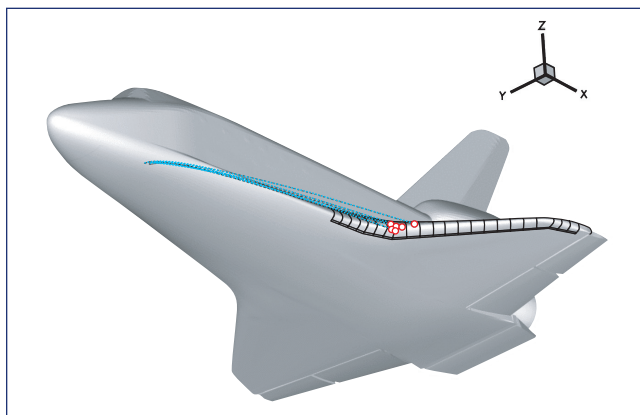
The foam debris trajectories for index ranges (7-13, 7-14, 7-15, 7-16, 8-13, 8-14, 8-15, and 8-16) are depicted in an oblique view of the Shuttle (Figure 7-13). These trajectories represent the optimal selection of the initial state and a constant BN to provide a minimum sum square error over the selected index interval. They begin at the initial state and are projected to impact the left Shuttle wing\*. For all cases the debris impacts the Shuttle on Reinforced Carbon-Carbon (RCC) panels 7, 8, or 9.

Figure 7-13. Optimized foam debris trajectories for index intervals 7-13, 7-14, 7-15, 7-16, 8-13, 8-14, 8-15, and 8-16, projected to Shuttle impact. Graphic courtesy of Phil Stuart – JSC/EG3.

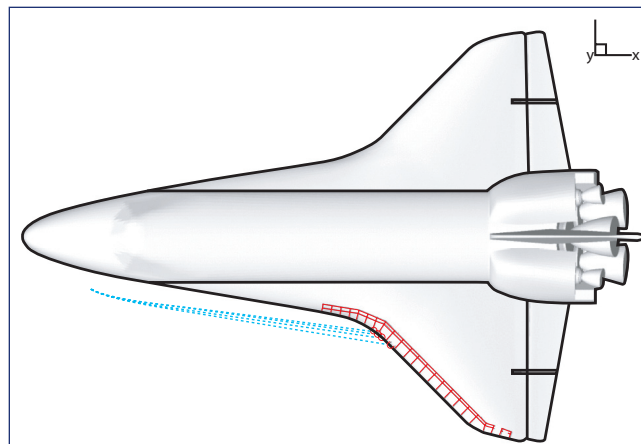
jectories shows that the impacts occurred with an outboard angle to the trajectory (see Figure 7-14).

The impact velocities for the selected-index-intervals trajectories shown in Figures 7-10 through 7-12 range from 729-815 fps, with the bulk of the velocity component in the ET coordinate frame x-direction (see Table 7-4). The trajectory heading ranges from about 6.5°-7.5° outboard at impact

Figure 7-14. Top view of optimized foam debris trajectories for index intervals 7-13, 7-14, 7-15, 7-16, 8-13, 8-14, 8-15, and 8-16, projected to Shuttle impact and showing outboard direction of trajectory at impact. Graphic courtesy of Phil Stuart – JSC/EG3.

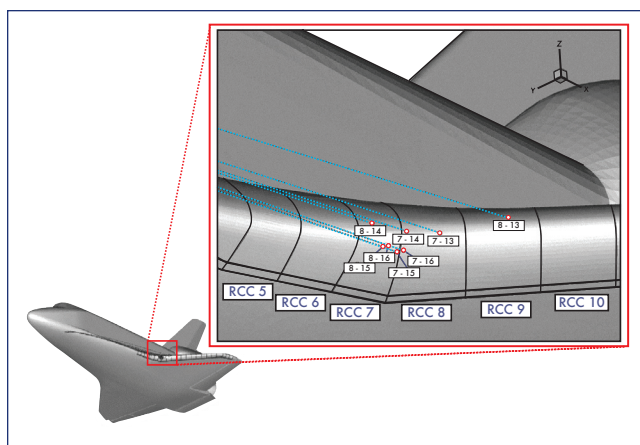
(as shown in Figure 7-15). The trajectory angle between the incoming debris trajectory and the Shuttle wing leading edge (impact angle) has a range of about 15.5°-31.8°. For all cases, the impacting debris trajectory lies within about 2.5° of the z-plane (angle x-y).

Figure 7-15. Close-up of optimized foam debris trajectories for index intervals 7-13, 7-14, 7-15, 7-16, 8-13, 8-14, 8-15, and 8-16, projected to Shuttle impact. Graphic courtesy of Phil Stuart - JSC/EG3.

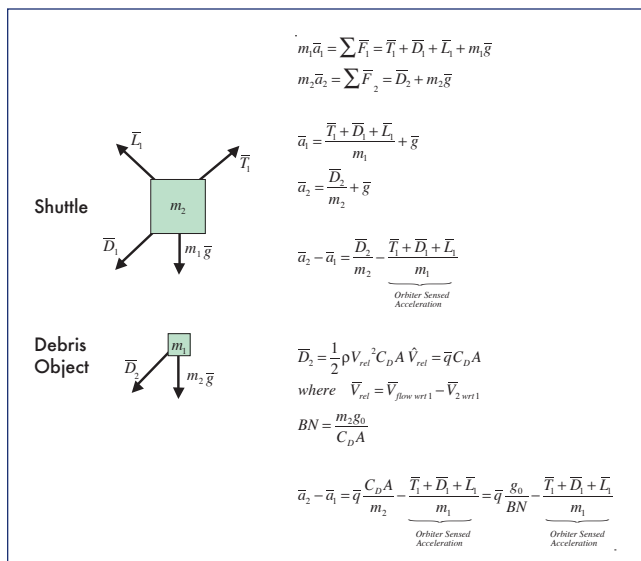
Figure 7-16. Ballistic equations of motion for debris object relative to the Space Shuttle.

Figure 7-16 presents a brief derivation of the equations of motion. This derivation is for a “ballistic” model – That is it includes drag, but no lift force on the debris object. The subscript 1 indicates the STS; subscript 2 indicates the debris object. Overbars indicate vectors, and “hats”, or bent bars indicate unit vectors. In general, vector names are as follows:

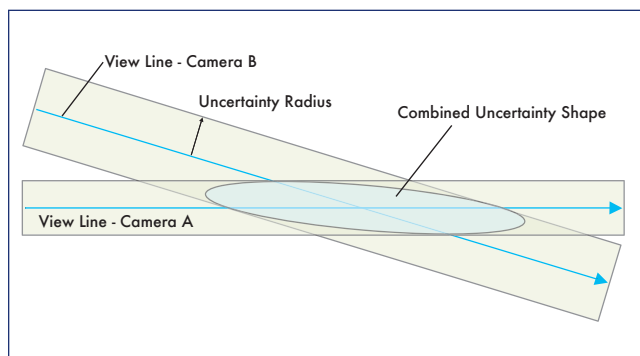
Complicating matters, the angle between the camera views, measured at the Orbiter, was fairly small (only 17.3 degrees). This means a little uncertainty in one view can “stretch out”, making a large uncertainty along the view direction. (See Figure 7-17- but note that the situation with simultaneous intersecting view lines is for illustration only.)

Figure 7-17. Combined uncertainty shape for camera views with small intersection angle.

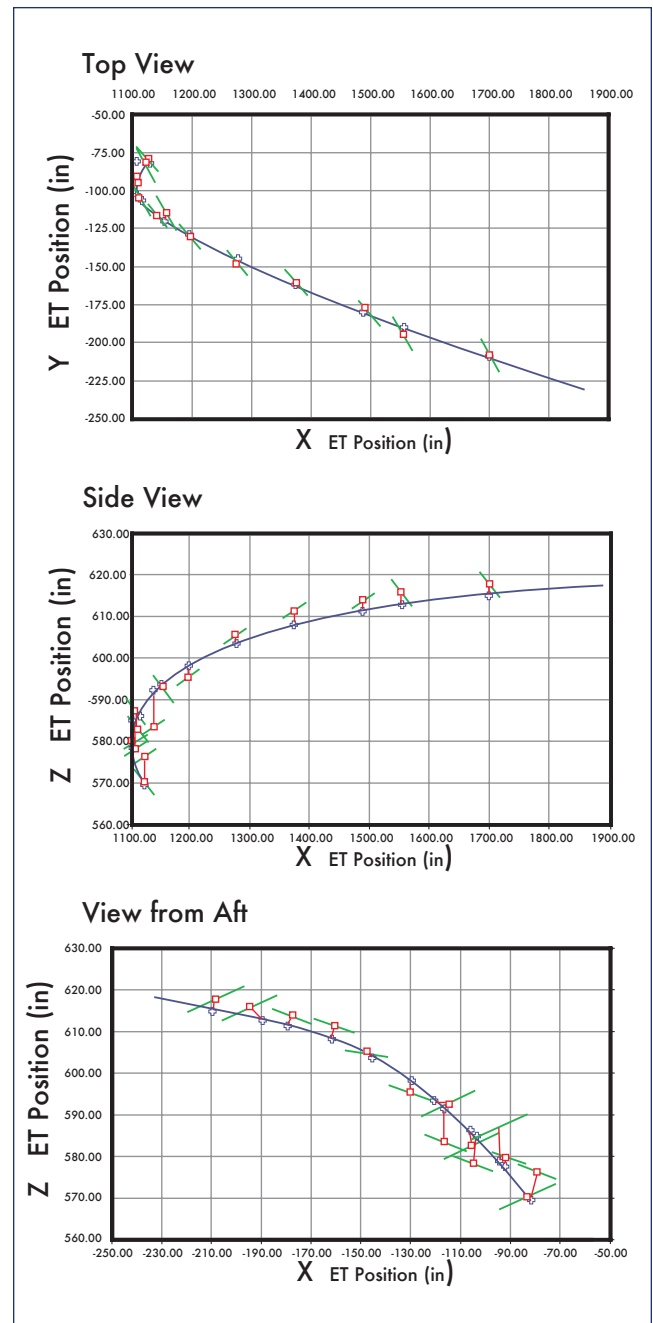
It is worth noting, however, that looking at Figure 7-19 ballistic-model trajectories do not seem to originate from an initial position and direction of motion consistent with departure from the bipod ramp location (pretty close, but not quite). Also, looking at Figure 7-18, while the ballistic model can fit the observational data pretty well, it doesn't seem to follow apparent trends in the Z direction. These discrepancies seem to suggest that lift is a significant factor in the trajectory shape.

Figure 7-18. Debris object trajectory solution with view vectors (ballistic model).

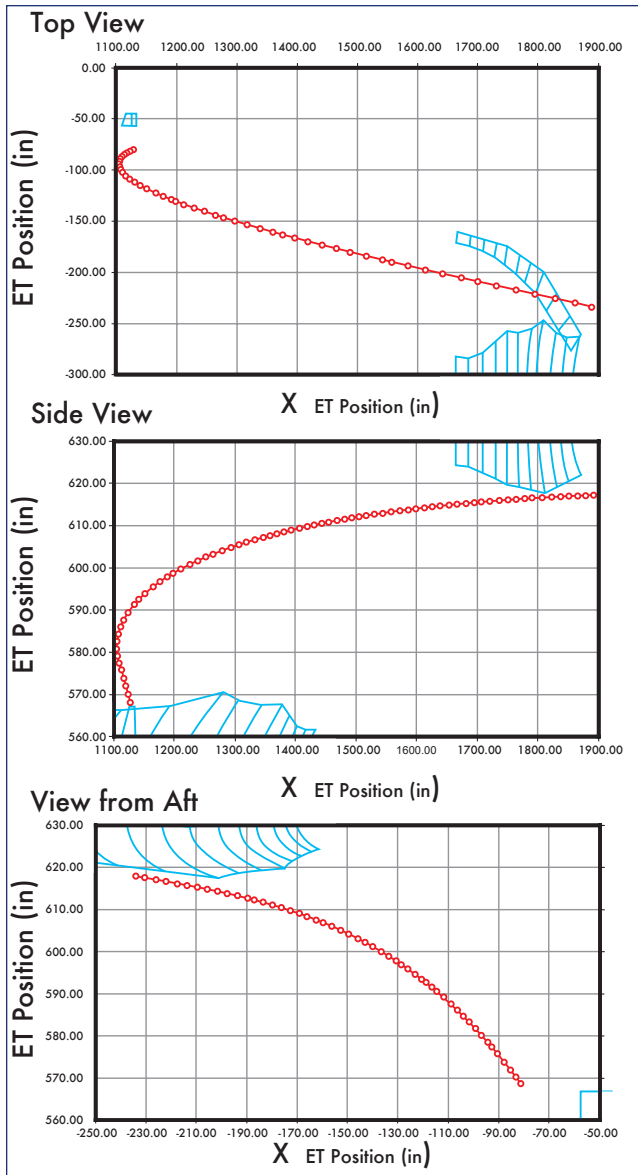
Figure 7-19. Debris object trajectory solution with rcc and bipod ramp outlines (ballistic model).

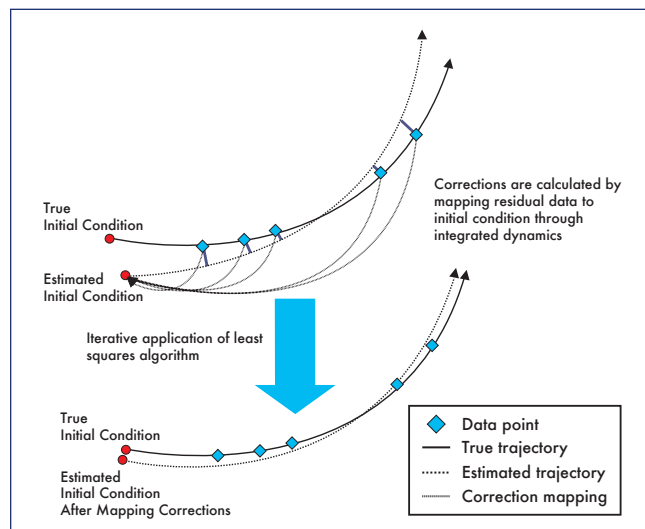
Figure 7-20 Batch least squares estimation process.

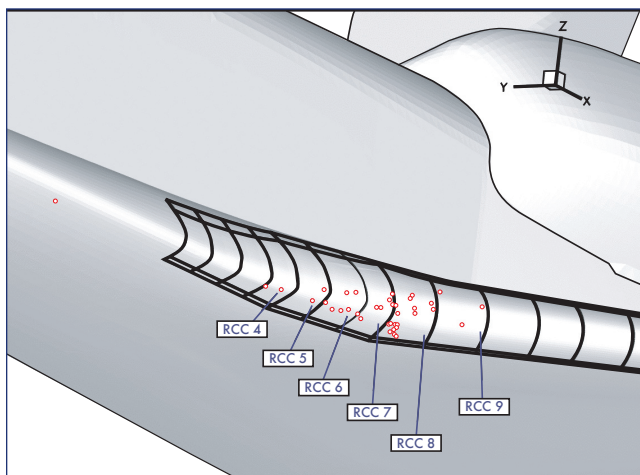
Figure 7-21. Interpolated impact points of all data sets.

cally the planes in these angles are +xy in the Space Shuttle up direction, +xz toward the starboard side, and +yz toward the Space Shuttle aft section. Note that data sets ES3-7 and SX3-7 did not impact the Space Shuttle. The velocity magnitudes at interpolated impact points ranged from 669 ft/sec to 853 ft/sec with incidence angles varying from 5 to 33 degrees. The impact point of each data set is represented visually in Figure 7-21.

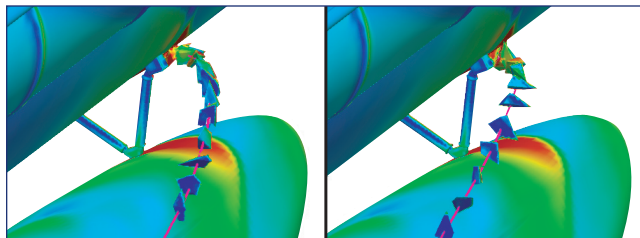
Figure 8-1. Backward vs. forward flip trajectories.

A trajectory that begins with a rotating forward flip (nose-down) is more likely than a backward flip (nose-up) to impact the Shuttle's lower wing leading-edge surface. A backward flip would generate significantly more lift before the

piece starts to tumble, carrying it too far outboard or over the top of the wing. In a forward-flip release, the debris leading edge is pushed down under aerodynamic loads, and begins tumbling almost immediately – experiencing little aerodynamic lift in the process. As a result the forward-flip trajectories follow the Orbiter’s surface more closely, and more consistently impact the wing leading edge. Also, trajectories produced by forward-flip releases are closer to the initial positions reported by the Image Analysis Team teams.

These images also illustrate the tumbling behavior of the debris after it separated from the launch vehicle. The homogeneous wedge shaped foam debris analyzed in these simulations is unstable and will tend to rotate rather than trim out in a stable attitude. To assume a stable attitude, with a correspondingly lower drag coefficient, would require a significantly different debris shape than the shape observed on the launch films or would require some additional mass embedded in the foam debris. No conclusive evidence supports this scenario.

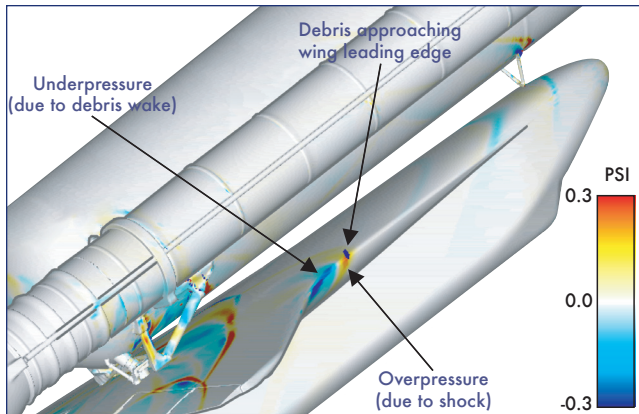
Figure 8-6. Delta pressure on vehicle surface caused by debris.

The effects of the debris on the surface pressures of the Shuttle were estimated by subtracting the steady state solution surface pressures from those computed during an unsteady trajectory computation. This analysis shows that the Orbiter leading edge pressure is lowered by approximately 0.4 psi just before the debris impact. This is shown in the following figure, which shows color contours of the difference in pressure on the surfaces.

Red and yellow indicate increased pressures and cyan and blue indicate lowered local pressure. White or gray regions show small or no change in pressure. The lowered local wing surface pressure is caused by the wake of the debris piece that precedes the debris as it travels past a fixed point on the Orbiter wing. This change in local pressure may help explain the anomalous accelerations measured on the left wing outboard elevon accelerometer recorded during ascent and may explain the unusual acceleration signature seen shortly after the debris impact on the leading edge of the wing.

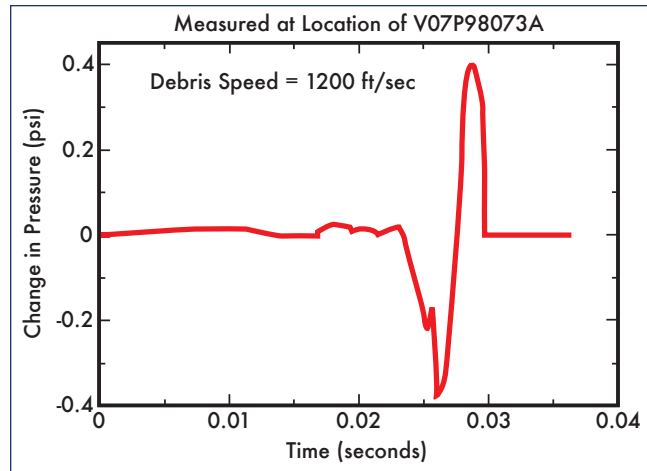
Figure 8-7. Delta pressure near orbiter lower surface pressure tap.

The following figure shows the change in pressure near one of the anomalous taps caused by the simulated debris shape passing near the Orbiter wing without an impacting the wing leading edge. For this debris velocity the pressure oscillation occurs over approximately 0.01 seconds and realistically would not have been sensed by the 10 Hz sample rate of the pressure taps. The zero value on the x-axis is simply a reference time prior to the debris's passage near the pressure tap.

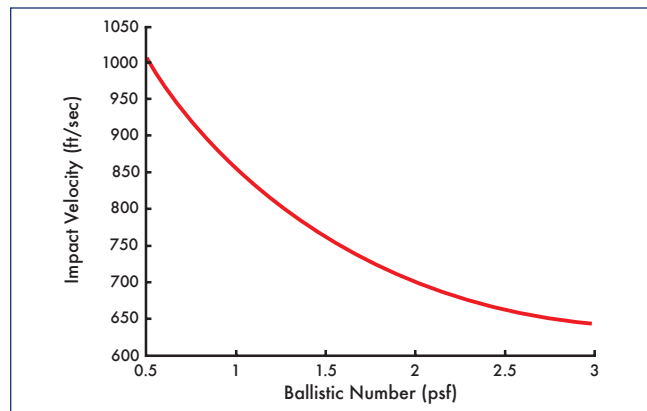
figure 9-1. impact velocity at 1,800 inches vs. ballistic number.

The debris mass estimates were based on the ballistic coefficient analysis results combined with the ADT program and unsteady CFD results for the 855 in<sup>3</sup> foam volume estimate from the External Tank Project. ADT and the unsteady CFD results predicted that the 855 in<sup>3</sup> foam would have a BN approximately equal to 1.0 with an impact velocity of 950 ft/sec.

Ballistic number analysis of the Image Analysis trajectories estimated the most likely range of  $1.2 < BN < 1.4$ . Due to the accelerated test schedule and lead times required to procure test article hardware a simple ratio of the predicted ballistic numbers to the baseline 855 in<sup>3</sup> geometry was used to predict the as tested foam weights.

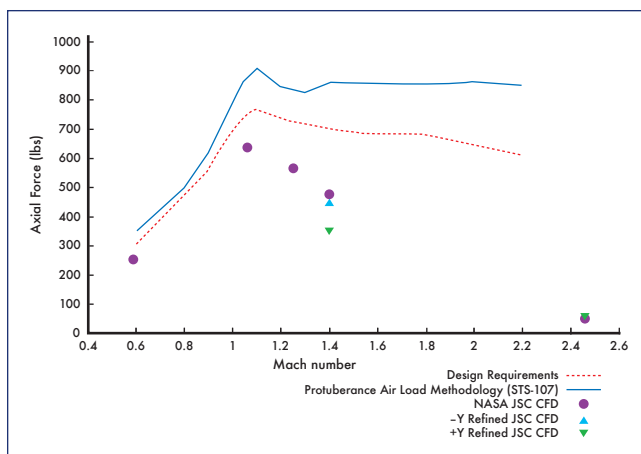
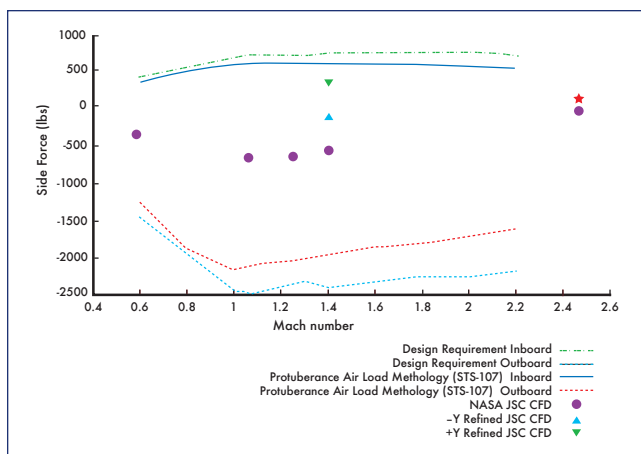
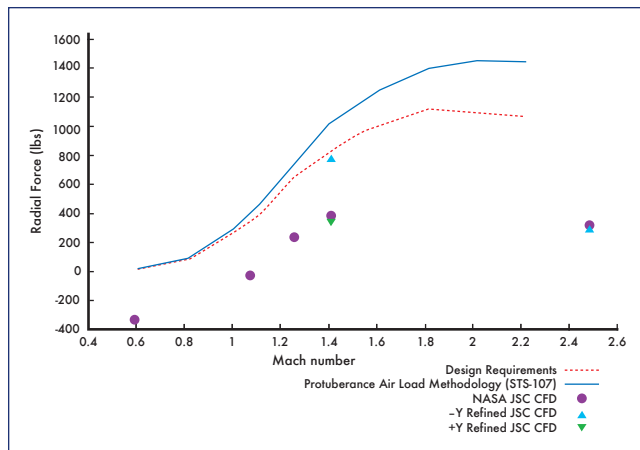
The following figures show the calculated loads on the -Y, or left-hand, bipod ramp. The design requirement curve is based on a high dynamic pressure trajectory designed to fly

at the Shuttle structural design limits. The STS-107 curve uses the same analysis procedure but uses the STS-107 trajectory dynamic pressures to compute the various loads. The NASA JSC CFD symbols were computed using a simplified geometry that did not include the External Tank Intertank Stringers. The Refined JSC CFD symbols are for an updated CFD geometry that includes the stringers and refined +Y ramp geometry.

This analysis shows that the air loads were within the design envelope and implies that a ramp with no flaws would not fail due to air loads alone. Internal voids could contain gas at atmospheric pressure that would result in local failures when the delta pressure between the gas voids and the external pressure exceeds the strength of the foam insulation. Information from the ET Project indicates that internal flaws could significantly reduce the foam strength and that cryogenic temperatures would cause a further reduction in strength.

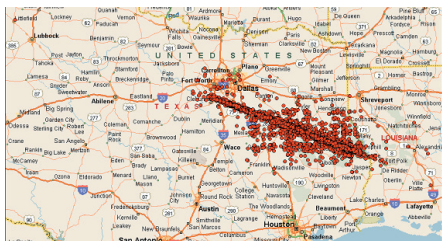
<p><b>STS-107 Columbia Reconstruction Report</b></p> <p>062303_01Section 12 - EPO &amp; Instrumentation</p>	<p>115</p>

On February 1, 2003 at approximately 0800 Central Standard Time the Orbiter Columbia broke up over east central Texas during re-entry into the earth's atmosphere. The Orbiter was returning to Kennedy Space Center (KSC) at the completion of mission STS-107. At the time of breakup, the Orbiter was traveling at about Mach 18 at an altitude of approximately 208,000 feet. The debris field was scattered over an area of eastern Texas and western Louisiana and measured approximately 645 miles long by 10 miles wide. The debris was recovered and shipped to KSC for examination in the Columbia hangar. It is estimated that approximately 38% (comprised of over 83,900 individual items) of the Orbiter, by weight, has been recovered to date. The debris field is depicted in figure 2.1 – Debris Field.

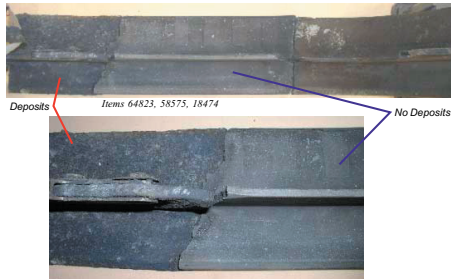
*Items 64823, 58575, 18474*

spar, with the aluminum access panel providing a secondary source. The highest concentration of deposits on the panels is the lower portion of right hand RCC panel 2, which coincides with a missing lower access panel 2. Fracture sequencing can be determined based on deposit levels. Panel 2 and its associated gap seal have a heavy concentration of metallic deposits on one side of a fracture while the mating fracture surface is completely free of deposits. This condition is found on the gap seal (64823, 58575, 18474) where the middle

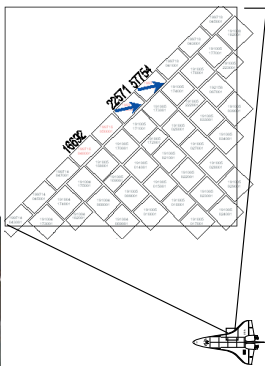
Evidence of overheating and slumping was observed on three LI-2200 Lower Left Carrier Panel 9 tiles adjacent to left hand RCC panel 9. The item numbers of these are: 16692 (V070-199716-048), 22571 (V070-199716-052) and 57754 (V070-199716-054). Figure 9.2 shows the simulated configuration of the carrier panel tiles. Depressed/slumped and eroded regions were observed in two of the three tiles (Items 16692, 22571). For

Figure 9.2. Reconstruction of recovered left hand lower LESS Carrier Panel 9 tiles.

One internal LI-900 tile originally located on Lower Left LESS Carrier Panel 9 was recovered. This tile (Item 50338, V070-194205-004) exhibited a heavily slumped and cratered appearance (Figure 9.2). An additional internal LI-900 tile was recovered from upper Left LESS Carrier Panel 8. This tile exhibited a greenish coloration and heavy slumping (Figure 9.5). The surface deposits on internal tiles 50336 and 50338 were not as thick as those

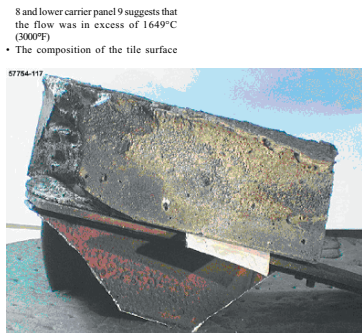
The item 57754 remained bonded to a section of underlying carrier panel 9 (Figure 9.7). The items 22571, 16692, 50338

Figure 9.7. Tile Item 57754 bonded to section of carrier panel

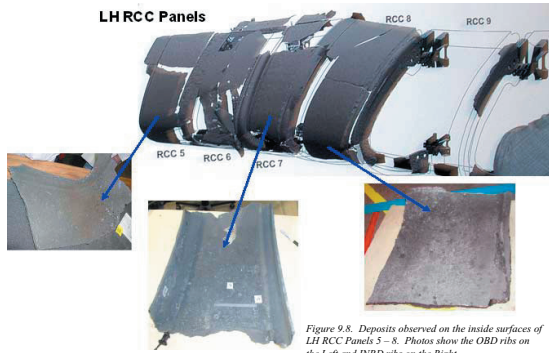
Figure 9.8. Deposits observed on the inside surfaces of LH RCC Panels 5 – 8. Photos show the OBD ribs on the Left and INBD ribs on the Right.

deposits suggests that the flow contained molten/vaporized materials from the LESS internal insulators, attachments, carrier panels, and/or wing spar.

Deposits similar to those observed on the LESS carrier panel tiles were also observed on the inner surfaces of several LH RCC panels (Figure 9.8). The deposits resembled solidified metallic slag, and were strongly adhered to the internal surfaces of the panel segments. The quantity and thickness of the deposits also varied according to the RCC panel number.

Table 9.4 and Figure 9.8 show the relative severity of the left wing leading edge deposits approached a maximum at RCC Panel 8 and decreased on either side. Heavy deposits were also observed on the inner surfaces of the Outboard Ribs of Panels 4, 5, and 7, however very few deposits were observed on the inboard ribs of these panels.

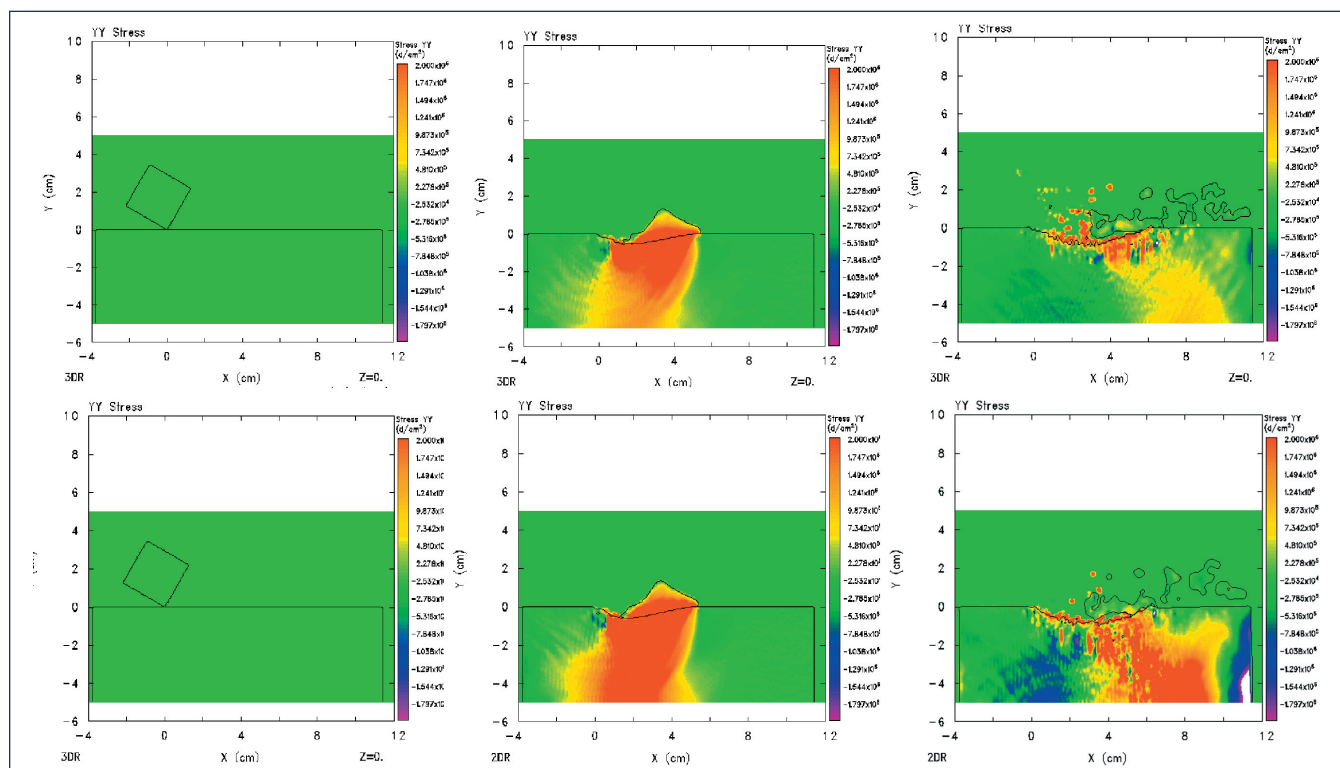
As a quantitative measure, results from the experiment as well as the computations are shown in Table 4. The final crater dimensions agree very well for the three cases. In addition to considering the final crater dimensions, the normal stress ( $\sigma_{yy}$ ) histories at 0.5 cm interval locations were compared (Figure 10). As can be seen, the normal stress histories agree very well for the two computations. Due to the agreement, further calculations to explore the behavior of the impact event were carried out in 2D plane strain.

Figure 9. CTH computations with new foam insulation and thermal tile models. Top is 3D computation, bottom is 2D plane strain of 1" cube of foam insulation material impacting thermal tile at 800 ft/s at 30° impact angle. Times are 0, 200 and 500 μs. Colors mark  $\sigma_{yy}$ , ranging from -200 kPa (-29 psi, purple) to 200 kPa (red); green is 0 kPa.

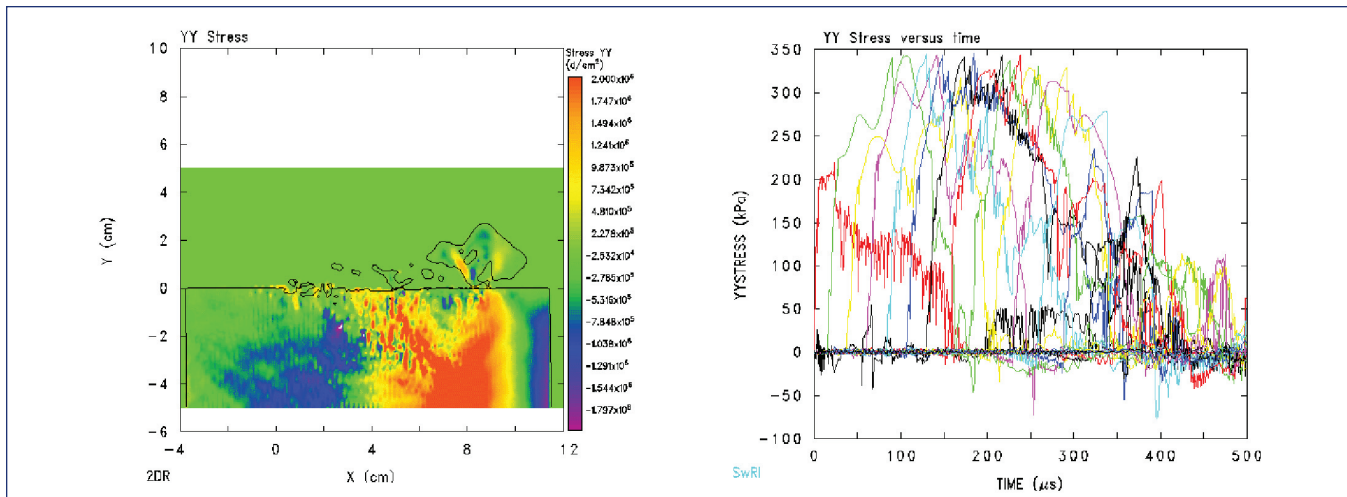
Given that the material models and impact simulations were behaving well and reproducing experimental results, it was decided to pursue a damage/no damage transition curve through computation. In particular, a sequence of computations was performed with the intent of determining whether an impacting 1" cube of foam insulation material would damage the thermal tile. The damage/no damage decision was based on an examination of both the final state of the tile surface and the normal stress history at the gage locations along the tile surface. For example, the computation at 700 ft/s at 15° impact angle was decided to have no damage since there was little deformation at the surface of the tile (what deformation is seen there is typical of numerical anomalies in interfaces in Eulerian codes) and the stresses remain below the 345 kPa (50 psi) crush-up stress determined above for the thermal tiles. The results are shown in Figure 11.

Figure 11.  $\sigma_{yy}$  (left) and normal stress ( $\sigma_{yy}$ ) histories (right) for 1" cube of foam insulation impacting thermal tile at 700 ft/s at 15° impact angle; no damage occurs to the tile.

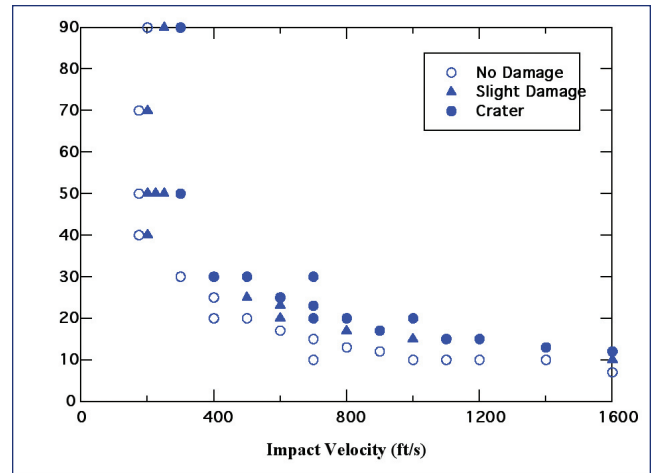
computations were then plotted in the impact speed-impact angle plane. After each computation, the decision was made on what case to run next, thus allowing the curve to be followed. Table 5 shows the results of the computations. When plotted on a graph, these results give indication of a fairly well defined damage/no damage transition curve in the plane (Figure 13).

Figure 13. Damage/no damage results from numerical calculations.

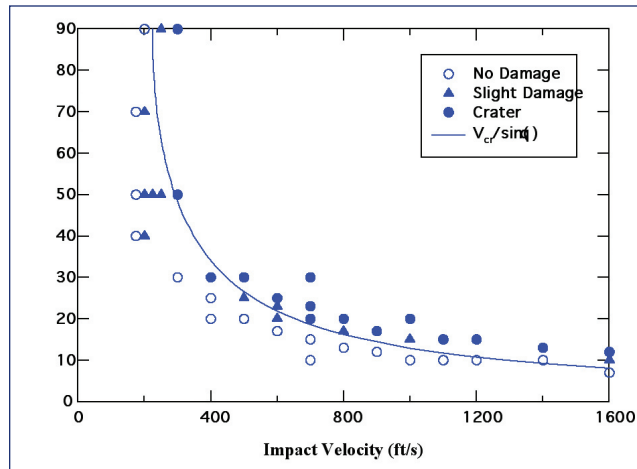
For the value of  $V_{crush}$  computed for the foam insulation impact into tile, this damage/no damage transition curve is plotted in Figure 14 along with the results from the computations. It is seen that there is excellent agreement.

Figure 14. Theoretical damage/no damage transition curve with computational results.
