# COLUMBIA

## ACCIDENT INVESTIGATION BOARD

REPORT  
VOLUME II

OCTOBER  
2003

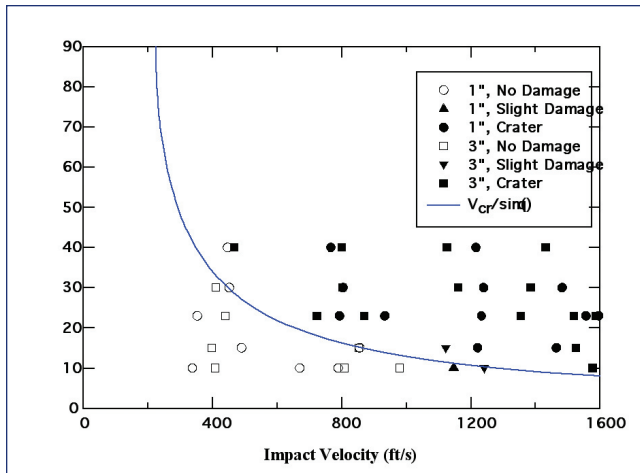
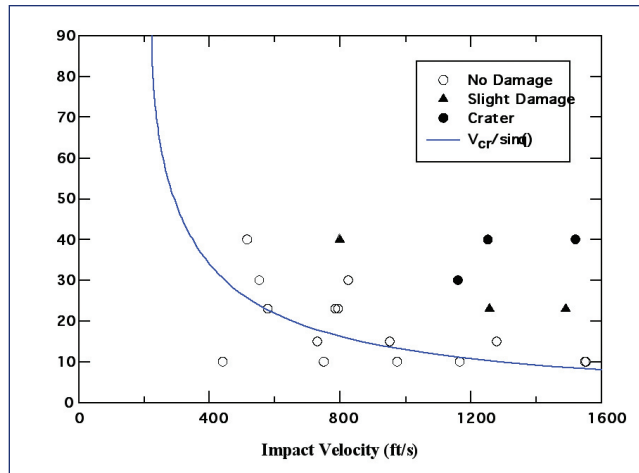
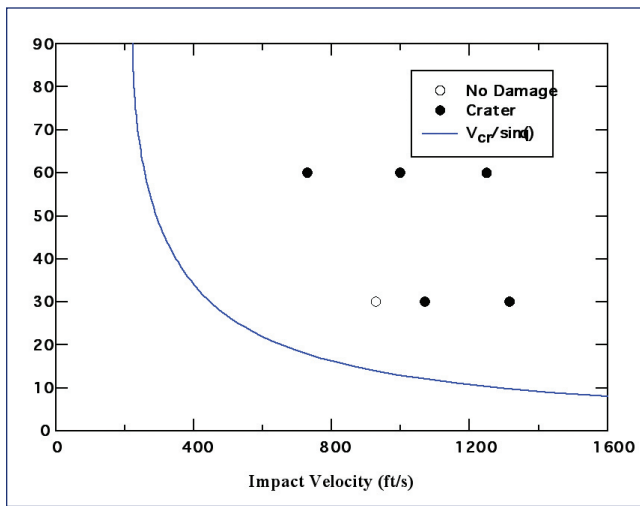
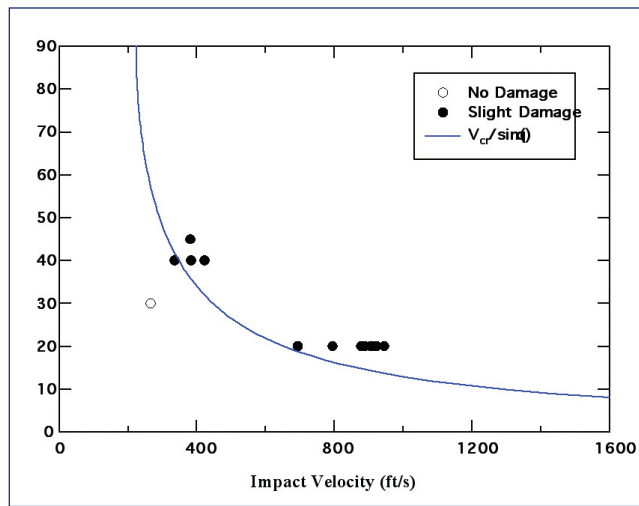
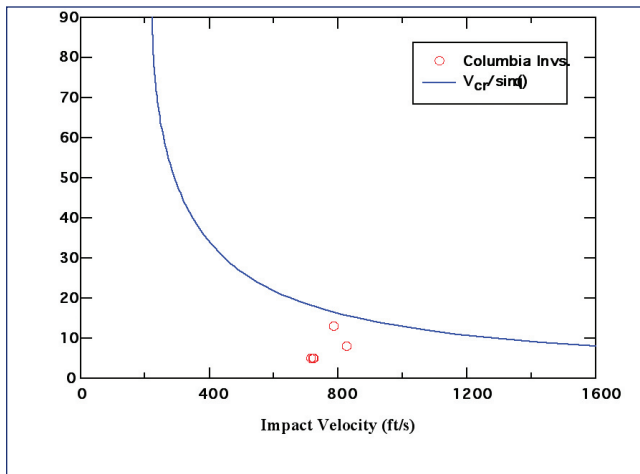
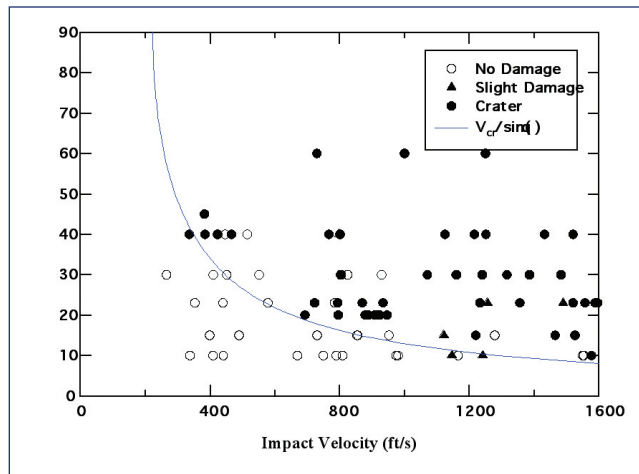
Returning to the reports of previous work performed at SwRI [1,3], all the experimental results of foam insulation impact into single thermal tiles were categorized with the same damage/slight damage/no damage designation. Figure 15 breaks out these various impact cases. Figures 15a-c are for NCFI 24-124 [1]. The material in Figure 15d from [3] is an ablator material with a higher density (around 0.3 g/cm<sup>3</sup>, 19 lb/ft<sup>3</sup>) and unknown crush strength.\* Rough dimensions of the impactors are shown in the figure captions. Of most interest are the foam insulation impactors with leading cross section 1" x 1" (Figure 15a). Though of two different lengths, the agreement is remarkable. In this case, the tile is fully loaded by the foam, and the length of the impactor does not affect whether damage occurred (it does affect crater size [1]). In other cases with much smaller cross sections, it is likely the projectile buckled before fully loading the tile, thus leading to less damage to the tile. Figure 15e shows results of tests performed during the Columbia investigation (discussed below). Finally, Figure 15f shows all the data points plotted with the theoretical curve. The agreement is excellent.

Figures 15a – 15f. Theoretical damage/no damage transition curve with results of all impacts into thermal tiles contained in [1,3] and Columbia investigation tests.

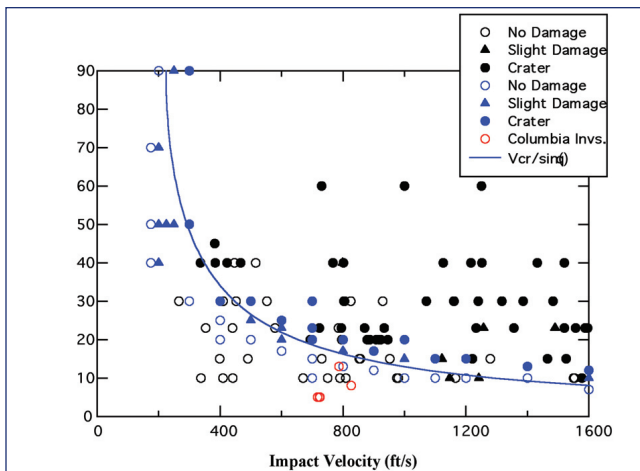
A strong case can be made that the foam insulation impacting thermal tiles is well understood. Good agreement has been shown between the large-scale numerical computations, the theoretical model, and experimental results. Thus, it is clear that loading from the foam arises from the component of the velocity normal to the surface being struck. If the resulting normal stress exceeds the crush-up stress of the tile, then the thermal tile crushes and a crater is formed. Otherwise, there is minimal or no damage to the tile. Figure 16 puts all three (CTH calculations, theoretical curve, experimental results) on one plot.

Figure 16. Theoretical damage/no damage transition curve with results of computations (blue) and all impacts into thermal tiles contained in [1,3] (black) and the Columbia investigation tests (red).

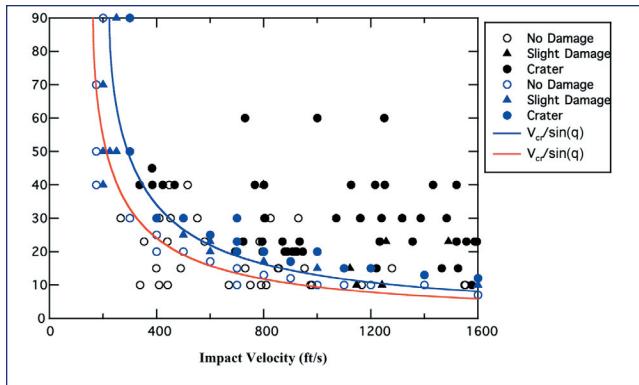
In this vein, two variables were considered. First, the question of what would be the effect of doubling the foam density is addressed. If the foam density is doubled from the value of 2.4 lb/ft<sup>3</sup> (0.03844 g/cm<sup>3</sup>) to 4.8 lb/ft<sup>3</sup> (0.07688 g/cm<sup>3</sup>), Eq. (8) gives that the new crush-up velocity is  $V_{crush} = 49.7$  m/s (163 ft/s), or a reduction of 27%. When plotted on the previous graph, the result of such an increase in density is clear: it reduces the allowable angle for a given speed by about 25% for speeds above 400 ft/s (Figure 17).

Figure 17. Effect of doubling the foam insulation density on the damage/no damage transition curve (red).

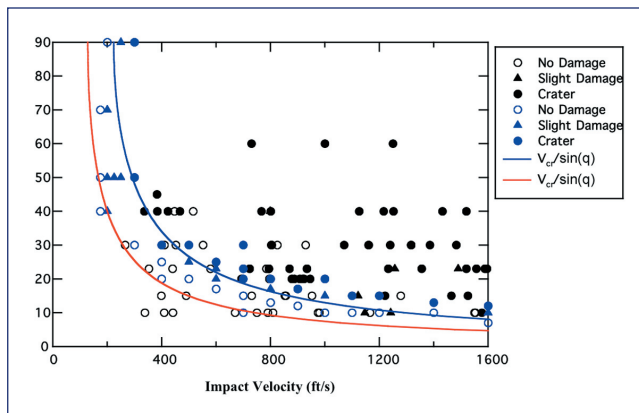
In a similar fashion, the question of what would occur if the thermal tile crush-up strength was reduced by 20%, from 345 kPa (50 psi) to 275 kPa (40 psi), was considered. Such a reduction has a much more severe effect on the damage/no damage transition curve:  $V_{crush} = 39.2$  m/s (129 ft/s), and the allowable angle is reduced about 40% for a given impact ve-

locity for velocities above 400 ft/s. Thus, tile failure is more sensitive to tile crush-up strength than relatively large variations in foam density. The condition of the tile is therefore of more concern than variations in foam properties.

Figure 18. Effect of reducing tile strength 20% (red).

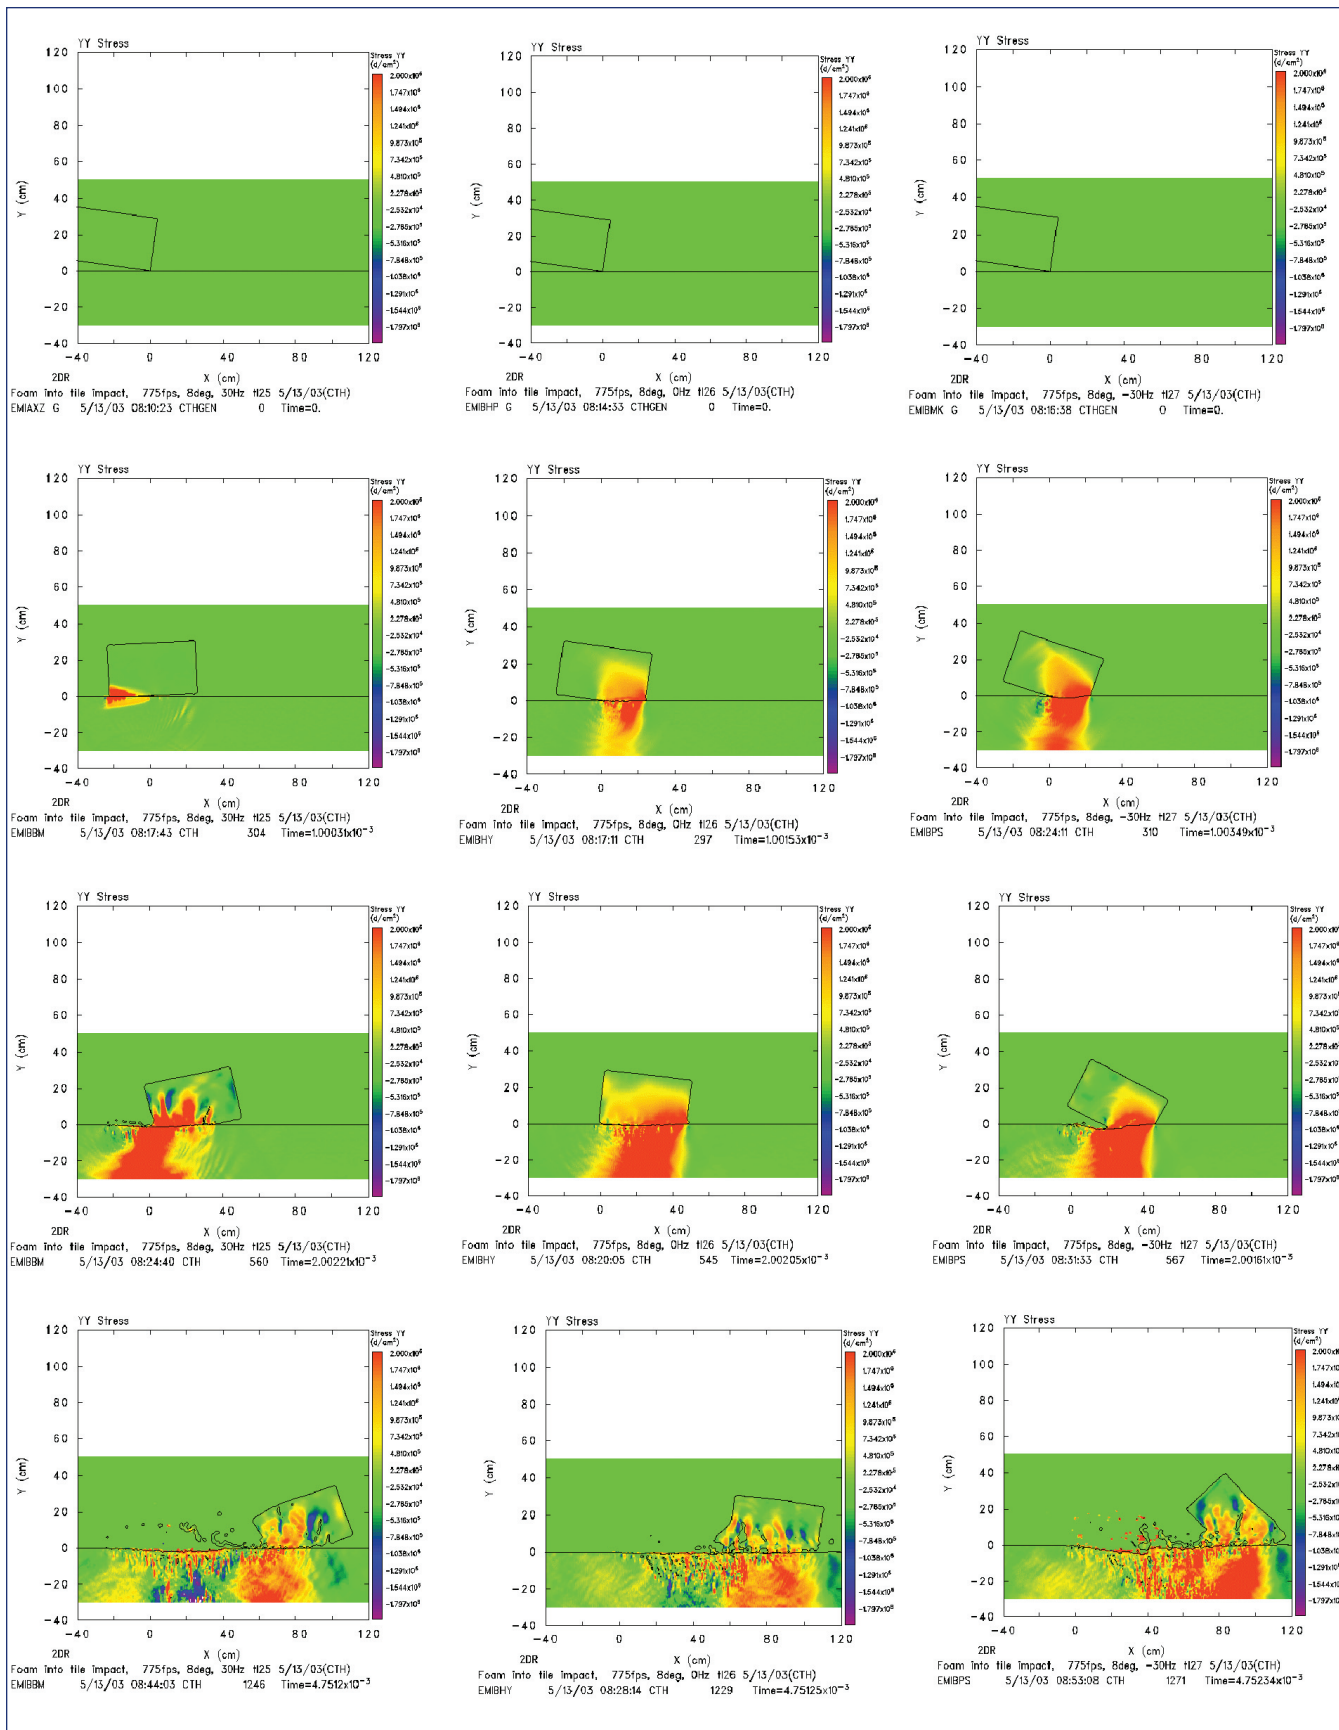
Computations were performed for the above impact geometry for a counterclockwise rotation, no rotation, and a clockwise rotation. Lacking a full model for a tiled surface, a single "large" tile was used to represent the thermal tile. Figure 19 shows the results of the CTH computations for the three cases. The figure shows the  $\sigma_{yy}$  stress. The images in the left column are for the impactor rotating counterclockwise, the center column is the non-rotating case, and the right column is the clockwise rotation. As time progresses (0, 1, 2 and 5 ms) it can be seen that the counterclockwise rotation prevents an impact on the front end of the impactor, and rather for this case the back end impacts first. For the counterclockwise case, little damage is done to the tile. As predicted, there is no crater formed for the non-rotating case. For the clockwise rotation case, however, the leading edge impacts with a normal velocity above the crush-up velocity and a crater is formed in the tile. Thus, for the clockwise case, rotation leads to damage of the thermal tile. Figure 20 shows the normal stresses at the tracer locations for the three cases; these normal stresses confirm the damage seen from the previous figure, namely that the stresses are below the 345 kPa (50 psi) tile crush stress for the counterclockwise and non-rotating cases and are well above the tile crush stress for the clockwise rotation case.

Figure 19. Comparison of rotation cases for 775 ft/s impact at 8° angle, 30 Hz counterclockwise in left column, no rotation in center column, 30 Hz clockwise rotation in right column. Times are 0, 1, 2 and 5 ms.

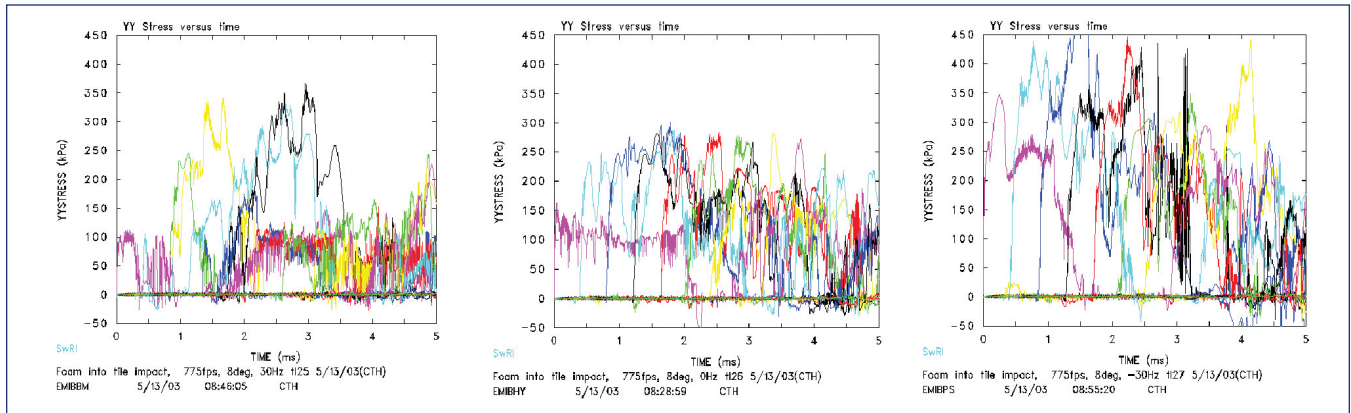
Figure 20. Normal stresses from rotation case comparison, left is 30 Hz counterclockwise, center is no rotation, right is 30 Hz clockwise. For the clockwise case, the stresses clearly exceed the 345 kPa (50 psi) crush-up stress of the tile, and damage is expected.

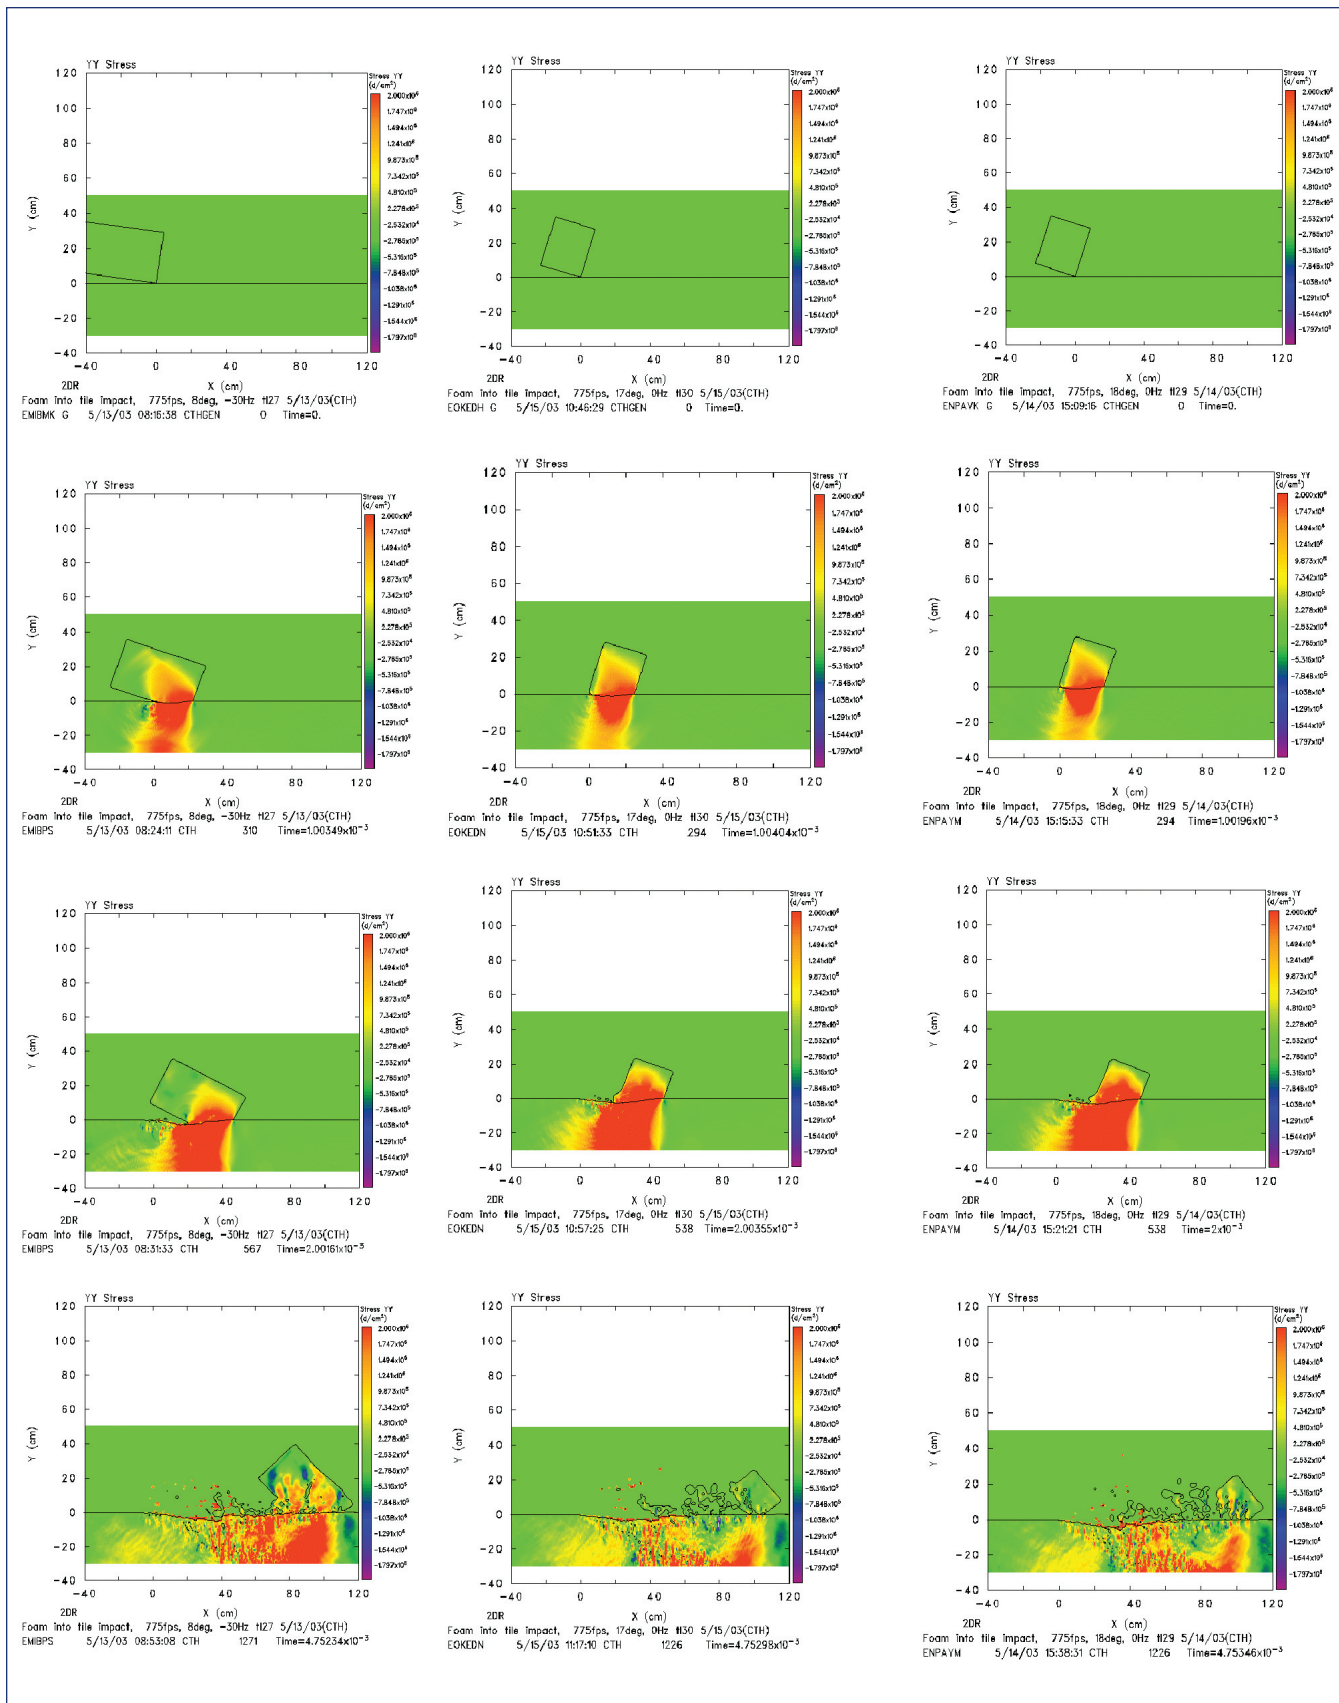
shows the  $\sigma_{yy}$  stress from three impact cases: 8° with 30 Hz clockwise rotation with the original sized impactor (left column), and 17° (center column) and 18° (right column) non-rotating impactors of half the length, or dimensions of 9.5” × 11.5” × 5.5” (though again the last dimension doesn’t enter in as the computation is 2D plane strain). It can be seen that all three impacts are producing similar stresses and craters in the tile. Figure 22 shows the normal stresses at the tracer locations. The tracers for the three cases are similar. Thus, to replicate the influence of 30 Hz clockwise rotation rate of the 8°-impact-angle impact one would use a non-rotating half-length projectile at a considerably higher impact angle of 17° or 18°. This equivalent impactor is determined based on how the tile crushes up and, in particular, that damage depends on the load delivered at the surface.

Figure 21. Nonrotating impactor to produce similar damage as 30 Hz clockwise rotating impactor. 30 Hz clockwise rotating impactor at 8° angle in left column, 17° degree nonrotating impactor in center column and 18° nonrotating impactor in right column. All impacts at 775 ft/s. Figures show  $\sigma_{yy}$  stress. Times are 0, 1, 2 and 5 ms.

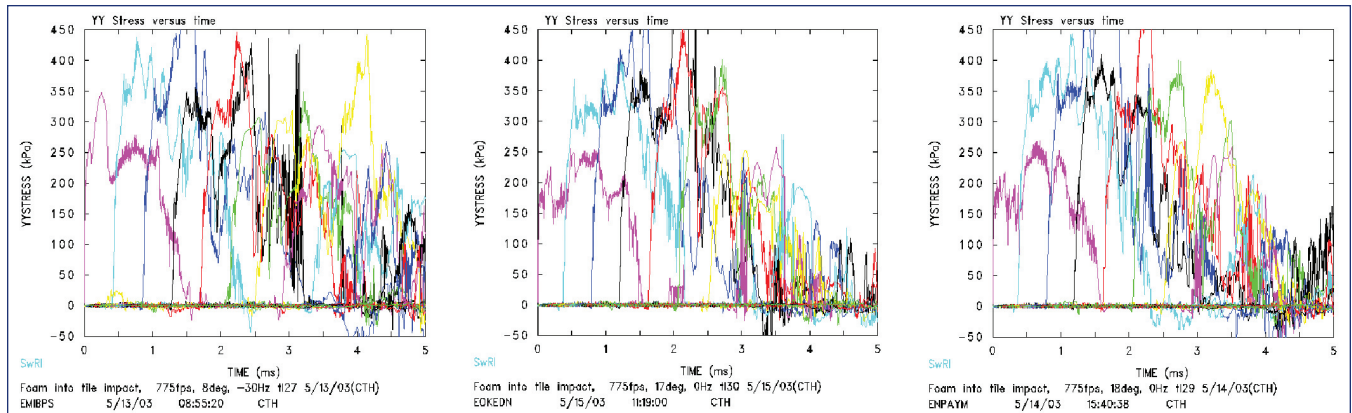
Figure 22. Nonrotating impactor to produce similar damage as 30 Hz clockwise rotating impactor. 30 Hz clockwise rotating impactor at 8° angle in left column, 17° degree nonrotating impactor in center column and 18° nonrotating impactor in right column. All impacts at 775 ft/s. Graphs show normal stress at tracer locations versus time.

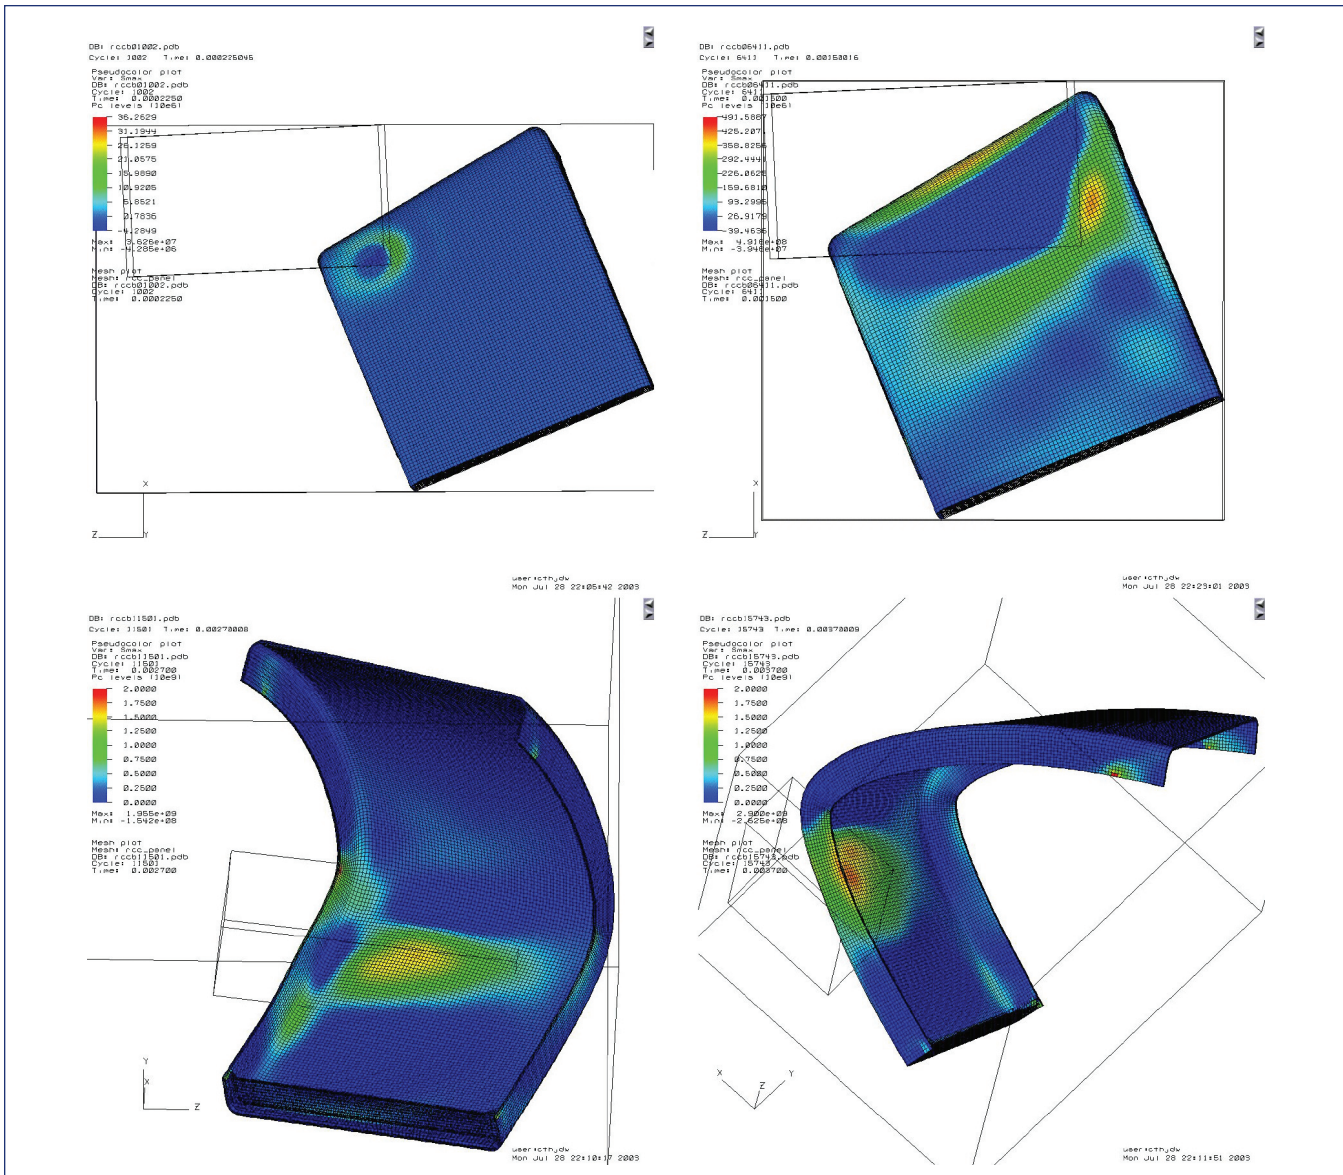
Figure 25 shows some stills from the computation. In the figure, the outline of the foam impactor as if it did not deform is shown (though the boundary pressures are provided analytically, as described above). All figures of the panel computations were made with Lawrence Livermore National Laboratory's MeshTV software. The panel is shaded to show the maximum principal stress at the given surface – that is, when looking on the outer panel face, the maximum principal stress in the outer layer of cells will be used, while looking at the inner surface of the panel face, the stresses from the innermost layer of cells will be used. The scale changes for each frame in the figure.

Figure 25. Four frames of the RCC Panel #6 test condition calculation ( $\alpha=5.5^\circ$ ,  $\beta=2.5^\circ$ , 768 ft/s), at 0.225, 1.5, 2.7 and 3.7 ms. The 2.7 ms frame is where the peak rib stress is achieved near the greatest curvature of the rib; the 3.7 ms frame is where the outward flexing of the rib achieves the greatest stress.

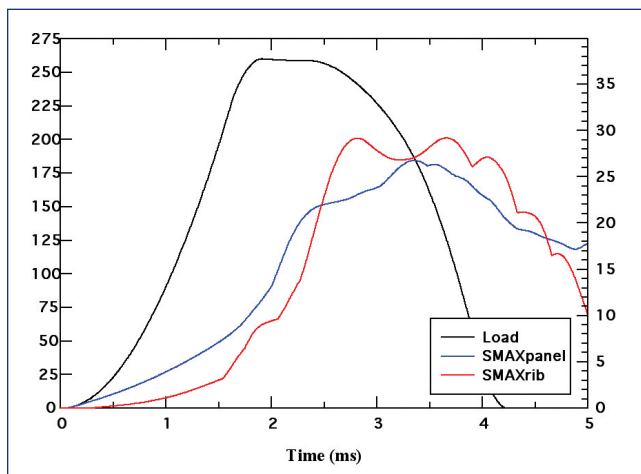
Figure 26 shows the maximum principal stress seen in both the panel and the rib as a function of time as well as the load as a function of time. The left hand scale is in metric units for both the load and stresses. The right hand scale is in English units and applies to the stresses. The undulating behavior seen in the maximum principal stress curves is due to the fact that these curves are the maximum of many curves, one for each computational cell. Thus, as one maximum principal stress curve decreases, another increases and overtakes the original maximum principal stress cell, thus becoming the maximum principle stress cell itself. It can be seen that both the maximum principal stress in the rib and in the panel are still increasing when the load decreases, thus showing that inertia plays an important role in the impact event. Finally, Figure 27 shows the maximum displacement and the maximum velocity seen on the panel during the impact event. Table 8 summarizes the historical maximums.

Figure 26. Load and maximum principal stress for panel face and rib vs. time for RCC Panel #6 test condition computation ( $\alpha=5.5^\circ$ ,  $\beta=2.5^\circ$ , 768 ft/s).

If one reasons that a higher failure stress is expected in the panel (since there are no boundaries) than in the rib (since the rib has an edge where presumably there are many fracture initiation sites), then no rigorous information can be obtained from Figure 26. (If it were assumed that the maximum failure stress is the same in the panel face and the rib, then it could be concluded that the minimum maximum principal stress the RCC material can support is 21.9 ksi (151 MPa), the value of the maximum principal stress when the two curves of Figure 26 cross at 2.47 ms). However, we know that at some time the rib broke, and that this point was after some load had accrued. Looking at the curves, at early time the maximum principal stress in the panel is significantly above the maximum principal stress in the rib. Thus, it is likely that the failure occurred at a later time, probably in the vicinity of the larger stress observed, 2.7-3.7 ms. The mechanics of the larger stresses are as follows. As the foam impact loads the panels, a large tensile stress is created near the largest curvature of the outer edge of the rib (see Figure 25 at 2.7 ms). The location of this large maximum principal stress is approximately 55 cm from the carrier panel. The maximum principal stress in the rib is at

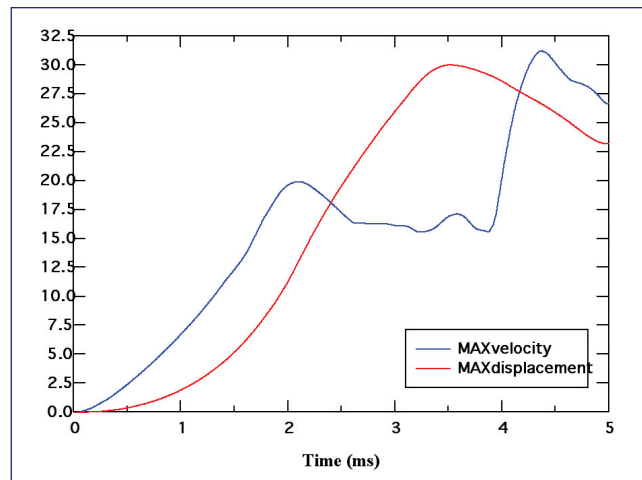
Figure 27. Maximum velocity and maximum displacement vs. time for RCC Panel #6 test condition computation ( $\alpha=5.5^\circ$ ,  $\beta=2.5^\circ$ , 768 ft/s).

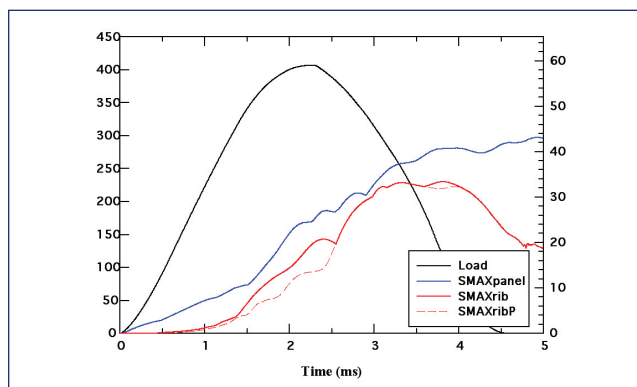
Figure 28 shows the maximum principal stress in the panel interior versus time, as well as the maximum stress observed in the thick portion of the rib (the dotted portion of the maximum principal stress for the rib includes only the thicker part of the rib). In this test, the thick portion of the rib did not fail, whereas the panel face did. At 2.7 ms, the maximum principal stress in the panel face was 30.0 ksi (207 MPa) and in the panel rib was 25.4 ksi (175 MPa). Based on the results of the RCC Panel #6 test, these seem to be reasonable stresses for the failure. Once a crack forms, it runs quickly leading

to extensive failure. Such failure was seen in the panel face. With failure of the face occurring around 2.7 ms, the load being transferred to the rib would reduce, and the stresses in the rib would decrease. This last statement is qualitative: there are inertial effects still, and so the stress could increase for a while. To quantitatively examine the histories beyond failure requires a failure model.

Figure 28. Load and maximum principal stress for panel face and rib vs. time for RCC Panel #8 test condition computation ( $\alpha=5.5^\circ$ ,  $\beta=5.0^\circ$ , 777 ft/s).

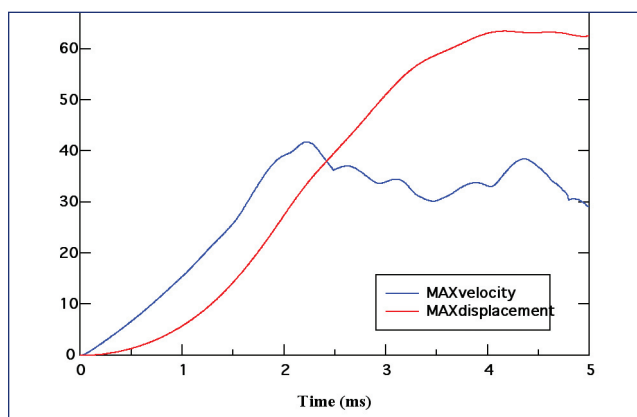
Figure 29. Maximum velocity and maximum displacement vs. time for RCC Panel #8 test condition computation ( $\alpha=5.5^\circ$ ,  $\beta=5.0^\circ$ , 777 ft/s).

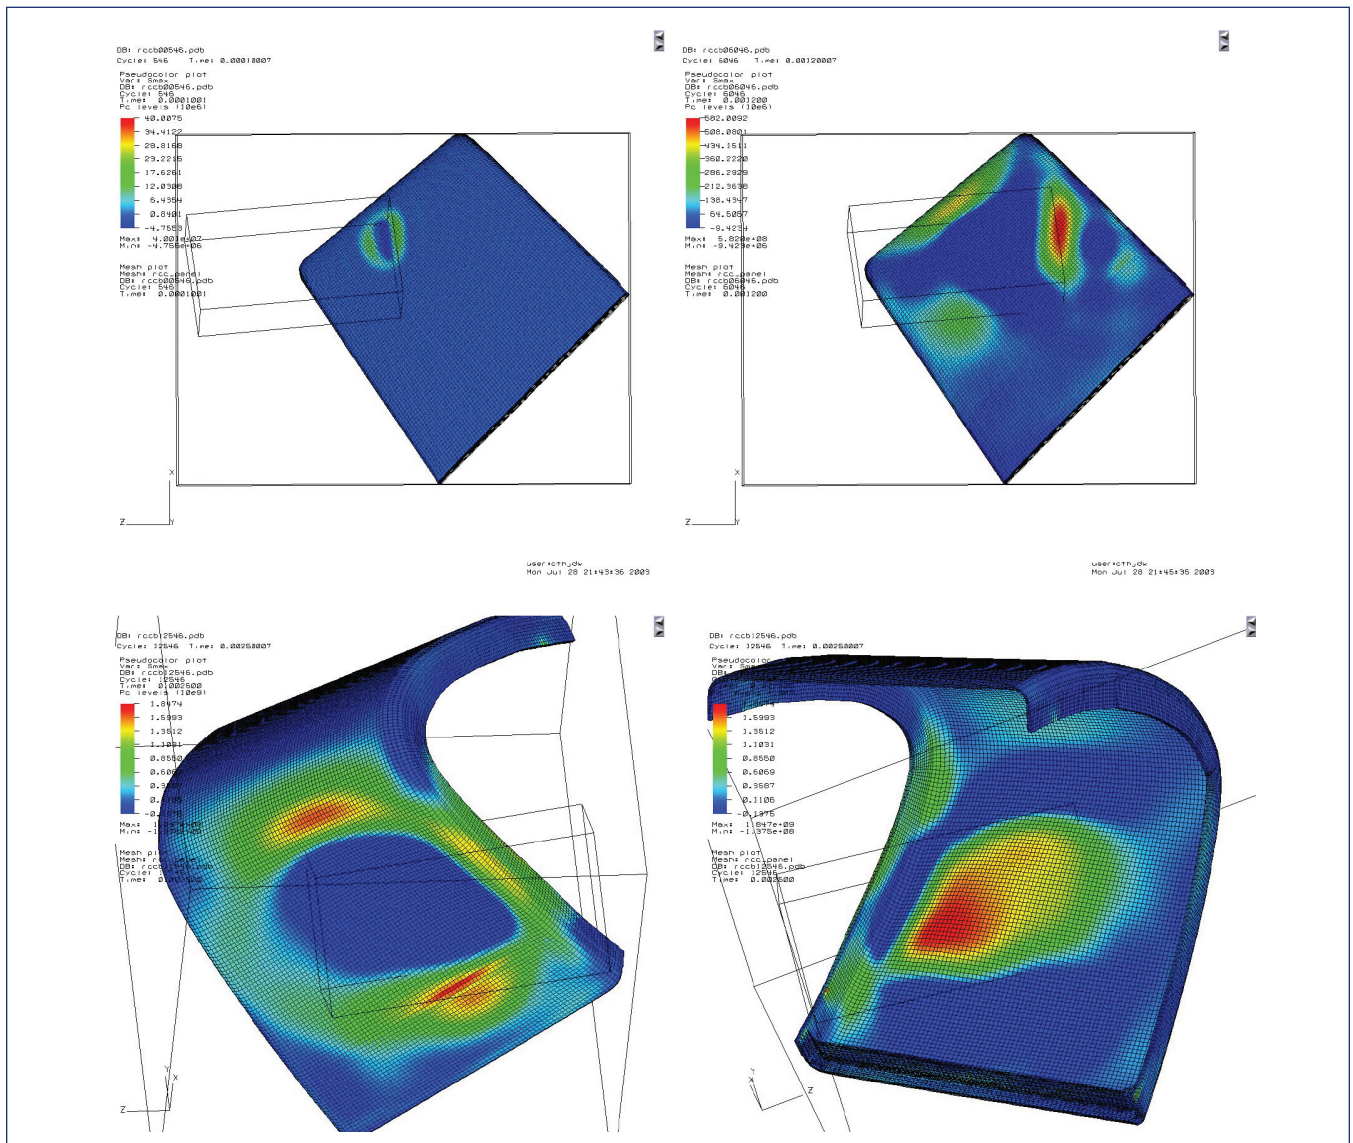
Figure 30. Four frames of the RCC Panel #8 test condition calculation ( $\alpha=5.5^\circ$ ,  $\beta=5.0^\circ$ , 777 ft/s), at 0.1, 1.2, 2.5 (front face) and 2.5 (back face) ms (the last two frames are probably near the failure time of the panel).

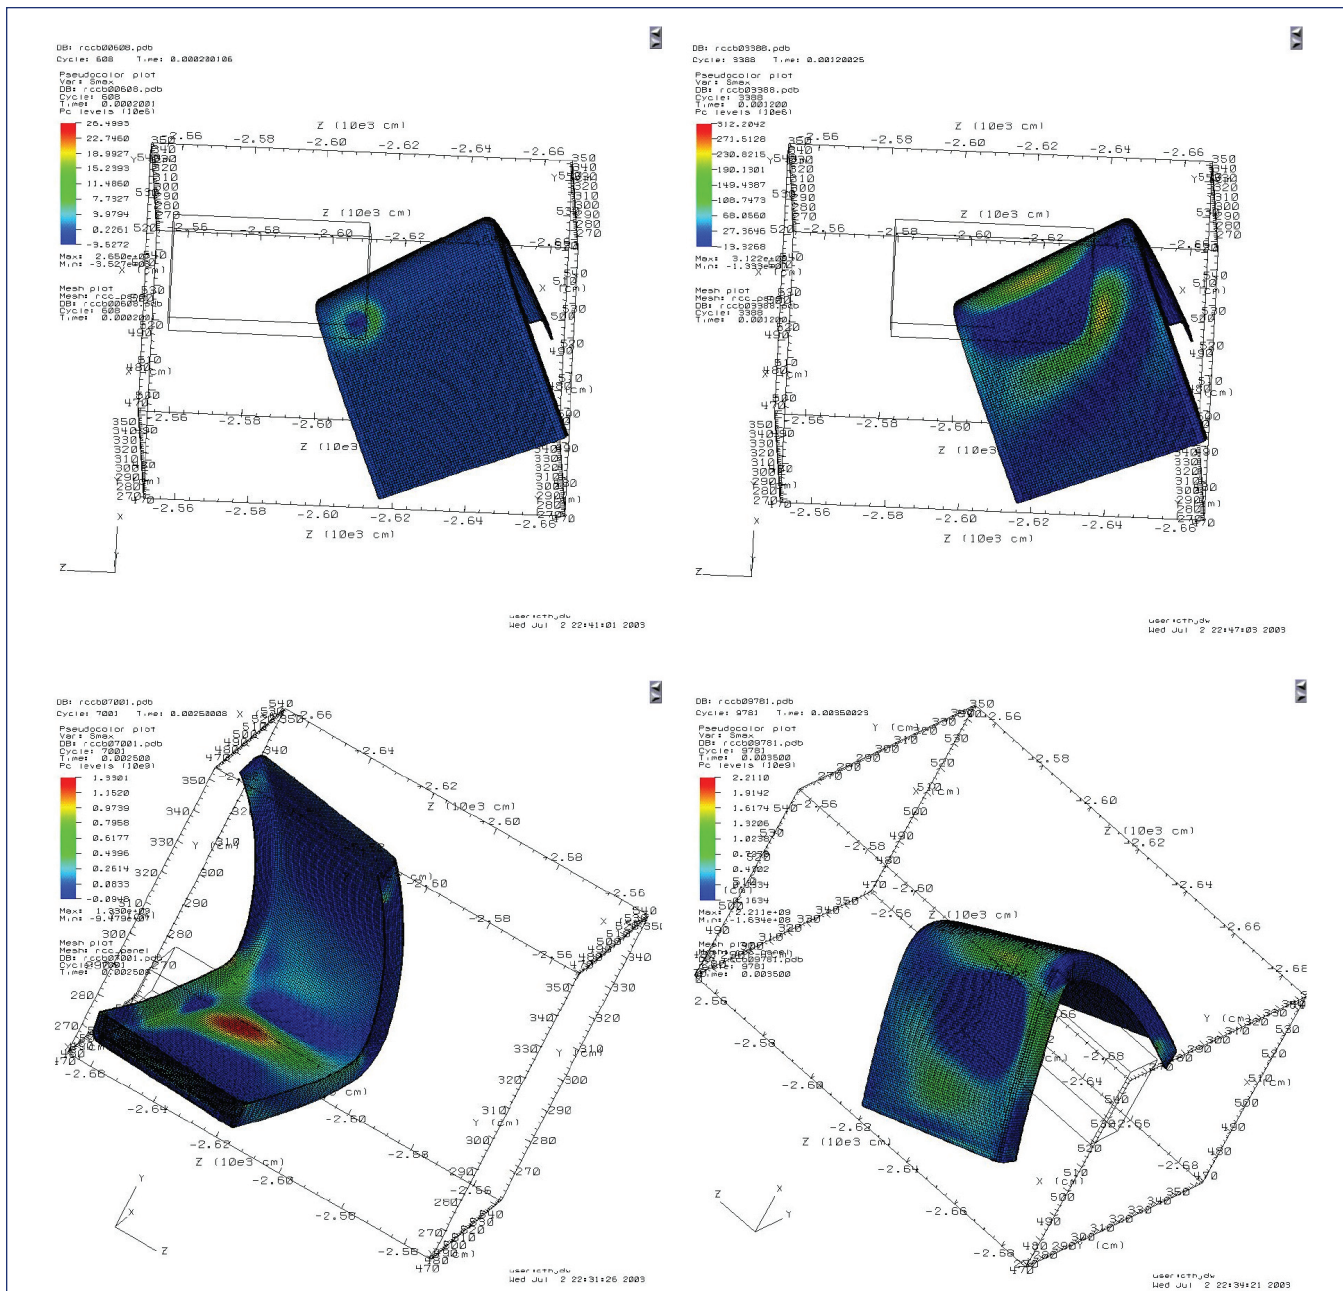
As a reference, results from the baseline impact (the same impact location as the RCC Panel #6 test but with  $\alpha=0^\circ$ ,  $\beta=0^\circ$ ) are presented. Figure 31 shows stills of maximum principal stress at four times: 0.2, 1.2, 2.5 and 3.5 ms. Figure 32 shows the stress history of the panel, and Figure 33 the maximum velocity and displacement. The same three-hump behavior can be seen in the rib stress as was observed in the actual test condition calculation, due to loading near the maximum curvature and then a downwind buckling type flexure of the rib. As the impact continues, the load from the foam projectile decreases as the loading area decreases as the foam continues to travel, and the buckling motion is relieved, and the rib straightens out. This places high stresses at the top of the arch, which are the high stresses seen in the 4 to 4.5 ms time frame in the stress history plot. The stress upon release of the buckling is especially high for the maximum stress case (impact point at 0.83" from 5-6 T-seal, 12.7" up from carrier panel) and is shown in Figs. 34 and 35. Though the maximum stress in the rib is a little higher in the earlier impact times (2-4 ms), it is the large peak upon the straightening of the rib between 4 and 5 ms that puts the maximum principal stress over 30 ksi (207 MPa). The impact location with the most severe stresses increased the

Figure 31. Four frames of the RCC Panel #6 baseline case computation ( $\alpha=0^\circ$ ,  $\beta=0^\circ$ , 768 ft/s), at 0.2, 1.2, 2.5 and 3.5 ms.

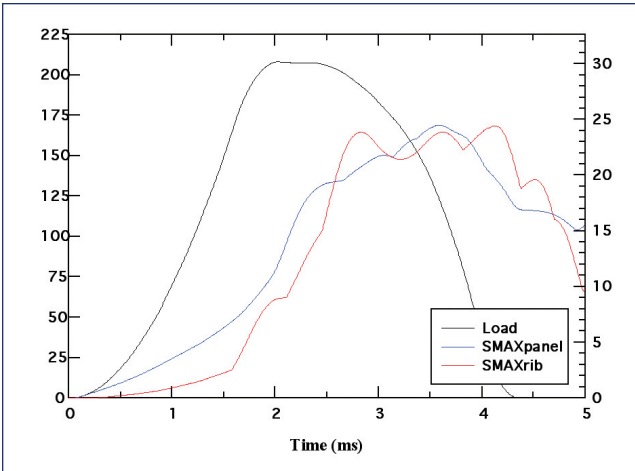
Figure 32. Load and maximum principal stress for panel face and rib vs. time for RCC Panel #6 baseline case computation ( $\alpha=0^\circ$ ,  $\beta=0^\circ$ , 768 ft/s, 0.83" from 5-6 T-seal, 18.7" up from carrier panel).

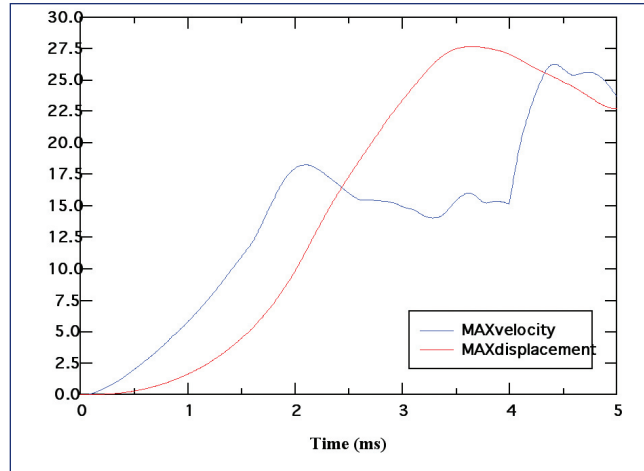
Figure 33. Maximum velocity and maximum displacement vs. time for RCC Panel #6 baseline case computation ( $\alpha=0^\circ$ ,  $\beta=0^\circ$ , 768 ft/s, 0.83" from 5-6 T-seal, 18.7" up from carrier panel).

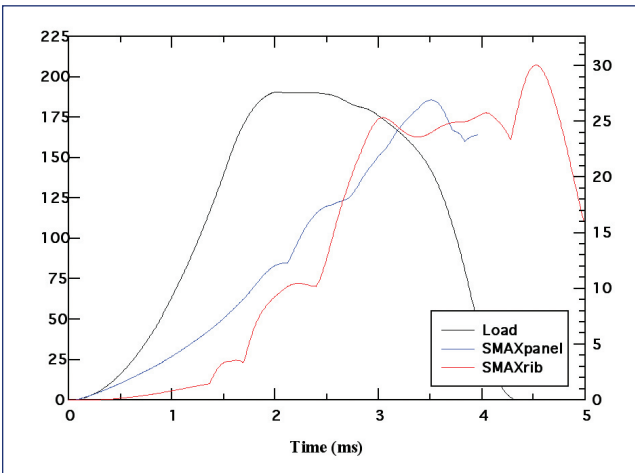
Figure 34. Load and maximum principal stress for panel face and rib vs. time for RCC Panel #6 hit location study maximum stress case ( $\alpha=0^\circ$ ,  $\beta=0^\circ$ , 768 ft/s, 0.83" from 5-6 T-seal, 12.7" from carrier panel).

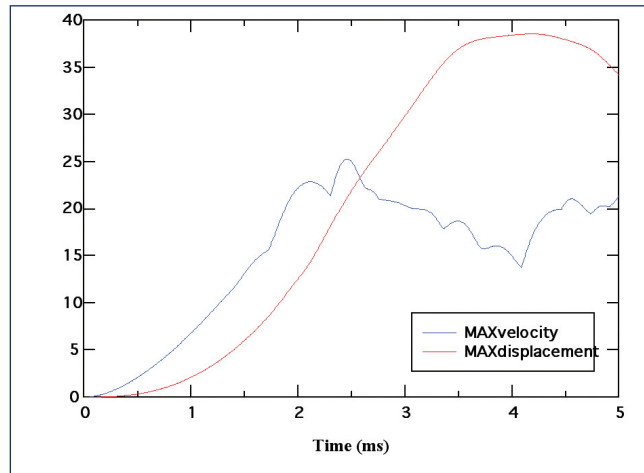
Figure 35. Maximum velocity and displacement vs. time for RCC Panel #6 hit location study maximum stress case ( $\alpha=0^\circ$ ,  $\beta=0^\circ$ , 768 ft/s, 0.83" from 5-6 T-seal, 12.7" up from carrier panel).

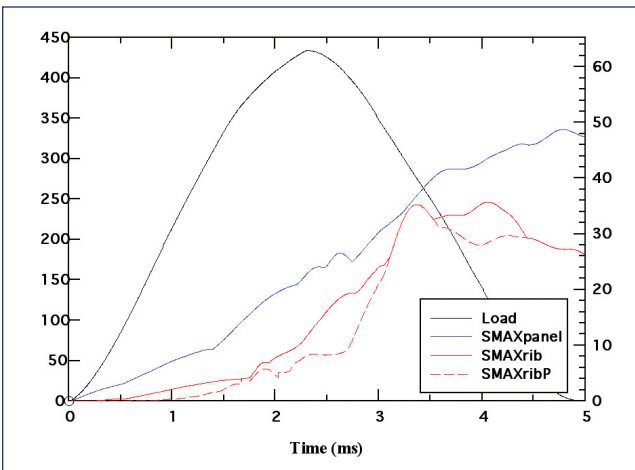
Figure 36. Load and maximum principal stress for panel face and rib vs. time for RCC Panel #8 "Option #2" ( $\alpha=5.5^\circ$ ,  $\beta=5.0^\circ$ , 777 ft/s).

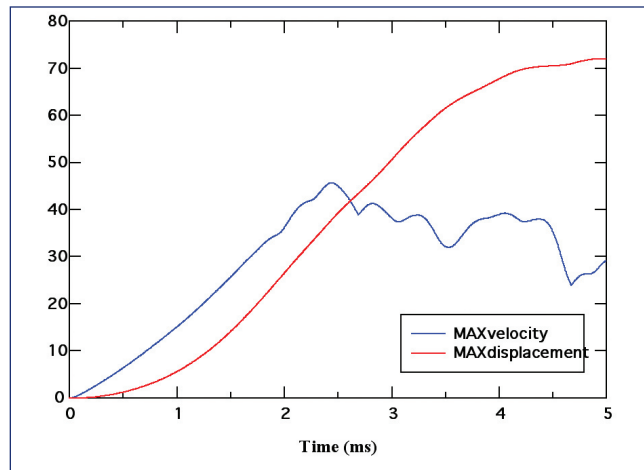
Figure 37. Maximum velocity and displacement vs. time for RCC Panel #8 "Option #2" ( $\alpha=5.5^\circ$ ,  $\beta=5.0^\circ$ , 777 ft/s).

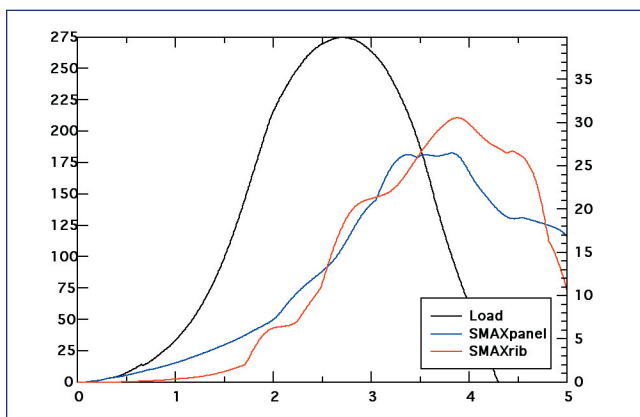
Figure 40. Load and maximum principal stress for panel face and rib vs. time for RCC Panel #6 clockwise rotation about *x*-axis case ( $\alpha=0^\circ$ ,  $\beta=0^\circ$ , 768 ft/s, 18 Hz).

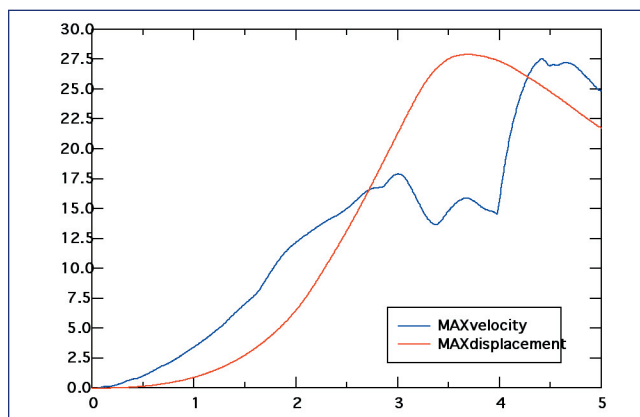
Figure 41. Maximum velocity and displacement vs. time for RCC Panel #6 clockwise rotation about *x*-axis case ( $\alpha=0^\circ$ ,  $\beta=0^\circ$ , 768 ft/s, 18 Hz).

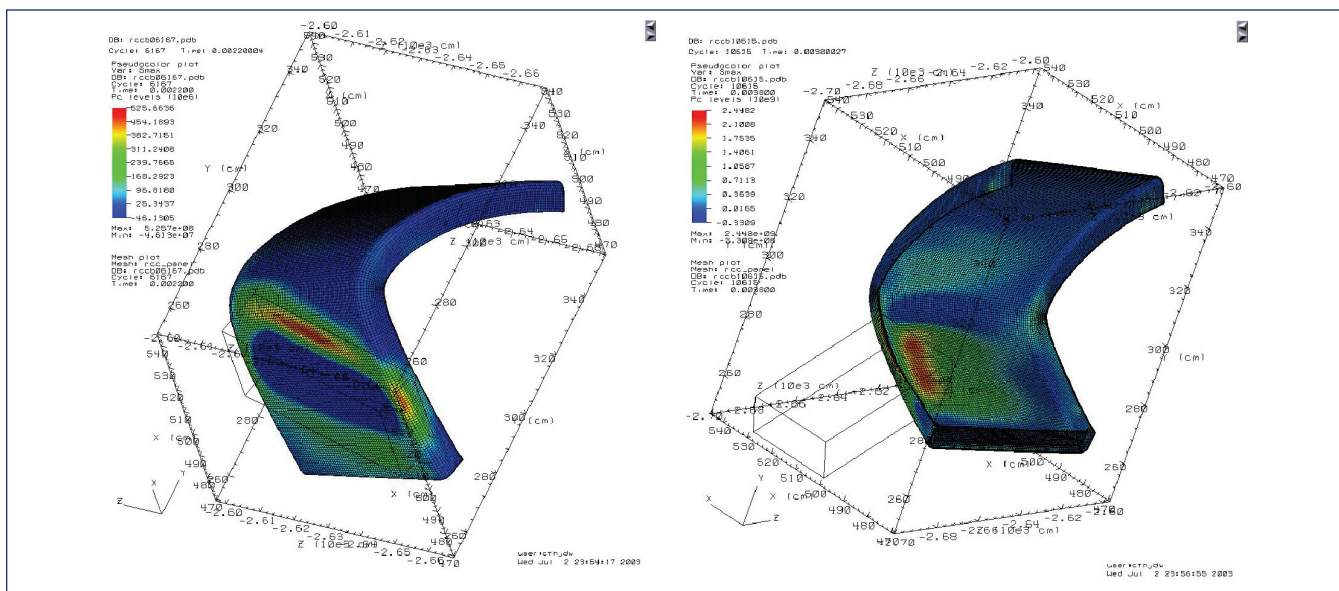
What would be the result of combining the lower impact location with the foam impactor rotation that led to the highest stresses (clockwise about the x-axis)? When these two states were combined, the resulting impact produced even larger loads and stresses as is seen in Table 12 (all save the lower right hand corner have appeared in previous tables). The increase in load over the baseline is 39% and the increase in the stress in the panel face is 36% and in the rib is 61%. Figure 42 shows two stills from the computation, and Figs. 43 and 44 show the various histories. Based on the stress history, it is expected that the panel face would fail.

Figure 42. 18 Hz clockwise rotation about x-axis with lower impact point, maximum principal stress at 2.2 (left) and 3.8 (right) ms.

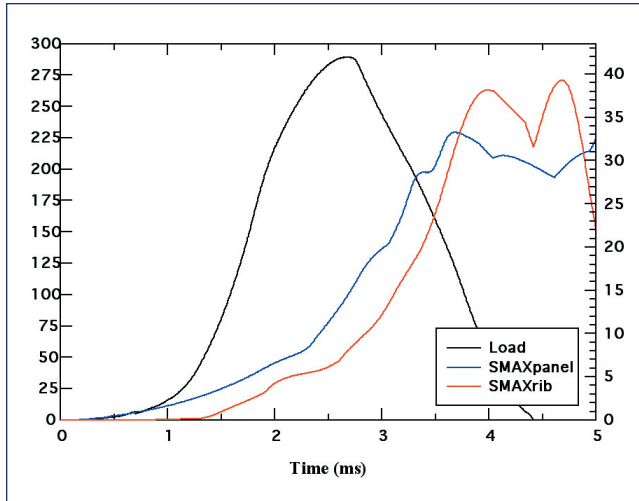
Figure 43. Load and maximum principal stress for panel face and rib vs. time for RCC Panel #6 lower impact point with clockwise rotation about x-axis case ( $\alpha=0^\circ$ ,  $\beta=0^\circ$ , 768 ft/s, 18 Hz).

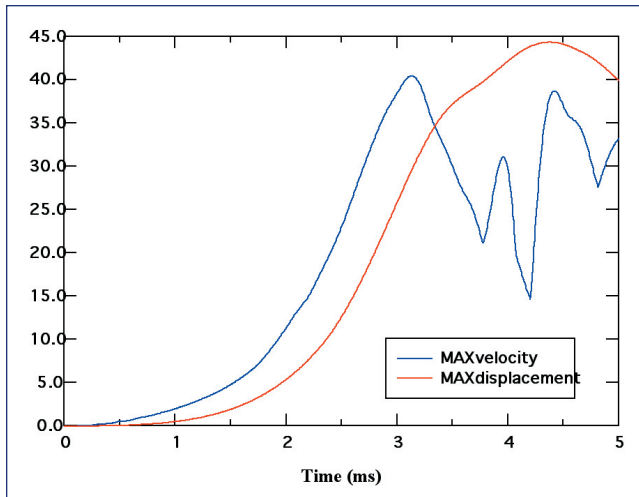
Figure 44. Maximum velocity and displacement vs. time for RCC Panel #6 lower impact point with clockwise rotation about x-axis case ( $\alpha=0^\circ$ ,  $\beta=0^\circ$ , 768 ft/s, 18 Hz).
