# COLUMBIA

## ACCIDENT INVESTIGATION BOARD

REPORT  
VOLUME II

OCTOBER  
2003

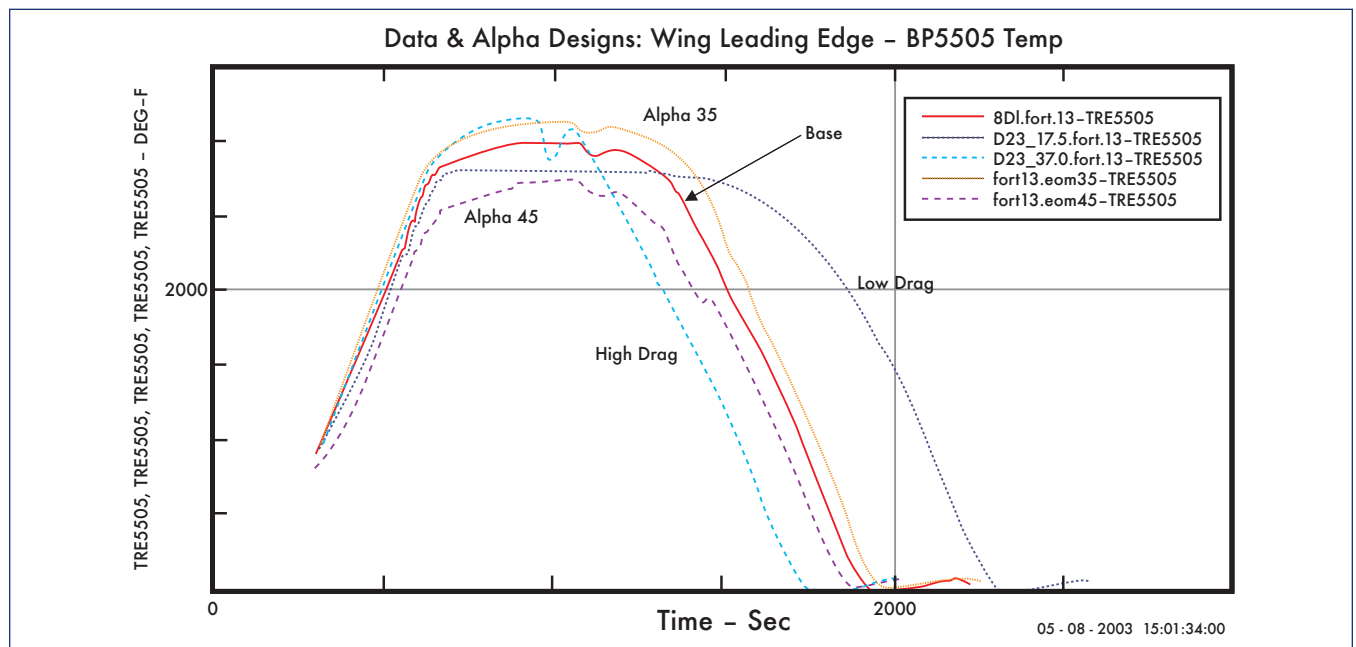
As previously stated, the team does not believe that an accurate thermal analysis can be performed to determine the effectiveness of any repair option. Rather, this is the best option relative to the other candidates, and it is possible that the combination of the repair, coldsoaking the wing, deorbiting from the minimum perigee, jettisoning available cargo bay hardware, and flying a 45 degree angle of attack could potentially provide enough relief to reach an acceptable bailout altitude. Limited thermal analysis was done on the option,

Figure 12. Relative Wing Leading Edge Temperature (No Boundary layer trip).

which assumed a flat plate of metal behind a flat plate of ice, behind a layer of AFRSI. The results while inconclusive, do not indicate this option was likely to succeed. However, the team believes it is sufficient to say that this would have been the best option to try, given the limited time and materials.

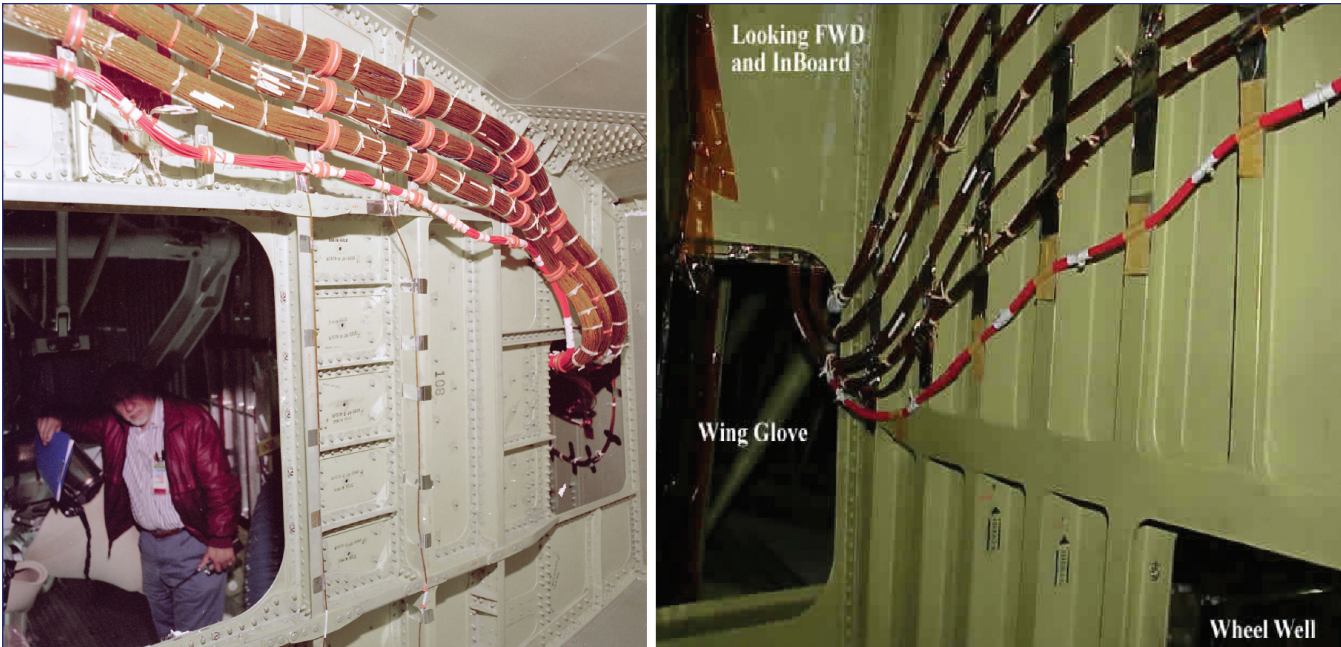
Figure 1.1.3. Wire Bundle Comparison.

There were wiring variations between the first Orbiter (OV-102) and subsequent vehicles. The wiring routed through the wing cavities outboard of the main landing gear wheel well wall of OV-102 were gathered in four bundles, while the wiring in other Orbiters was secured in seven bundles. (See Figure 1.1.3) This variation resulted from design changes to the wire bundle securing method. Clamps were used on OV-102, and metalized tape (MBO 135-050) straps were used on the remaining vehicles. Although effective, metalized tape is incapable of securing a bundle containing a large quantity of wires as configured in OV-102, hence the increased number of smaller bundles in subsequent Orbiters. Nearly 90 percent of wires routed through OV-102’s left wing forward of the main landing gear belonged either to systems gathering thermal, strain load, acoustic and other data for the Orbiter Experiment (OEX) instrumentation package (similar to the Modular Auxiliary Data System – MADS – on other Orbiters) or to disconnected systems. OEX data was recorded on magnetic tape that was downloaded after landing and not relayed via telemetry. The typical wire harness routing passes within 8-10 inches of the forward wing spar at the forward corner pass-through, immediately aft of the Reinforced Carbon-Carbon (RCC) panel 6. All temperature sensors in the main landing gear well were located within a four-foot radius with the main landing gear retracted. Fifty percent of all electrical drawings for the Orbiter fleet were unique to OV-102, due to first-production unit anomalies/changes, and additional wiring for the Developmental Flight Instrumentation (DFI, later OEX).

Analysis of telemetered data from 14 of *Columbia*’s left wing sensors (hydraulic line/wing skin/wheel temperatures, tire pressure, and landing gear downlock position indication) in the final minutes prior to the Orbiter’s breakup provided failure signatures supporting the leading causal scenario of left wing thermal intrusion, as opposed to a catastrophic failure (extensive arc tracking) of Kapton wiring. Actual NASA testing in the months following the *Columbia* tragedy, during which wiring bundles were subjected to intense heat (hot

oven, blowtorch, and arc jet), verified these failure signature analyses. Finally, extensive testing and analysis for years prior to STS-107 showed that, given the low voltages and low currents associated with the Orbiter's instrumentation system (such as those in the left wing), the probability of arc tracking is commensurately low.

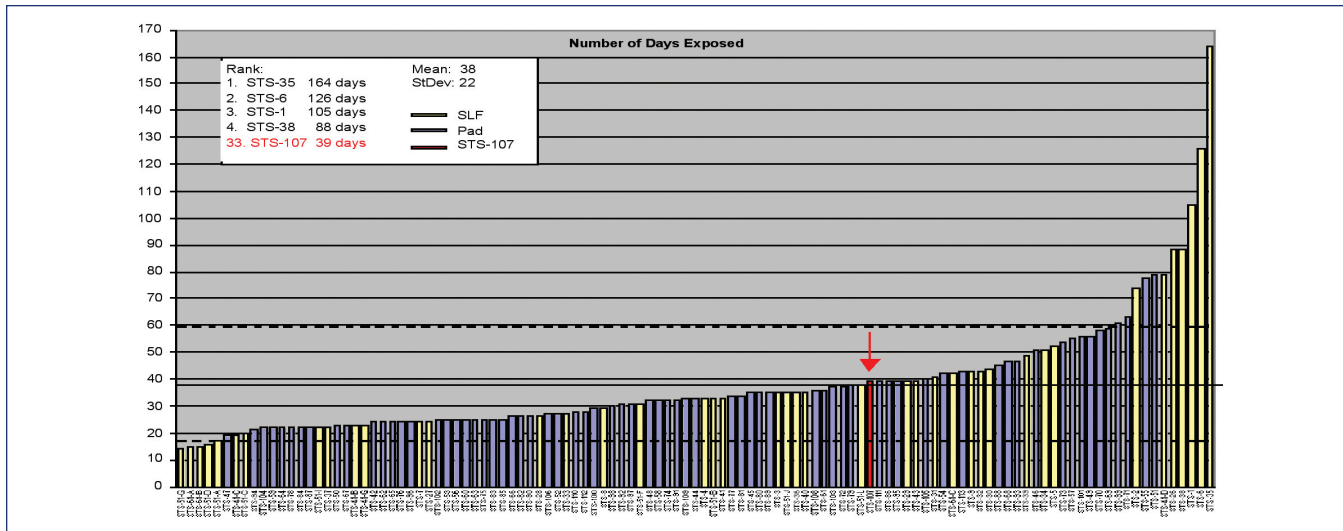
Figure 1.3.2. Exposure by Mission: red arrow depicts STS-107, STS-35 is at far right.

The 164-day exposure for STS-35 occurred over eight months and four launch attempts, from April to December 1990, and illustrates the complexities associated with launching Shuttles. OV-102's initial rollout was on April 22; a Freon system repair added 14 days, but the launch was scrubbed on May 30 due to a Main Propulsion System (MPS) liquid hydrogen (LH2) leak. After troubleshooting and maintenance preparations, OV-102 was rolled back to the VAB on June 12. It was rolled out a second time on August 9, but required a 6-day stand down for telemetry repair. Its September 1 launch was scrubbed on 5 September due to another hydrogen leak. Following maintenance at the pad, the next launch attempt was scrubbed on September 18, due to another MPS LH2 leak. After further troubleshooting and maintenance preps, it was rolled back on October 9. Rollout next occurred on October 14, followed by special LH2 tanking tests for two additional days; however, Auxiliary Power Unit water valve problems and follow-on maintenance and servicing took another 16 days. OV-102 finally launched successfully on December 2. It should be noted that STS-35 is an outlier when compared with all other Shuttle launches. Figure 1.3.2 shows a comparison of exposure time by mission.

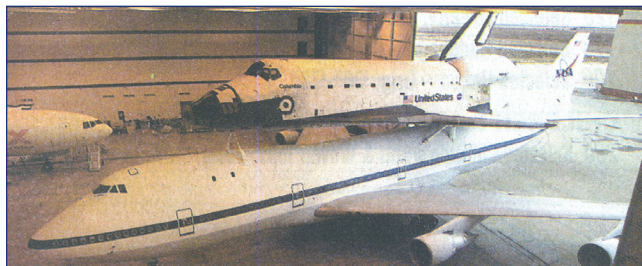
Figure 1.3.4. An Orbiter and SCA partially inside a hangar in Palmdale.

Aircraft (SCA) for a ferry flight to Palmdale, California, it was caught in the rain; 128 pounds/16 gallons of water were removed after its arrival at Palmdale. In February 01, after OV-102 had been mated to the SCA for its return from Palmdale to KSC, it was again caught in a downpour. The mated Orbiter/SCA were partially sheltered in a hangar but, due to

vertical clearance limits, the tails of both craft remained exposed (See Figure 1.3.4). After arrival at KSC, 112 pounds/14 gallons of water were removed. The same February 2001 rainstorm at Palmdale also affected OV-104, which had recently landed (February 20/STS-98) and was being prepared for its ferry flight to KSC. OV-104’s “aft fuselage under bay 6 [was] full of standing water” and water was “five inches deep along [the] back of 1307 bulkhead;” 1,600 pounds (200 gallons) were removed after its arrival at KSC.

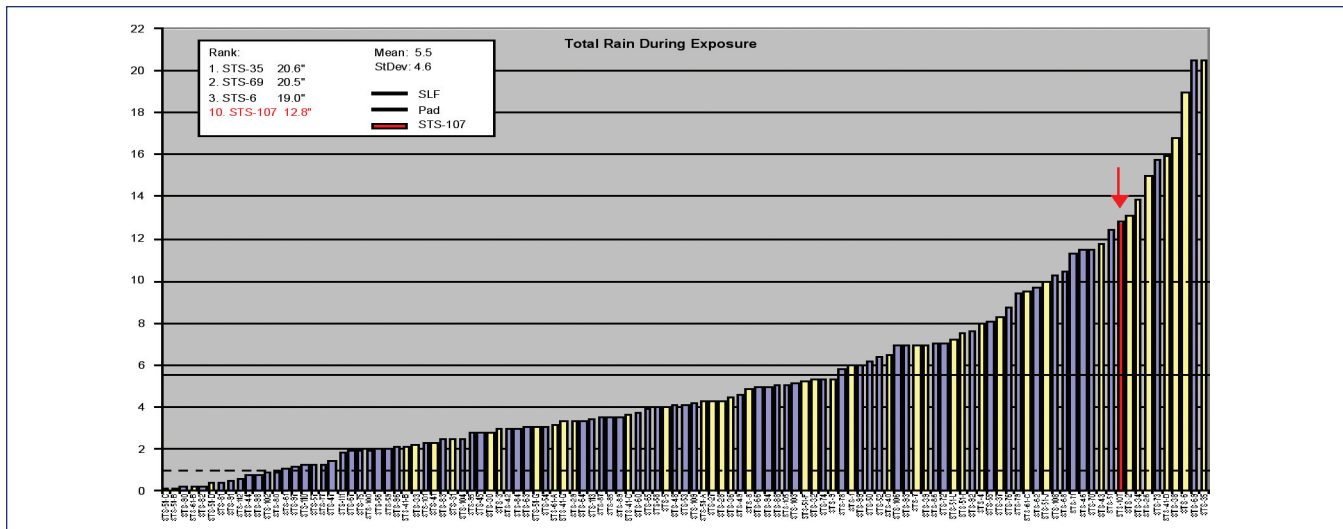
Figure 1.3.5. Total rain exposure by launch (arrow denotes STS-107; STS-35 at far right).

Environmental exposure constraints are clearly outlined in RTOMI S0018.100, Adverse Environmental and Lightning Monitoring at LC39. This publication includes guidance on actions to minimize exposure to rain, hail, winds, freezing temperatures, or tornados. In spite of this existing guidance, circumstances such as those related above, both on the launch pad and during ferry operations, contribute to more exposure than is desirable. Figure 1.3.5 shows rain exposure data by launch, with STS-35 again being the worst case.

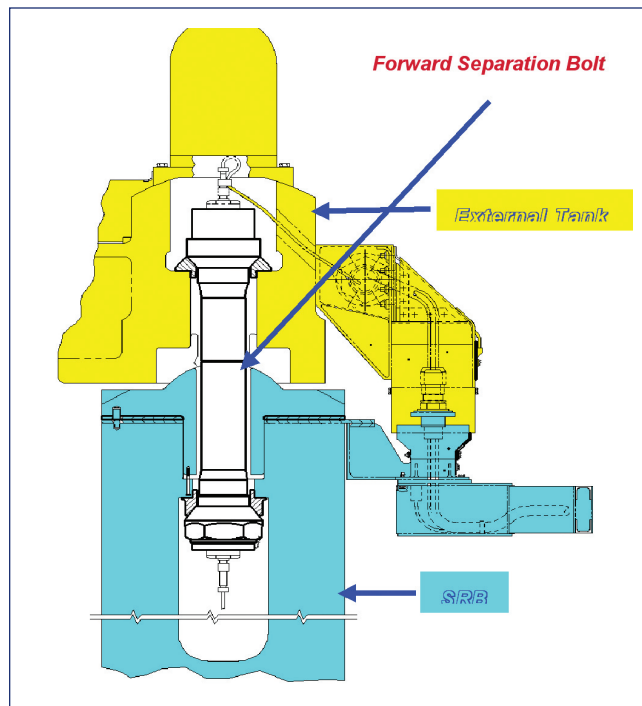
Figure 1.5.1. Diagram of a bolt catcher.

The External Tank (ET) is attached to the SRB Forward Skirt with one pyrotechnic separation bolt. At SRB separation, this bolt is pyrotechnically separated into two halves. On the ET side of the interface, a "bolt catcher" (see Figure 1.5.1) is mounted to catch the upper half of the fired separation bolt following NASA Standard Initiator (NSI) firing. The bolt catcher consists of a domed aluminum cover containing an aluminum honeycomb matrix to deform and absorb the bolt's energy as it is "caught." The bolt catcher is designed to prevent liberated objects from hitting the Orbiter after firing.

The configuration of the current bolt catcher flight hardware differs significantly from the original qualification test configuration.<sup>6</sup> First, the attachment of the bolt catcher used in the original test fixture was qualified using through-bolts into a metal that was dissimilar to the ET/SRB attach point. The mounting method used for flight hardware (including STS-107) is bolts threaded into inserts. Second, original catcher testing did not have the SLA applied. Third, the original design load expected during bolt separation was determined to be 29,800 pounds in the 1979 timeframe. During initial tests the bolt catcher failed at the weld. The reason for this failure was determined to be overly rigid honeycomb, which led to the redesign of the honeycomb to reduce its static pressure capability from 1400 to 1000 psi. Finally, during the original test, temperature and pressure data were not recorded for the bolt firing. Instead of conducting additional tests, the flight design configuration was accepted by analysis (of extrapolated test data and the redesign specifications) and similarity. Consequently, predictive failure analysis, in the absence of post-flight evidence for examination (the bolt catcher and upper half of the separation bolt remain with the external tank and are therefore lost on reentry), must also be

based on analysis of limited data from testing 24 years ago or a new round of testing in order to remove the bolt catcher from investigative consideration. The current bolt catcher design was certified on the basis of analysis and similarity after limited testing. A new round of testing is underway to support the investigation.

In the absence of physical evidence and adequate test data to measure bolt catcher performance against, it must be assumed that the bolt catcher could have played a role in damaging the left wing LESS of *Columbia*. Specifically, the dome could have catastrophically failed at the weld, SLA coating could have come off (in adequately large quantity to damage the shuttle), or a bolt/insert could have failed to hold. Review of radar imaging data reveals objects were liberated from the STS-107 stack at the time of SRB separation (approximately 126 seconds).<sup>7</sup> Much of this debris is from known sources aft of the Orbiter, and do not present a threat to the vehicle. However, the radar data has been inconclusive, to date, as to whether the bolt catcher could have been a part of the separation debris. Several other methods will be used to investigate the bolt catcher's potential as a source of damage to the LESS Thermal Protection System on *Columbia*. First, review of existing, but limited, data from STS-107. Second, a new set of tests of the as-flown configuration is being performed to better characterize the bolt catcher performance parameters.

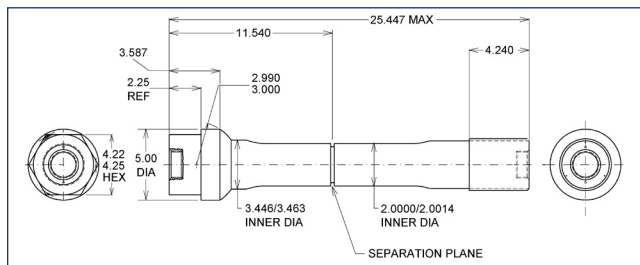
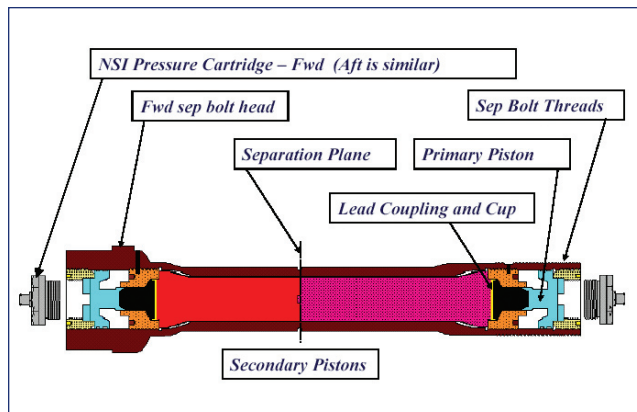
USA replaced Hi-Shear as the prime contractor for separation bolts in May 2000. Certification of new bolts may have

been done without adequate NDI (magnetic particle) of the internal bore. (See Figures 1.6.1 and 1.6.2.)

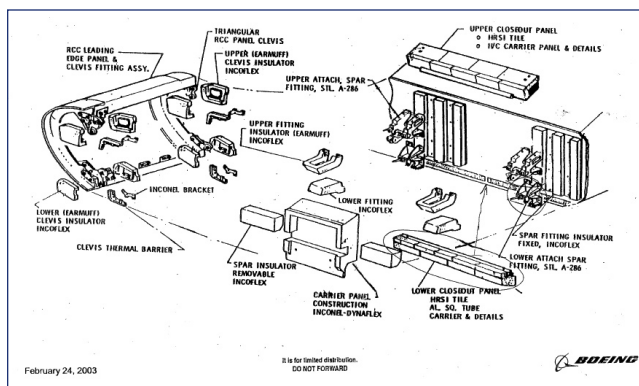
Figure 1.7.1. Details of the wing Leading Edge Support System.

The Orbiter’s wing leading edges are subjected to thermal and aerodynamic stresses during reentry. Proper inspection and maintenance of the LESS components, including attaching hardware, are essential to the system performing as designed/intended. The LESS consists of: 22 Reinforced Carbon-Carbon (RCC) panels on each wing; 44 carrier panels (22 on each wing’s upper and lower surface); numerous other components (such as spar insulators, clevis insulators, spanner beam insulators, spar attach fittings, and brackets); and hardware (including bolts, pins, and sleeves). See Figure 1.7.1 for details.

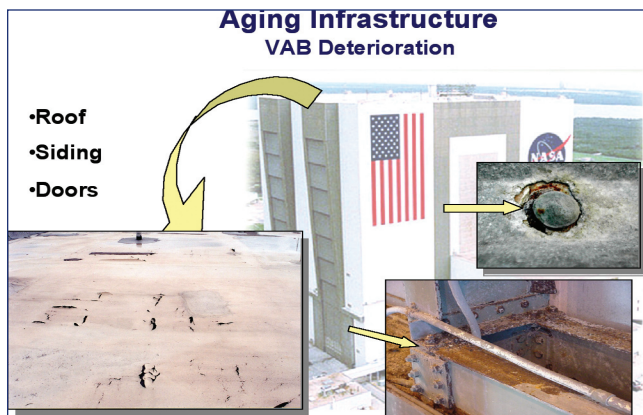
Figure 3.2.2. Vehicle Assembly Building.

Example 2: The Vehicle Assembly Building (VAB) is the only facility of its kind in the world and a critical element of the Space Shuttle Program. It is where the Orbiter, External Tank, and Solid Rocket Boosters are mated and demated. It was constructed in the 1960s for Saturn V buildup. Like the launch pads, it serves as an example of both the problems faced by the SSP and NASA in maintaining aging infrastructure, as well as ongoing efforts to meet these challenges. The 5-acres of roof from its original 1964 construction are comprised of 6 inches of foam and vinyl layers added over the concrete slab through the years. Regular repairs are accomplished on the roof’s outer surface using sealant and asphalt paper. Roof leaks over the years have led to deterioration (spalling) of the concrete ceiling on the interior of the roof slab, with concrete fragments occasionally falling loose from a height of over 500 feet. This FOD hazard has been mitigated by the installation of a subdeck five feet below the ceiling to catch debris and safety nets at lower levels. A comprehensive repair effort has been funded for FY2004 to remove all roof outer layers down to the original slab and recover with sloped roofing boards and a synthetic membrane, as well as repairs to the interior concrete ceiling. Significant portions of the VAB’s 1.1 million square feet of siding also require repair due to corrosion; this is especially critical due exposure of this vast surface area to hurricane-force

winds; repairs are scheduled for FY2006. Several of the VAB’s massive multi-panel doors require extensive corrosion repair. The structure’s overhead bridge cranes are a mix of 1960s and 1990s vintage equipment, but are effectively sustained through regular maintenance due to their critical role in mating/demating operations.

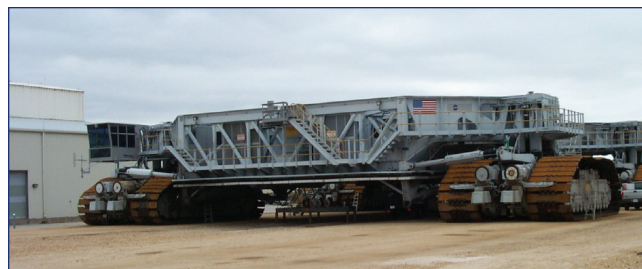
Figure 3.2.3. Crawler Transporter (CT).

Example 3: Two of the Shuttle Program’s most critical pieces of equipment, the Crawler/Transporter (CT) systems, pose a significant technical sustainment challenge. (See Figure 3.2.3) These unique vehicles are necessary to move the stacked Space Shuttle to and from the launch pads. During hurricane season – roughly half of the year starting in early summer – both must be up and running in the event Shuttles must be moved from the pad back to the VAB for “safe haven.” This precludes extensive maintenance during this entire period. Built in 1965, the CTs each average over 1,700 miles. They have received incremental capability upgrades over the years, including a laser docking system, computerized control stations, and replacement control cabs. The massive hydraulic actuators used to jack, level, and carry the Mobile Launch Platform (MLP) and Shuttle Stack were recently refurbished for the first time. Obsolescence of purpose-built components poses a major challenge, and will continue to need correction through upgrades. Corrosion is a significant problem due to no sheltered storage, and maintenance is frequently suspended due to severe weather. As support costs rise due to aging and obsolescence, it was noted that managers track resources expended (costs of modifications/parts/labor) over time, but do not do so per unit of output (miles driven or operating hours). While costs over time will always increase, a more valuable metric is cost per unit of output, as this can be used for analysis and trending and can help in more clearly comparing the cost/benefit tradeoffs of inaction, modification, or replacement.

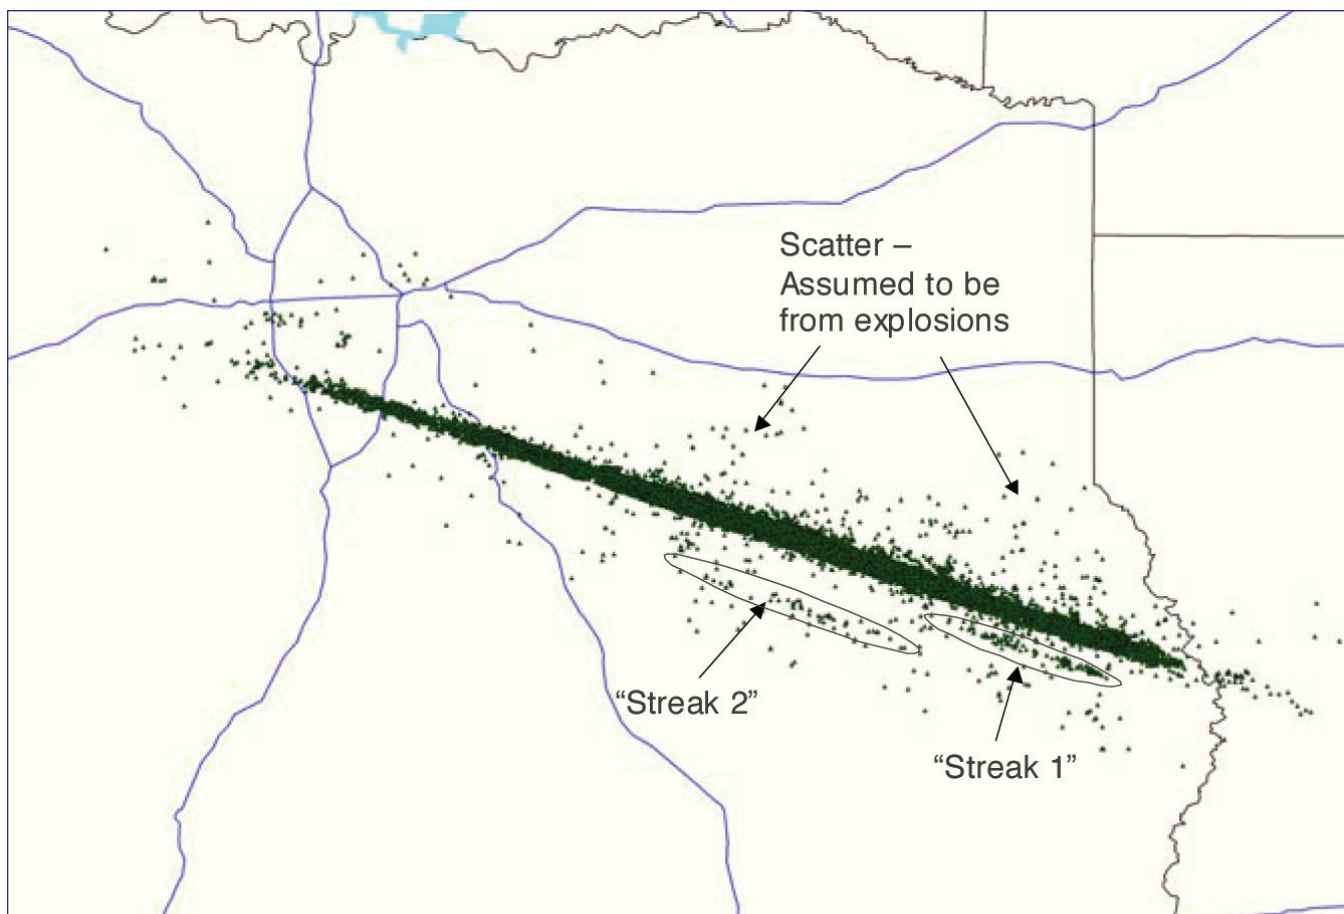
Figure 2-1. Locations of Recovered Debris.

Figure 2-1 contains a map showing where the debris was recovered. A primary data grouping, Group 1, was used to account for the main debris field. Two secondary debris groups, Group 2 and Group 3 (identified as Streak 1 and Streak 2 in the figure) were created with separately fitted trajectories. Group 4 accounted for the widely scattered debris recovered outside of Group 1. The scatter observed in Group 4 debris seemed beyond the range that could be explained by lift, and thus it was assumed that a large velocity impulse of unknown source (an explosion?) was responsible. A standard deviation of 333 ft/sec in the velocity impulse produced a scatter that proved to be the best fit to the gathered Group 4 debris. There is no current explanation for the high veloci-

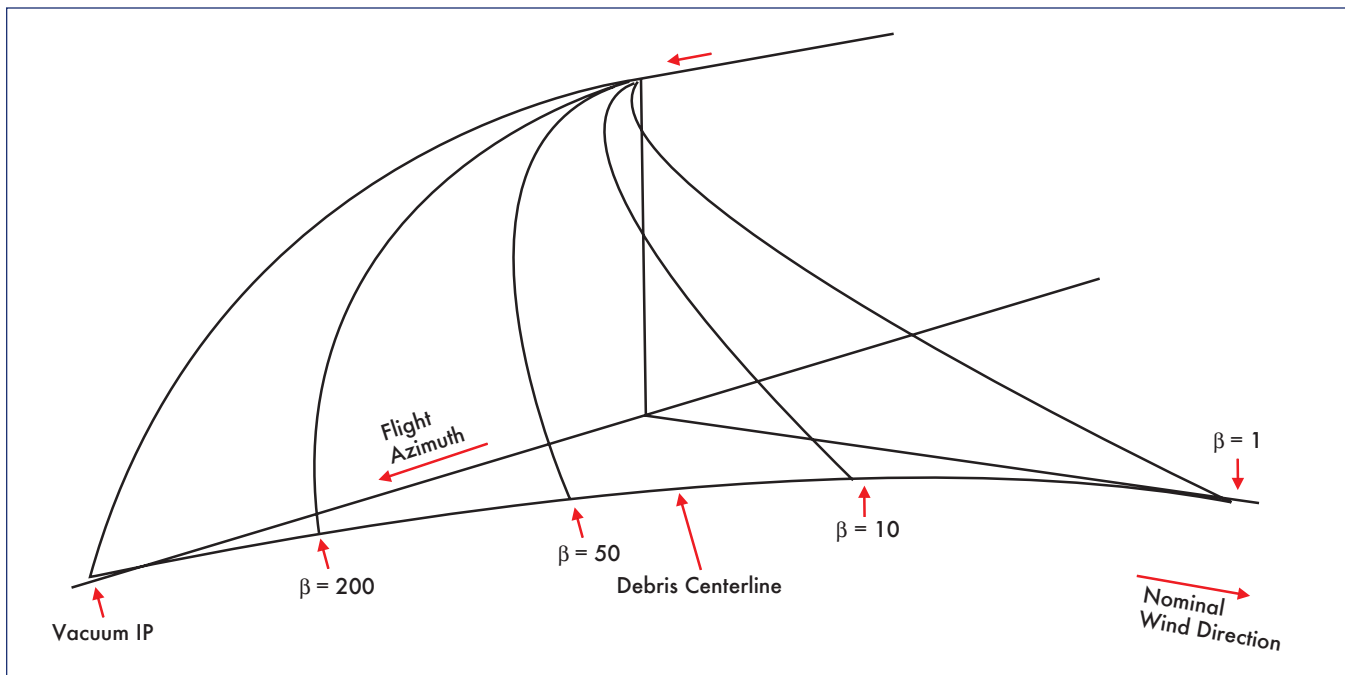
Figure 2-3. The Influence of the Ballistic Coefficient,  $\beta$ , and Wind upon Debris Impact Points.

Wind is the other major factor affecting the fall of the debris. The effect, without explanation here, is proportional to  $1/\sqrt{\beta}$ . Thus, in summary, debris with smaller ballistic coefficients will fall closer to their initiation point, in the absence of winds, but will be moved more due to the wind (and in the direction of the wind). This is demonstrated in Figure 2-3.

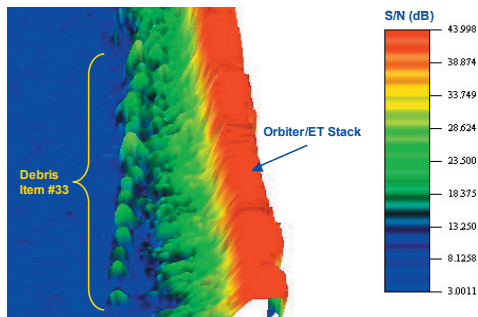
Fig. 8. Item #33 RTI Contour Plot

Debris Item #33 (Fig. 8) is first observed at T+128 s, one second after the SRB separation command was issued. The item has a range separation rate of 520 m/s (with a 120 m/s uncertainty), and is visible for two seconds. The signal return of this item is significantly stronger than any of the debris detected by any radar from SRB separation through the remainder of the mission, indicating a larger or a more highly reflective item than any of the other detected debris items. An RTI contour plot depicting debris Item #33 separating from the Orbiter/ET stack is shown in Fig. 8.

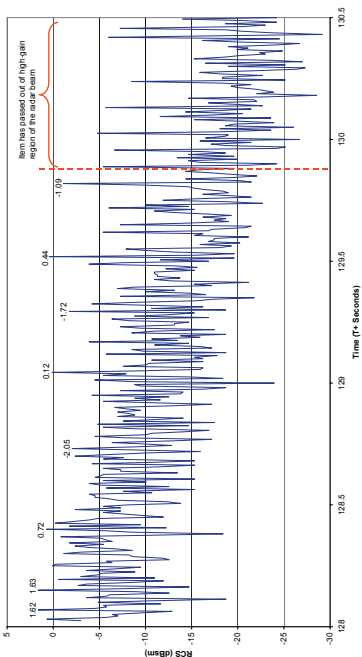
Fig. 9. Item #33 Spectral Plot

Item #33 radar signatures are shown in Fig. 9. Analysis of the peaks in this figure suggests a tumble rate of at least 310 degrees per second. At this rate, the 160-PRF of the observing radar limits the speculars to a maximum resolution of 1 point for every 2 degrees. The low resolution of the signature data limits the information that can be extracted from this data. Comparison of the radar spectral with the Bolt Catcher RCS data gathered at the AFRL (Fig. 4 and Fig. 5) does not eliminate Item #33 as a candidate for a Bolt Catcher, but the low resolution of the signature prevents positive identification. Although the radar signature analysis to determine the shape is inconclusive, the signature peak magnitudes provide information of the maximum RCS of the item, which can be translated into approximate sizes for selected shapes.
