COLUMBIA

ACCIDENT INVESTIGATION

**REPORT VOLUME IV** OCTOBER 2003

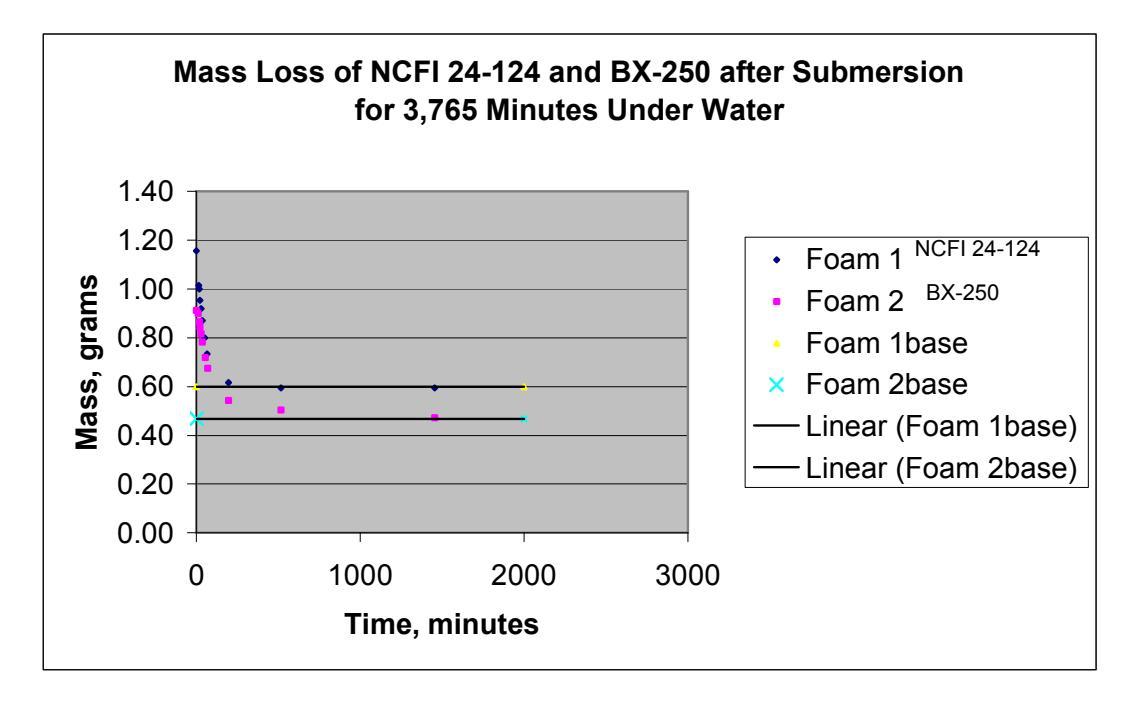
- Procedure:
      - NCFI 24-124 and BX-250 as two small, 1-inch-cube specimens referred to as Foam1 (NCFI 24-124) and Foam 2 (BX-250). Water-mass gain was measured when these specimens were submerged 2 ½ inches below distilled, de-aired water surfaces for 3,765 minutes. See Figure 1.

**Figure 1.** Plot of mass changes for NCFI 24-124 and BX-250 following submersion under 2.5 inches of distilled water for 3,765 minutes and blotting excess surface water before starting measurements.

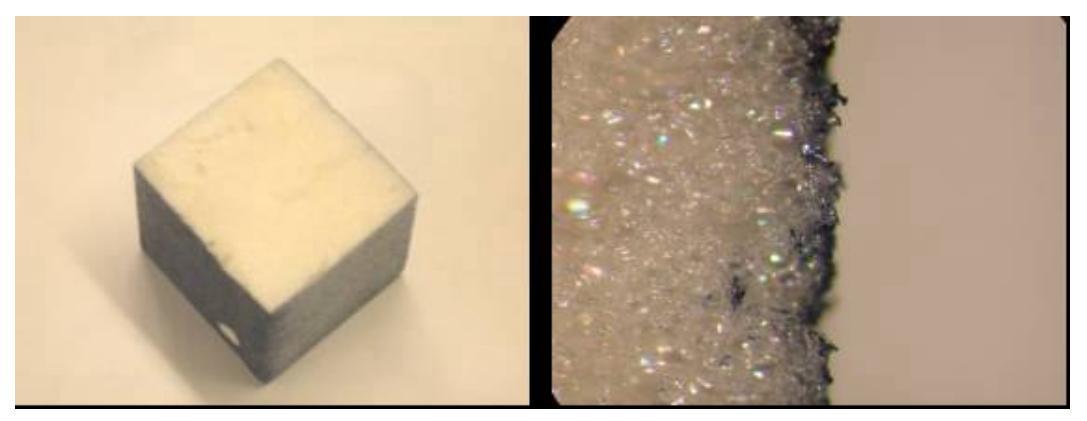
- Sectioning of foam after submersion indicated only absorption in thin layer around the machined foam. This layer characterized to be less than or equivalent to broken cells on surface. See Figure 2.

**Figure 2.** (a) Shows blue dye decorating the surface of a BX-250 foam cube that was submerged 26.5 hours then sectioned, revealing the interior. (b) Shows a magnified image at the sectioned surface.

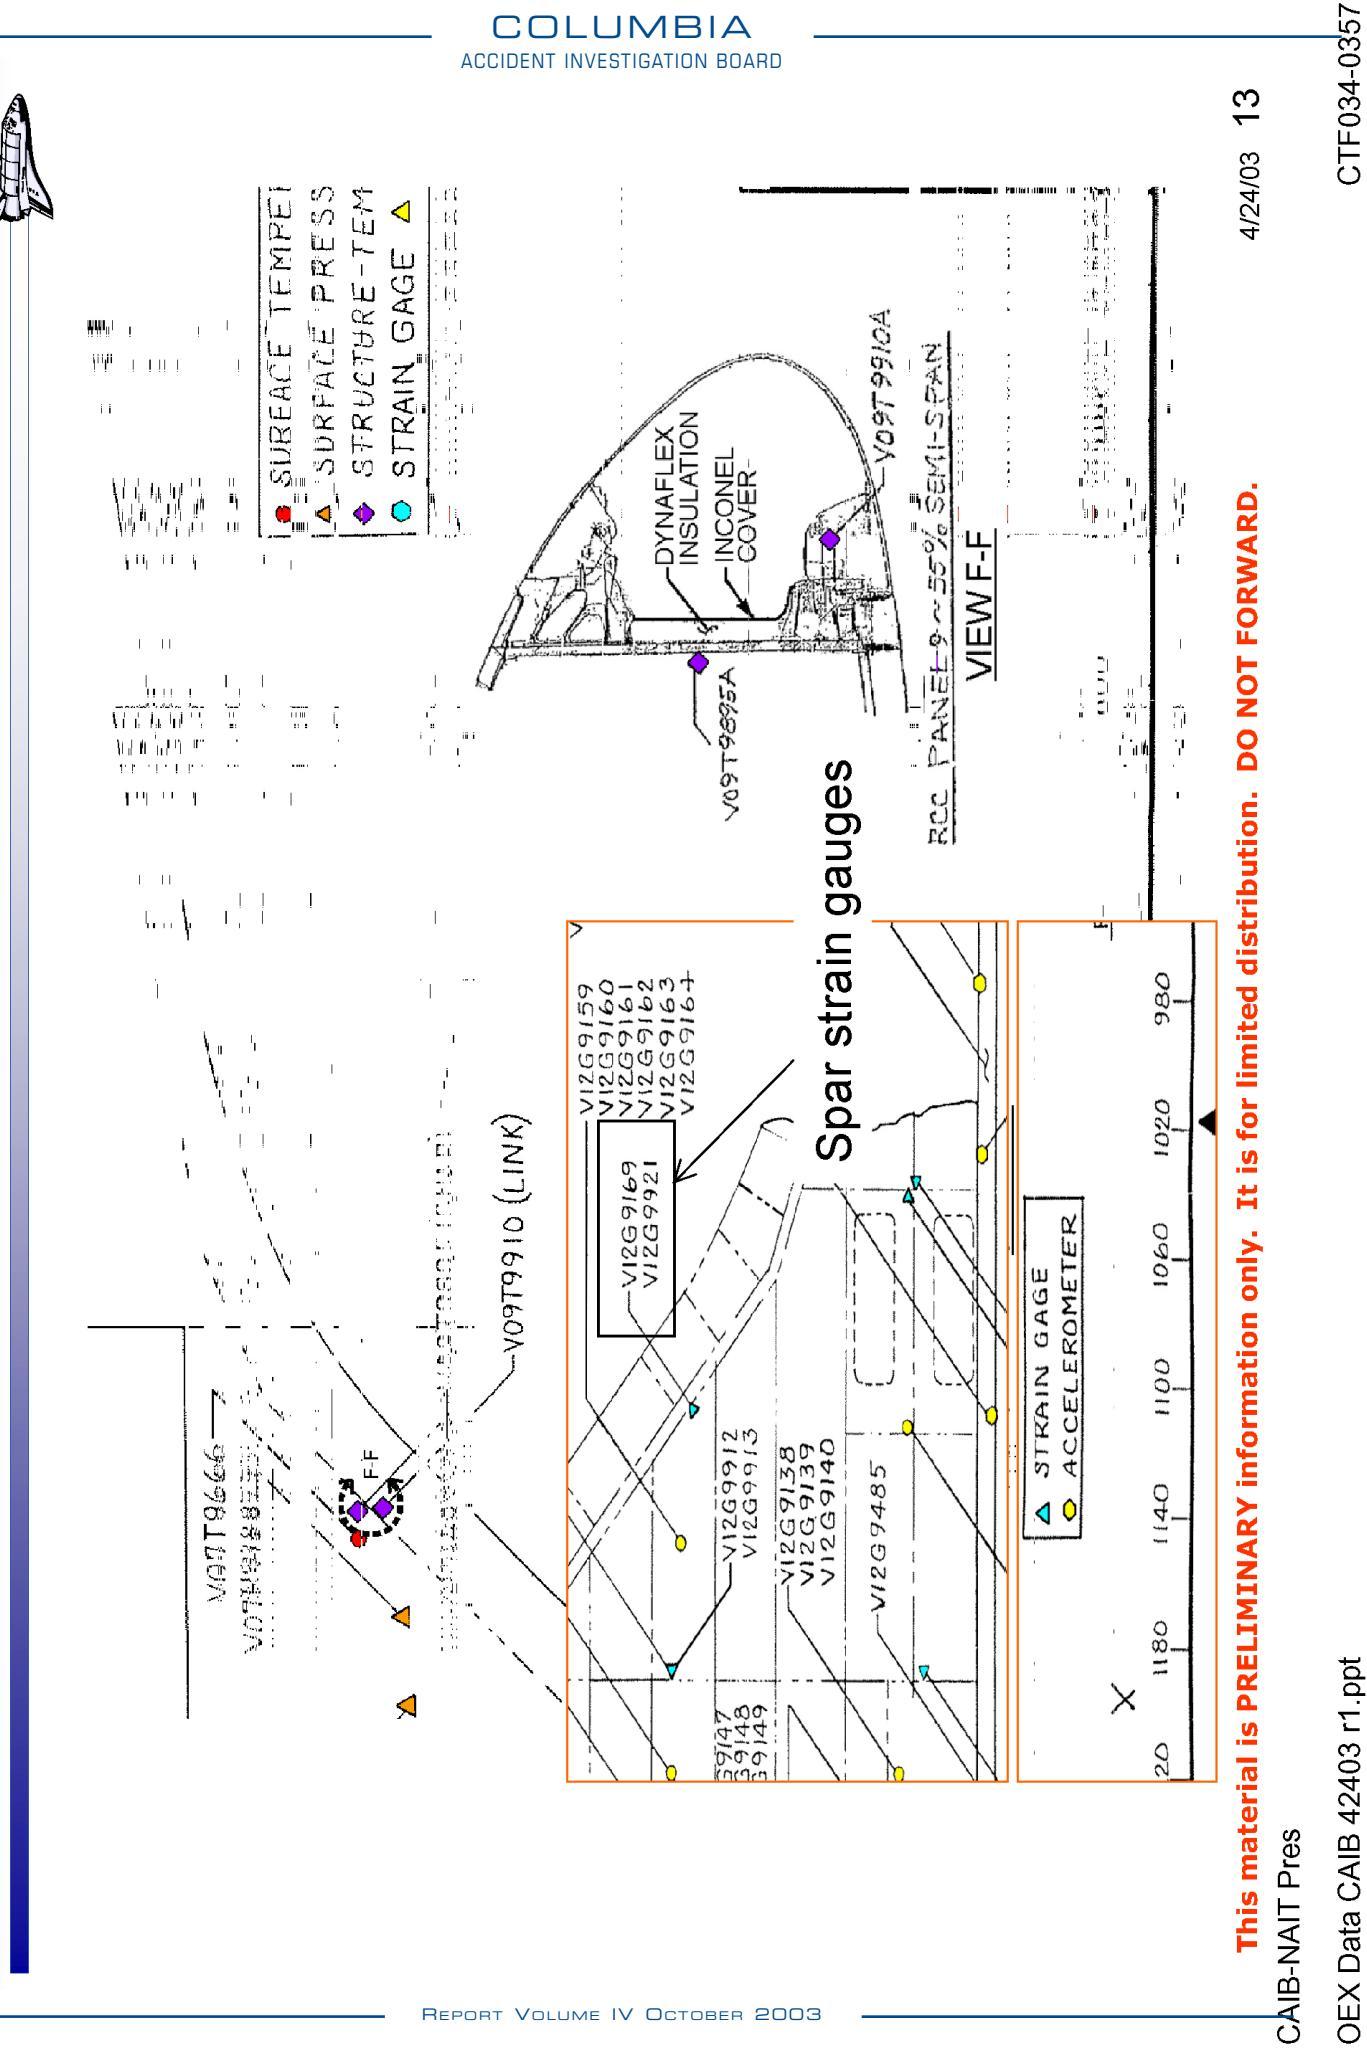
RCC Panel 9 Spar Temperature Data - Ascent	<ul> <li>Reviewed Previous OV-102 Ascent Data</li> <li>STS-107 has earliest warming indication at 310 seconds</li> <li>STS-107 has only occurrence of a 3 bit (7.5°F) warming during ascent, 67°F initial temp.</li> <li>STS-94, a summer launch with 82°F initial temp, had less than a 2 bit rise</li> <li>No spar temperature sensor on other vehicles</li> </ul>	<b>*RELIMINARY information only.</b> It is for limited distribution. DO NOT FORWARD.       4/24/03       12
RCC Panel 9 S	<ul> <li>Reviewed Previo</li> <li>- STS-107 has es - STS-107 has es initial temp.</li> <li>- STS-94, a st rise</li> </ul>	This material is PRELIMINARY information on CAIB-NAIT Pres

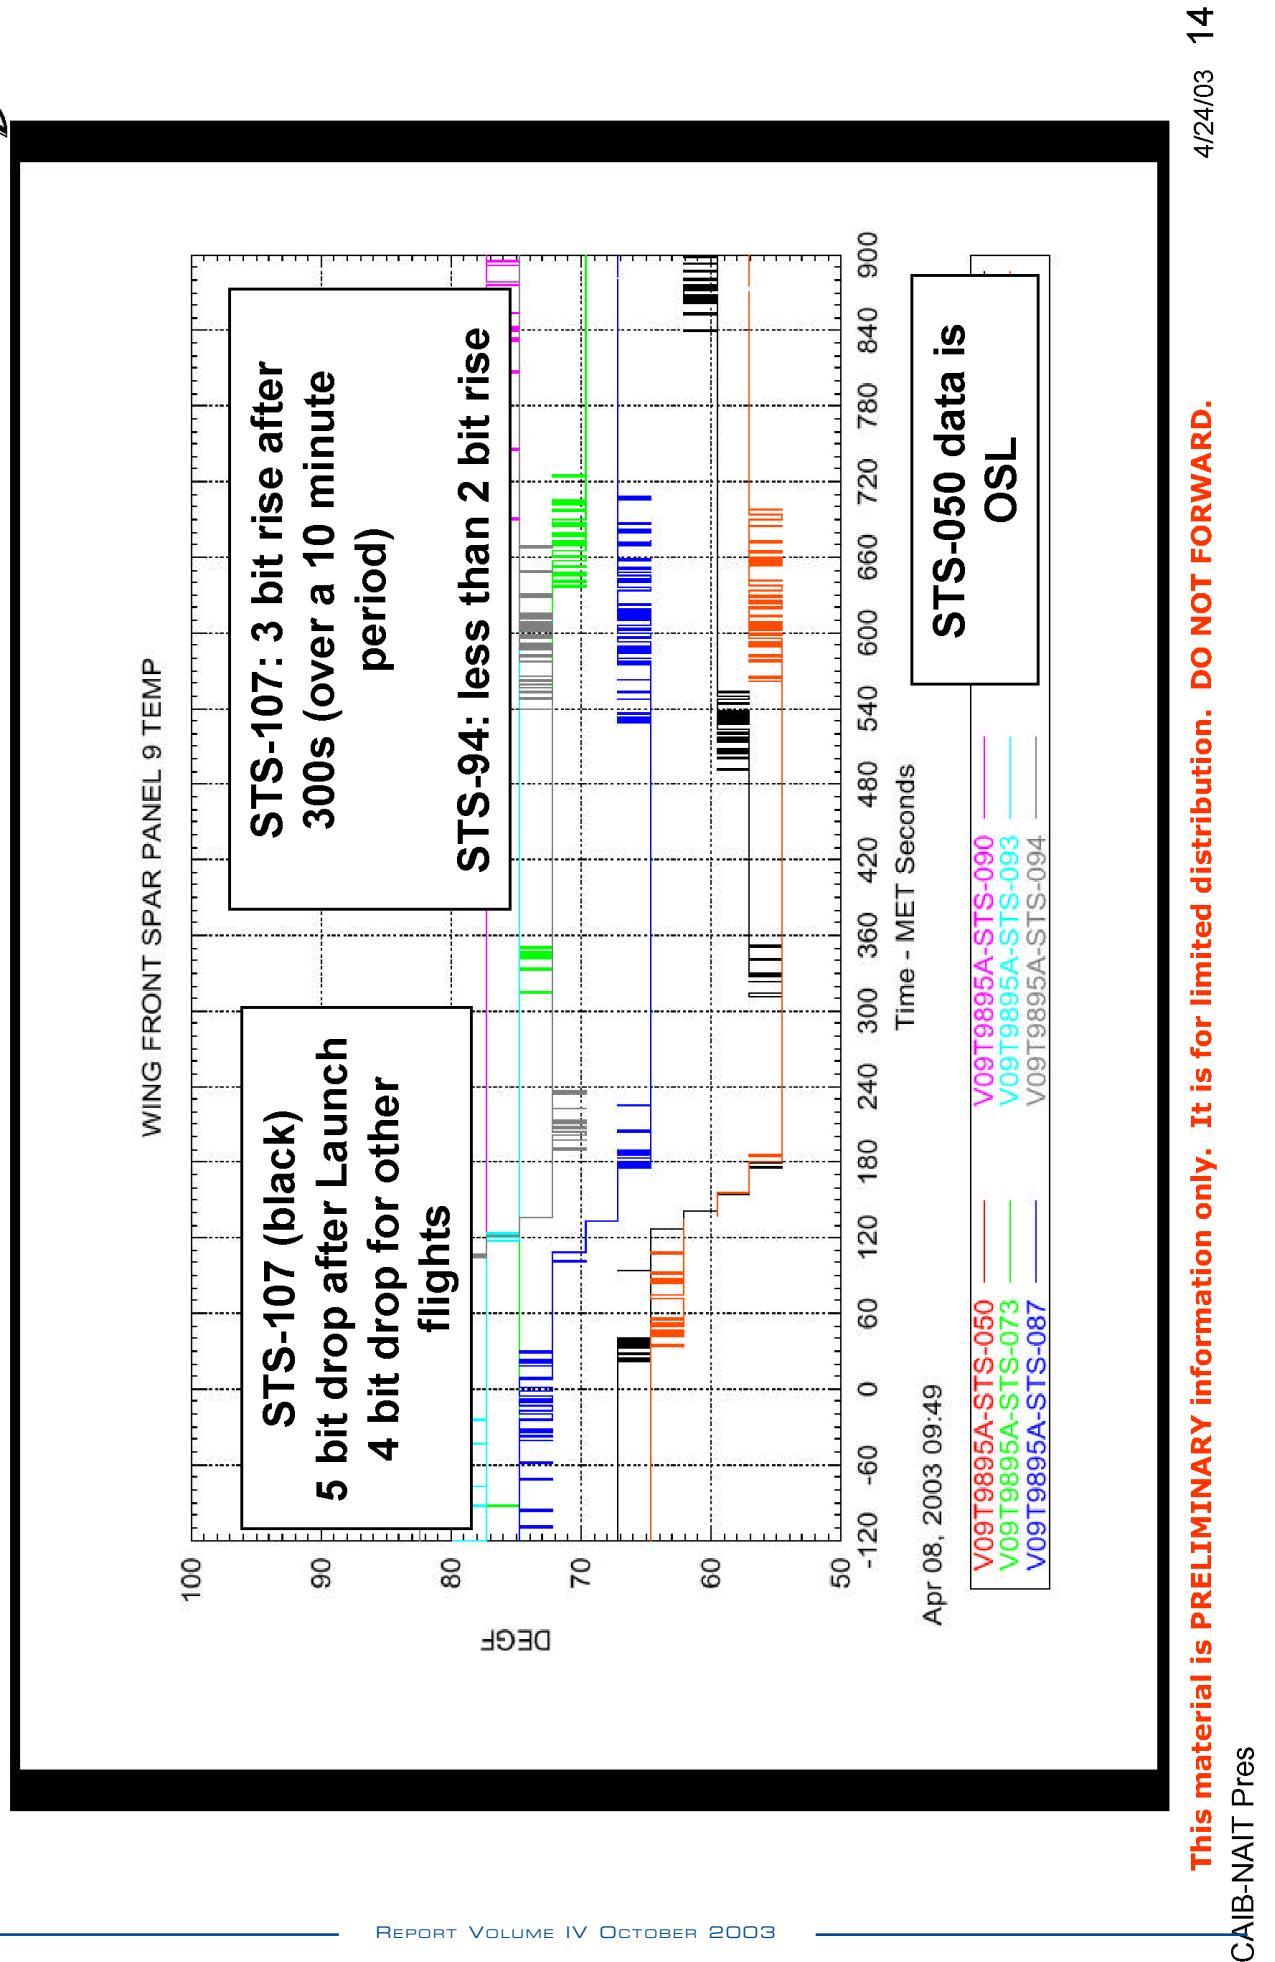
**RCC Panel 9 Sensor Locations**

900 seconds RCC Panel 9 Spar Temp V09T9895a	2/0 3/0 3/0 1/0 1/0 4/1 1/0 1/0 4/1 5/3 (67 degF initial temp)	
OV-102 Columbia	STS-73 10/20/95 STS-75 02/22/96 STS-78 06/20/96 STS-80 11/19/96 STS-83 04/04/97 STS-94 07/01/97 STS-94 07/01/97 STS-94 07/01/97 STS-93 07/01/97 STS-90 04/17/98 STS-90 04/17/98 STS-90 04/17/98 STS-90 04/17/98 STS-109 03/01/02 STS-107 01/16/03

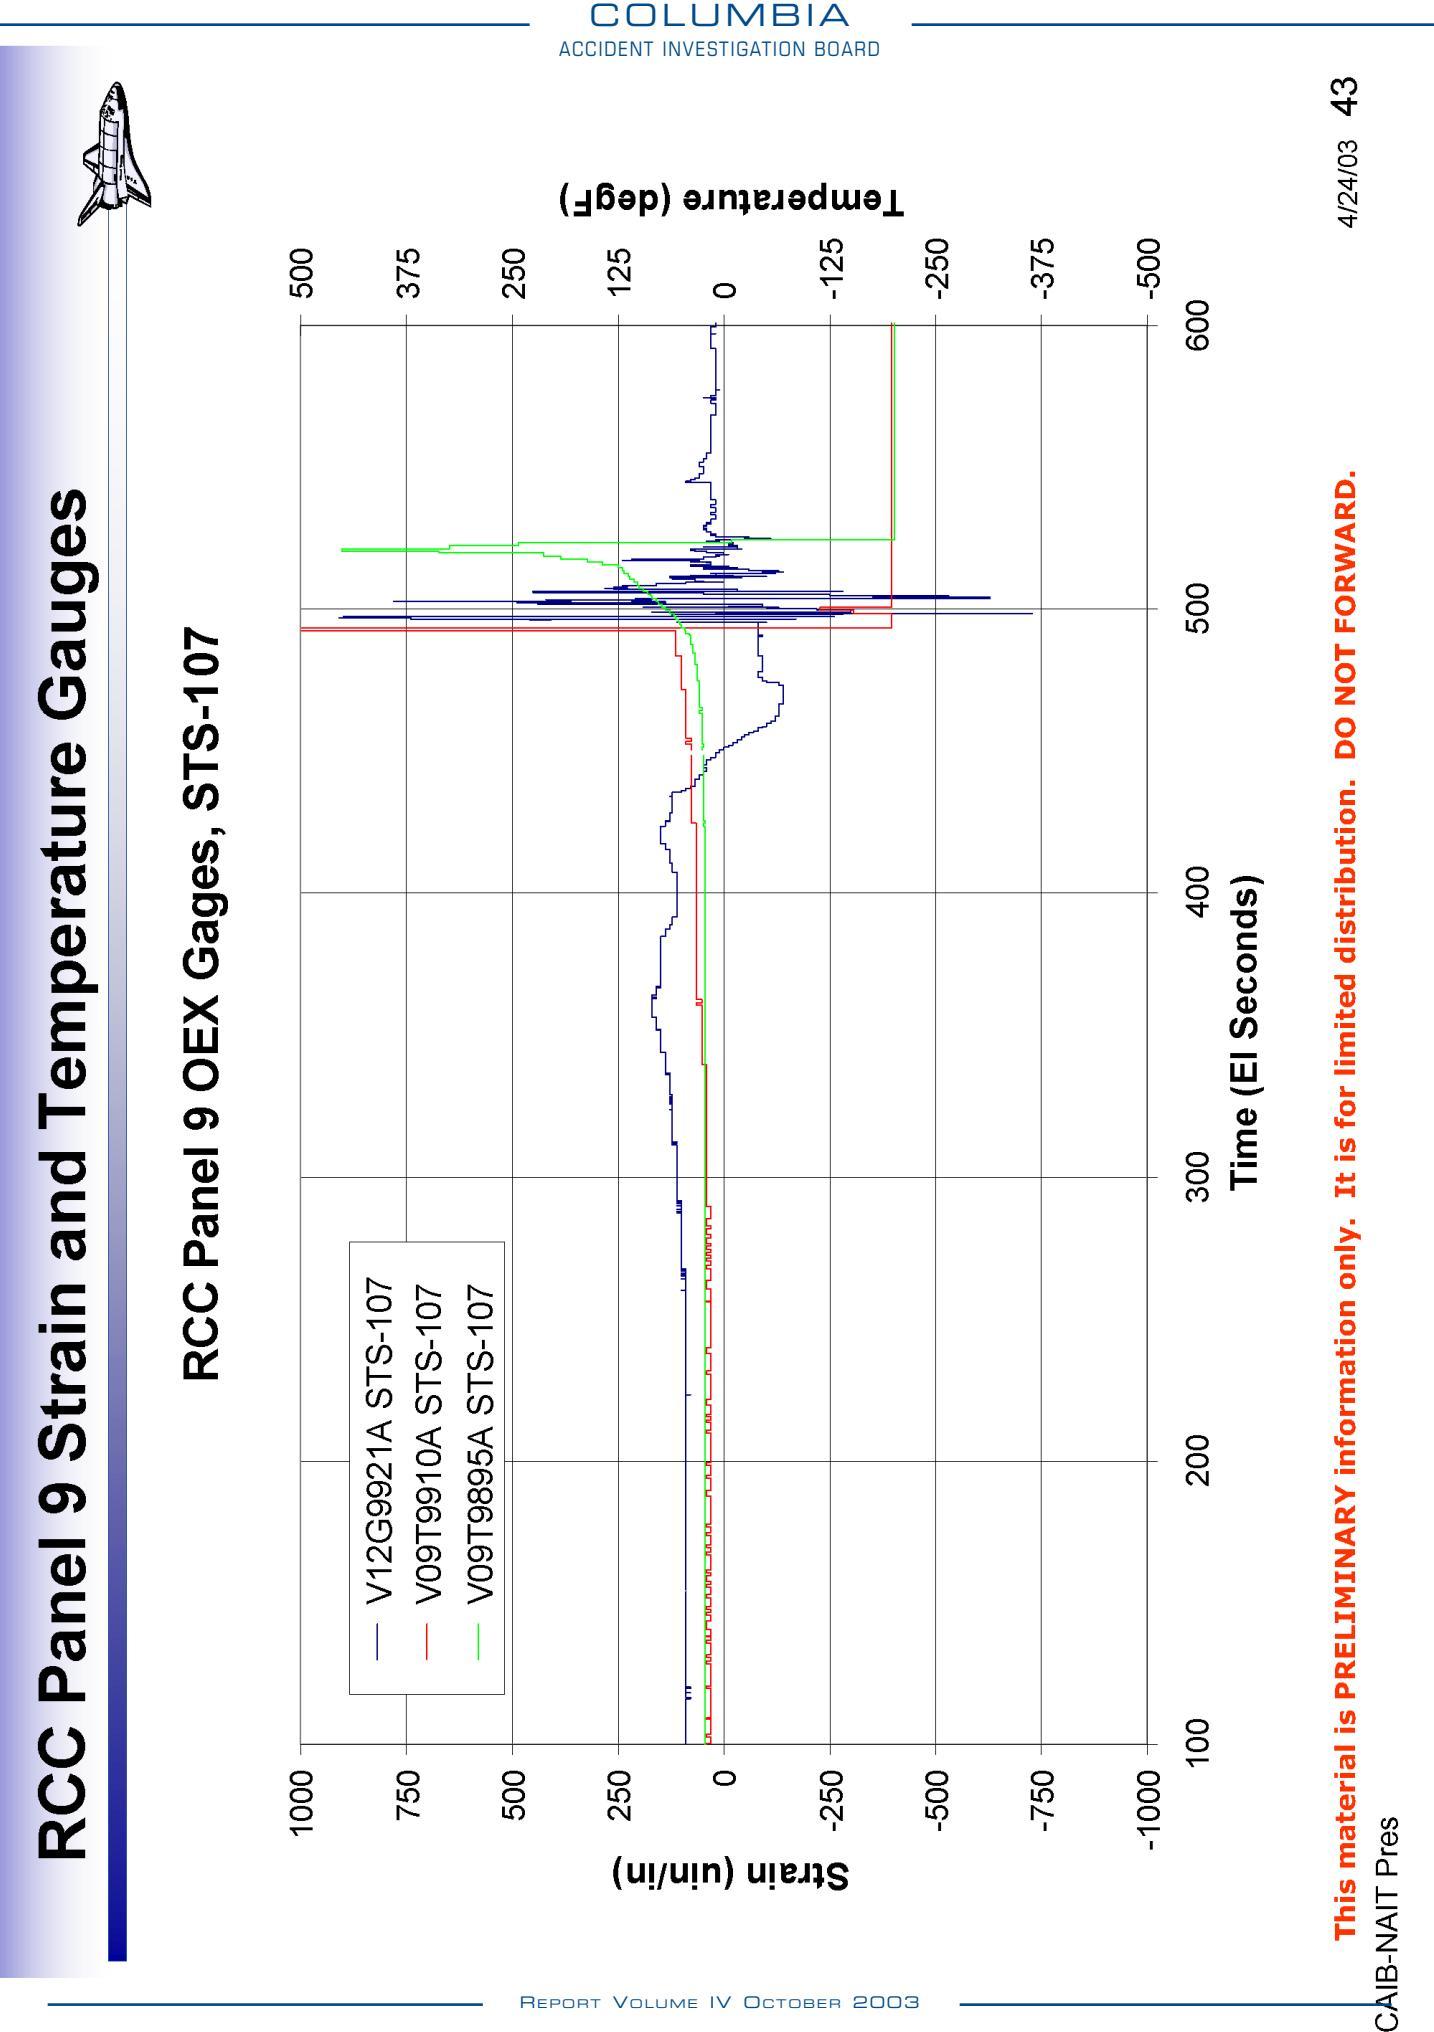
- Three MADS gauges of particular interest near RCC Panel 9 on the Left Wing
- One Strain gauge, Two Temperature gauges
- V12G9921A, V09T9910A, & V09T9895A
- Data for these three gauges was plotted together
- Indicates failure at approximately the same time for V12G9921A and V09T9910A (~EI +495sec)
  - Later failure for V09T9895A (~EI +515sec)

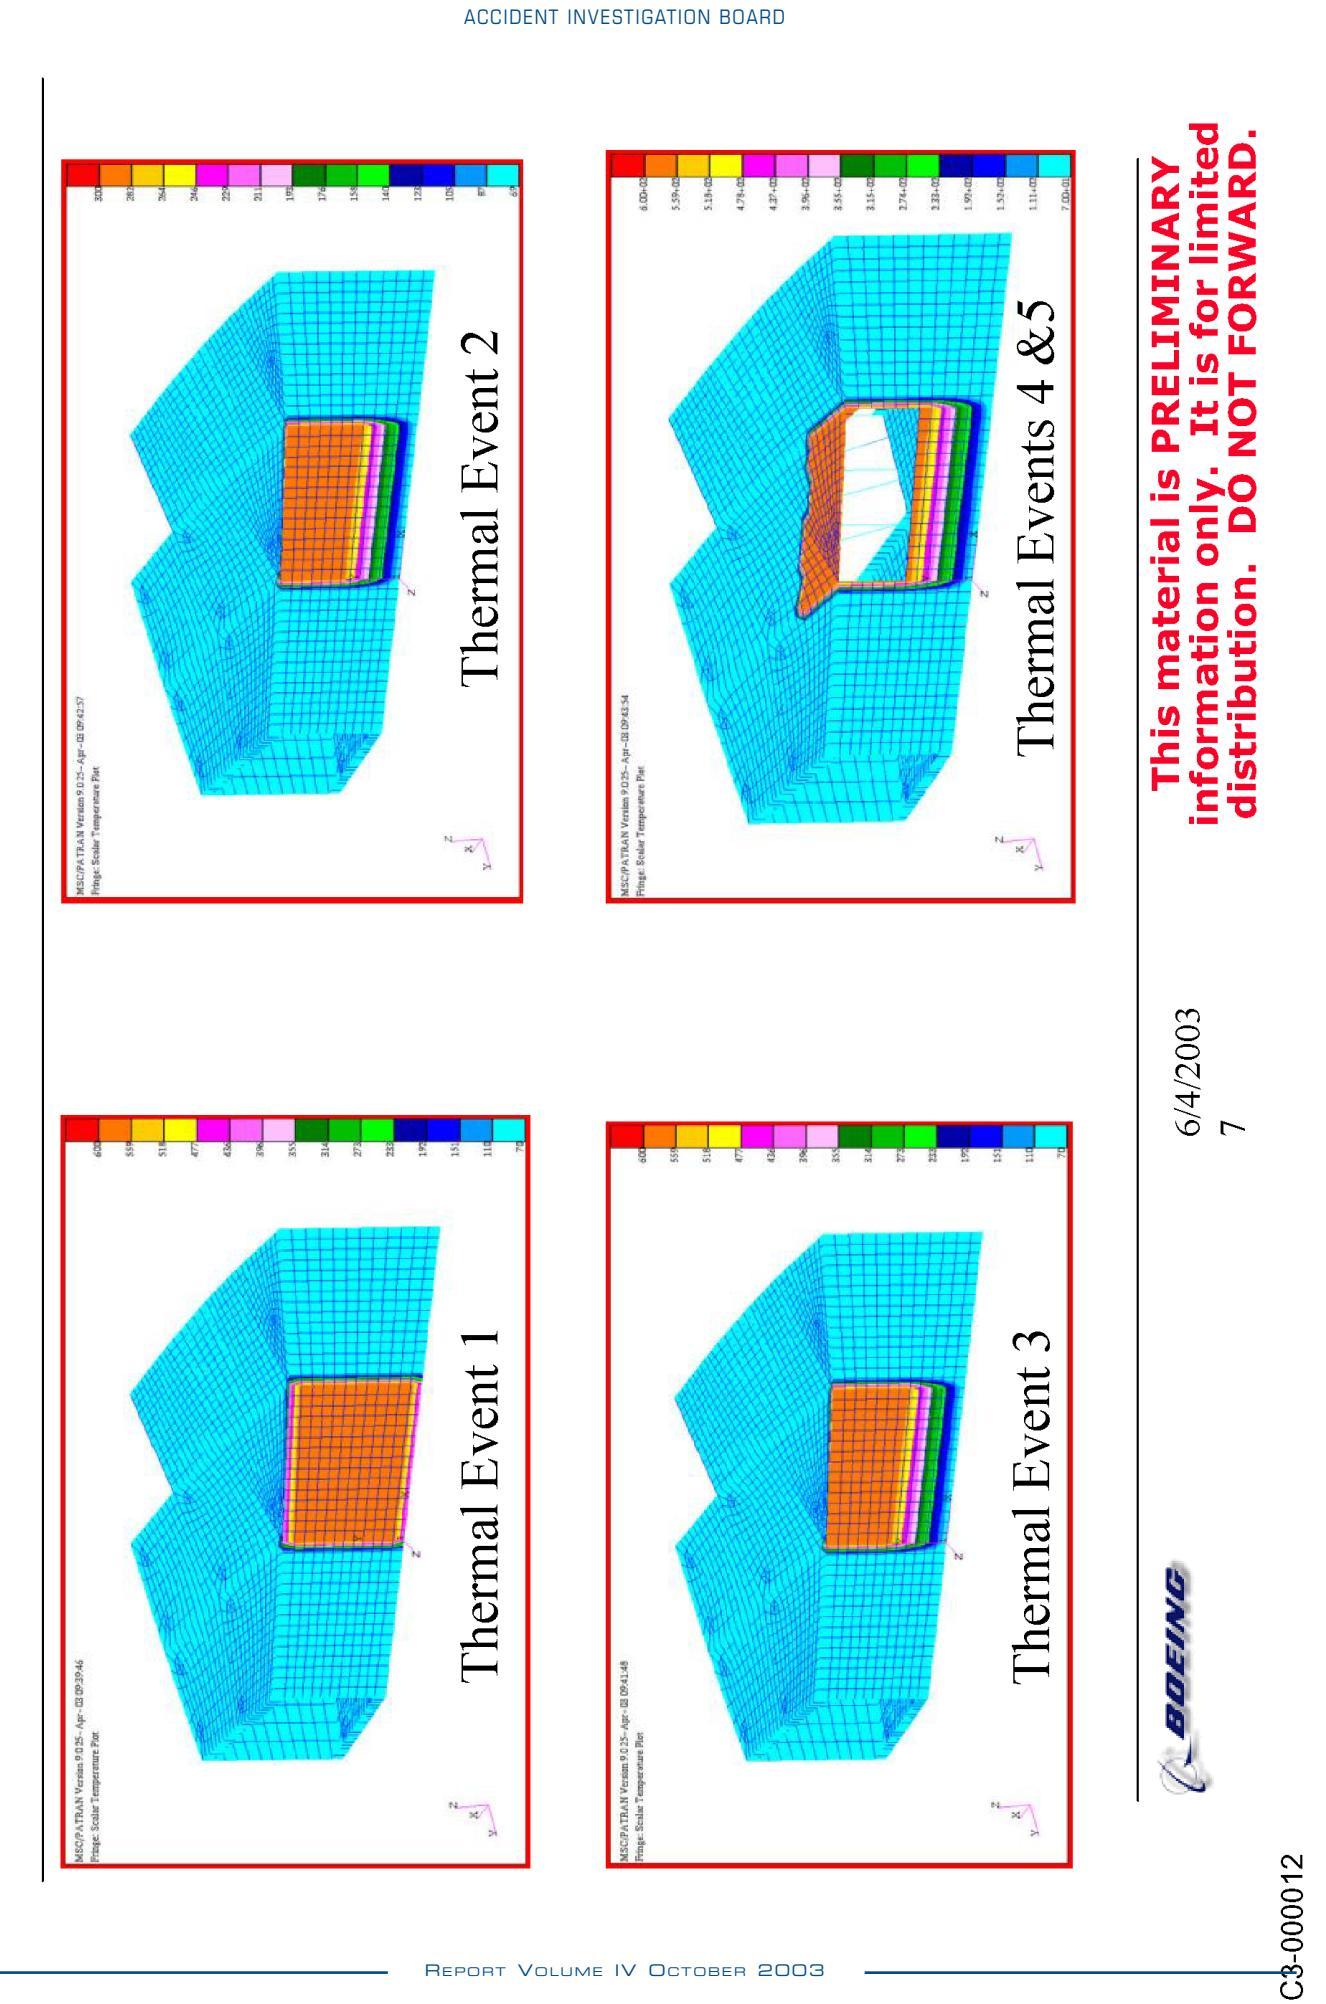
**Thermal Event Temperature Distributions**

- Thermal events analyzed continued...
- Assume burn through on upper half WLE spar web 4
- Assumed 600°F on upper WLE cap, wing skin, and wing ribs up to 16 inches from WLE
- from edge of burn through (middle of WLE web) to bottom Assumed linear temperature distribution of 600°F to 70°F WLE cap
- 70°F on rest of structure
- Assume burn through on upper half WLE spar web and spar cap . ເ

- Assumed 600°F on upper wing skin and wing ribs up to 16 inches from WLE
- from edge of burn through (middle of WLE web) to bottom Assumed linear temperature distribution of 600°F to 70°F WLE cap I
- 70°F on rest of structure I

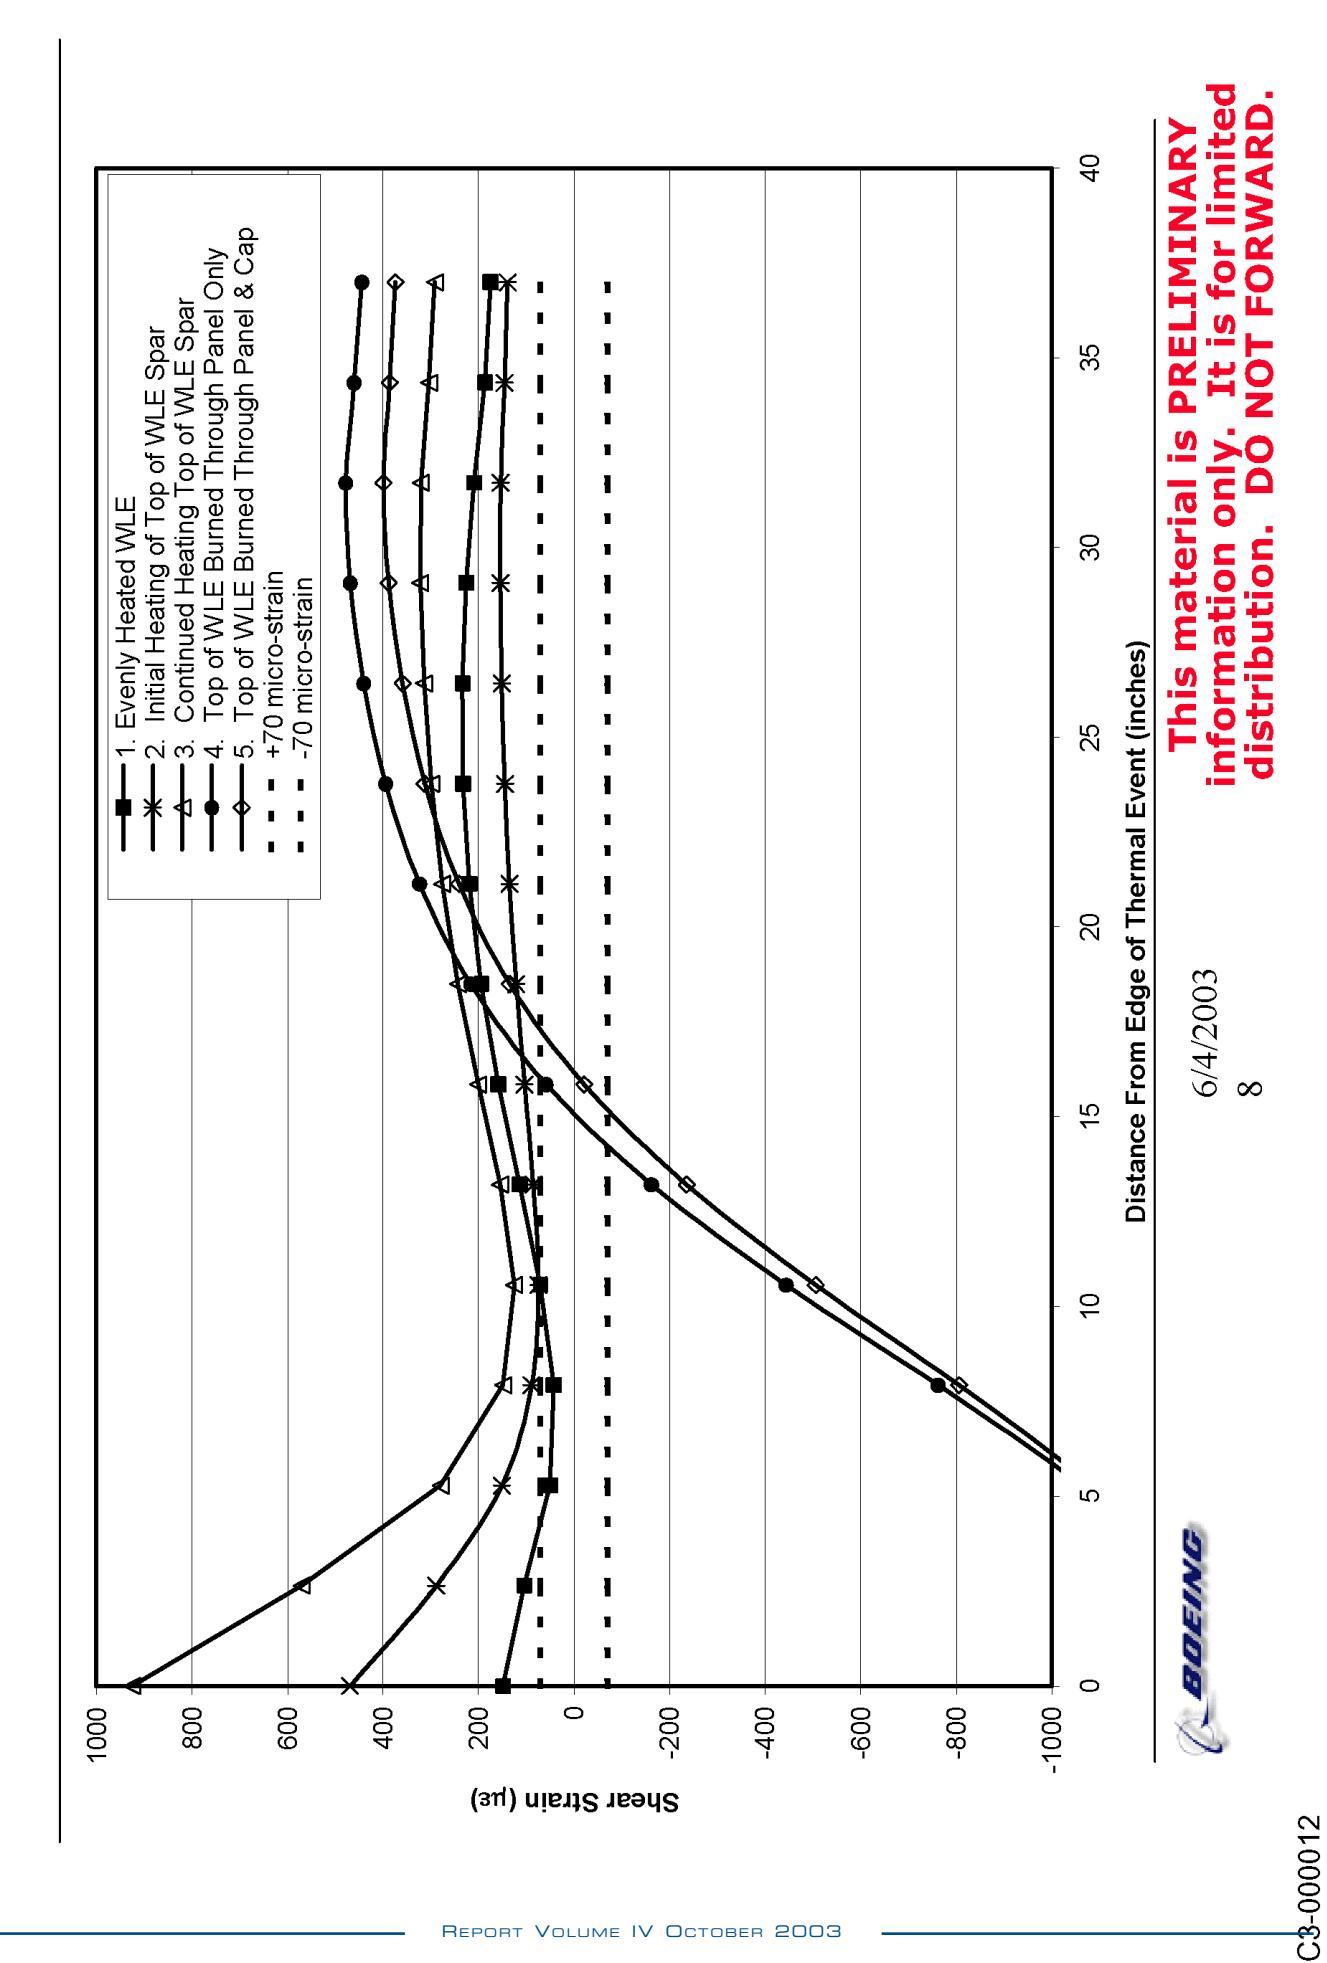
Shear Strain Results Along Midspan of WLE Spar

- Partial breech in WLE TPS allows plasma impingement on WLE spar
- Causes general temperature increase on WLE panel and cap
- Shear strain readings begin to increase
- Upper WLE panel and spar subjected to primary heating
  - Creates temperature gradient on WLE spar from top to bottom

- WLE shear strain gage readings continue to increase
- Upper WLE spar panel burn through I
- Shear strains are reduced in region around thermal event causing a strain sign reversal
  - Panel burn through relieves thermal stresses

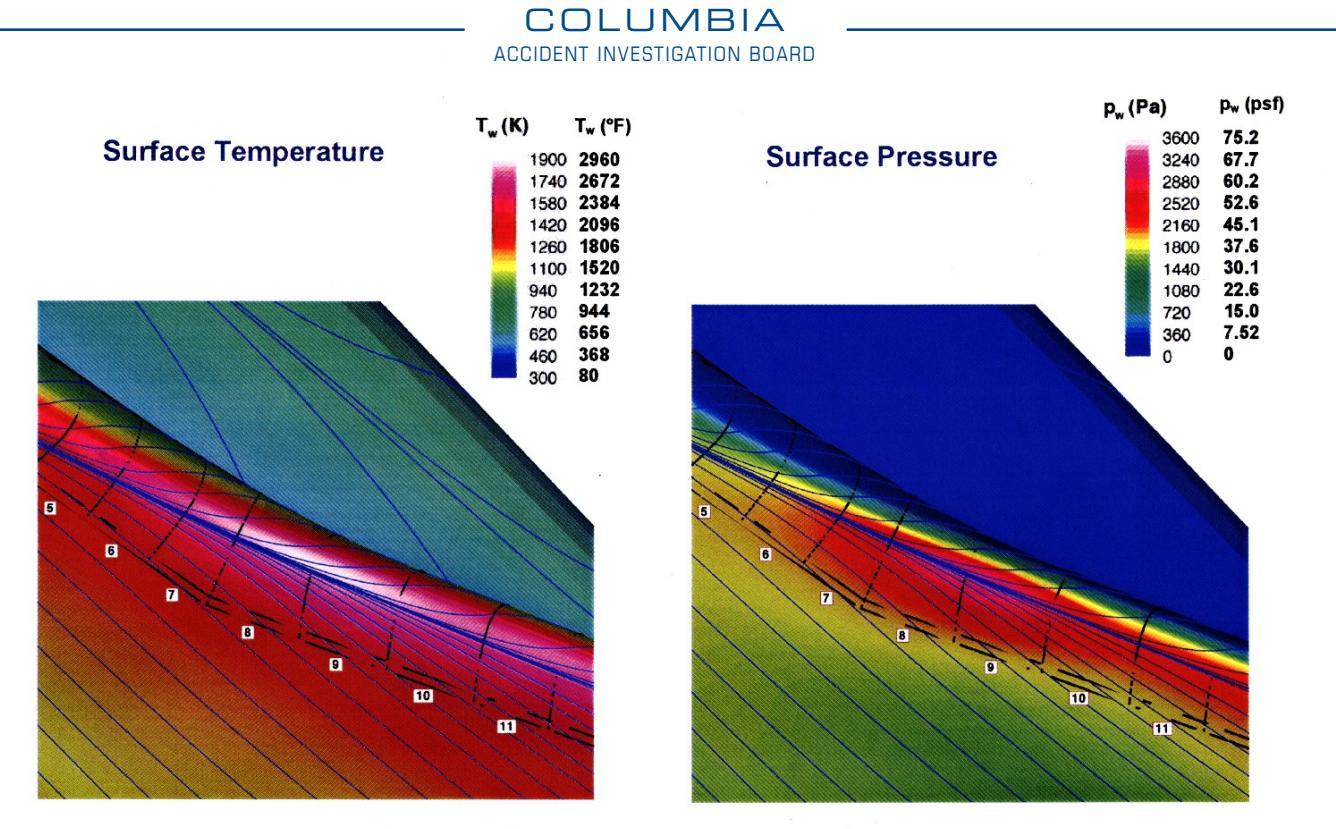
Figure 3: Zoom-in on CFD Solutions from Figure 2 in the Regions of RCC Panels 5-11.

Figure 3 is based on the CFD results from Figure 2. Here one sees zoom-in views of wall temperature and surface pressure distributions in the left wing leading edge area. Also shown are RCC panel locations. As can be seen, there is an attachment line along the wing leading edge where the flow divides, part going over the wing and part going below the wing. In both instances the flow is expanding into lower pressure locations. Along and near the attachment line, the principal direction of the flow at the surface is along the wing, in the outboard direction.

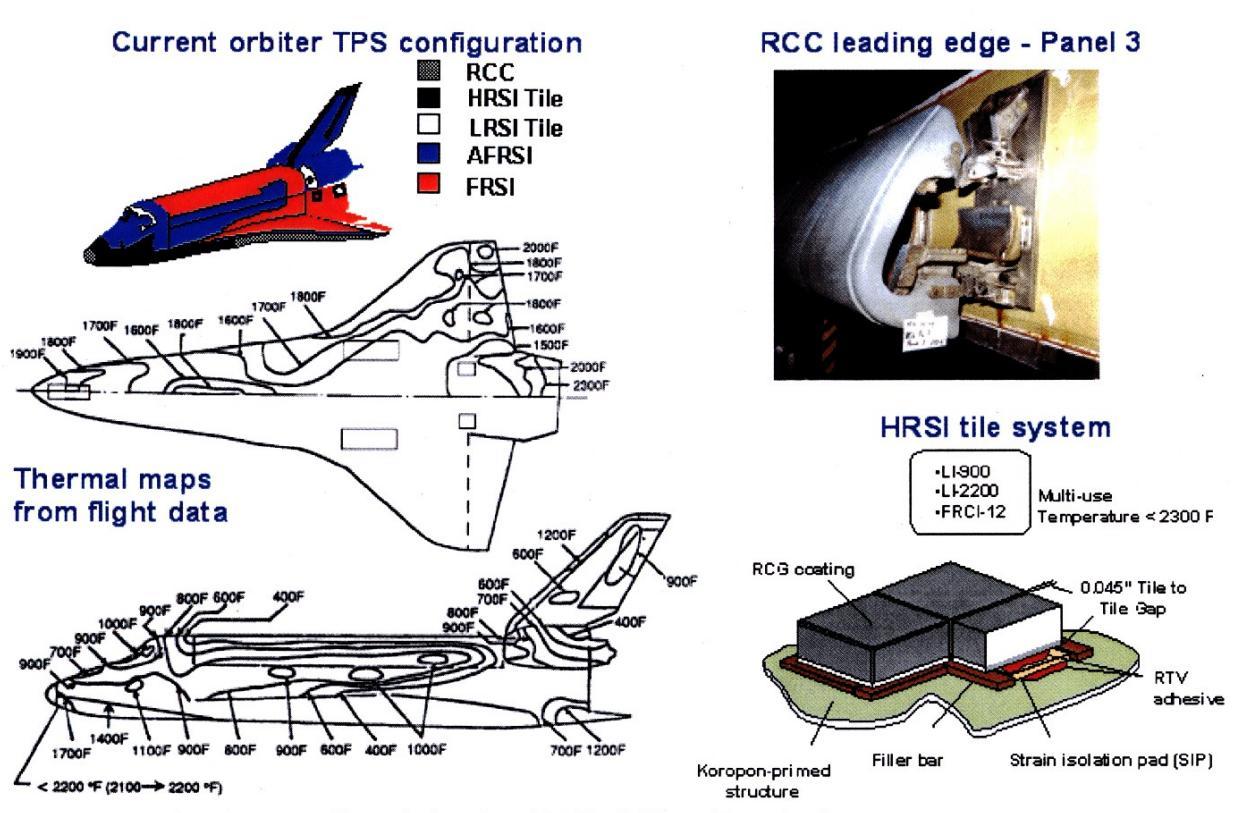
Figure 4: Overview of the Shuttle Thermal Protection System.

Figure 4 overviews the Shuttle TPS system with selected images from a comprehensive presentation (Reference 11) of the Shuttle Thermal Protection System TPS by NASA JSC TPS personnel, J. Kowal and D. Curry, delivered to the CAIB on February 10, 2003. As seen, the Shuttle's aluminum skin and structure are protected by a TPS configuration of RCC, a thermostructural material capable of reuse temperatures to 3,000 + °F on the wing leading edges and nose cap; lightweight ceramic tiles with multi-use capabilities to 2,300 °F; and two types of blankets, Advanced Flexible Reusable Surface Insulation (AFRSI) capable of reuse temperatures to 1200 °F and Flexible Reusable Surface Insulation (FRSI) capable of reuse temperatures to 800 °F.

Thermal maps obtained from Orbiter Experiments (OEX) data early in the Shuttle Program, are shown in Figure 4. Also shown is a depiction of how the tiles are bonded to the Shuttle's aluminum skin. A photograph of a RCC wing panel (Panel 3) with the insulation, mounting attachments and the aluminum wing spar is also shown. Not used in the Panel 3 area are metal beams that span the open end of the RCC, from the top to bottom attachment points. These spanners are used in the Panel 8/9 area to provide additional strength. Note that there is a cavity behind the RCC and insulation between the RCC and the wing spar. This insulation protects the spar against radiation from the inside of the RCC. Not shown in this picture is the insulation that covers all internal metal surfaces ensuring that no structure is exposed to the radiation from the RCC. RCC has a very high thermal conductivity and therefore its inside surface is nearly as hot as the outer surface exposed to aeroconvective heating. During reentry, at an angle of attack of 40 degrees, the lower portion of the RCC panels receive most of the aeroconvective heating. The higher temperature lower panels are cooled by internal radiation through the cavity behind the RCC to the cooler top of the panels, which in turn radiates off to space. There are 22 RCC panels on each wing, and the gaps between them are

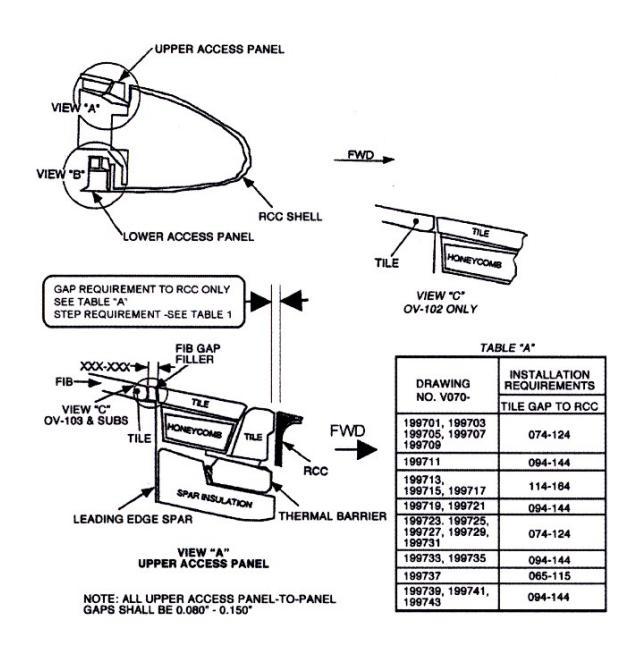
Figure 5: Details of Wing Leading Edge Subsystem Vent Design. Orbiter Vehicle (OV) 102 is named Columbia.

To understand the events that occurred on STS 107, to be discussed below, it is important to note that the RCC-LESS cavity is vented. The venting is accomplished by a gap, ranging in width from 0.065 to 0.164 inches between the upper back edge of the RCC panels and the upper wing tiles. This gap runs the entire length of all RCC panels, giving a total vent area of 47 to 74 square inches depending on the actual gap widths. The smaller area corresponds to using the minimum allowable, installed gap width requirements and the larger area corresponds to using the maximum allowable, installed gap width requirements. Details of the gap design and width specifications are shown in Figure 5. The location of the gap was chosen because of the low heating rates and pressures that exist there as listed in Table 2. As can be seen, the pressure ratio peaks at RCC Panel 10 and falls off gradually in both the inboard and outboard directions. The fluid physics of the wing flow provides an extremely large driver pressure differential for a breach through the wing leading edge as illustrated by these pressure ratios.

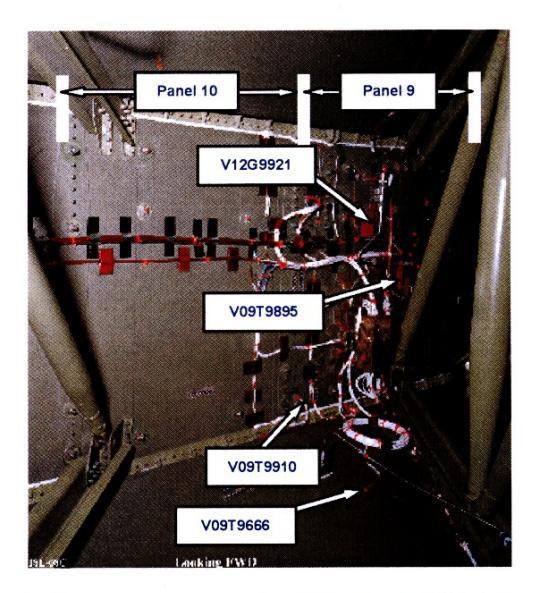
Figures 9 and 10 depict the physical location of the MADS/OEX sensors in the Panel 9/10 area of Columbia's left wing. Figure 9 is a photograph of the backside of the wing spar, looking forward. The approximate locations of RCC Panels 9 and 10 are shown near the top of the photograph. Fortunately, this region of the wing on Columbia was instrumented for the Orbiter Experiments (OEX) activity early in the Shuttle Program, and the instruments were still operational and recording data during STS 107. Data from four sensors are extremely valuable in helping understand the temporal events leading up to the failure of the wing leading edge system: V12G9921, a strain gage mounted to the spar; V09T9895, a thermocouple mounted to the back of the spar at the Panel 9 location; V09T9910, a thermocouple mounted to the clevis which held RCC Panel 9 in place (under an "earmuff" which insulated the clevis); and VOT9666, a thermocouple mounted in a tile in the lower wing, near the tile surface, close behind the number 9 carrier panel tiles. VO9T9910 is imbedded in the RCC mounting hardware, which secures the panel to the spar.

Figure 9: Photograph of Rearward Side of Columbia's Left Hand Wing Spar, Looking Forward. OEX Sensor Locations are Depicted.

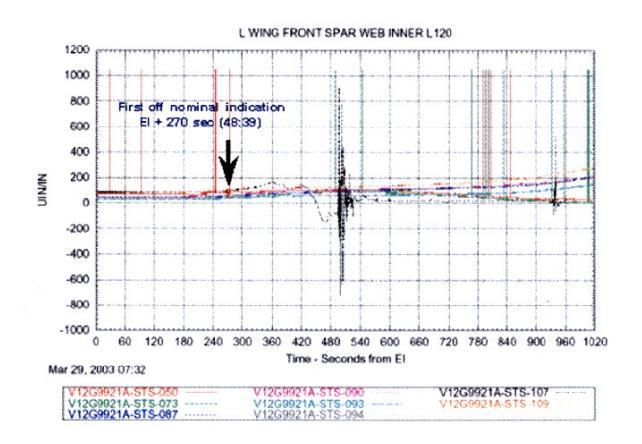
Figures 11 through 13 show data from the two sensors (one strain and one temperature) discussed in Figures 9 and 10. The information from these sensors is very significant in determining the progression of events as the thermal damage from the initial breach progressed to burn a hole through the wing spar. In addition to the data

Figure 11: OEX/MADS STS-107 Flight Data.

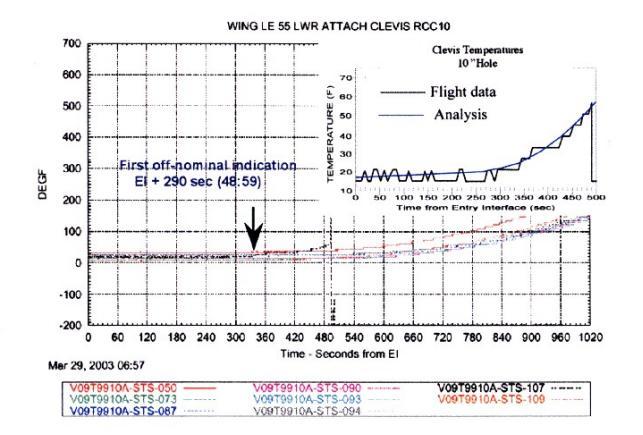
Figure 12: OEX/MADS STS-107 Flight Data and Thermal Analysis (Reference 12).

Figure 12, prepared in the same format as Figure 11 displays the time history of a thermocouple imbedded in the clevis fastener at the lower edge of the RCC located between Panels 9 and 10. The temperature changes recorded on the RCC clevis during STS 107 entry, appear to be quite small, but it is noted that this thermocouple is highly insulated and attached to a large thermal mass.

A thermal analysis by NASA (Reference 12) has shown that a hole of  $6 \rightarrow 10$  inches in diameter in the lower RCC Panel 8, could account for the early behavior of the thermocouple. The result of this analysis is shown in the inset in Figure 12. The "stepped" curve is the flight data while the blue, smooth curve is the result of the referenced analysis.

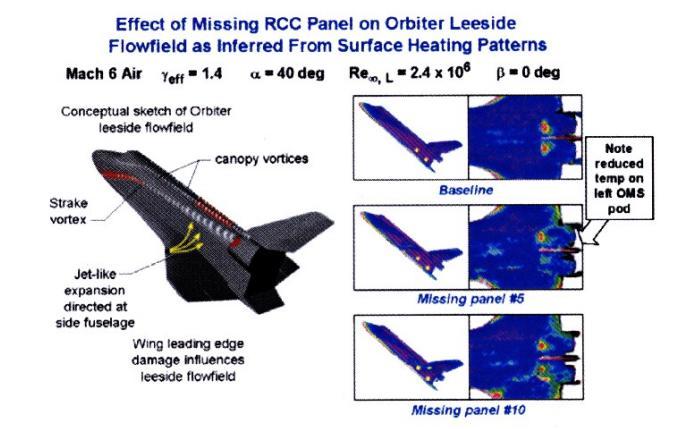
Figure 14, prepared by NASA (Reference 14) shows the results of wind tunnel tests from Langley Research Center. Data were obtained in a Mach 6 air stream at the conditions specified on the figure. The three boxes on the right of the figure show the results of a thermally sensitive coating on a model of the Shuttle. As noted, for the results of RCC Panels 5 and 10 missing, there is a definite temperature decrease from the baseline on the left OMS pod location, noted by the absence (missing panel number 5) or dimming of the red dot on the forward location of the OMS pod. The conceptual sketch, also shown in Figure 14, suggests that the jet-like expansion directed from a damaged wing influences the leeside flow field, reducing OMS heating if there is a disturbance in the Panel 5-10 RCC area.

Figure 14: NASA Langley Wind Tunnel Test Data Help Explain Below Nominal Temperatures Recorded on the Left OMS Pod.

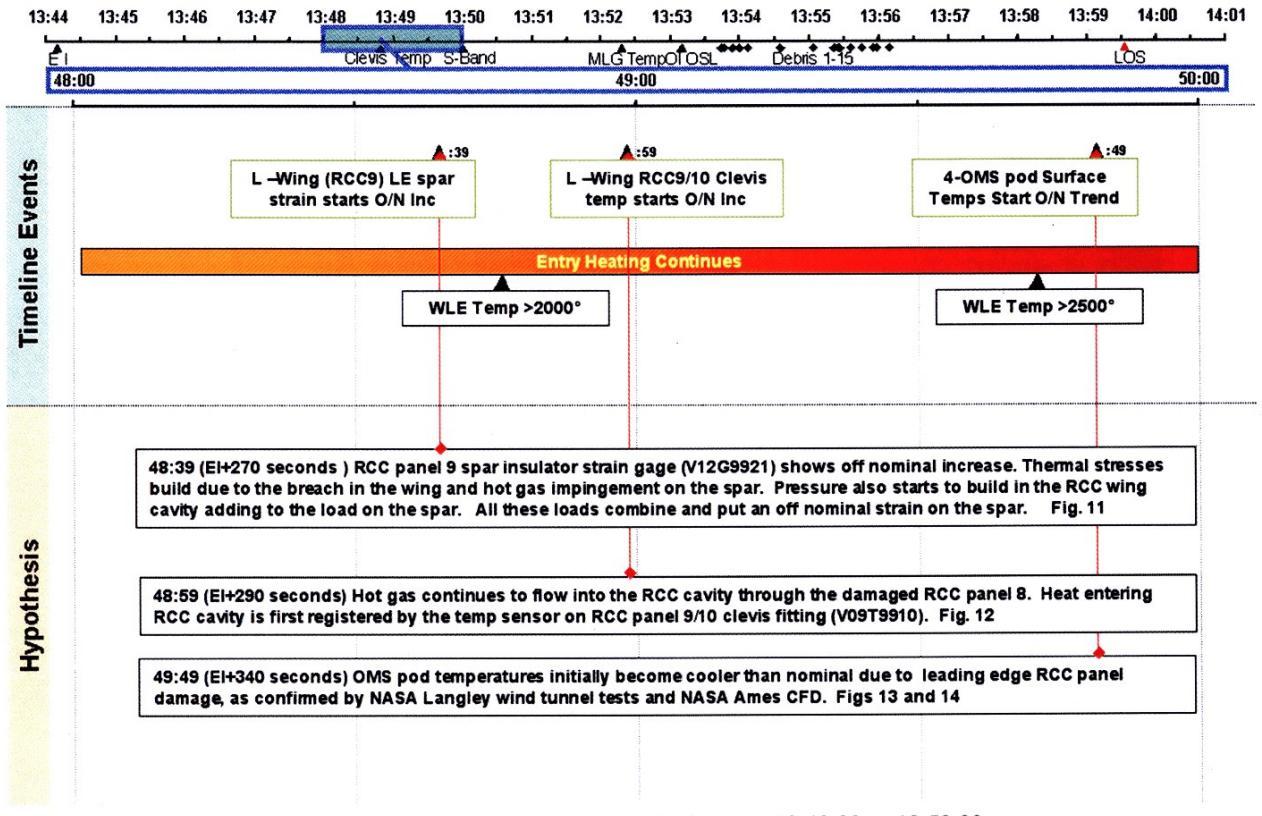
Figure 15 graphically depicts the timing of events recorded by the OEX sensors. The captions are self-explanatory. The MADS/OEX off-nominal data in the wing leading edge and spar are additional evidence that a breach existed in the RCC at the EI. The below nominal temperature on the OMS pod is consistent with the hypothesized damage in the wing leading edge in the RCC Panel 5 - 8 area.

Figure 15: Timeline Versus Hypothesized Events 13:48:00 -> 13:50:00.
