COLUMBIA

ACCIDENT INVESTIGATION

**REPORT VOLUME IV** OCTOBER 2003

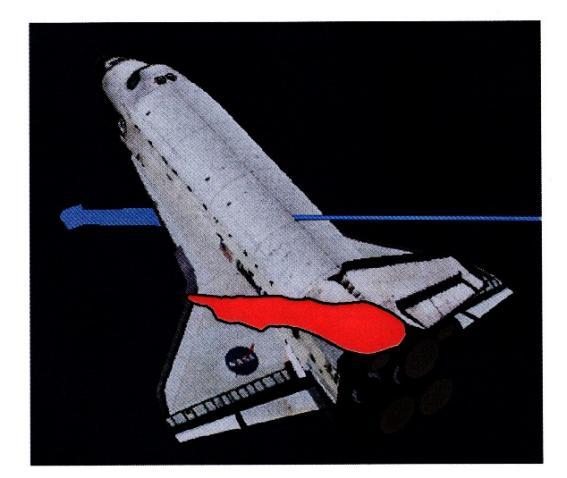
Figure 16 depicts a possible explanation for some of the early (near 13:50:00) communication dropouts observed during Columbia's entry. As known from many years of experience with entry of vehicles, small amounts of charged species (electrons and ions) between an antenna and the receiver can cause communication signal attenuation and even its total loss. As shown in the figure, a possible explanation for some of the early signal attenuation could have been electrons and ions, along with molten materials from the wing hardware, being entrained in the flow and transported to locations between the antennae behind Columbia's cockpit and the receiving TDRS communications satellite.

At the request of the authors, D. Potter of Sandia National Lab performed a scoping study (Reference 15) which shows that melting aluminum would provide charged species concentrations in sufficiently large quantities for signal attenuation in the 13:50:00  $\rightarrow$  13:50:30 period. However, to date (July 2003) analysis by NASA has failed to provide an understanding of how the flow behind Columbia could have provided a pathway to place the charged species and/or molten metal between the antennae and the receiving satellite. Darling (Reference 4) has pointed out that the communications drop out occurred at times quite close to several major debris shedding events and to the breach of the LW spar. However, a definitive link between the two is still conjectural.

Figure 16: Entry Plume is Possibly Affected by Damaged Structure Accounting for Communications Dropout.

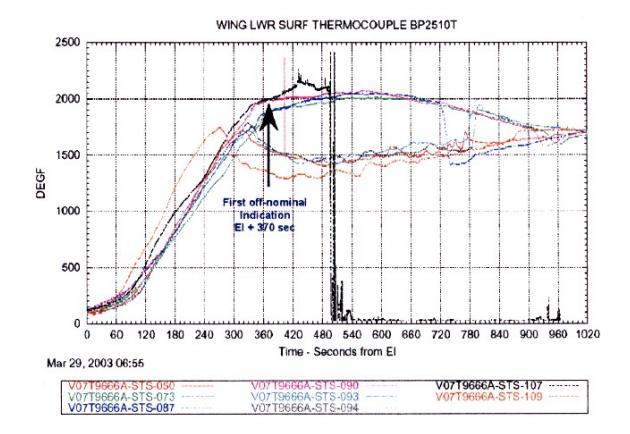
Figure 18 displays the temperature recording from the thermocouple V07T9666A located in a lower wing tile, near the wing leading edge, behind Panel 9. This sensor location was shown above in Figures 9 and 10. As can be seen, there is an off-nominal heating trend in this thermocouple starting at EI + 370 seconds (GMT 13:50:19).

Figure 18: OEX/MADS STS-107 Flight Data.

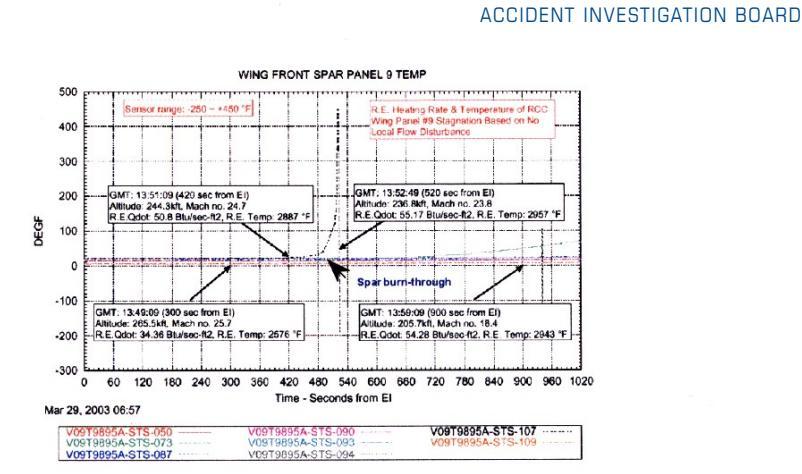
Figure 20 displays the temperature recordings from thermocouple V0T9895A, located on the inside of the spar, behind Panel 9, as discussed in Figures 9 and 10 above. These data are quite valuable in understanding the progression of damage to the wing leading edge. As seen, the first off-nominal indication begins at 420 seconds after EI, GMT 13:51:09 with a very slight increase in temperature. Later discussion of this figure will focus on the burn through of the spar.

Figure 20: OEX/MADS STS-107 Flight Data.

Figure 20 shows a rapid temperature increase at EI + 487 seconds as recorded by the thermocouple V0T9895A on

the back of the spar behind Panel 9. This rapid increase at EI + 487 seconds strongly suggests an appearance of a plume of superheated air and that spar penetration had occurred. According to study (Reference 13 and 19) by NASA, this timing for spar burn-through is consistent

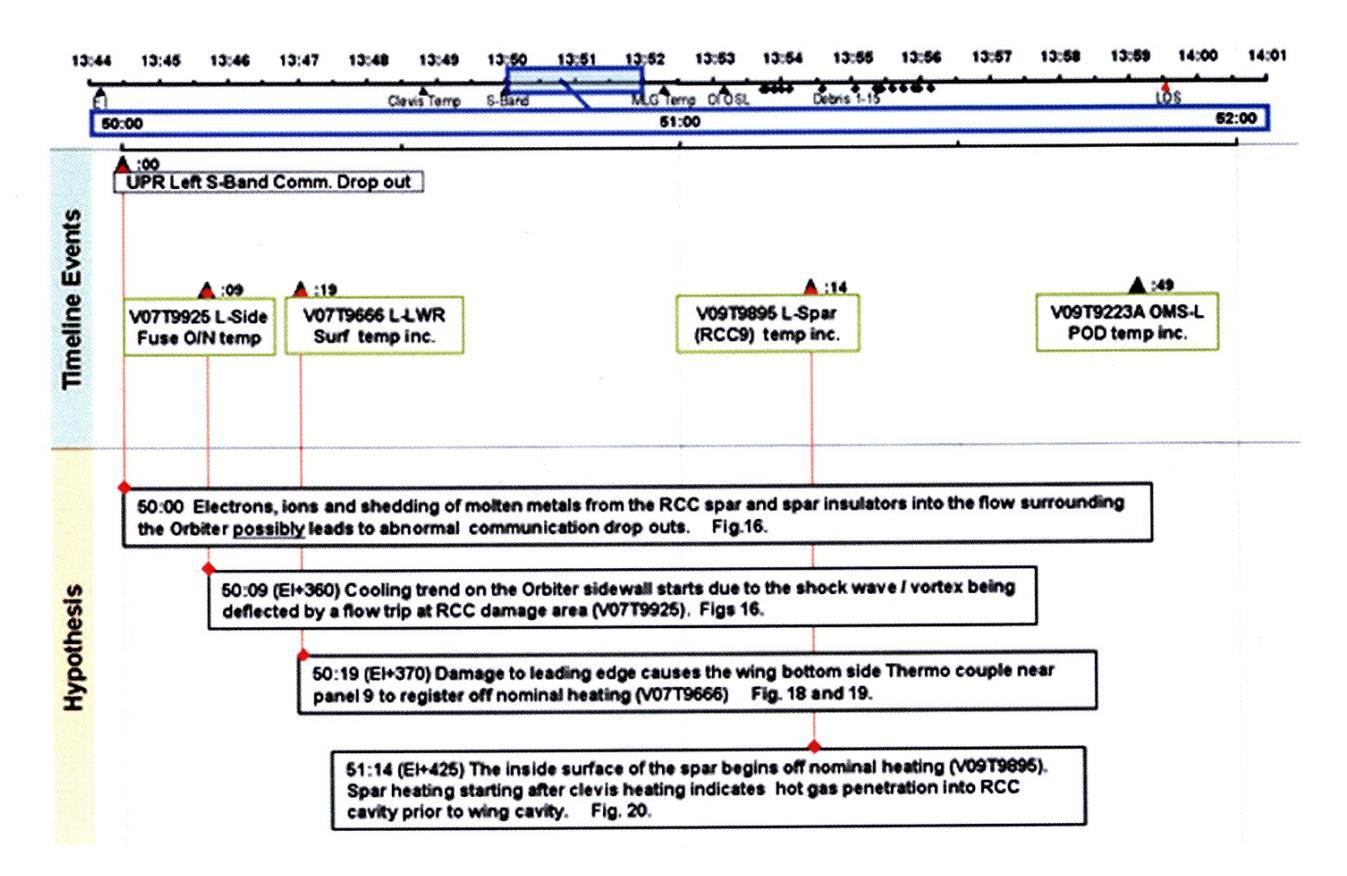
Figure 21 graphically depicts the timing of communication drop out and additional events recorded by the OEX sensors. The captions are self-explanatory. The MADS/OEX off-nominal data in the wing leading edge and spar are additional evidence that a breach existed in the RCC at the EI. The below nominal temperatures recorded on the fuselage sidewall is consistent with the hypothesized damage in the wing leading edge in the RCC Panel 5-8 area. The spatial correlation by the streamline analysis in Figure 19, showing how the outflow from the lower juncture of RCC Panel 8 and 9 can affect the lower tile thermocouple behind Panel 9 and the above nominal behavior of thermocouple V07T966, is additional and compelling evidence for the existence of a breach in the Panel 8/9 area. It is clear from this figure that the temporal evolution of the heat flow shows that the hot gas penetration began in the cavity in the wing leading edge prior to heating in the wing box behind the spar.

Figure 21: Timeline Versus Hypothesized Events - 13:50:00 to 13:52:00.

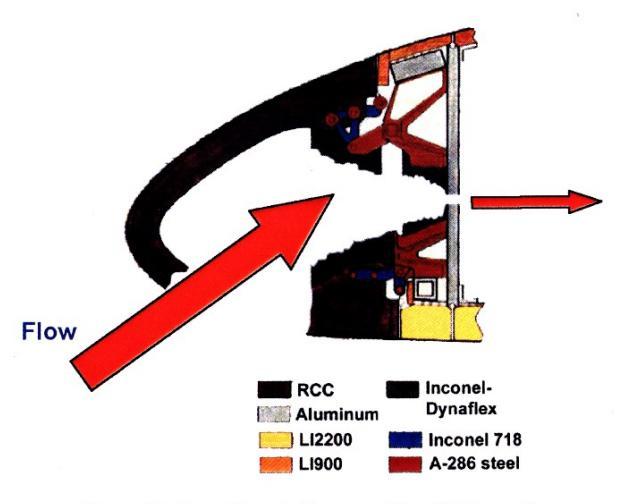
Figure 22: Spar Breach Occurs at EI + 487 Seconds.

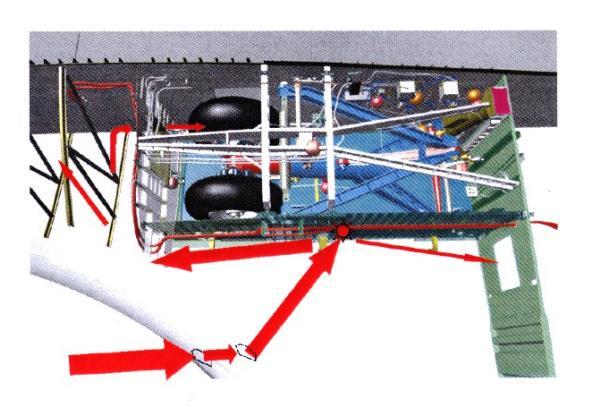
Figure 23: Hot Gas Begins to Fill Wing Box.

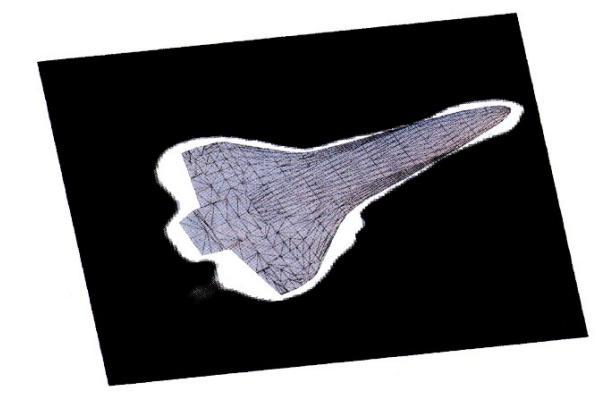
Figure 25 is a photograph of Columbia, taken at GMT 13:57:14 from the Starfire Facility at Kirtland AFB in Albuquerque, NM. At this time, Columbia was about 50 miles NW of Starfire at an altitude of about 40 miles, it had an 80 degree left angle (with the left wing down) and a 40 degree angle of attack. Therefore, the view of the vehicle is from the forward, bottom, left side, so that any hot plumes spilling over the top of the left wing leading edge or out of the top of the wing near the leading edge are visible.

The left wing has two apparent "bulges" on the leading edge and two corresponding wakes behind the wing. The authors believe that these are due to the following: hot flow and burning material ejected upward over the wing leading edge from the Panel 8 area; and a large plume of hot gases and burning material and debris ejected upward from the breach in the top surface of the wing aft and outboard of the Panel 9/10 area.

Figure 25: Starfire Photo from Kirtland AFB. GMT 13:57:14. Model Scaling and Orientation Based on Telemetry from NASA. The Columbia Model was Provided by NASA.

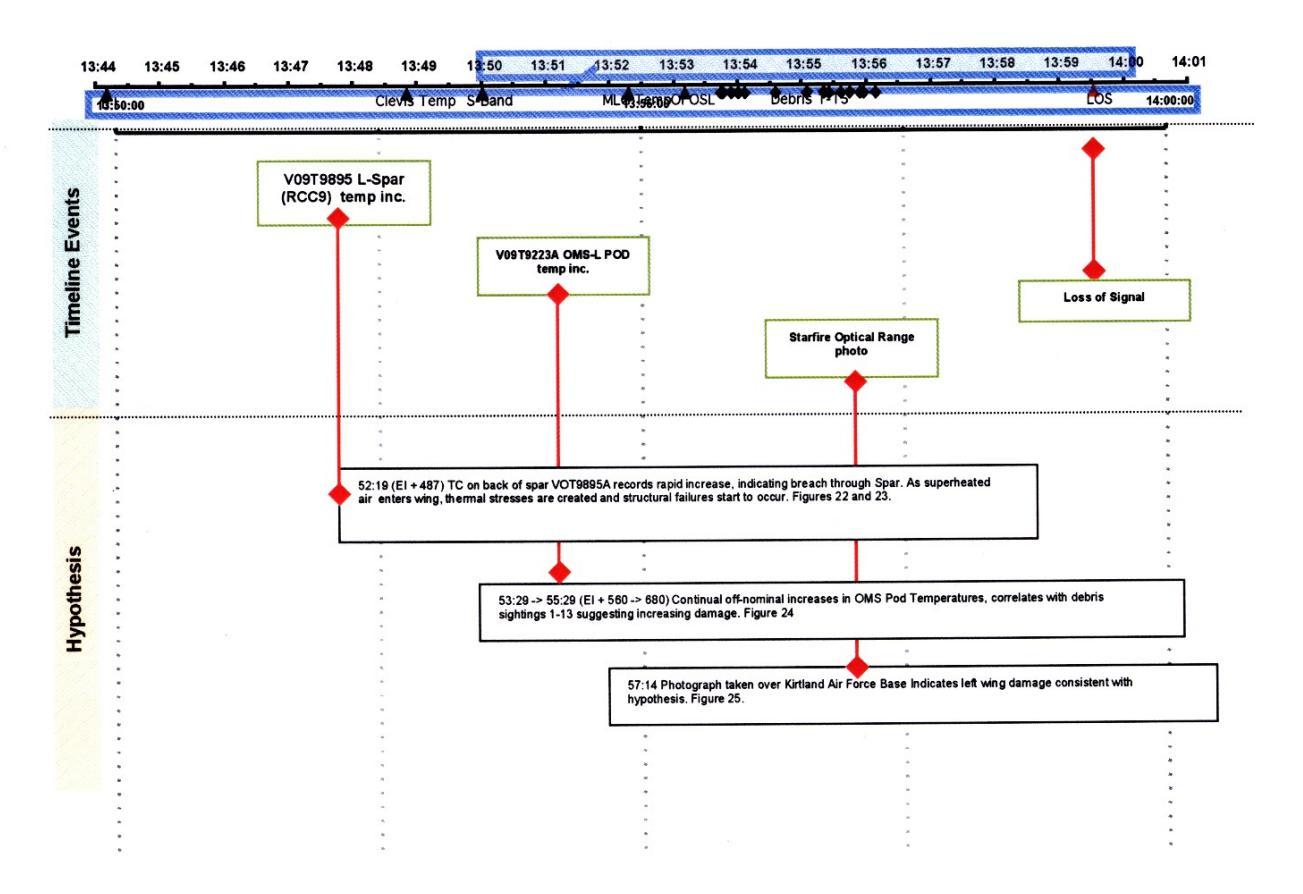
The captions within Figure 26 displaying the comparison to the hypothesis and the timeline between GMT 13:52:00 and 14:00:00 are self-explanatory. During this time, the breach through the spar and internal heating to the wing box and wheel well have rendered the loss of the vehicle inevitable. The temporal progression of damage to the TPS has been outlined herein with the exception of the shedding of tiles and RCC panels/parts. Geographic locations of the recovered TPS debris and ballistic analysis suggest that much of this occurred over Texas. Others have written in detail on the analysis of debris sightings, sensor readings, etc. and it is outside the scope of the "Follow the TPS" charter to dwell further on these topics.

Figure 26: Timeline from 13:50:00 Through Loss of Signal 13:59:32 Versus Hypothesized Events.

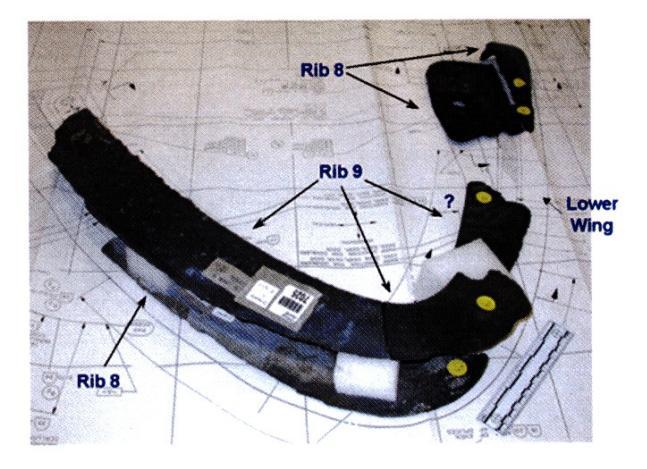
Figure 29 is a photograph showing an inboard view of recovered parts of RCC ribs from Panel 8 and 9. Here, the two recovered and identified parts of the inboard rib of Panel 9 are sitting on white foam blocks. The recovered parts from the outboard rib of Panel 8 described in Figure 28 are now shown lying on their full-scale drawing. Note that the yellow tags here are labeled "NA," meaning not ablated and verifying the statements made in the discussion of Figure 28.

Figure 29: RCC Panels 8/90 Ribs (Inboard View).

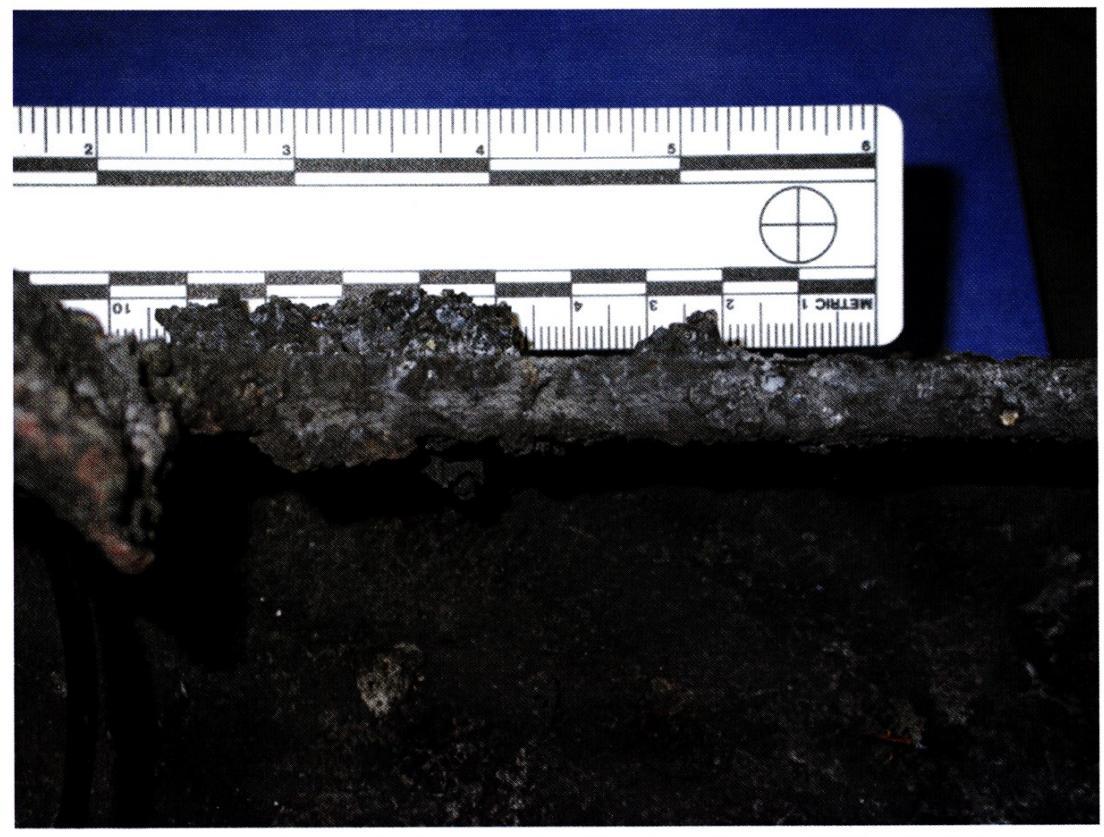
Figure 32: Slag Deposits on Upper Edge of Panel 8 on the RCC Side of the Vent.

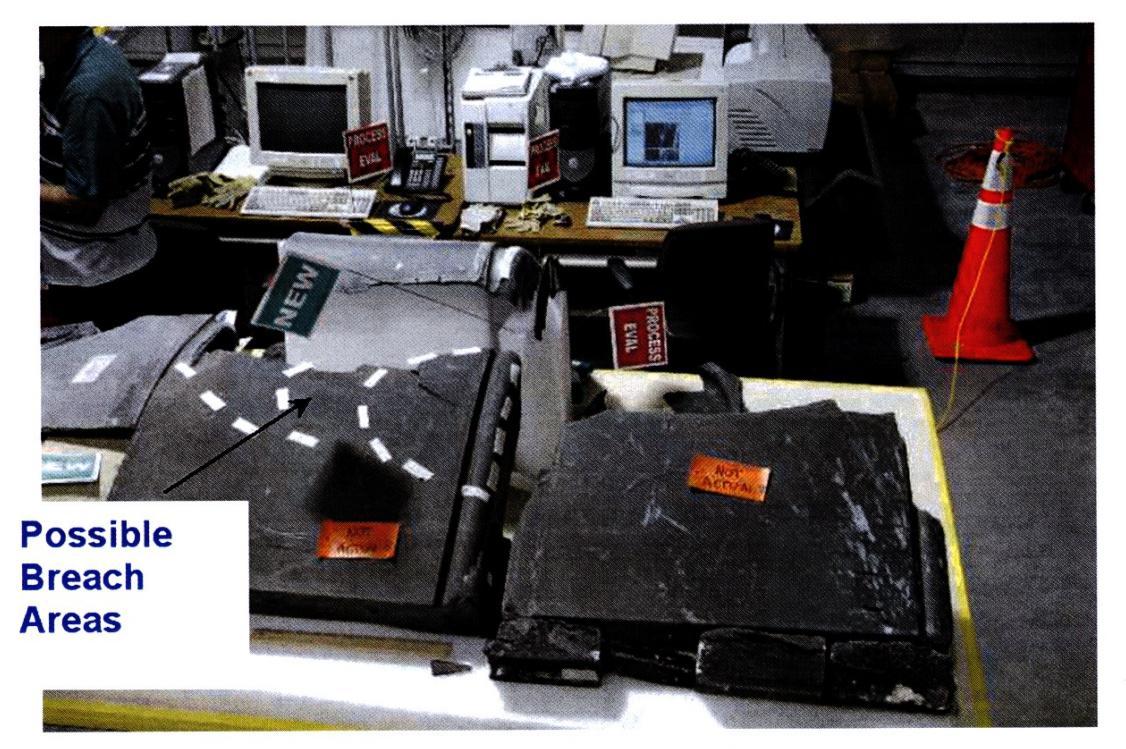
Figure 33 shows the probable initial breach location on the lower Panel 8 area. The size of the hole is difficult to determine, but could be bounded by the three dotted locations outlined by white tape. Analysis by NASA discussed above suggests the damage is consistent with a hole of  $6 \rightarrow 10$  inches in diameter. All of these are consistent with the flow patterning seen on the debris and the Computational Fluid Dynamics flow calculations to be discussed below. The authors note that areas this large would be consistent with the "piece" shown by DoD radar observations that "left" Columbia on day two of its orbital maneuvers. A part of a broken T-seal (possibly from Panel 8, located between Panels 8 and 9) could also account for the "piece" observed leaving the shuttle on day two of orbital operations. Note that on this photograph, the two recovered Panel 8 carrier panel tiles are not shown.

The authors believe that in addition to a breach in Panel 8, the upper part of the T-seal between Panels 8 and 9 must have been missing or severely misaligned for a major part of the entry. This is required to account for the severe erosion of the upper RCC Panel 8 outboard and Panel 9 inboard ribs shown in Figures 28 and 29 and discussed above. Flow patterns of the recovered upper Panel 8, suggest this happened as discussed in Reference 20.

Figure 33: Probable Initial Breach in Panel 8.

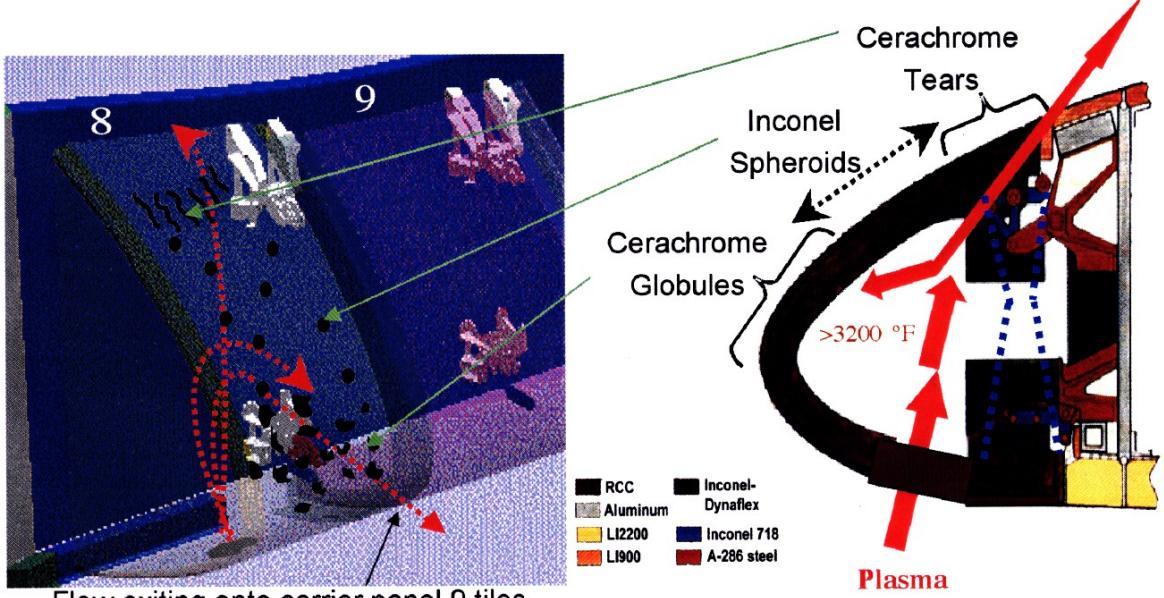
Figure 34, adopted from Reference 20 summarizes work by the NASA Forensics Team. The analysis of the slag deposited on the inside of RCC Panel 8 shows that cerechrome and Inconel were deposited first in the slag layer. Deposition of aluminum occurred last. This is consistent with the sequence of thermal damage seen in the MADS/OEX data and is additional proof that the damage moved from the RCC -> aft. There were large amounts of melted cerachrome in the slag, consistent with prolonged presence of superheated air, since the melting point of cerachrome is in excess of 3200 °F. The presence of Inconel in the slag proves there was hot gas impingement on the RCC spanner bars, insulation foil and RCC panel fittings made of this material.

The absence of significant amounts of A286 stainless steel in the slag (Reference 20) suggests that the breach location was not close to these fittings. As shown by the figure, the deposition of Inconel spheroids and the cerachrome tears and globules suggests a "splashing" effect of the flow entering from a hole below the apex of the RCC Panel 8. As discussed above, some of the flow exited out of the vent at the top, rear of RCC Panel 8 and some came out in a "sneak flow" in the slot in RCC Panel 8 outboard and eroded the carrier panel tiles below RCC Panel 9. In addition, the slag on the vertical surfaces of the internal LESS hardware was generally on outboard surfaces of the hardware inboard of Panel 8 and on the inboard surfaces of the hardware outboard of Panel 8.

Figure 34: Wing Leading Edge Chemical Analysis of Panel 8 (Reference 20).

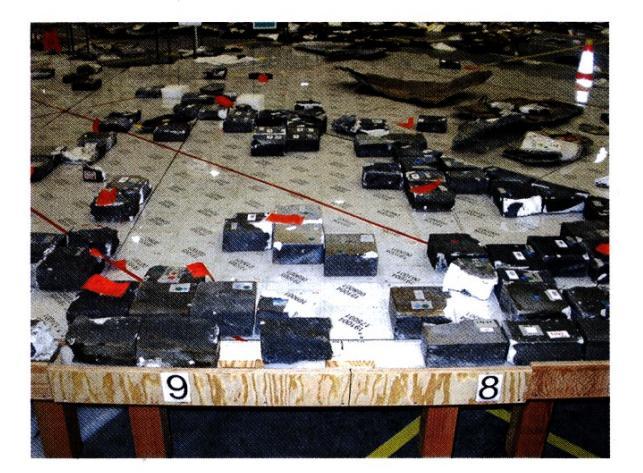
Figures 35 and 36 show photographs of recovered tiles affixed to a 110 percent scale drawing of the left wing tile field. Here, a key of circular dots was used: Red means a tile is not in its final location, blue means a tile is in its final location and has been positively identified. Yellow means the tile failed at the densified layer, near the bond line and green means the tile failed owing to internal heating. In this case the Koropon/SIP failed or the Strain Insulation Pad (SIP) failed due to overheating. Koropon is the primer coating the aluminum skin.

There is a distinct pattern of RCG coated tiles, in the general X-direction downstream of Panels 8 and 9, outboard of the wheel well where the tiles appear to have little of the dark metal deposit (aluminum - rich) generally seen on the recovered tiles. These normal-appearing tiles all have been identified to have failure at the tile/Koropon bond line and departed from the wing surface prior to a major outflow of molten aluminum. This is indicative of extreme heat, inside the wing behind Panel 8. It then seems probable from this observation that the breach in the wing spar occurred at the Panel 8 location, and this is consistent with the observations discussed above. Ballistic analyses of the trajectories and the geographic location of the recovered tiles (both those detached owing to bond failure and those that did not) suggest they came off from about 100 nautical miles west of their recovery location in Texas.

Figure 36: View of Tile Table from RCC Panel 8/9 Area.

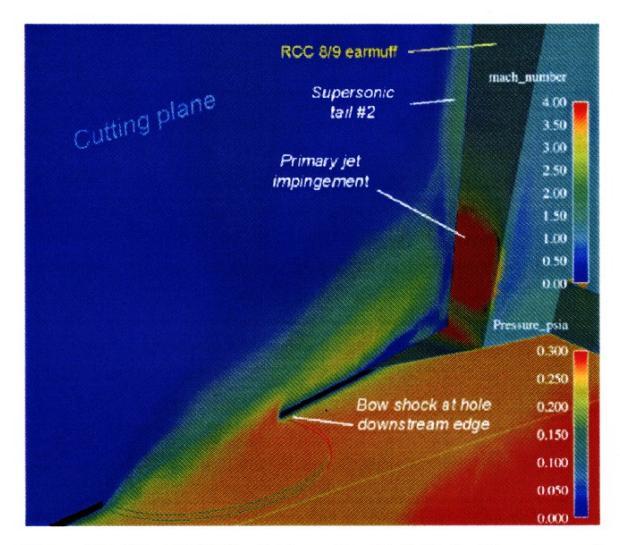
Figure 38 (a): CFD Predictions for Wall Static Pressure and Mach Number for a 10" Hole in RCC Panel 8, Corresponding to Solution in Figure 37. Static Pressure is Color Coded on Walls and Mach Number Distribution is Shown on the Cutting Plane.

Figure 38 (a) from the Boeing Propulsion and Power group depicts the static pressure on the WLESS internal walls and the Mach number on the cutting plane, which passes through the 10 inch diameter hole. The results indicate that all of the external boundary layer and some of the local inviscid (freestream) flow is ingested into the WLESS channel. The primary jet strikes the earmuff at a near-normal incidence ( $80^\circ$ ). Its stagnation pressure exceeds the freestream-shock pressure because of a precompression by the oblique vehicle shock.

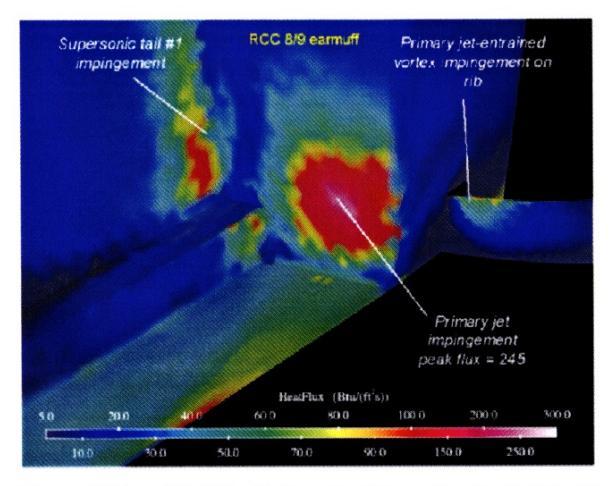
Figure 38 (b): CDF Predictions for Convective Heat Flux on Hot Tubs, Earmuff and Rib for a 10" Hole in RCC Panel 8, Corresponding to the Solution in Figure 37.

Figure 38 (b) shows CFD predictions for convective heat transfer to the spar insulation (hot tub), spanner insulation (earmuff) and the RCC outboard rib corresponding to the solutions shown in Figures 37 and 38 (a). The heat fluxes on the earmuff at the center of the jet impingement are significantly higher than that of an undamaged wing, immediately upstream of the breach in Panel 8 with a finite catalytic wall (Reference 18) (300 vs. 27.3 Btu/ft<sup>2</sup>s).

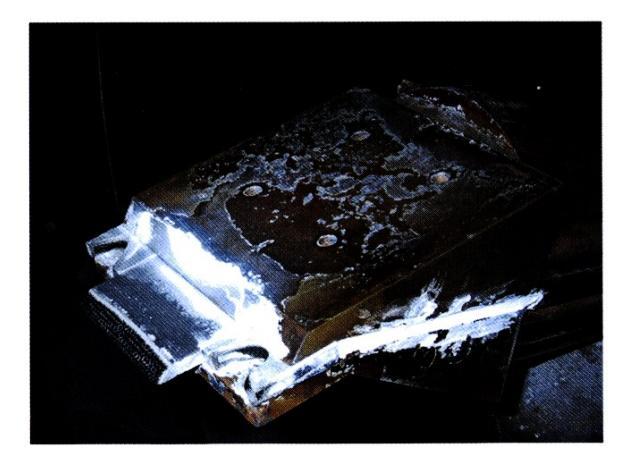
Figure 44 (b): Post-test Photograph Showing Knife-edges in Both RCC Test Article and Closeout.

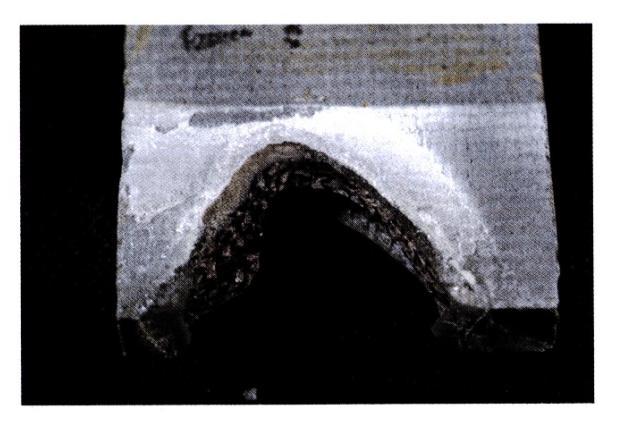
Figure 44 (c): Close Up, Post-test Photograph Showing Knifeedges in the RCC Closeout.

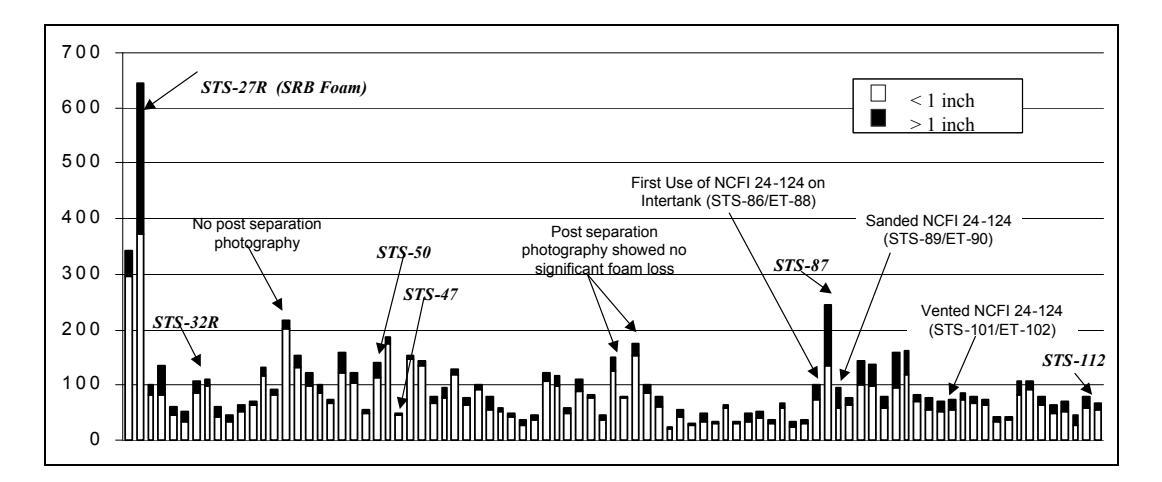
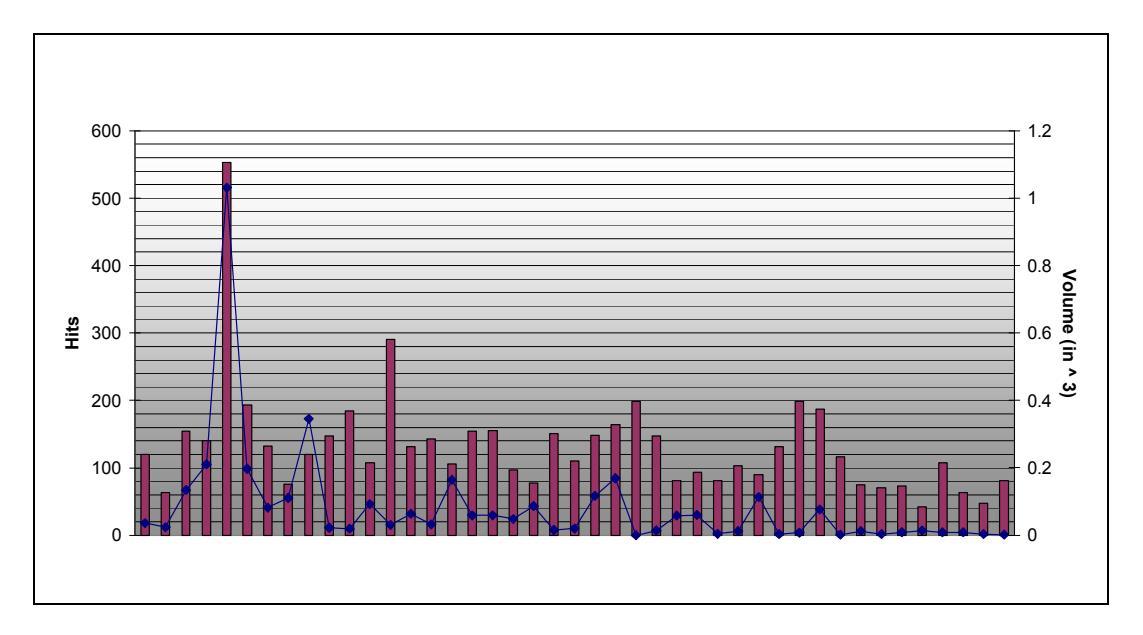
While on-orbit imagery is the only valid method for determining ET TPS performance, post-landing inspection of the Orbiter TPS is sometimes used as a measure of TPS performance. Figure 5.3.2.2-3 shows the number of Orbiter lower surface infects correlated to TPS damage. As shown below, there have been cases when Orbiter tile damage could not be correlated to significant ET TPS loss. Statistical analyses of data indicate that ET foam loss has a weak correlation to Orbiter damage. There are other significant sources of damage to the Orbiter tiles.

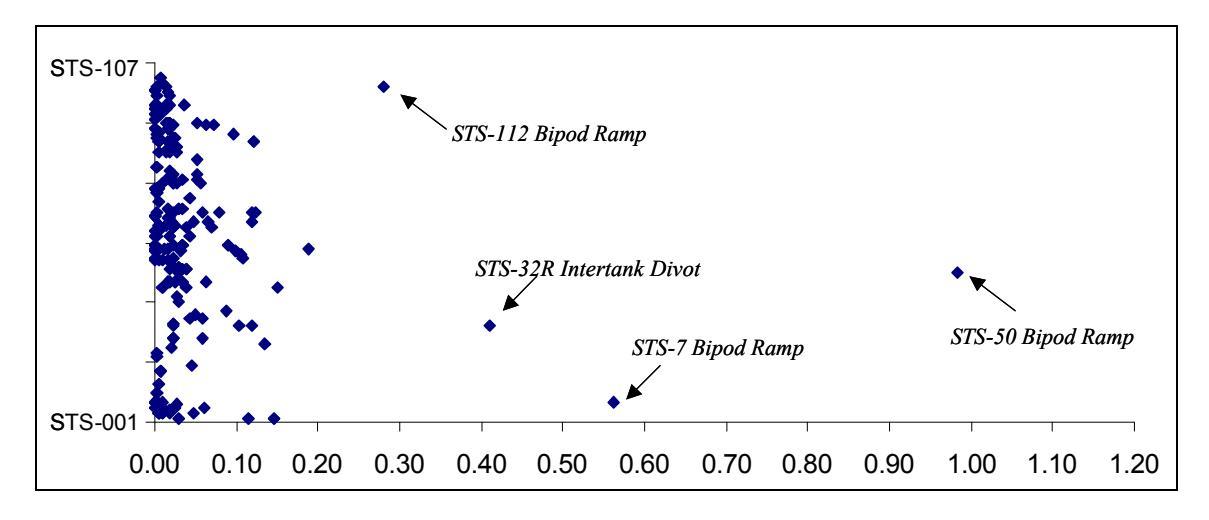
Figure 5.3.2.2-6. TPS Mass Loss (lb)

ET TPS loss is visible on each flight and can be categorized as either "typical" or "significant." Typical" TPS loss is characterized as divots that are frequently observed with a mass of <0.1 lb. Divots of this mass are small shallow divots usually seen on the intertank-to-LH2-tank flange or tank acreage TPS. Smaller

divots (also known as "popcorning") are commonly observed on the intertank thrust panels and LH2 aft dome. "Significant" TPS loss, as categorized by the SSP, is usually related to the size (>0.2 lb), location, or pattern of TPS loss that has occasionally correlated to an increased level of Orbiter TPS damage quantity or TPS damage size. Significant events through the program history are shown in Figure 5.3.2.2-6. Programmatic action was required for those events that were characterized by the Space Shuttle Program as 'significant' events, *i.e.,* determination of cause and identification of corrective action. As these TPS loss events were observed, flight rationale for the subsequent vehicles was presented to the SSP, and to the extent possible, probable causes were assessed, eliminated, or mitigated.

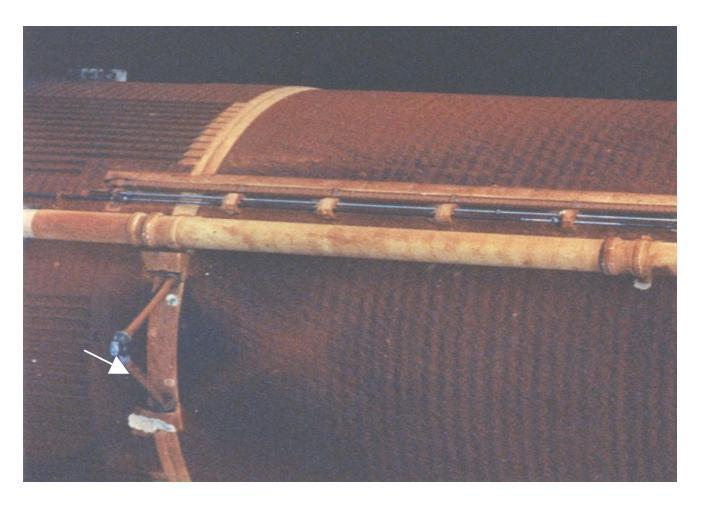
Figure 5.3.3.2-2. STS-50/ET-50

The TPS loss event on STS-50/ET-50 encompassed the majority of the bipod ramp, measuring 26 in. x 10 in. and weighing 0.98 lb (Figure 5.3.3.2-2). This loss was attributed to voids/debonds in the Isochem bond layer of the non-vented two-tone TPS area. ET-50 was the last ET built with this intertank TPS configuration.

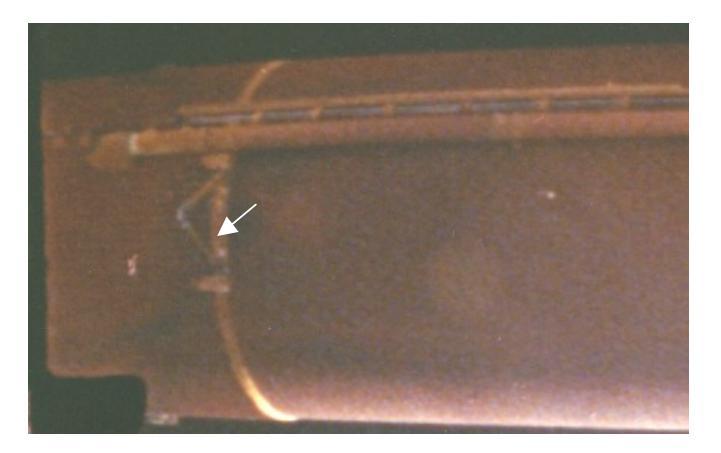
Figure 5.3.3.2-3. STS-52/ET-55

On STS-52/ET-55, the TPS loss was estimated to be 8 in. x 4 in., weighing 0.02 lb. (Figure 5.3.3.2-3)

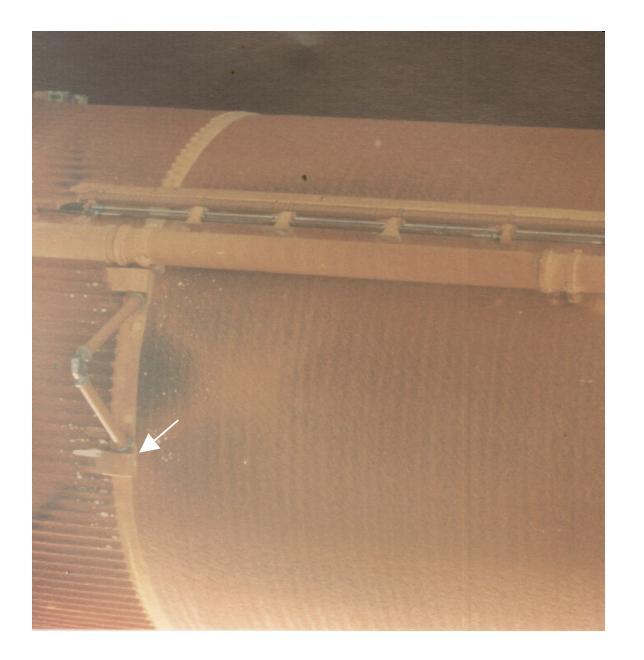
Figure 5.3.3.2-4. STS-62/ET-62

On STS-62/ET-62, there was a small divot in the aft face of the ramp measuring approximately 3 in. x 1 in. and weighing 0.001 lb. (Figure 5.3.3.2-4)

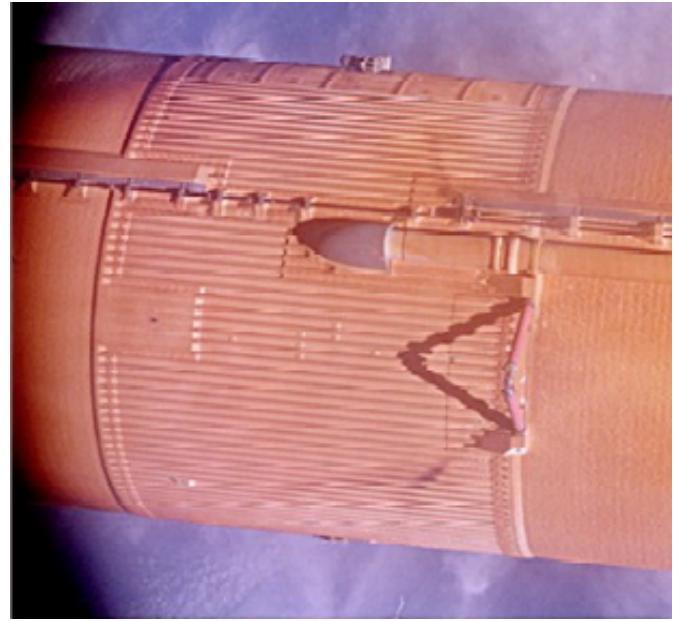
Figure 5.3.3.2-5. STS-112/ET-115

On STS-112/ET-11, the TPS loss location and shape was similar to that observed on STS-52 (Figure 5.3.3.2-5). The TPS loss on STS-112 was estimated to be 7 in. x 12 in. with a mass of 0.3 lb.

Following this occurrence of ramp loss, the ET Project initiated plans to evaluate the materials, design, and processes used for the ramps.

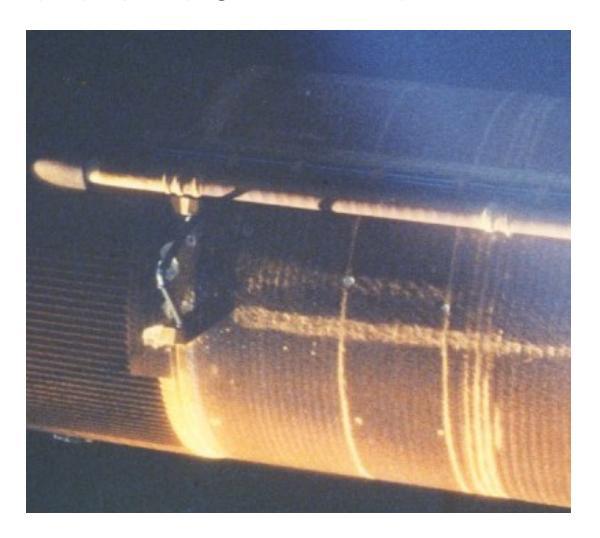
*Figure 5.3.3.5-1.* STS-32R/ET-32 Post-Separation Photograph

Post-separation umbilical camera films showed several large divots in the area of the bipods. Two of the divots, measuring 12 to 14 in. in diameter, were located between the bipods just forward of the intertank-to-LH2-tank flange. A third divot, approximately 14 in. in diameter, was located between the bipod ramps and extended into the intertank-to-LH2-tank flange. The largest divot, measuring 28 in. wide, surrounded the forward part of the -Y (LH) bipod (Figure 5.3.3.5-1).

The most probable cause of this TPS loss was related to inadequate depth of drilled holes (venting) in this two-tone TPS location in conjunction with localized voids at the TPS CPR-488/Isochem bond layer. Following this occurrence of TPS loss, an inspection was added to the manufacturing process to verify vent hole depth. The most probable cause and corrective actions to preclude recurrence were presented/approved at the Level II Program Requirements Control Board (PRCB(PRCBD S044812A) on February 6, 1990.

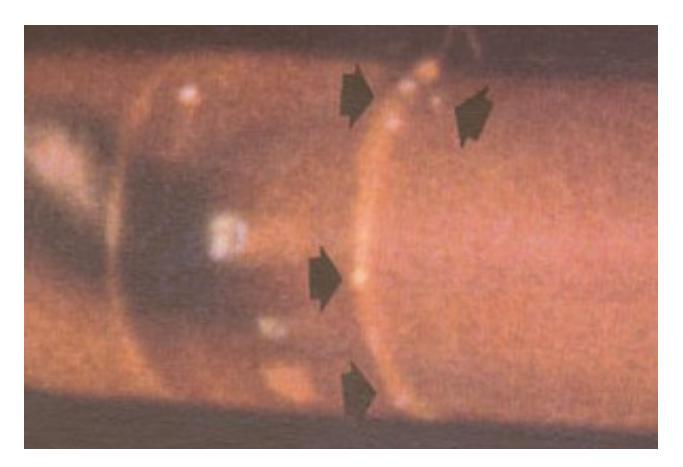
Figure 5.3.3.5-2. STS-35/ET-35 Post-Separation Photograph

Post separation umbilical camera films showed five divots on the left side (-Y axis) of the intertank-to-LH2-tank flange closeout and five divots on the right side of the closeout (+Y axis). The largest divots ranged from 8 to 10 in. in diameter (Figure 5.3.3.5-2). Divots from this area (previously observed on other ETs) did not show a correlation with an increased level of Orbiter tile damage.

The most probable cause of this TPS loss was localized voids behind the intertank-to-LH2-tank flange bolts. The closeout is a very complex manual two-step operation with TPS sprayed into a narrow/deep cavity and around the attach bolts. A review of the manual spray TPS technique showed that voids were a consequence of operator technique. Following this occurrence of TPS loss, an improved application technique was developed to reduce the potential for voids around the flange bolts. This process was validated and the operators were required to demonstrate their ability to perform the closeout successfully. Through the process enhancement, the number of divots was reduced but not completely eliminated.

The most probable cause and corrective actions to preclude recurrence were presented/approved at the Level II PRCB (PRCBD S044824C) on June 14, 1991.

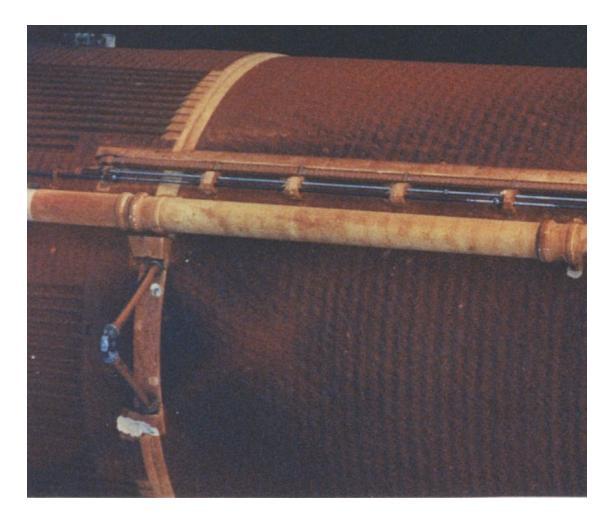
Figure 5.3.3.5-4. STS-50/ET-50 Post-Separation Photograph

Post-separation umbilical camera films showed two areas of TPS damage near the forward bipod area. The first showed approximately 60% of the –

Y bipod ramp was missing with a 24 in. by 8 in. divot. The second location was the +Y jack pad closeout, measuring 4.5 in. sq., located just below the right bipod strut (Figure 5.3.3.5-4). The TPS surface under the bipod ramp was the intertank two-tone TPS configuration. The jack pad is a Polymer Development Laboratories (PDL) closeout of a tooling mount used to jack the Orbiter into place for mate at KSC.

The most probable cause of the bipod ramp TPS loss was related to debonds/voids in the Isochem bond layer of the two-tone TPS configuration. This area was not vented because of proximity to the cryogenic zone. Following this occurrence of TPS loss, the vented area on remaining ETs with Intertank two-tone TPS (ET-48/STS-46, ET-49/ST-53, and ET-45/STS-47) was revised to add vent holes just forward of the ramp to acreage interface (Figure 5.3.3.5-5).

The most probable cause of the jack pad closeout was cryopumping of a subsurface void under the PDL pour TPS closeout. It was determined that loss of this TPS during ascent was not considered a flight or safety issue; therefore, it was recommended to fly the subsequent ETs with no

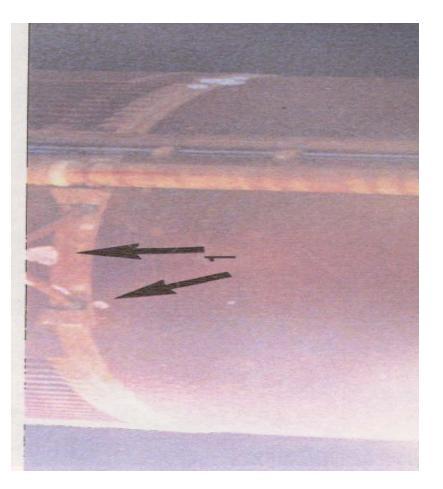
Post-separation umbilical camera films showed a divot approximately 14 to 16 in. in diameter on the intertank between the left and right bipod fittings just forward of the intertank flange closeout in the two-tone TPS area (Figure 5.3.3.5-6).

*Figure 5.3.3.5-6. STS-47/ET-45 Post-Separation Photograph* Minimal Orbiter tile damage was observed post-flight on OV-105 (STS-47). TPS loss of this type was not considered a safety of flight concern but one of Orbiter tile maintenance.

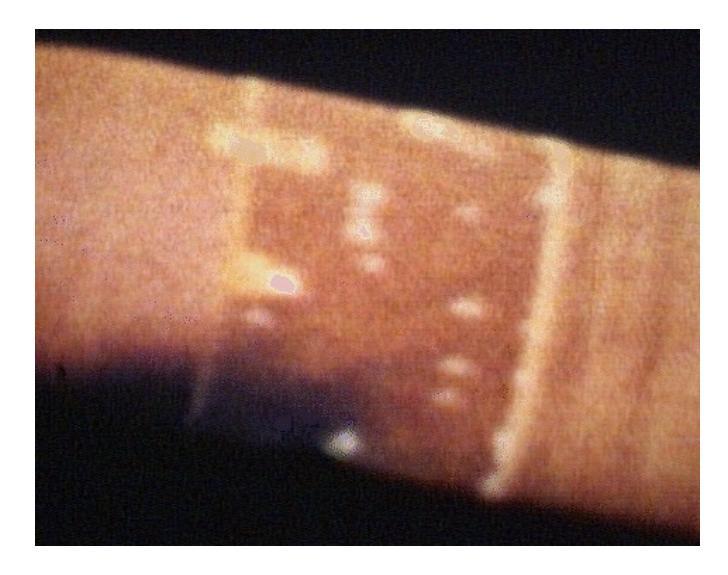
*Figure 5.3.3.5-7.* STS-56/ET-54 Post-Separation Photograph

Post separation crew handheld camera films showed 10 large, shallow divots on the –Z side of the intertank acreage (Figure 5.3.3.3-7). The divots were in a unique pattern, with two lines with 3 and 4 divots each. The magnitude of the TPS loss experienced on STS-56 was within the STS experience base.

The most probable cause of this TPS loss was not conclusively determined. The most likely scenario is rollover/crevicing anomalies in the TPS (Figure 5.3.3.5-8), and the effects in the flight environment. Differential pressure caused by aeroheating, flight loads, and panel flexure may have caused anomalies to propagate along the TPS knitlines (area between TPS spray passes), with shallow divots as the result.

No immediate corrective actions were implemented. An application process enhancement was implemented to minimize or eliminate the occurrence of rollover or crevicing. This enhancement would reduce the

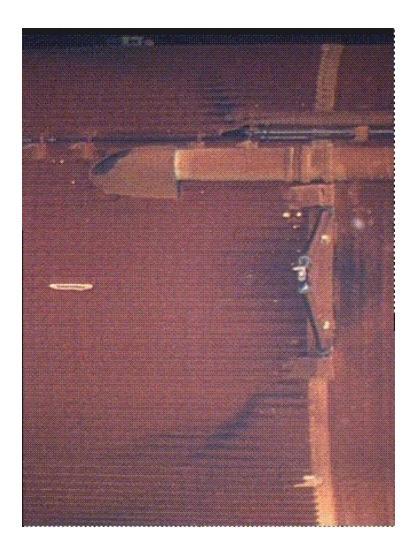
Figure 5.3.3.5-9. STS-58/ET-57 Post-Separation Photograph

Post-separation umbilical camera films showed three areas of TPS loss on the intertank +Z side. One divot (approximately 28 in. L x 3 in. W) was in the acreage TPS, and the other two divots were identified as the TPS from the jack pad closeouts. Exposed primer was observed in both jack pad cavities (Figure 5.3.3.5-9), Divots of this magnitude and the Orbiter tile damage were within the STS experience base.

The most probable cause of the intertank acreage divot on STS-58 is the same as suspected for the TPS loss on STS-56 – Anomalies in the TPS caused by rollover/crevicing phenomenon.

The most probable cause of the jack pad closeout was cryopumping of a subsurface void under the PDL pour TPS closeout. Following this jack pad closeout TPS loss occurrence, a tool was developed to allow spray around the holes masking the jack pad tooling holes, leaving four 1-in. diameter holes on each side of the closeout to eliminate the large closeout/repair area (6 in. x 6 in. square). The jack pad itself is now closed out in conjunction with the flange closeout.

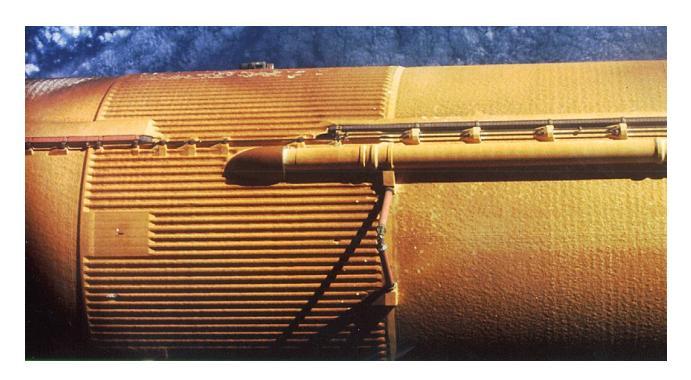
Figure 5.3.3.5-10. STS-87/ET-89 Post-Separation Photograph

Post-separation crew handheld camera films showed areas of missing TPS on the +Y and -Y thrust panels (Figure 5.3.3.5-10). Post-landing inspection also showed a significant increase in Orbiter tile damage: 308 damage sites on the Orbiter lower surface, with 132 sites greater than 1 in. The total number of lower surface damage site and the number of damage sites greater than 1 in. were out of family when compared to previous missions.

The most probable cause of this TPS loss was a combination of the following factors:

- Reduced mechanical properties of the TPS and its trapped gases
- Environmentally induced cell gas pressure from heating, vacuum, and moisture in the cells
- Stress concentrating geometry, especially evident on the intertank thrust panels and to a lesser extent on the skin/stringer panels.

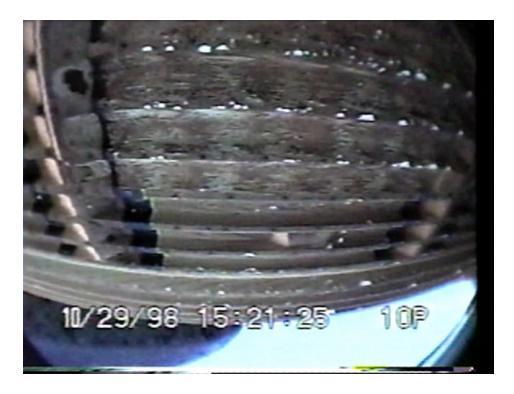
Figure 5.3.3.5-11. STS-95/ET-98 Post-SRB-Separation Photography

A study to gain an understanding of the TPS loss event ensued; the first data gathering exercise included the installation of a camera on one SRB of STS–95/ET-98. This camera imaged the ET intertank thrust panel during flight and provided the first opportunity to view TPS loss up close and in real time (Figure 5.3.3.5-11). The camera showed TPS loss initiating approximately 92 sec into the flight and continuing until SRB separation, at which time the view was lost.

TPS loss was seen to be most severe on the tops and sides of the thrust panel ribs but was not limited to these areas. Some material loss was also observed on the skin-stringer areas of the intertank. From a visual standpoint, the TPS loss closely resembled the phenomenon known as 'popcorning', which has been observed in thermal-vacuum testing at MSFC and MAF test facilities.

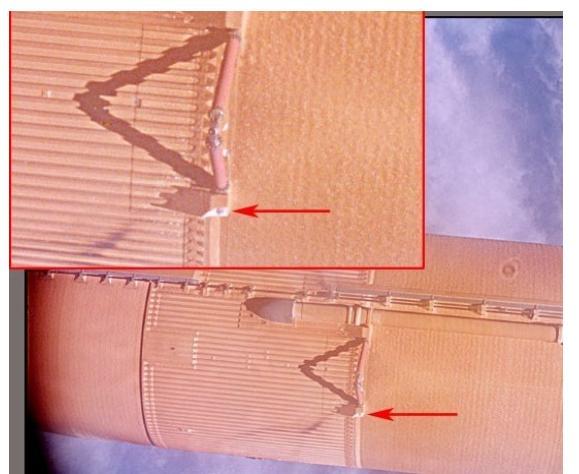
*Figure 5.3.3.5-12.* STS-112/ET-115 Post-Separation Photography

Post-separation crew handheld camera films showed an area of missing TPS (approximately 4 in. x 5 in. x 12 in.) on -Y bipod ramp exposing the bipod housing SLA closeout (Figure 5.3.3.5-12).

The most probable cause of this TPS loss occurrence was suspect subsurface void(s) during bipod ramp closeout coupled with launch environments. The most probable cause was presented at the SSP PRCB (S062151, Action # MSFC-ET/1-1) on December 19, 2002 and at that time, the Project identified the corrective action that was under evaluation. The proposed corrective action was to enhance the closeout configuration by eliminating the SLA under the TPS, thereby eliminating the potential for air entrapment (subsurface voids). The final corrective action was to have been presented at the SSP PRCB on February 6, 2003.

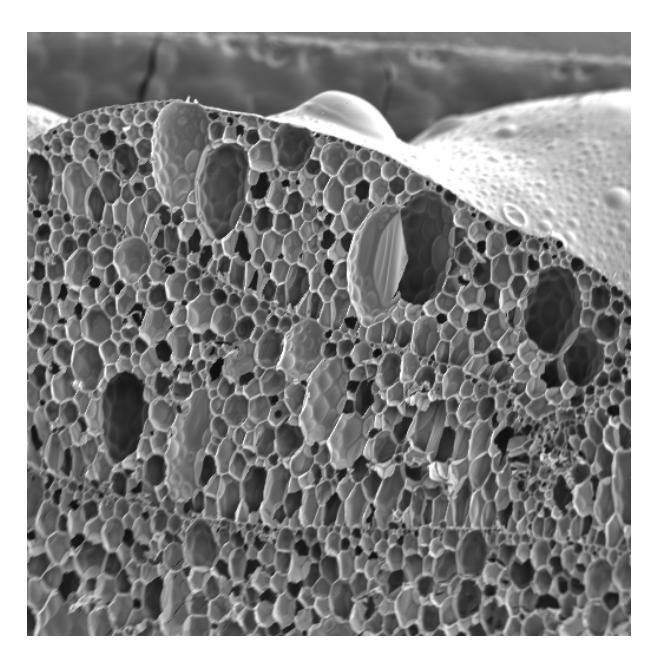
Figure 7.2.1.8.1.1-2. NCFI Scanning Electron Microscopy Photomicrograph (30X)

The internal cell structure of the NCFI material is a closed-cell foam, as shown in Figure 7.2.1.8.1.1-2.

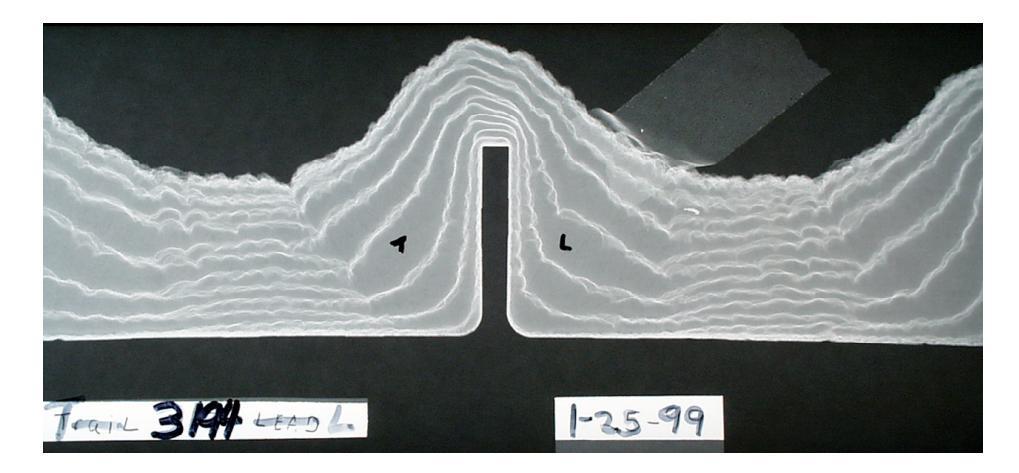
Figure 7.2.1.8.1.1-3. Foam Structure

ETWG\_FnIRpt\_Volume\_I.doc 340 application is controlled to provide an "as-sprayed" finish within the required ET thickness, roughness, and waviness constraints without machining. During the SLWT design process, however, a decision was made, which is being revisited as the acreage foam transitions to NCFI 27-68, to machine the intertank TPS surface in acreage regions outside of the LO2 and LH2 ice/frost regions for weight savings. Figure 7.2.1.8.1.1-3 shows a section through the intertank thrust panel foam.
