COLUMBIA

ACCIDENT INVESTIGATION

**REPORT VOLUME IV** OCTOBER 2003

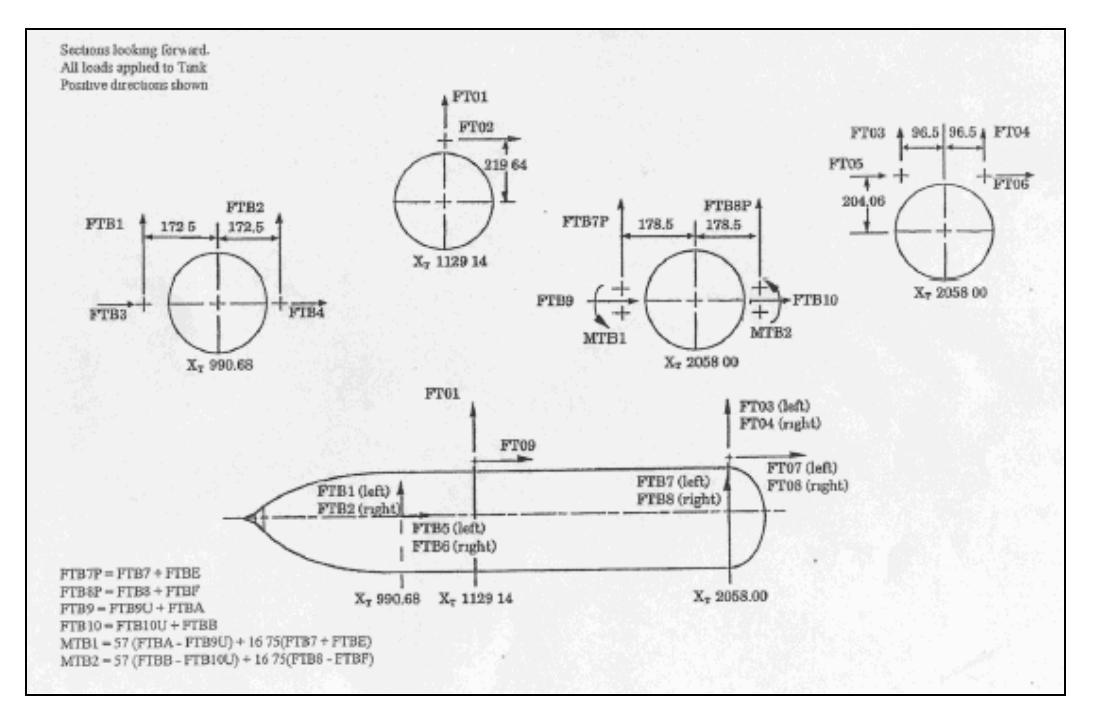
Figure 7.2.3.8.1.2-2. ET Interface Load Indicators

No loads issues were found with any phase of operations. All indicators were well within design limits. The flex body loads reconstruction was actually less than the BET reconstruction, so they did not affect the evaluation. All of the analysis to date shows no evidence of excessive or anomalous loading.
