NASA TN D-7143

APOLLO EXPERIENCE REPORT - DESCENT PROPULSION SYSTEM

*by William R. Hammock, Jr., Eldon C. Currie,
and Arlie E. Fisher*

*Manned Spacecraft Center
Houston, Texas 77058*

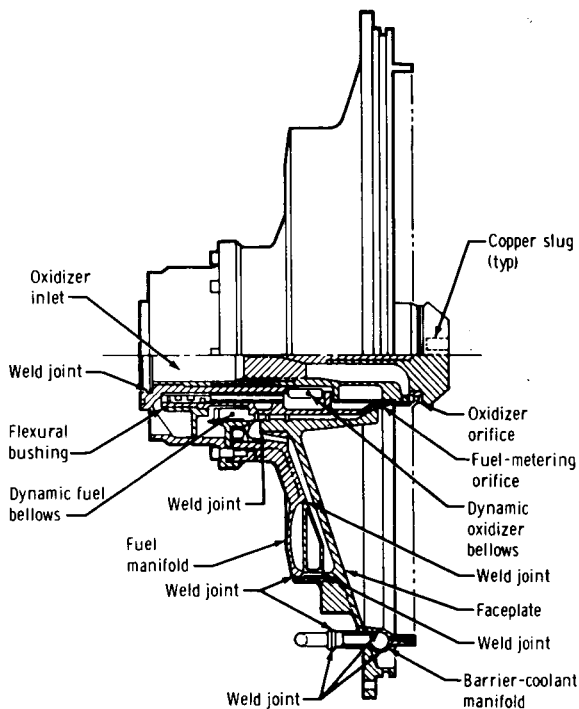
Figure 9. - Cross section of LM descent-engine injector.

combustion roughness was experienced, which was a random-type pressure oscillation with no cyclic resonant frequency. The source of this combustion roughness appeared to be primarily the coarse injector design. The relatively few oxidizer streams (36 primary and 36 secondary) provided a source of uneven combustion. Bomb tests were performed at various positions in the chamber, and no incidence of combustion instability occurred. The bomb tests were performed in a steel-wall combustion chamber to minimize the natural damping effect of the ablative chamber.

The original injector pintle tip (figs. 9 and 10) was made of stainless steel, and it incurred severe erosion during engine operation because of inadequate cooling. As a result of the erosion, copper slugs were incorporated in the pintle tip to promote better

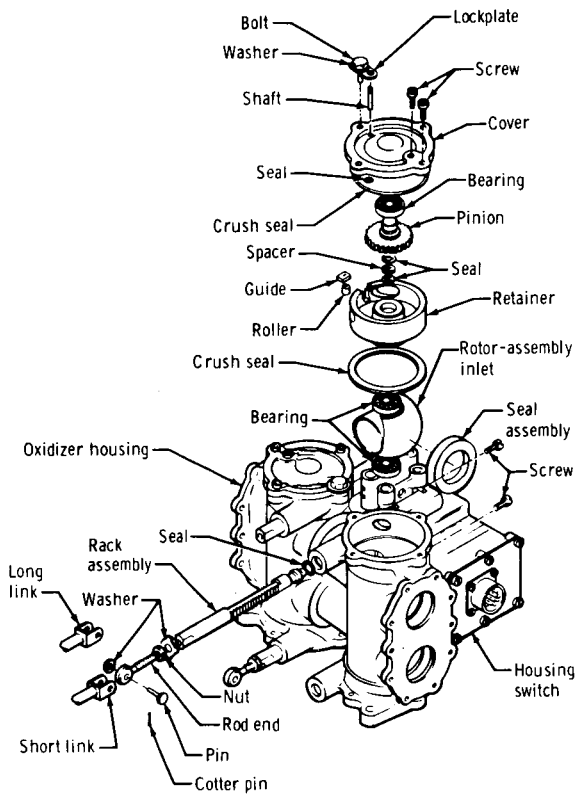
Figure 11. - Exploded view of oxidizer section of engine shutoff valve.

In the testing of developmental and WSTF engines, several instances of rack jamming or sluggish valve actuation occurred. This problem was caused by oxidizer leakage past the shaft seals (fig. 11) into the gear cavities and by subsequent reaction of the oxidizer with the gear lubricant. No cases occurred where the valve completely jammed, but all cases resulted in sluggish valve actuation on the affected rack. The gear cavities on all flight engines were checked for leaks and acidity (pH factor) before delivery. Also, a force-pressure check to detect sluggish valves was performed at the plant of the contractor and at the NASA John F. Kennedy Space Center to measure the pressure for cracking and full-open actuation of each of the four actuators.

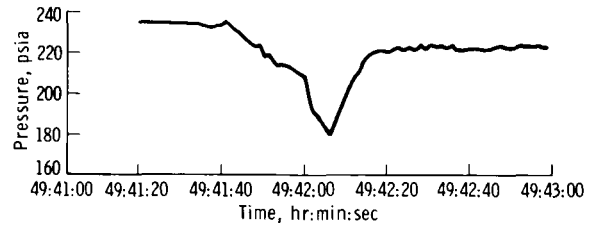
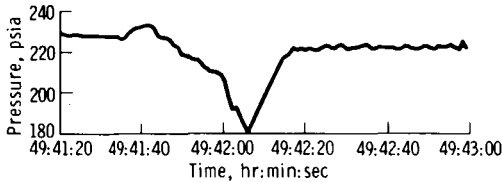
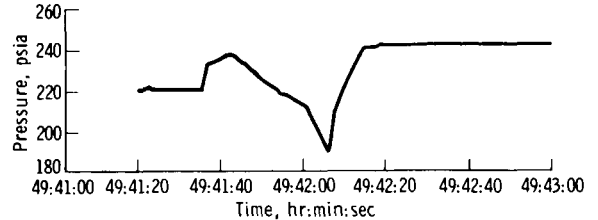
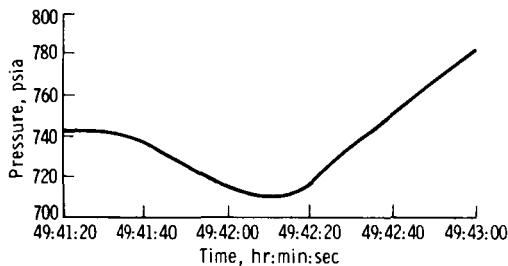
Figure 13. - Apollo 9 DPS pressures during start of first firing.

The SHe tank internal-heat-exchanger freezing: During the first 35 seconds of the first descent-engine firing, the regulator outlet-manifold pressure decreased from 235 to 188 psia. The regulator should have regulated at 247 psia (fig. 13). The
