# Shuttle Liquid Hydrogen (LH2) Engine Cut-Off (ECO) System Anomaly

**Presenter:**

**Michael D Stirling**

**NASA Electrical Systems**

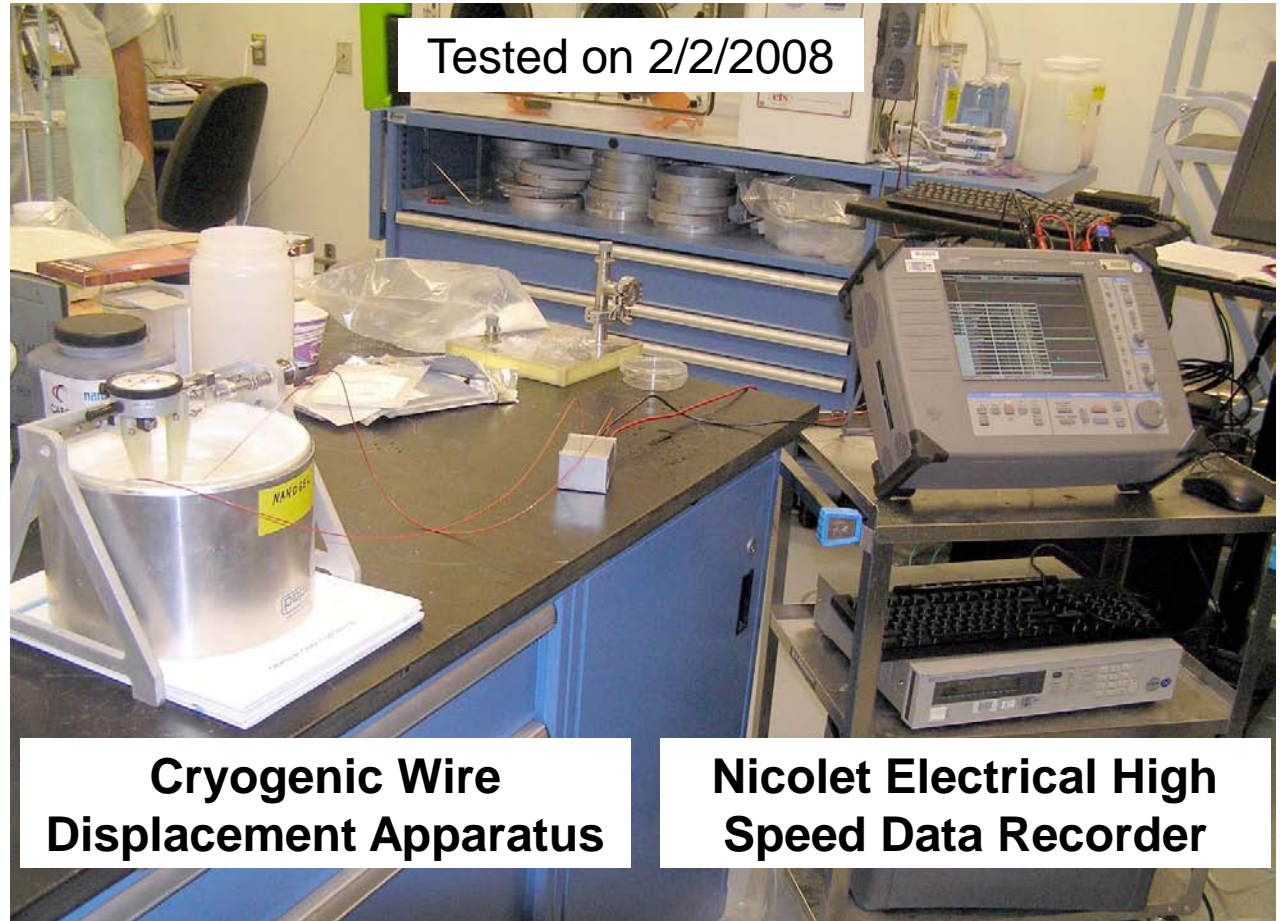
**Cryogenic Wire  
Displacement Apparatus**

Anomalous electrical behavior and opens are noted with respect to displacement and contaminant condition (i.e. Krytox®, water, frost, Krytox®/water, or baseline/clean).

Krytox®/water contamination is achieved by cooling engaged pin/socket in LN2 for 3 minutes then removing from LN2 and allowing frost/condensate to form engaged or disengaged or a combination thereof. Pin/socket is engaged 160 mils then placed back into LN2 for at least 3 minutes before displacement.
