VEHICLE ENGINEERING

STS-112 FLIGHT READINESS REVIEW

Presenter:
	Organization/Date: Orbiter/09-17-02

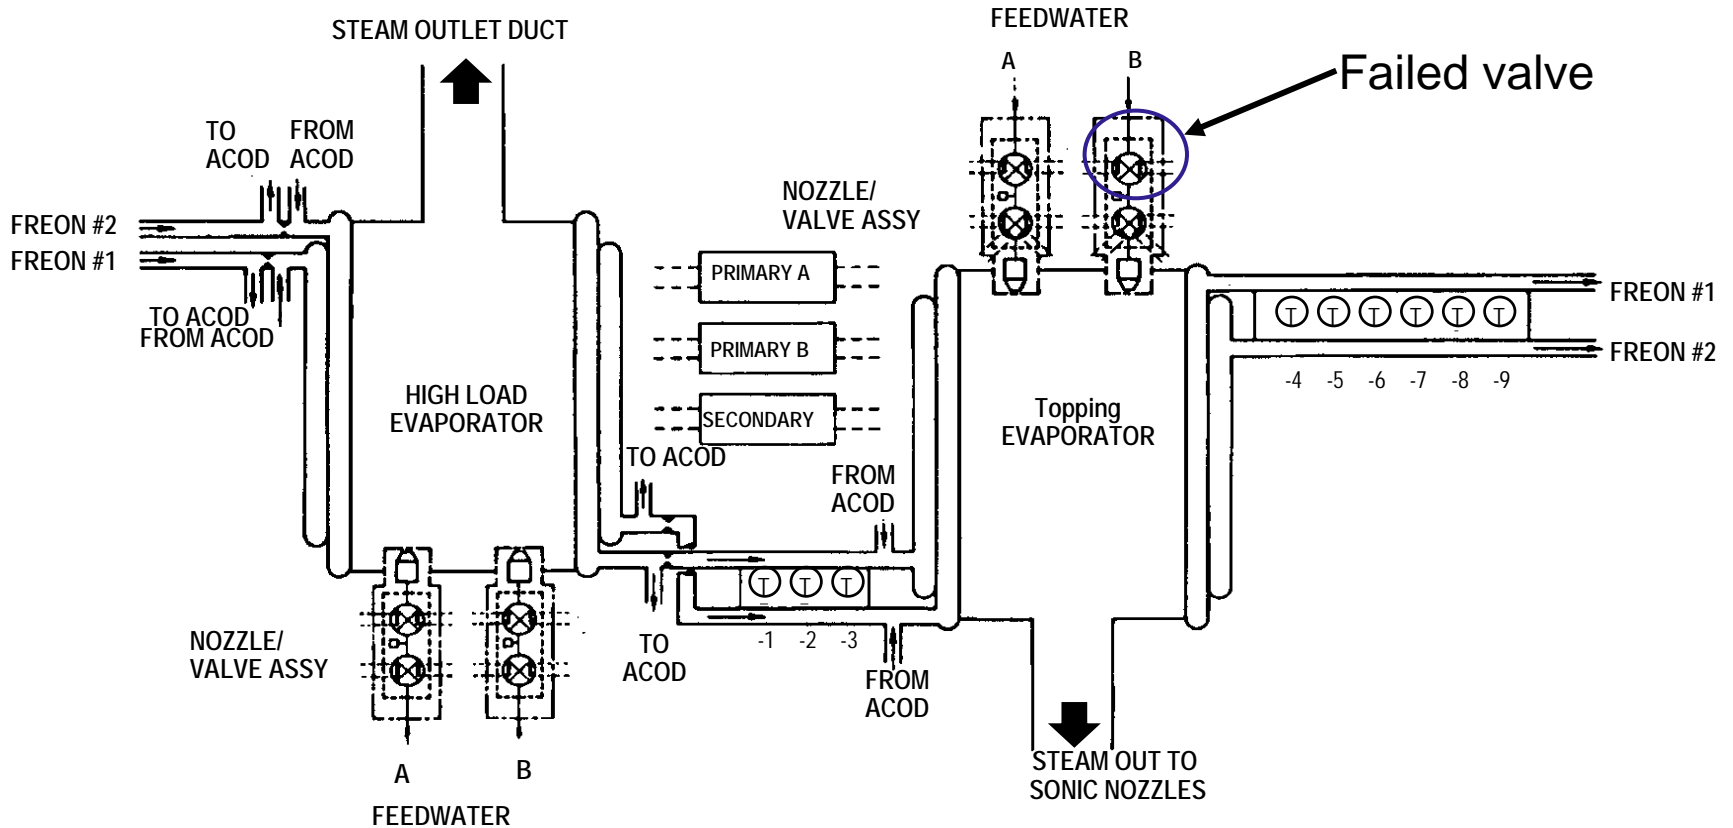
STS-111-V-02: FES FAILURE ON PRIMARY B CONTROLLER

- Two attempts to restart the topper in primary B failed
- Core flush using secondary controller was successful, verified that:
 - Feedline B was not obstructed
 - FES B system isolation valve and pulser valve are mechanically sound
 - Primary A and secondary controllers are good

- Fault tree was developed and most probable cause was isolated to the primary B control system
- Post-flight troubleshooting showed the FES water system B isolation valve coil to have high resistance
 - Open circuit across the isolation valve
 - Valve was removed and replaced
 - TT&E and FA will be performed

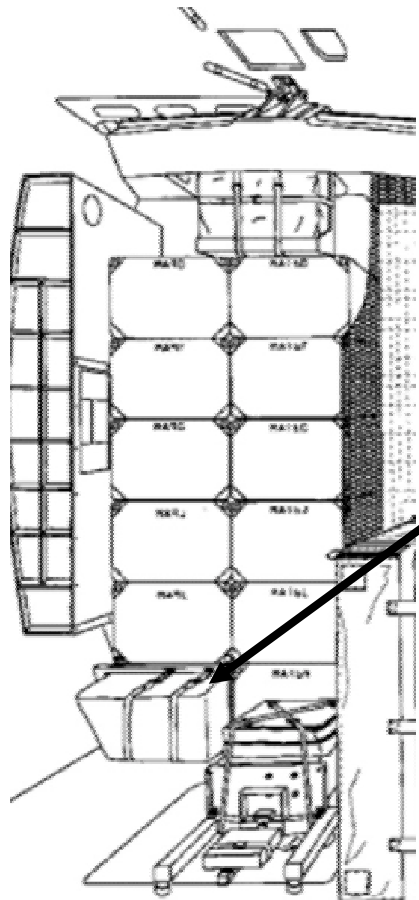
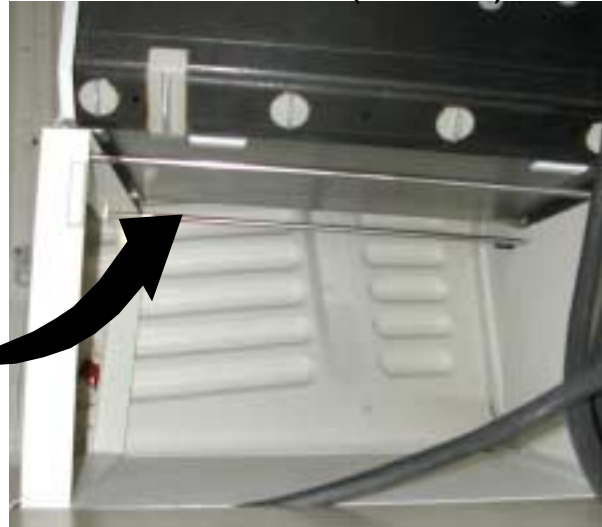
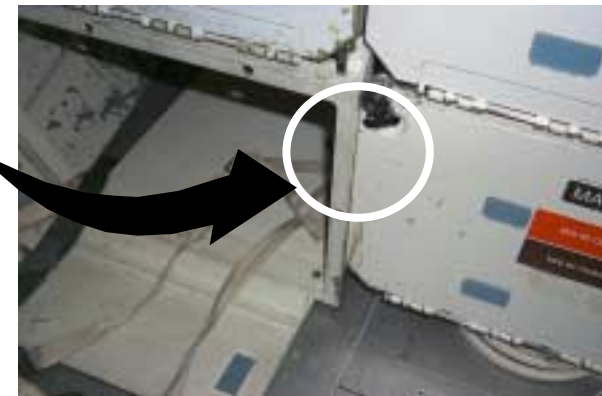
MCR 18755 MA9N Interference

INTERFERENCE
LOCATION

TWO BRACES
ADDED

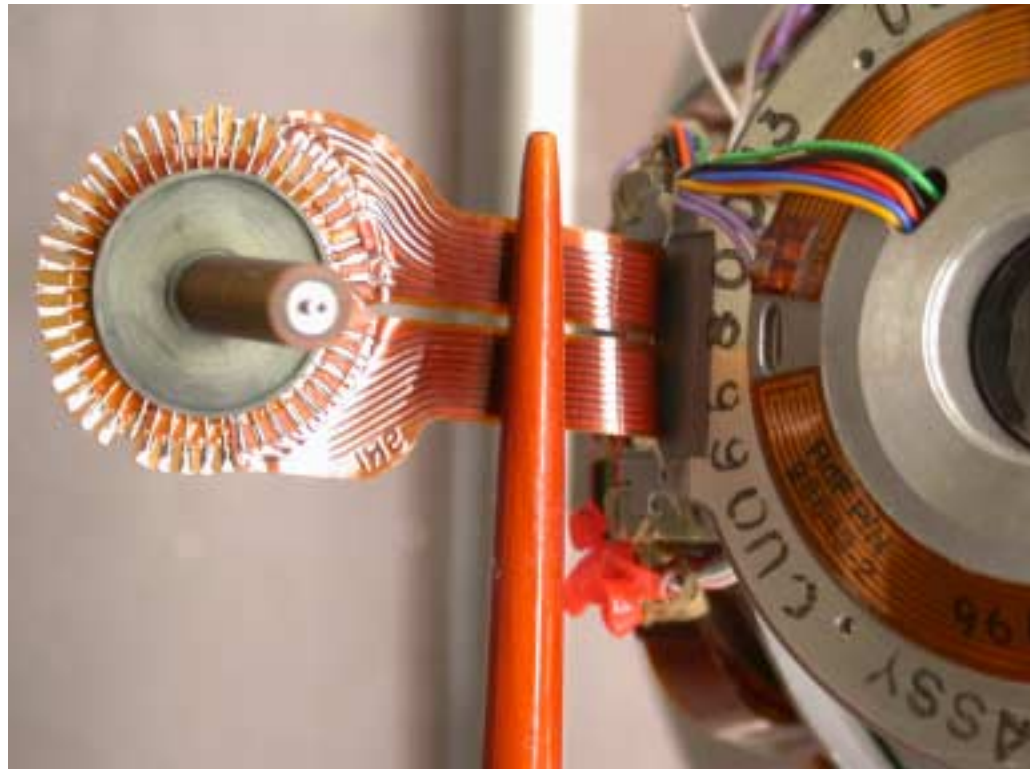
Slip Ring Fan-Out Removed from Coordinate Resolver

- X-ray analysis of the 42-wire azimuth slip ring found breaks in fan-out wires 3, 5, 6 & 7
 - Wire 3 carried the 90 degree phase of the azimuth gyro motor power
- SEM analysis indicates fatigue failure from up/down flexure
- Slip ring misalignment is a phenomenon observed to be present and variable between IMUs
 - A side load on the slip ring shaft from the brush block tape cable is the major contributor to slip ring misalignment
 - Slip ring misalignment varies among IMUs

Most probable cause of wire failures appears to be a combination of the degree of slip ring misalignment and the number of times it is flexed (usage related)

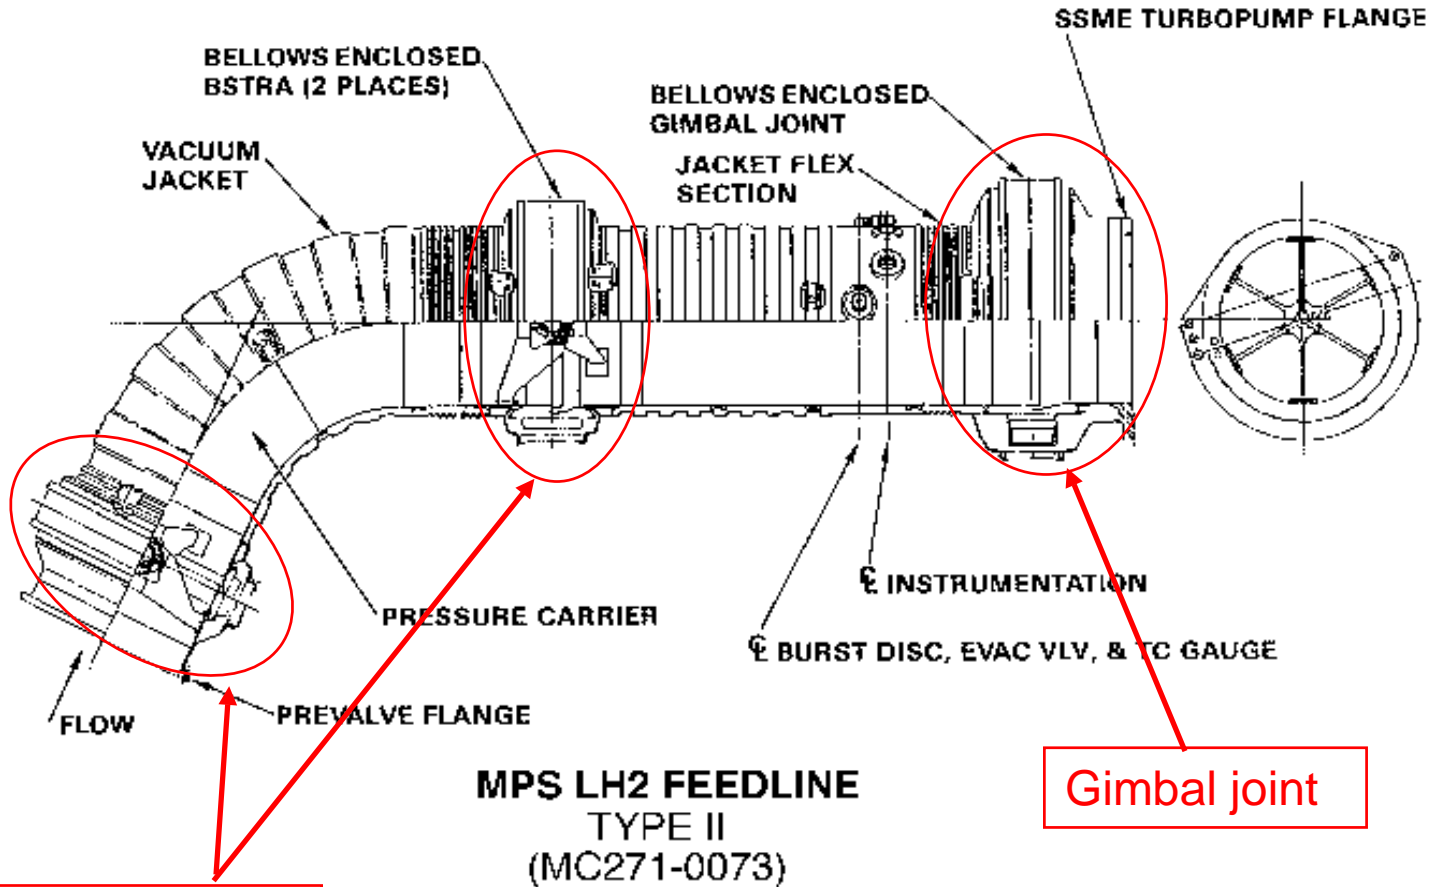
- Crack propagation resulting in possible:
 - Metallic FOD ingestion by SSME
 - Loss of flowliner integrity
 - Disruption of flow field leading to LPFTP cavitation

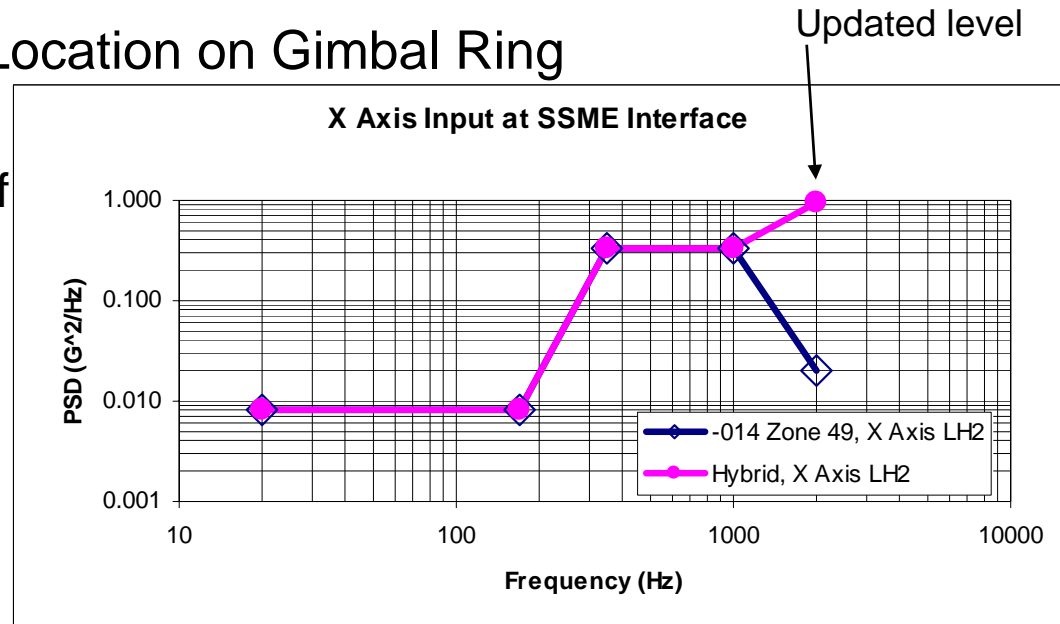
- Fatigue Critical Location on Gimbal Ring

- Updated to model based of latest test data and updated environment based on review of flight data

- Feedline dynamic loads re-run using adjusted input levels for axial direction
- Found significant increase in response
 - Axial loads up by a factor of 2.5
 - Primary frequency doubled, more cycles

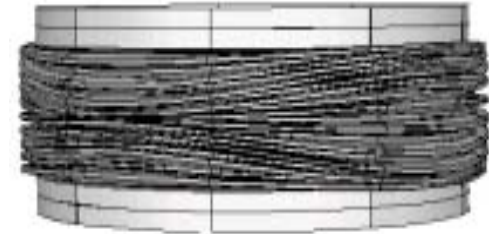
2nd Vibration Mode
of Bellows

- Bellows
 - Performed dynamic response analysis with pressure fields tuned to vibration modes
 - Fatigue analysis resulted in 51 missions of life with a scatter factor of 4

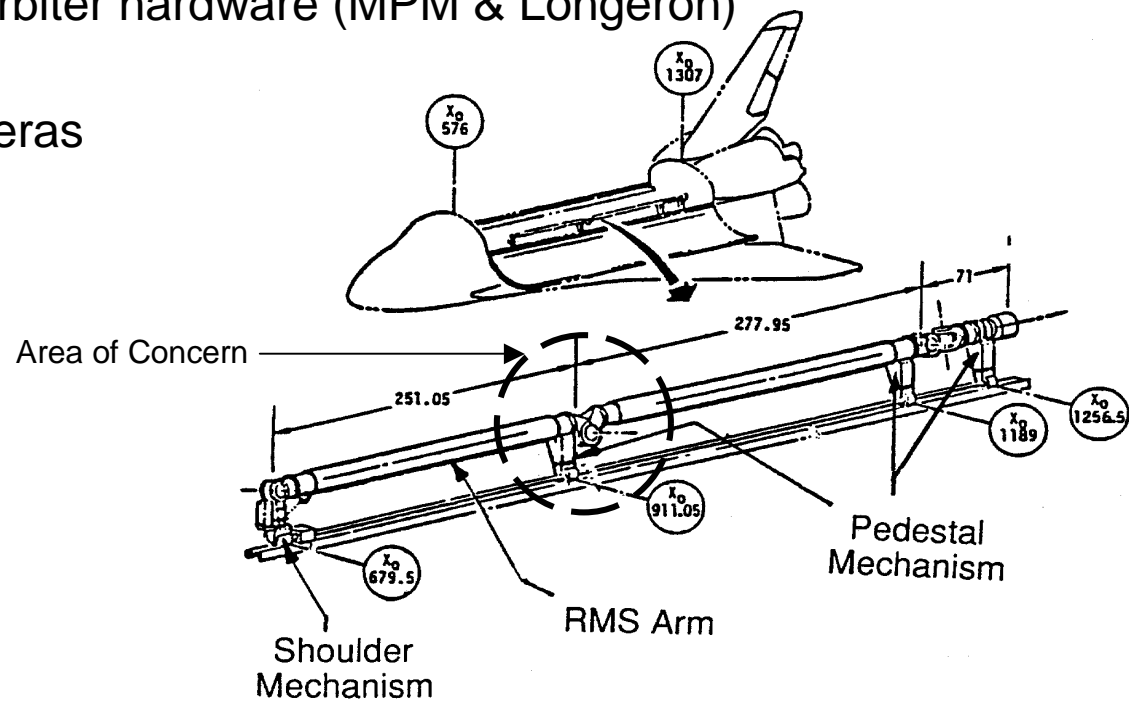
- STS-112 analysis identified exceedances for MPM pedestal 1 +Mx (X_0 911)
- Dynamic base drive analysis performed to produce high fidelity loads for RMS and its attachments
 - Affected Orbiter hardware (MPM & Longeron)
 - RMS
 - RMS Cameras
