SPACE SHUTTLE MAIN ENGINE THE FIRST TEN YEARS¹

Robert E. Biggs²

Part 1 – The Engine

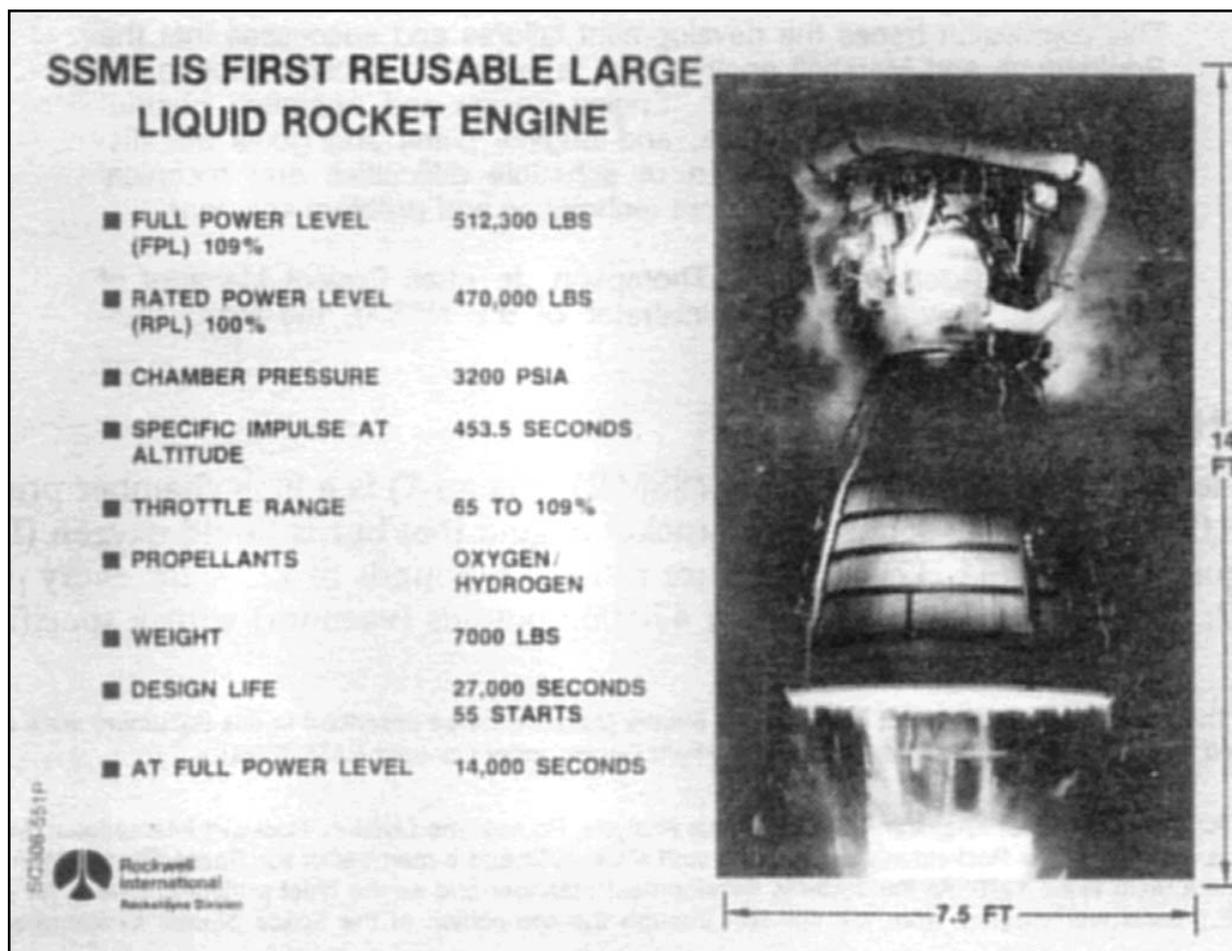
Figure 1. Space Shuttle Main Engine (Photo No. SC308-551P)

The Space Shuttle Main Engine (SSME) (Figure 1) is a high chamber pressure (over 3,000 pounds per square inch) rocket engine that burns liquid oxygen (LOX) and liquid hydrogen (LH2) at a mixture ratio of 6 pounds of LOX for every pound of LH2. It produces a rated thrust of 470,000 pounds (vacuum) with a specific impulse greater than 453 pounds of thrust per pound of propellant per second. This very high efficiency is achieved by the utilization of a “staged combustion cycle” wherein a portion of the propellants, partially combusted at a fuel-rich mixture ratio, is used to drive the high pressure turbopump

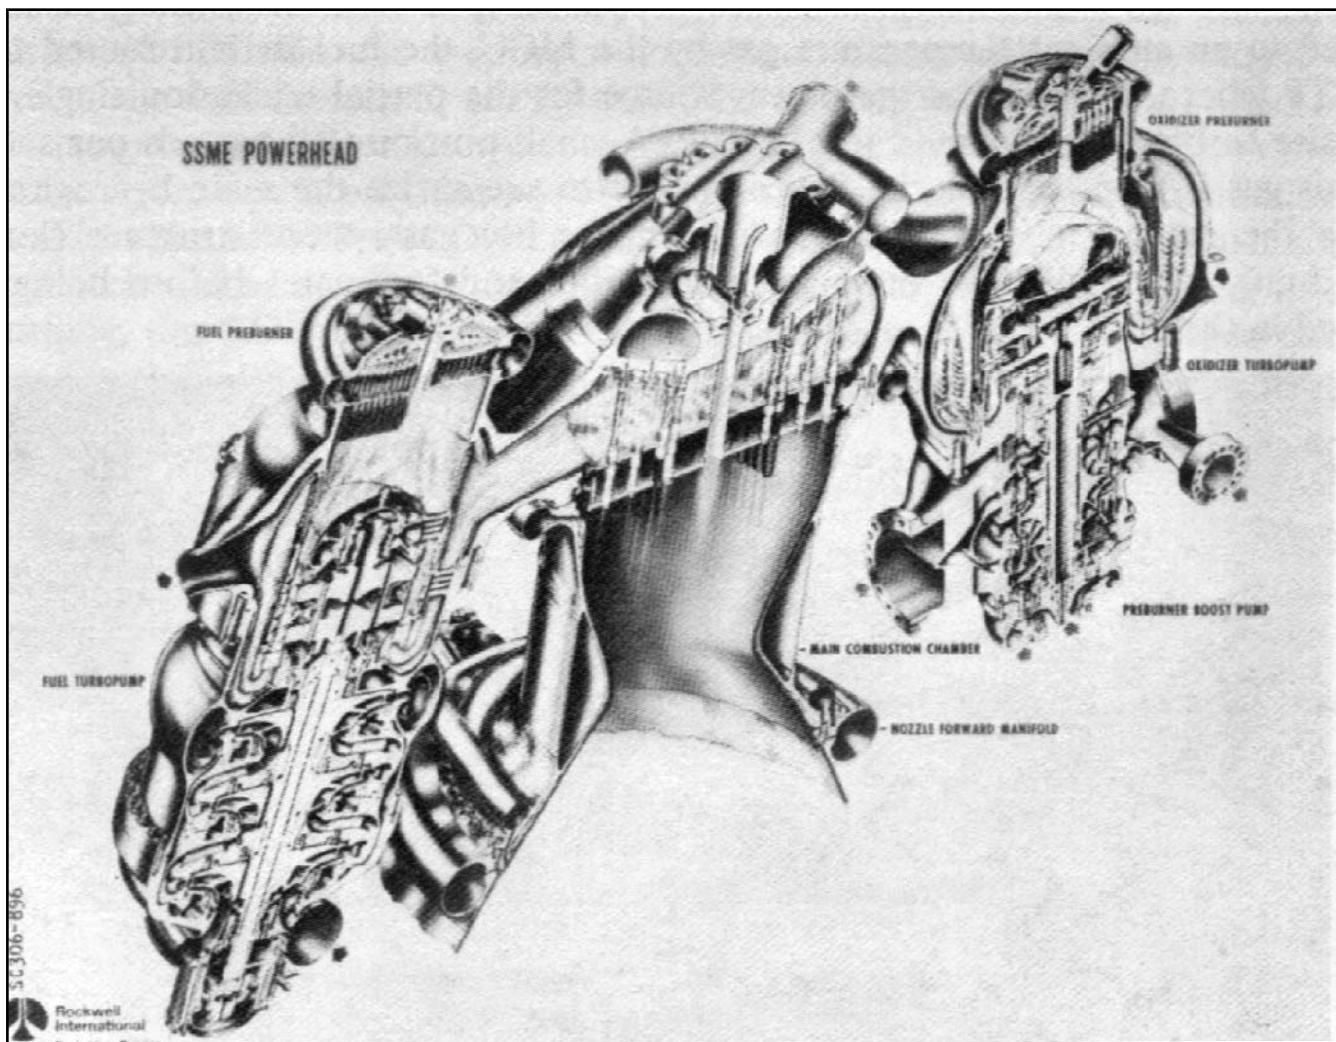
turbines prior to being completely burned in the main combustor. Figure 2 is a representation of the major components of the powerhead. As can be seen in this cutaway view, the turbine drive gases are produced in two “preburners” to provide the power for the two high pressure turbines, they then exit into the main fuel injector, and are burned with the remainder of the propellants in the main combustion chamber. This results in maximum propellant efficiency because all the propellant is used in the main combustor, and none is wasted by being dumped overboard from a low pressure turbine exhaust system as was the case with all prior large liquid rocket engines. This improved efficiency is achieved at a significant cost in system pressures. With the turbines in series with the main combustor, the turbine exhaust pressure has to be higher than the main combustion chamber pressure. Although the turbines are designed for low pressure ratio (approximately 1.5 to 1) the turbine inlet pressure has to be about 50 percent higher than the exhaust pressure in order to provide sufficient power. The preburners that provide the turbine drive gases have propellant injectors that require a minimum differential pressure in order to assure stable combustion. This further increases the required turbopump discharge pressures for the propellant pumps to as much as two and a half times the main combustion chamber pressure.

Figure 2. SSME Powerhead (Photo No. SC306-896)

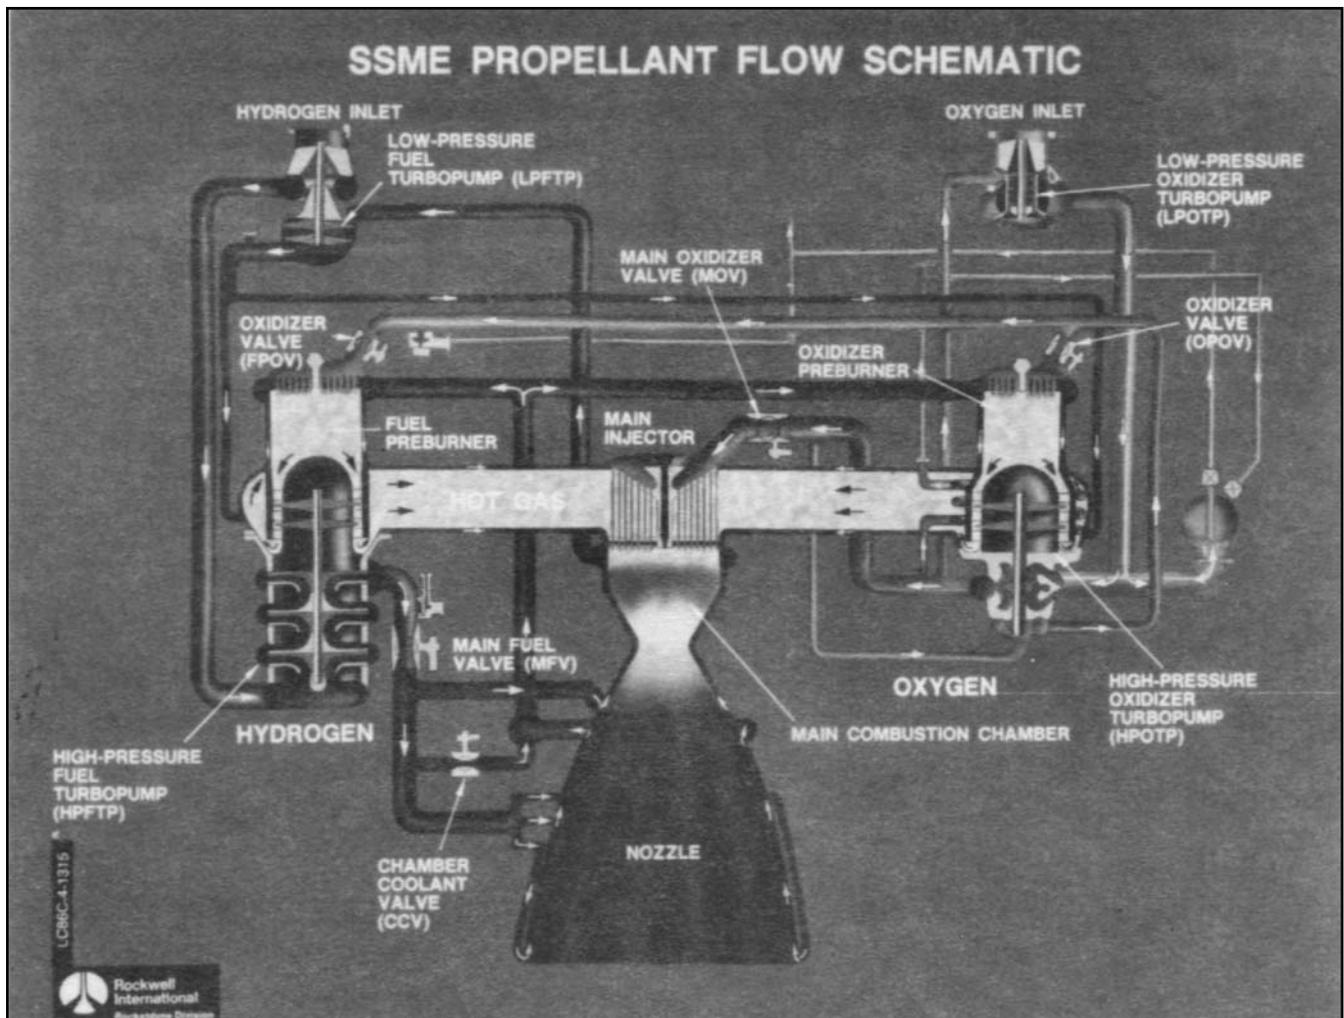
Figure 3 is a schematic representation of the engine system showing the interrelationship of the major components and the flow path of the propellants. To provide turbine power in the staged combustion cycle, 80 percent of the fuel (LH2) is burned in the two preburners with 12 percent of the oxidizer (LOX). The turbine exhaust gases are then burned in the main combustion chamber (MCC) with the remainder of the propellants.

Figure 3. SSME Propellant Flow Schematic (Photo No. LC86C-4-1315)

The LH2 enters the engine at the low pressure fuel turbopump (LPFTP) inlet at a pressure of 30 psia and is increased in pressure by the 15,000 rpm turboinducer to over 250 psia. This pressure is required to prevent cavitation of the high pressure fuel turbopump (HPFTP). The three-stage centrifugal pump, operating at 35,000 rpm, further increases the pressure to over 6,000 psia. The LH2 is then divided into three separate flow paths. Approximately 80 percent of the fuel flows to the two preburners; half of this, however, is used to cool the thrust chamber nozzle and

then mixed with the other half prior to entering the preburners. The remaining 20 percent of the fuel is used in the major component cooling circuit. The LH2 is first routed to the MCC where it provides coolant for the main combustion process by flowing through 390 milled slots in the copper alloy combustor. Having been converted to an ambient temperature gas by the MCC, the fuel is then routed to the LPFTP where it is used as the power source for the partial admission single stage impulse turbine which drives the LPFTP. A small portion (0.7 pounds per second) of this gas is then used by the Space Shuttle to pressurize the main hydrogen tank while the rest of it is used to cool the major hot gas system structure (hot gas manifold) and finally, the main injector baffles and faceplates before being consumed in the MCC.

The LOX enters the engine at the low pressure oxidizer turbopump (LPOTP) inlet at a pressure of 100 psia and is increased in pressure by the 5,000 rpm turboinducer to over 400 psia. This pressure is required to prevent cavitation of the high pressure oxidizer turbopump (HPOTP). The dual inlet single stage centrifugal main impeller, operating at almost 30,000 rpm, further increases the pressure to about 4,500 psia. Most of the LOX is then routed through the main oxidizer valve to the coaxial element main injector of

the MCC. A small amount of LOX (1.2 pounds per second) is routed through an engine-mounted heat exchanger and conditioned for use as the pressurant gas for the Space Shuttle main oxidizer tank. The remainder of the LOX is ducted back into a smaller boost impeller on the same shaft to increase the pressure to as much as 8,000 psia. This provides enough pressure to allow the use of throttle valves to control the LOX flow rate into the two preburners. Thrust control is achieved by closed loop throttling on the oxidizer preburner (OP13) side and mixture ratio control is accomplished by closed loop control of the fuel preburner (FPB) side. The throttle valves are controlled by an engine-mounted computer known as the main engine controller (MEC). A built-in recirculation flow path provides power for the six stage axial flow hydraulic turbine which drives the LPOTP. A LOX flow rate of approximately 180 pounds per second is supplied from the discharge side of the main impeller; and, after passing through the turbine, this LOX is mixed with the discharge flow of the LPOTP and thereby returned to the HPOTP inlet.

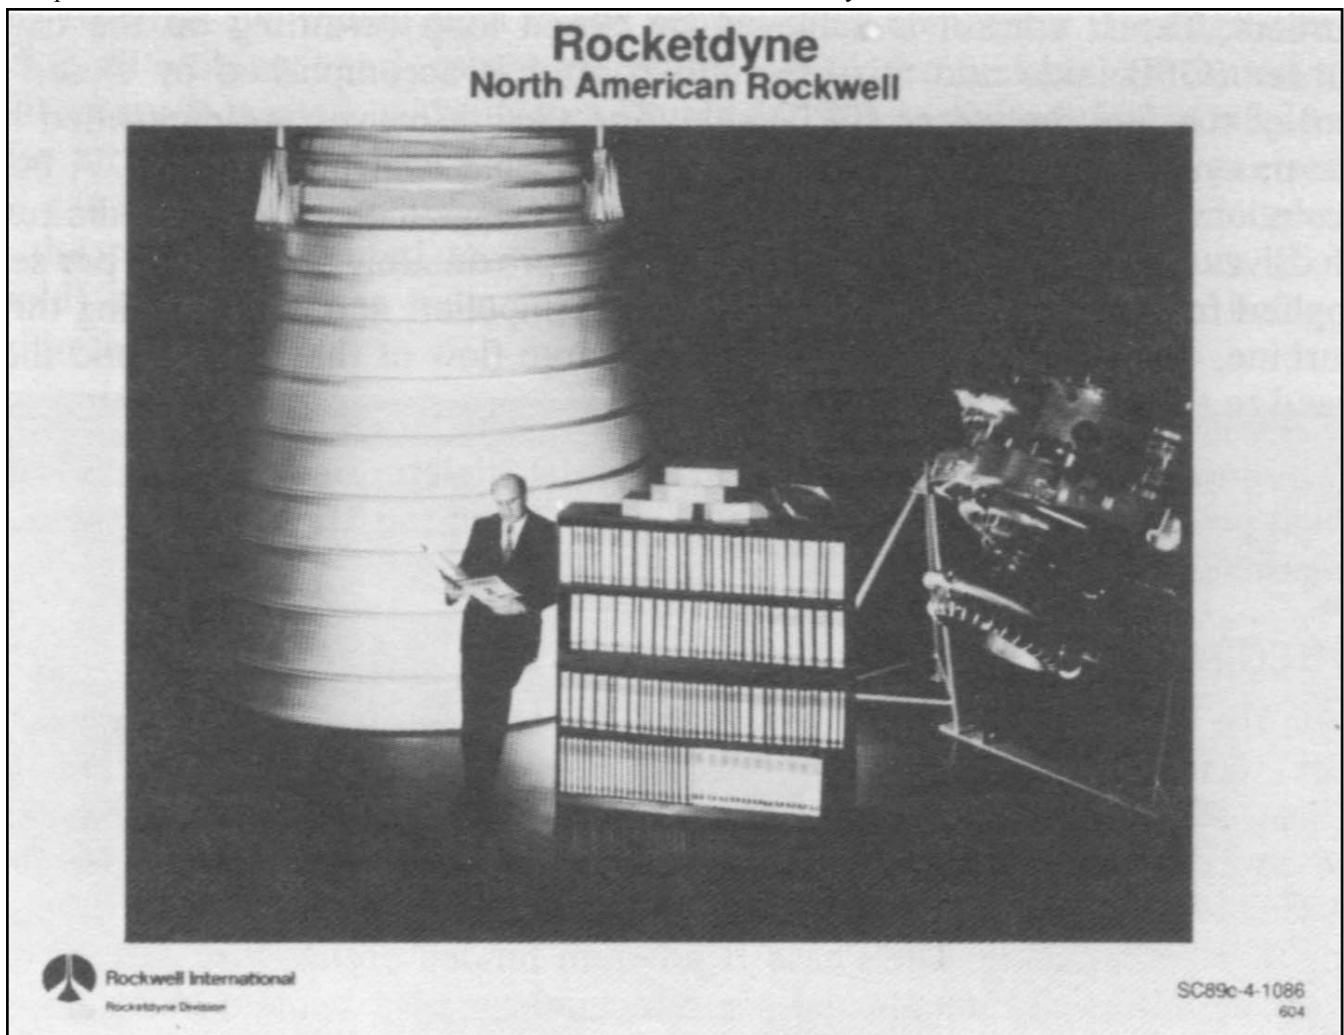
Figure 4. Rocketdyne Space Shuttle Main Engine Proposal (Photo No. SC89c-4-1086)

The Rocketdyne proposal [4] consisted of an executive summary, a seven-volume technical proposal, a five-volume management proposal and 81 volumes (87 books) of related data for a total of 100 books (Figure 4). The key feature of the Rocketdyne proposal was the construction and test of a nearly full-scale model of the combustion devices for the SSME powerhead. It contained two preburners and a regeneratively cooled main combustion chamber, operating in a staged combustion cycle and developing approximately 400,000 pounds of thrust (Figure 5). Paul Castenholz, vice president and program manager, had chosen to pursue this objective in order to clearly demonstrate the required technology for high pressure staged combustion.

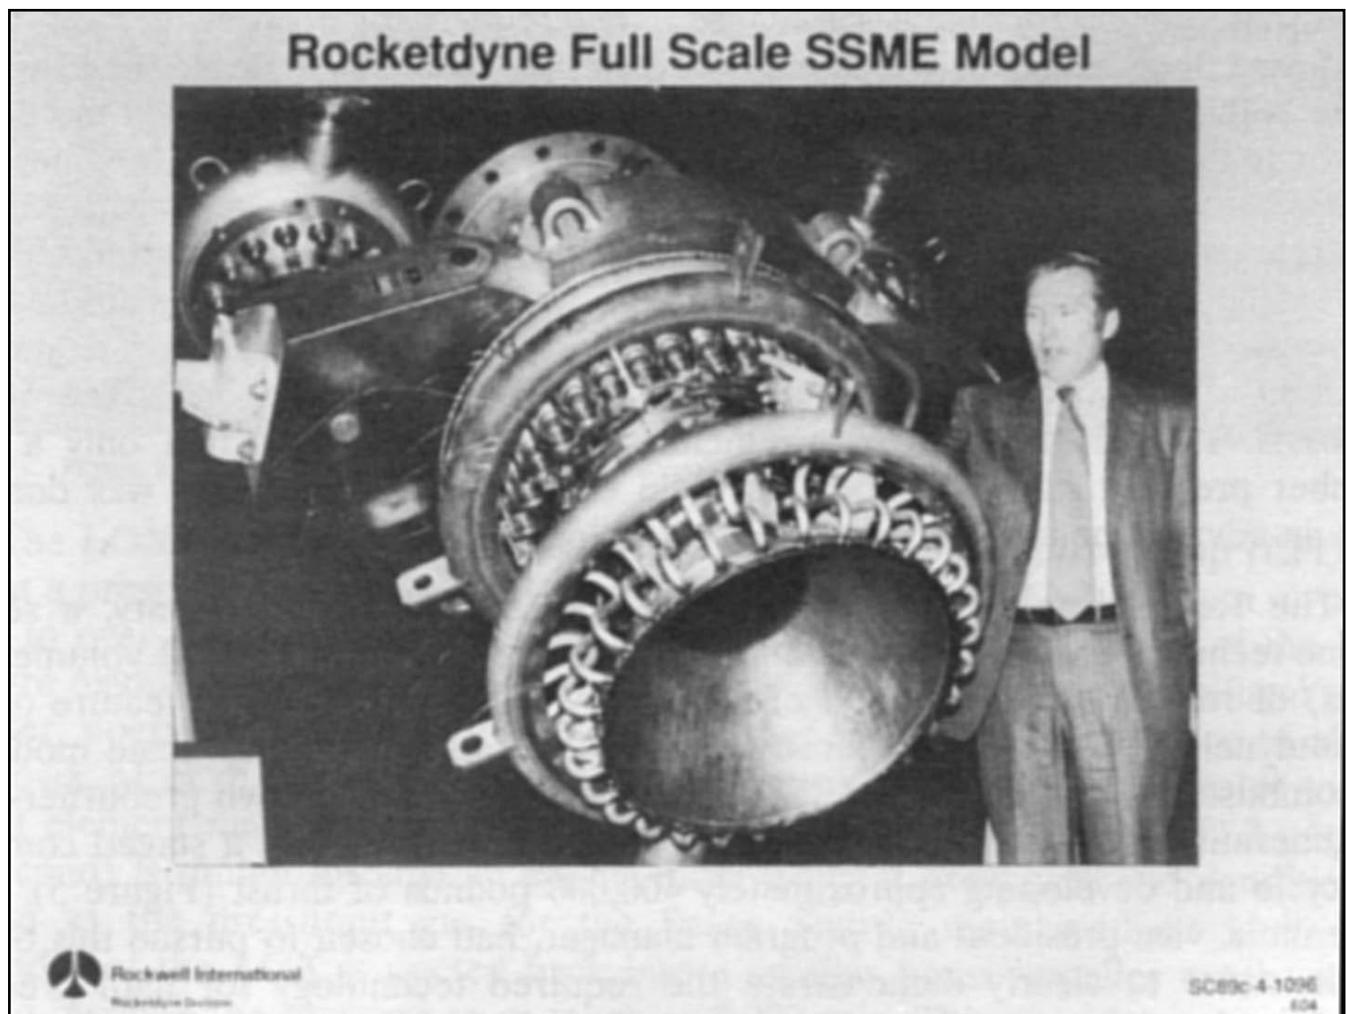
Figure 5. Full Scale Staged Combustion Cycle Test Model (Photo No. SC89c-4-1096)

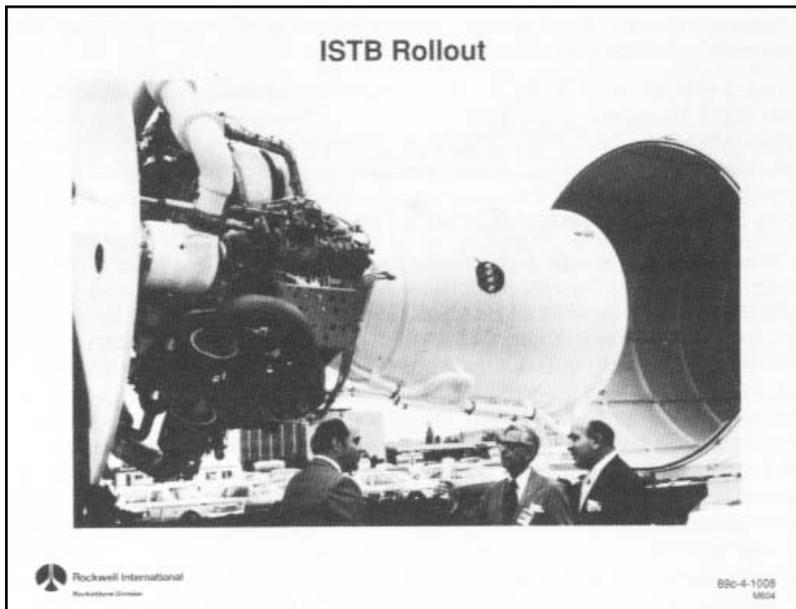
**Figure 6. The Integrated Subsystem Test Bed
(Photo No. 89c-4-1008)**

The ISTB first full-up ignition test date had been selected by the Management and Budget Office of the White House as one of the major Space Shuttle program milestones by which that office would monitor the program progress and health. This very important milestone was achieved on schedule. The ISTB was installed in NSTL test stand A-1 (Figure 6) and a countdown demonstration test (Test 901-001) was conducted on 19 May, 1975. After five

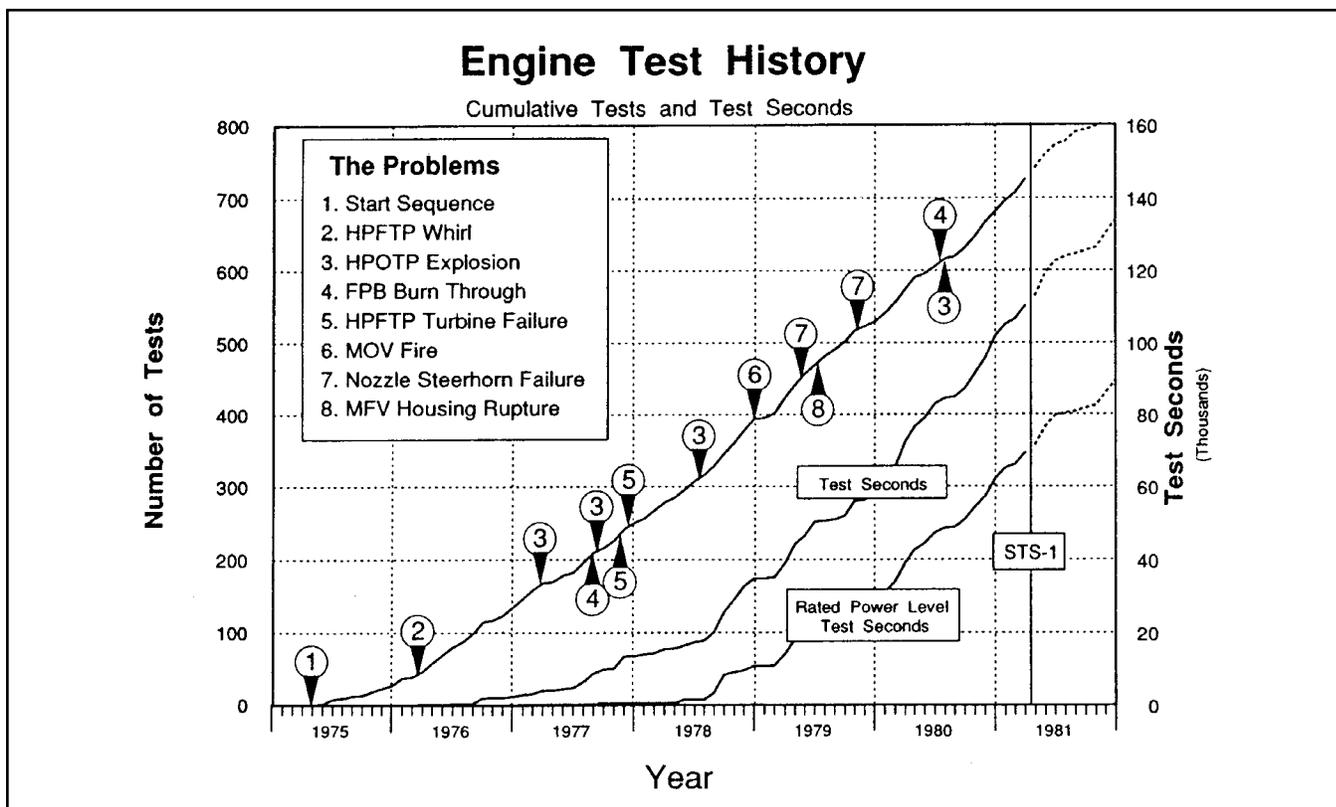
Figure 7. Engine Test Problem Summary (Photo No. 89c-4-1014)

The engine test program is summarized in Figure 7. It shows the number of engine tests as a function of calendar time from the first test in May 1975 to the first flight in April 1981. Also shown are the total test seconds and the test seconds at rated power level. Superimposed on the accumulated tests plot are indicators showing the initial dates of the major engine problems that are to be discussed in the following chapters. The eight problems listed were chosen as being the most significant as they relate to flight safety; and, even though some other problems also caused loss of resources during the program, the recovery effort for these eight was judged to be the most difficult in terms of what had to be done to allow program continuation and to assure a safe first flight.

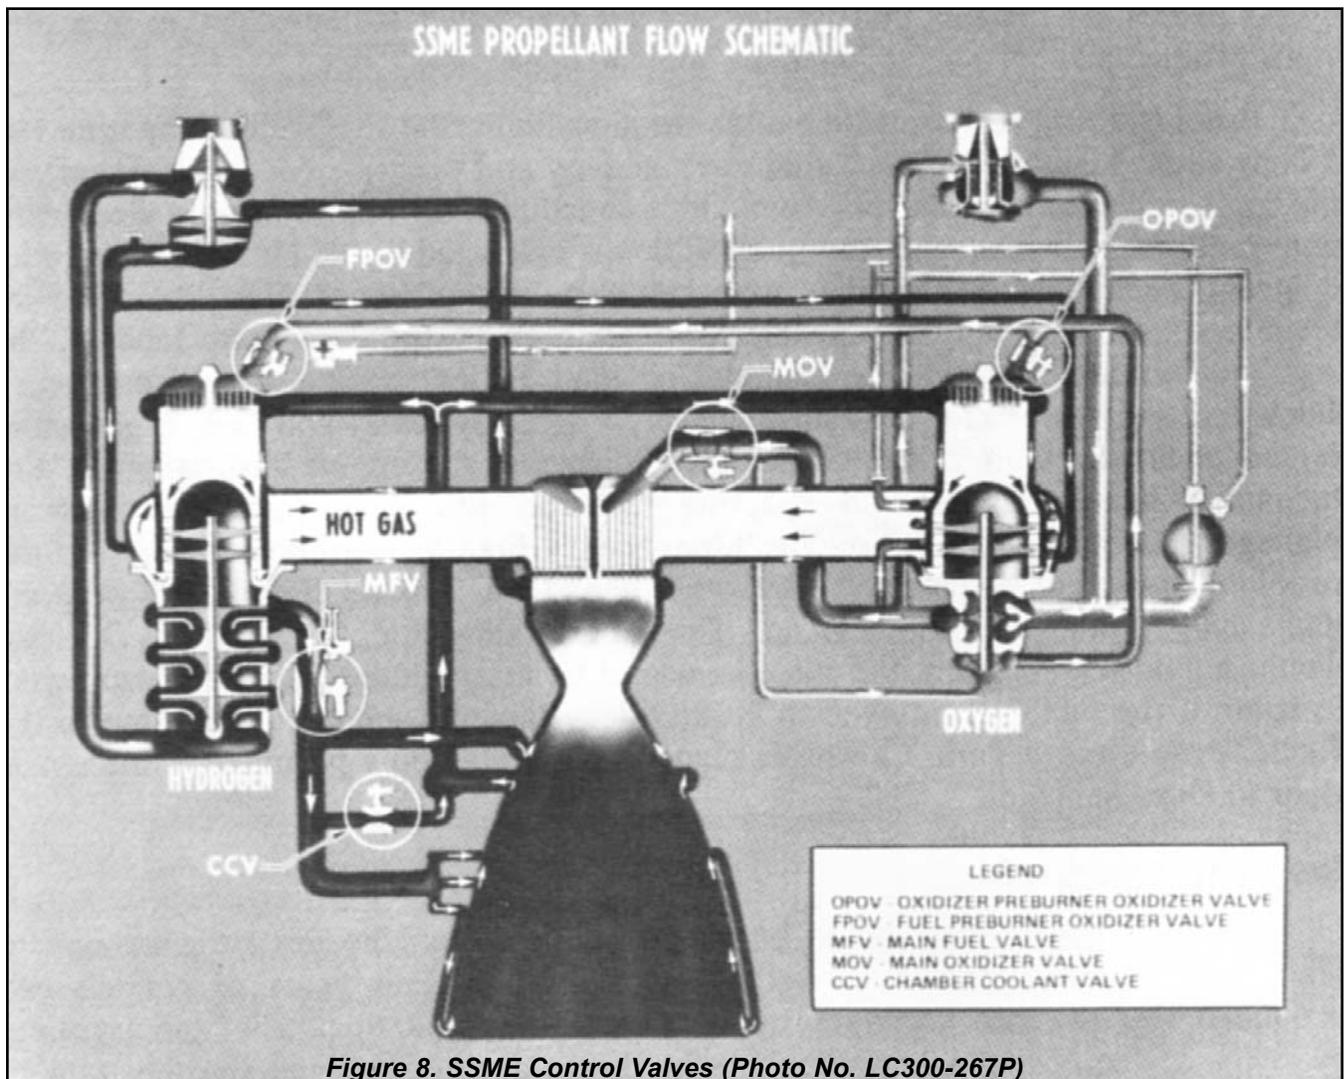
Figure 8. SSME Control Valves (Photo No. LC300-267P)

Figure 8 is an SSME schematic showing the propellant flow paths and the location of the primary propellant valves relative to the other components. During the propellant conditioning period, LH2 fills the fuel side of the engine down to the main fuel valve (MFV) which is a single shutoff valve for all of the fuel. A small recirculation flow is main-

tained by flowing through a bleed valve located at the MFV to an overboard dump line or pumped back to the LH2 inlet. Liquid oxygen (LOX) fills the oxidizer side of the engine down to the three oxidizer valves. The main oxidizer valve (MOV), oxidizer preburner oxidizer valve (OPOV) and fuel preburner oxidizer valve (FPOV) act as three parallel shutoff valves for the LOX. Recirculation flow of LOX is maintained by flowing through a bleed valve located at the FPOV to an overboard dump system. The small recirculation flows are maintained for an hour or more to chill the four turbopumps to cryogenic temperatures and to eliminate gas pockets in the propellant feed system.

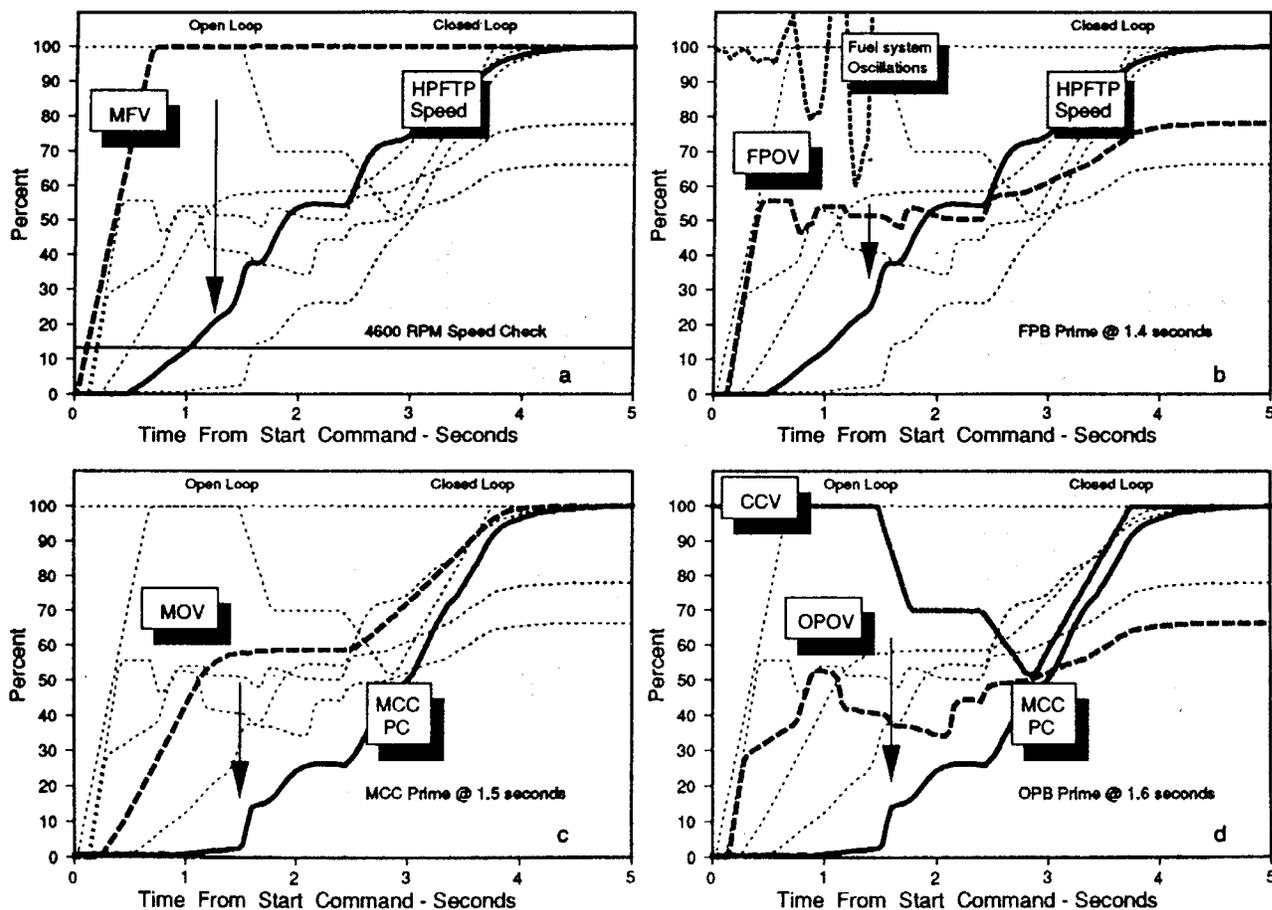
Figure 9. SSME Start Sequence (Photo No. 89c-4-1015)

When a start command is received, the MFV is immediately ramped to its full open position in two-thirds of a second (see Figure 9). This enables the LH2 to fill the downstream system and begin to power the high pressure turbines. The latent heat of the hardware imparts enough energy to the hydrogen to operate as an “expander-cycle” engine for the early part of the start sequence. This eliminates the need for any auxiliary power to initiate the start sequence, however it also creates a thermodynamic instability which is referred to as the fuel system oscillations. When the cold LH2 begins to flow into the thrust chamber nozzle, the hardware latent heat causes the hydrogen to expand rapidly, creating a flow blockage and momentary flow reversal. The result is a pulsating fuel flow rate with an unstable pressure oscillation at a frequency of approximately 2 Hz. The oscillations continue to increase in magnitude with dips (reductions in pressure) occurring at approximately 0.25, 0.75 and 1.25 seconds, until the establishment of MCC chamber pressure causes it to stabilize after 1.5 seconds. Events prior to stabilization had to be made to conform to the idiosyncrasies of the fuel system oscillations. Simultaneously with the opening of the MFV, electrical power is provided to the spark plugs in the augmented spark igniters (ASI) included in each of the three combustors. The ASI will then ignite the combustors when both fuel and oxidizer are present in the proper mixture ratio. The fuel is provided first by the MFV being opened and then the oxidizer is provided later for each combustor separately through the three oxidizer valves. Each valve has an ASI LOX supply line that allows LOX to flow to the ASI upon initial valve motion (about 5 percent). The proper mixture ratio for ignition is achieved by the second dip in pressure caused by the fuel system oscillations.

When the FPB prime occurs at 1.4 seconds, there is a rapid rise of pressure at the inlet to the HPFTP turbine. Since the turbine back pressure is not provided until MCC prime, this pressure rise causes a high turbine pressure ratio and a significant acceleration in the HPFTP speed (Figure 9b). The higher HPFTP speed is desirable for a cool fuel-rich start, however, the turbine back pressure must be applied (MCC prime) soon to prevent a runaway condition.

MCC prime is primarily controlled by positioning of the MOV. After an initial delay of 0.200 seconds, the MOV is slowly ramped to just under 60 percent open. This combination of time delay, ramp rate and position provides a LOX flow rate that causes MCC prime to occur at 1.5 seconds and creates an engine system balance that will produce a safe low mixture ratio (between 3 and 4) for the stabilized operation just prior to activating the closed loop thrust control system at 2.4 seconds. When MCC prime occurs at 1.5 seconds, it causes a rapid rise in MCC chamber pressure (Figure 9c) which, because it increases the turbine back pressure, acts as a break to decelerate the HPFTP (Figure 9b).

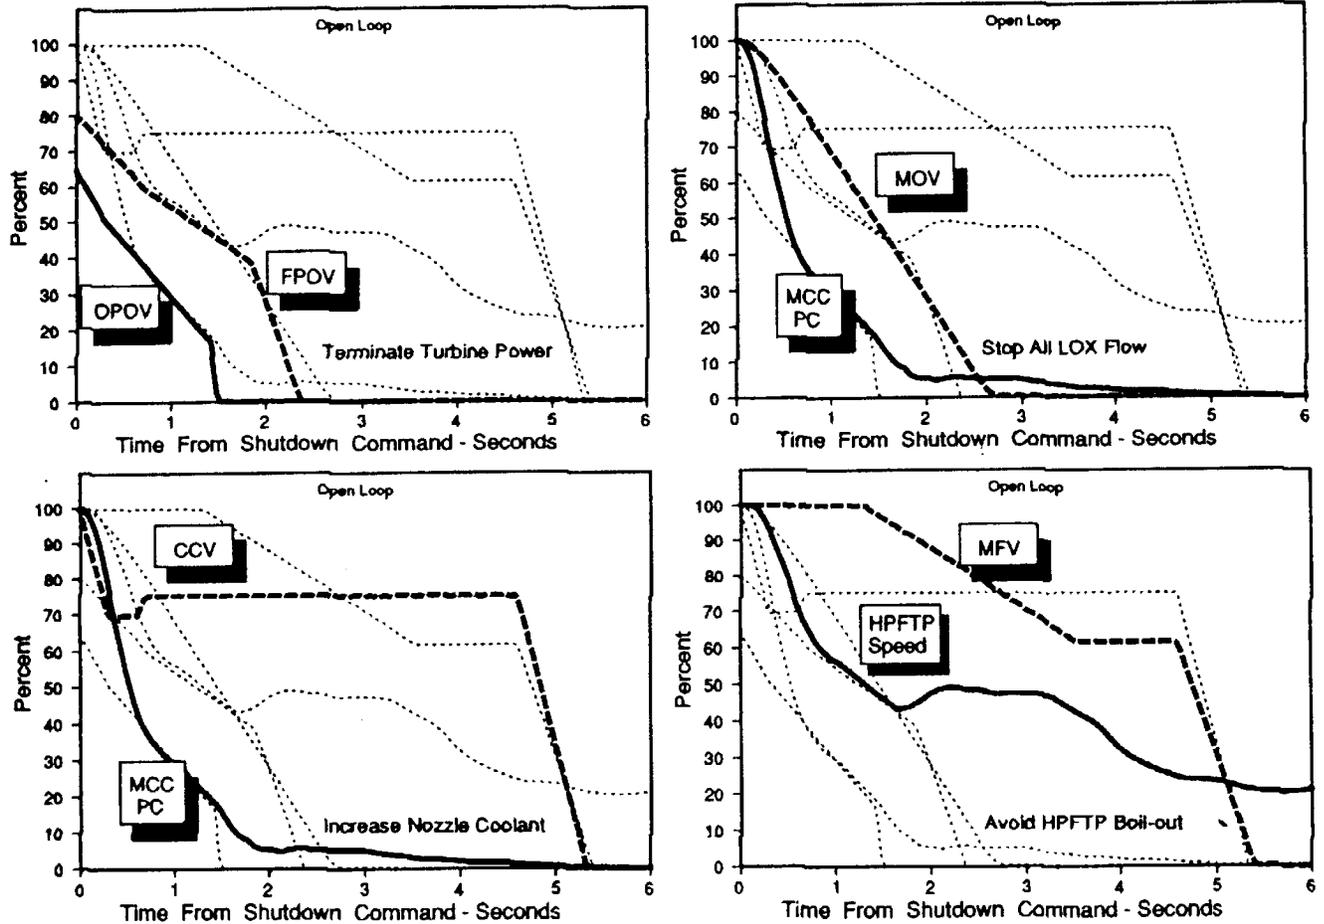
Figure 10. SSME Shutdown Sequence (Photo No. 89c-4-1016)

As with the start, the SSME shutdown must contend with high power and low inertia; however, it does not have the further complications of fuel system oscillations and critical priming sequences. Although some problems were encountered during the evolution of the shutdown sequence, they were not as significant as the start problems. This discussion will be limited to a brief summary of the reasons for the various features of the final shutdown sequence. The shutdown sequence, which is totally open loop, is shown graphically in Figure 10.

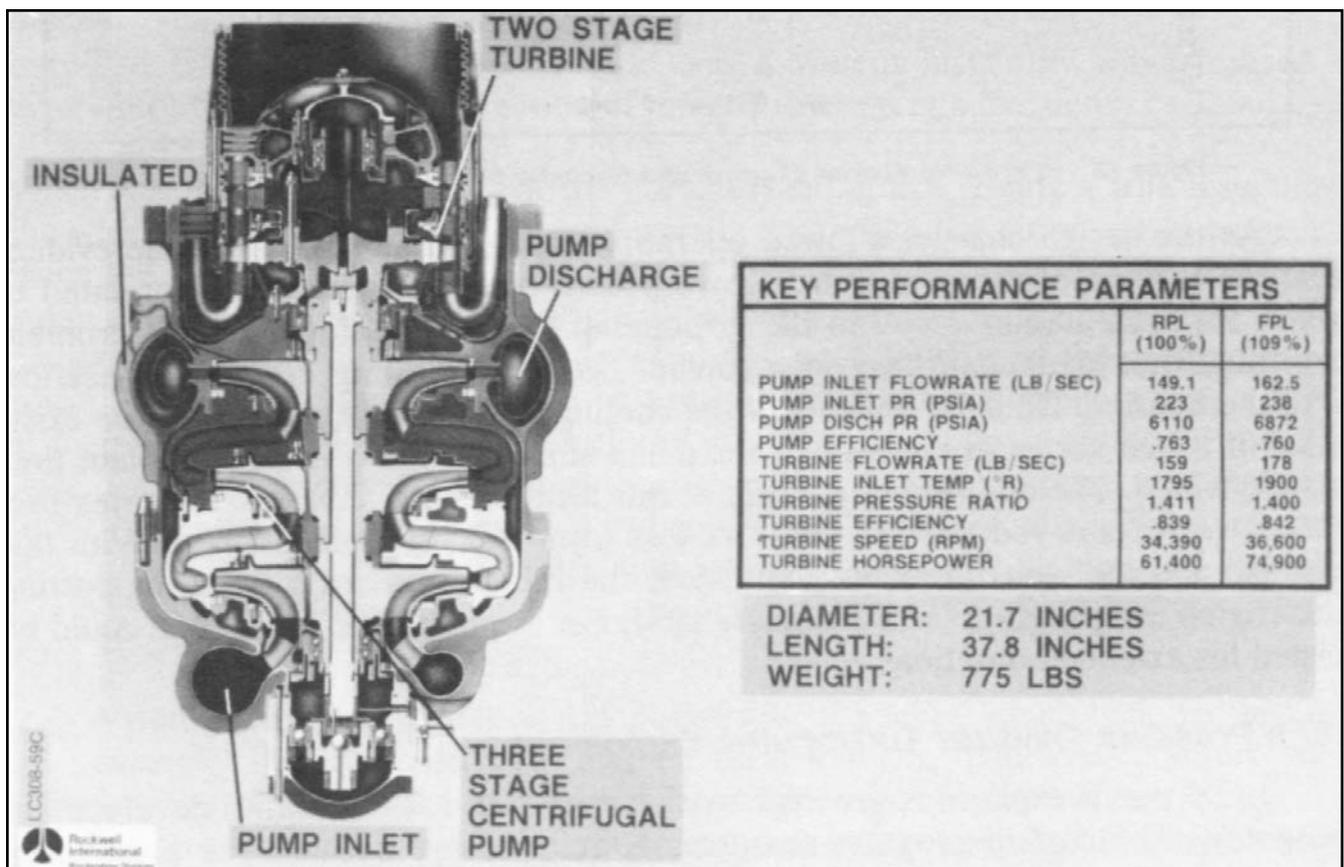
Figure 11. SSME High Pressure Fuel Turbopump (Photo No. LC308-59C)

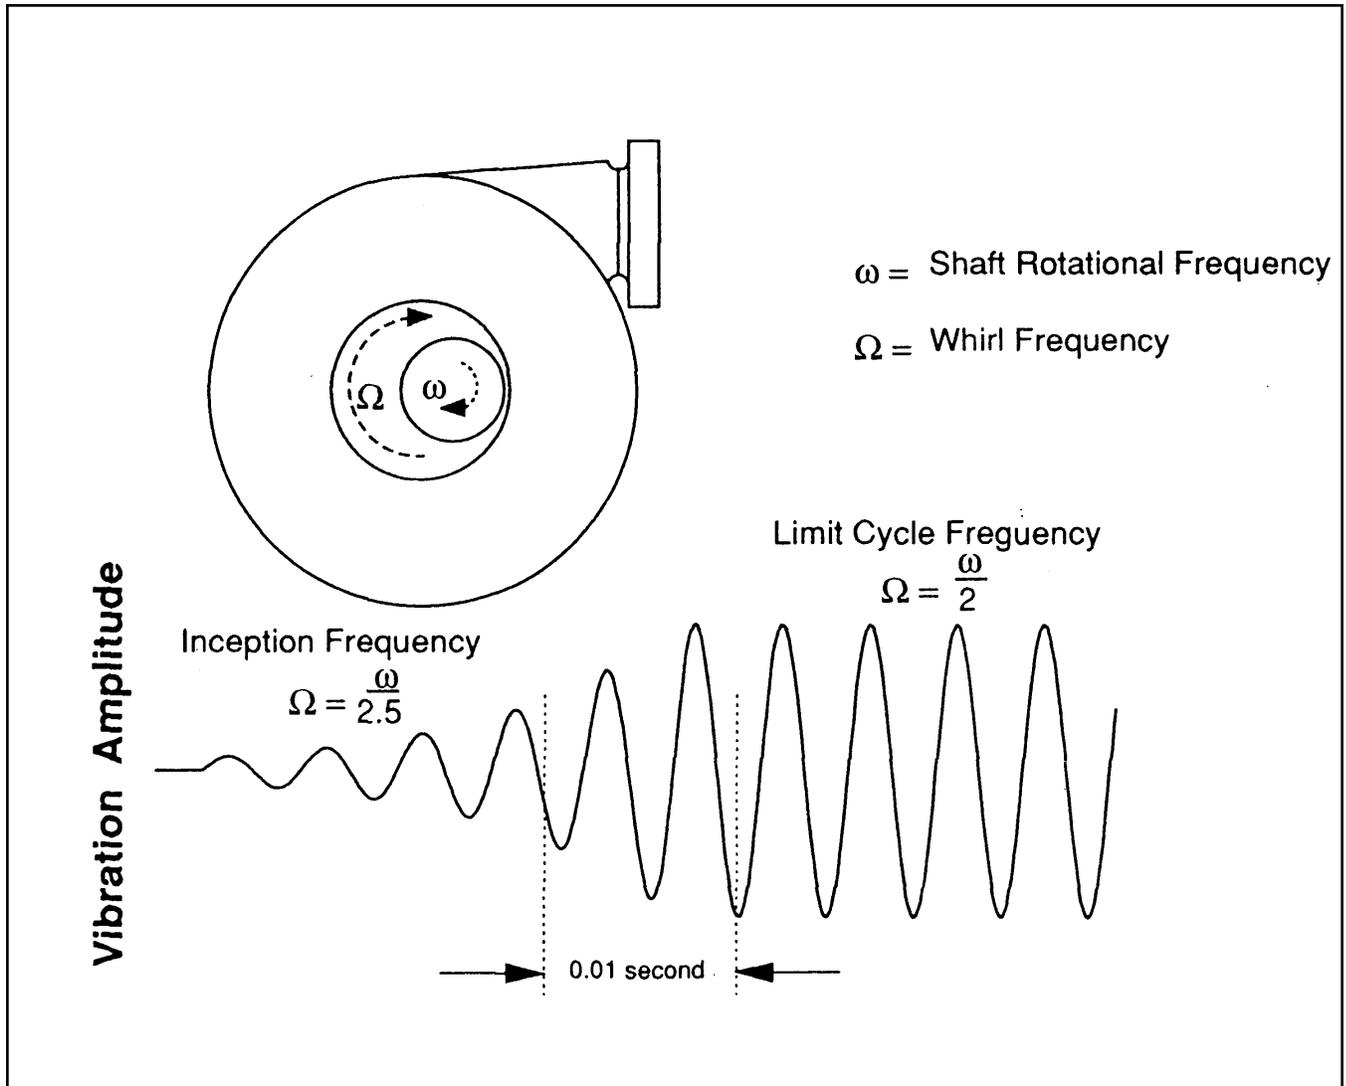
Figure 12. HPFTP Whirl Vibration Characteristics (Photo No. 89c-4-1017)

A multidisciplinary approach was pursued by the team, which included historical research, literature surveys, mathematical models, and consultations with universities and other companies with related knowledge or experience. A vigorous test program included laboratory, component, subsystem and engine tests. Twenty-two potential drivers were identified and analyzed; however, it was eventually concluded that two factors were far more significant than all the others. The most significant destabilizing effects were, hydrodynamic cross-coupling of the pump interstage seals combined with the low natural frequency of the rotating assembly [22]. These effects were attacked by a series of design changes to decrease cross-coupling drivers and provide damping at the seals and to increase the rotor critical speeds by stiffening the shaft and bearing supports. Over a ten-month time period, the whirl inception speed was gradually increased from 18,000 rpm (below MPL) to above 36,000 rpm, which allowed whirl-free operation to above RPL.

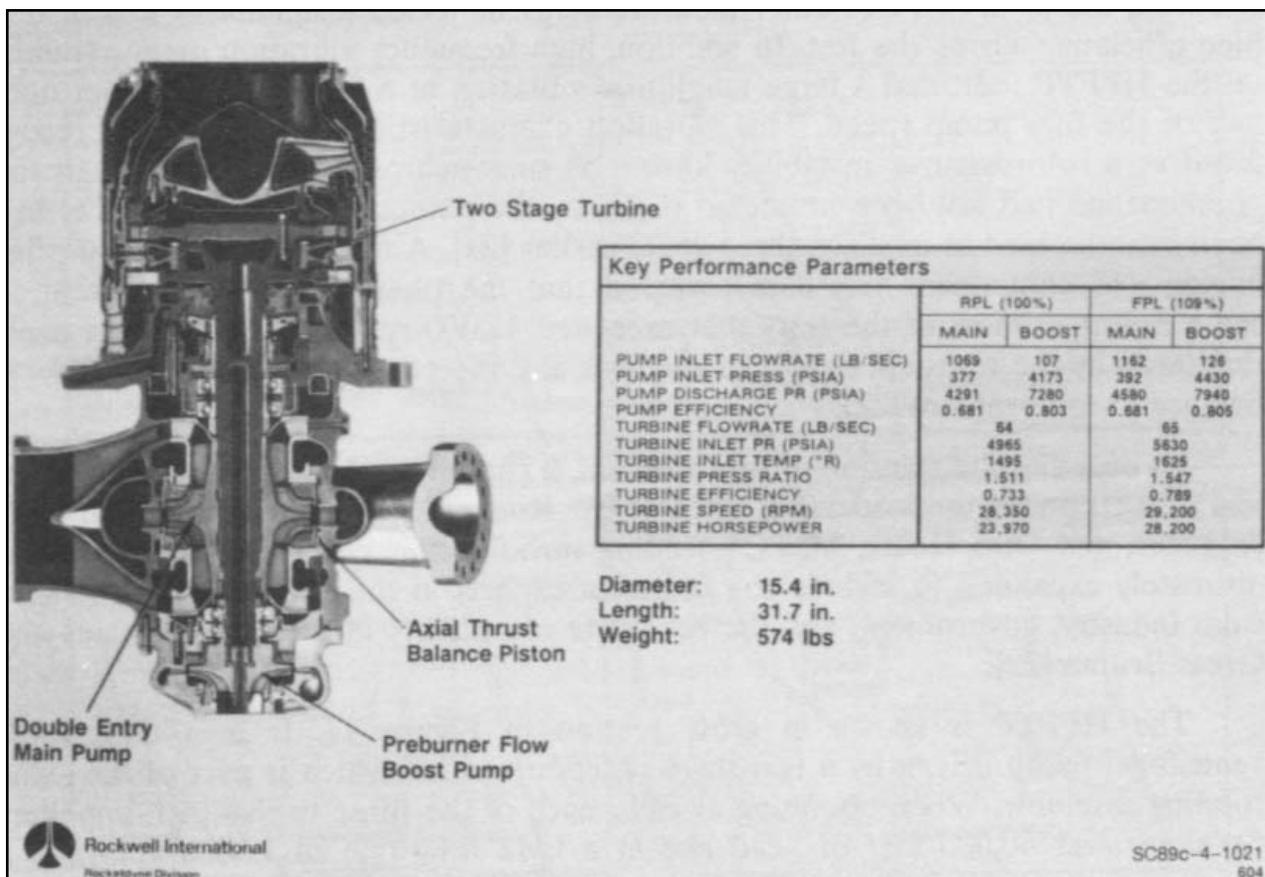
Figure 13. SSME High Pressure Oxidizer Turbopump (Photo No. SC89c-4-1021)

The HPOTP assembly contains two pumps and a turbine on a common shaft, which rotates at a speed of almost 30,000 rpm (see Figure 13). The main pump is a double-entry, single-discharge centrifugal pump with a built-in inducer on each side of the dual-inlet impeller. It has an overall diameter just under seven inches and pumps up to 7,500 gpm of LOX at a pressure in excess of 4,500 psia. The smaller (five-inch diameter) boost pump is a single-stage impeller without an inducer and is separately mounted on the bottom end of the turbopump shaft. In supplying LOX to the preburners, it pumps about one-tenth as much LOX as the main pump, while increasing the pressure another 3,000 psi. The eleven-inch diameter two-stage reaction turbine delivers over 28,000 horsepower with an efficiency of almost 80 percent while operating with a pressure ratio slightly over 1.5.

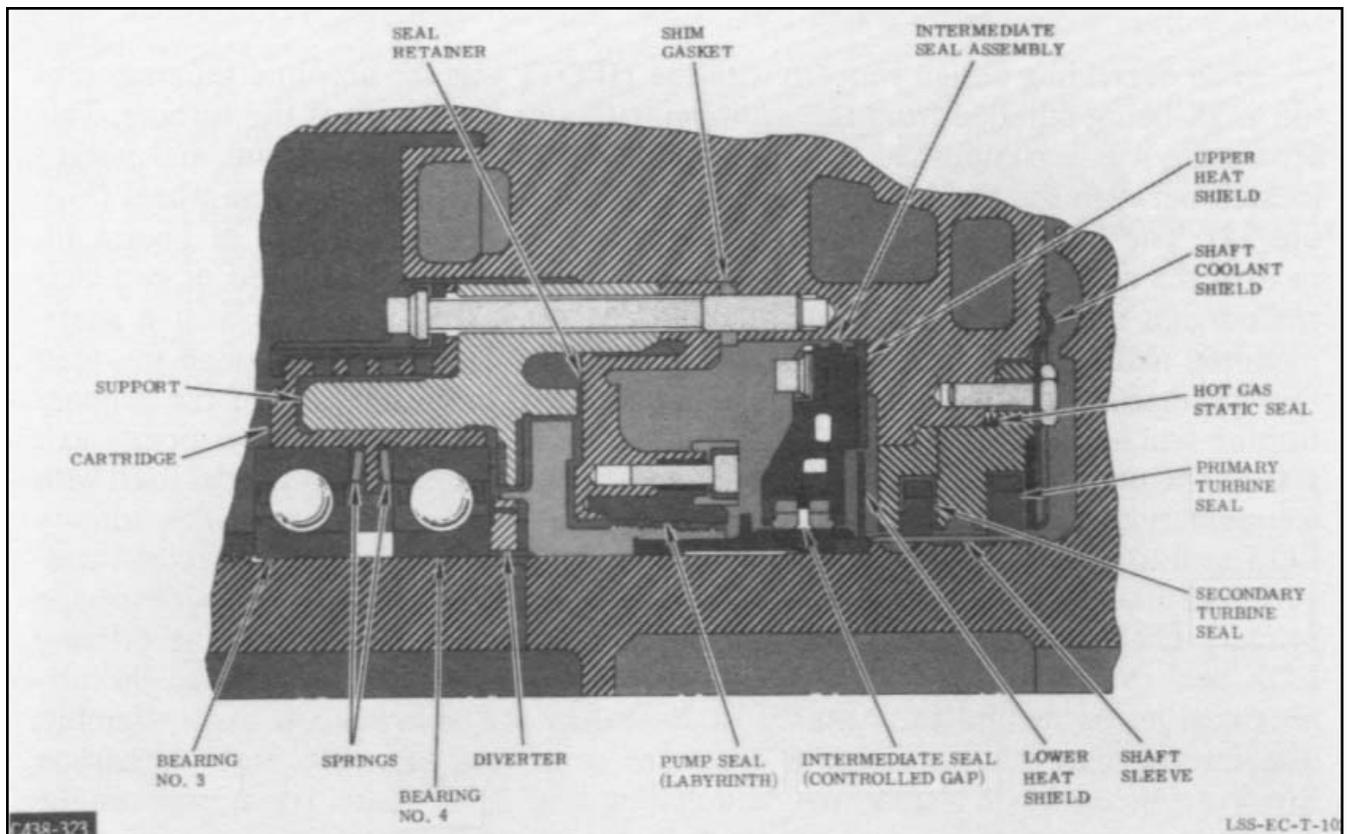
**Figure 14. HPOTP Shaft Seal and Drains (Engines 2004 and Subsequent)
Photo No. LC438-323 or LSS-EC-T-102**

The overriding design concern with the HPOTP was the absolute separation of the LOX being pumped from the hydrogen-rich steam that drives the turbine. This separation was accomplished by an elaborate set of shaft seals, drains and purges located between the turbine end bearings and the second-stage turbine wheel (Figure 14). The turbine seal assembly is shown on the right-hand side of Figure 14, next to the second-stage turbine wheel. The turbine seal is comprised of two controlled-gap, self-centering carbon floating ring seals that are used with a shaft mounted mating ring. The space between the two seals is vented through

fourteen flow passages to the primary turbine-seal overboard drain line. All of the primary turbine seal leakage is vented through this system to the thrust chamber nozzle exit plane. The primary LOX seal is a three-step, shaft-mounted labyrinth seal used with a stationary plastic (Kel-F) wear ring. A slinger is used at the inlet of the primary LOX seal to isolate it from the turbine end bearing coolant inlet pressure and convert potential leakage flow from a liquid to a gas. The downstream side of the primary LOX seal is vented through eleven radial flow passages to the primary LOX seal overboard drain line. Additional isolation is provided between the turbine seal assembly and the primary LOX seal by the intermediate seal assembly. The intermediate seal assembly is a pair of controlled-
