SPACE SHUTTLE MAIN ENGINE THE FIRST TEN YEARS¹

Robert E. Biggs²

Part 1 – The Engine

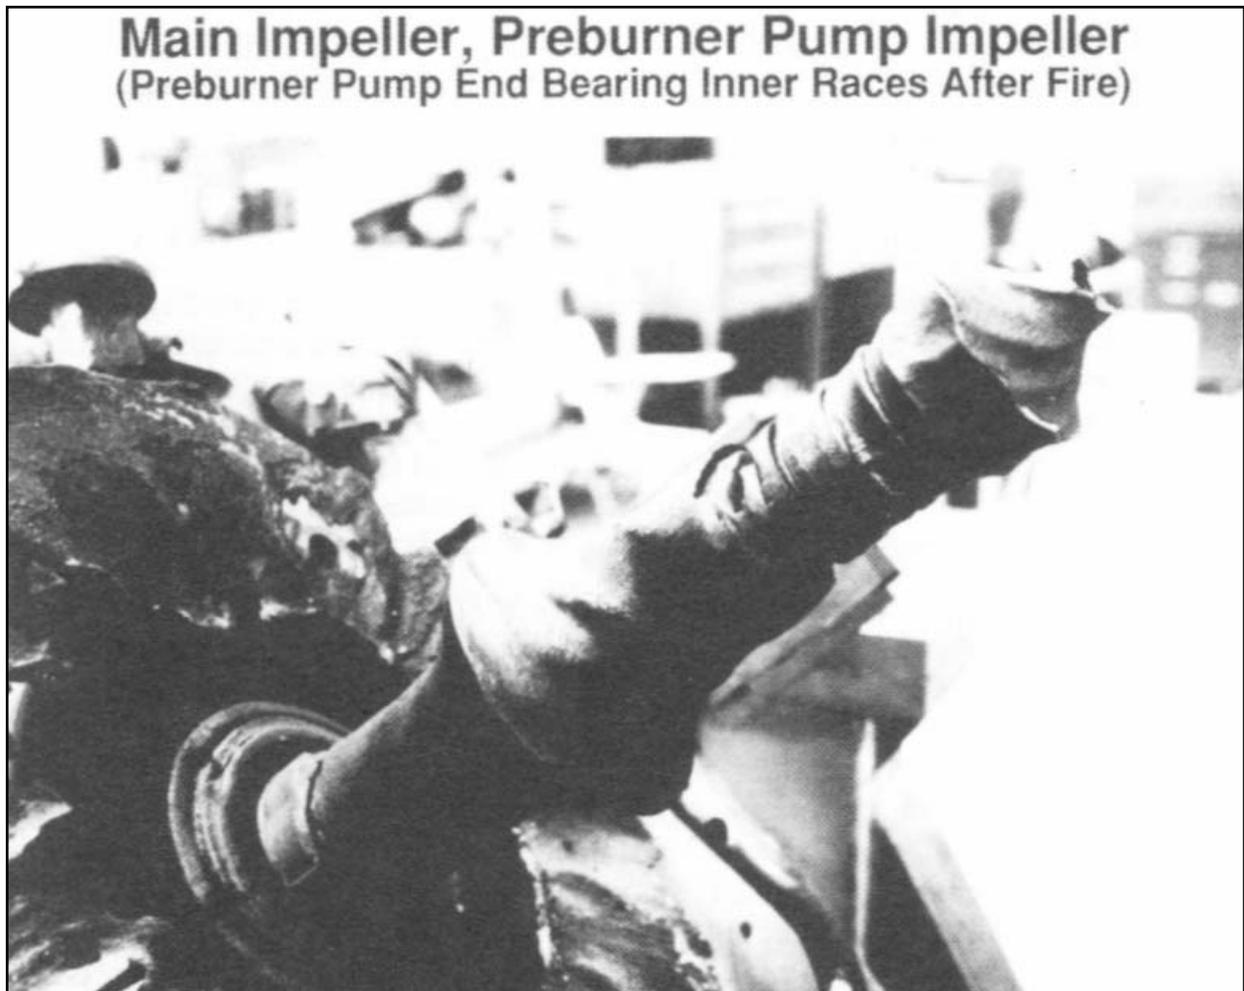
Figure 16. HPOTP Rotor After Test 901-136 (Photo No. 89c-4-1029)

ware contained clues as to what caused the gradual failure of the turbine end bearings. (see Figure 16). An in depth analysis was conducted covering 31 potential failure modes [26]. Each failure mode was evaluated using a fault-tree diagram to describe how it could have caused or contributed to a fire in the HPOTP Supporting and refuting evidence was obtained from test data, prior experience, hardware inspections, previous pump conditions, analytical models, and other sources. The team concluded that the most probable initial failure cause was wearing of a turbine end bearing due to uneven load sharing and inadequate cooling. It was also concluded, however, that it was almost as likely that the first failure was in a pump end bearing. Because of the lack of conclusive evidence, all failure modes that were judged to have sufficient supporting evidence and, more importantly, those with insufficient refutative evidence, were placed in the final potential cause list. Seven basic failure modes were identified, with an average of three root causes each. For each of these, short-term and long-term action was taken to reduce or eliminate the potential for a similar event in the future.

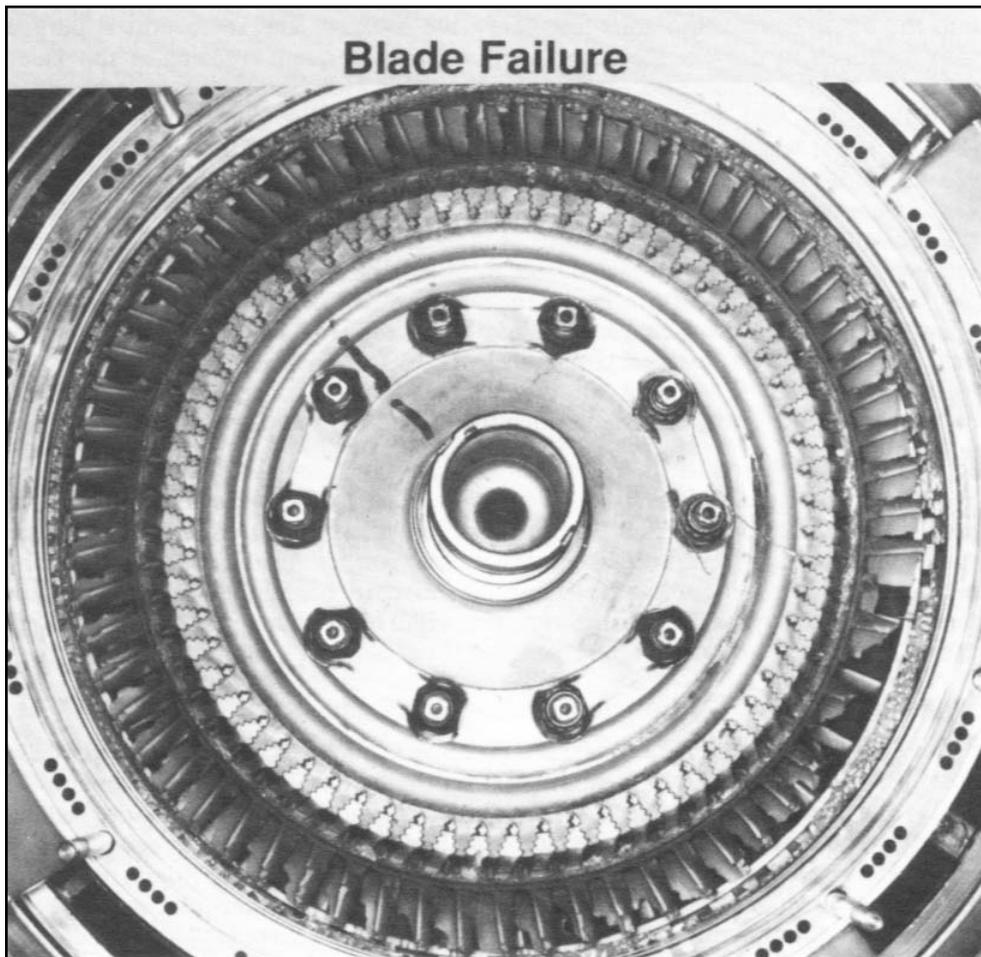
Figure 17. HPFTP First Stage Turbine - Test 902-095 (Photo No. SC89c-4-1032

violently shook the entire engine. The test was not shut down by the HPFTP vibration monitor because it had a built-in time delay of 0.240 seconds, and the HPOTP redline time delay was only 0.100 seconds. A post-test inspection revealed that a first-stage turbine blade had broken off and inflicted significant damage to both turbine stages. Figure 17 shows the damage to the first-stage wheel. The engine was shut down safely

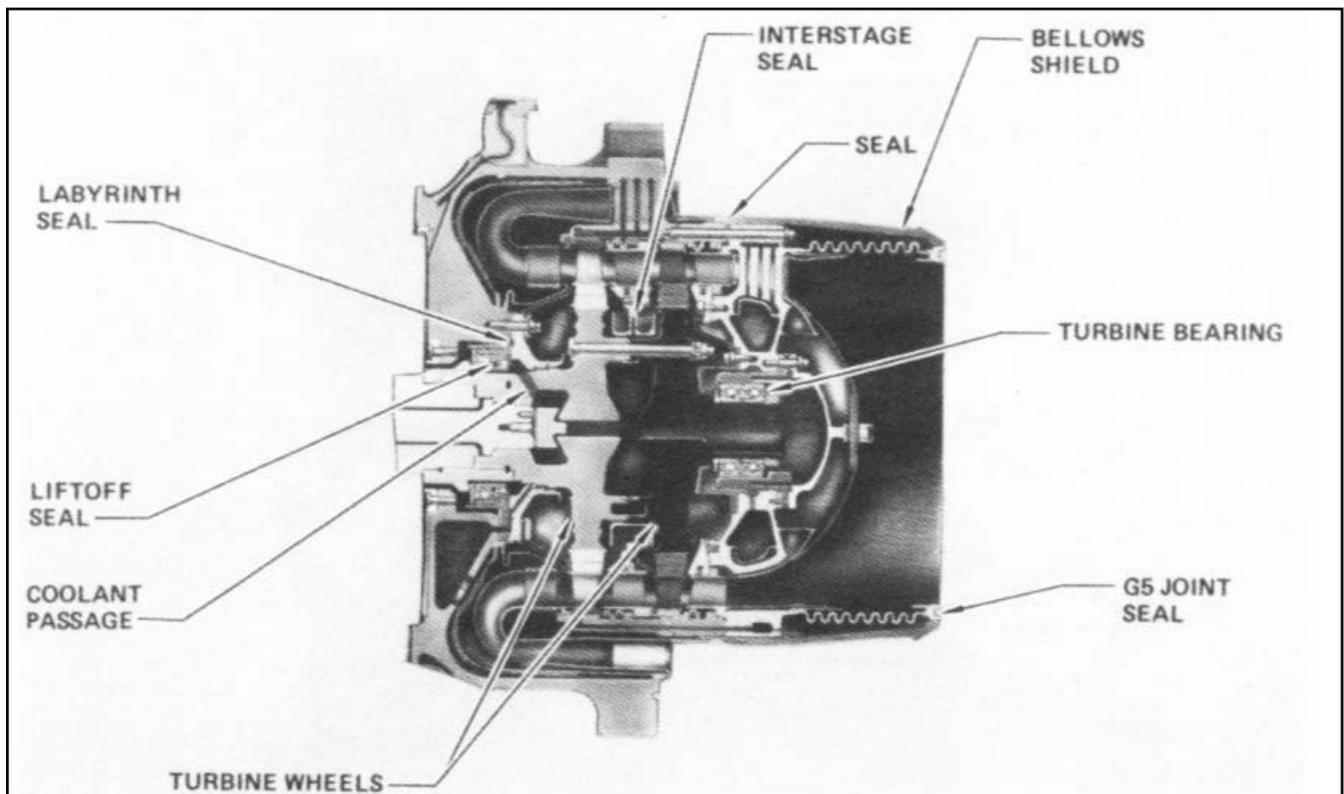
The HPFTP turbine (Figure 18) is a two stage reaction turbine powered by hot hydrogen-rich steam produced by the FPB. The turbine drive gas is directed by 41 first-stage nozzle vanes into 63 first-stage turbine blades. The first-stage exhaust is gathered by 39 second-stage nozzle vanes and redirected through 59 second-stage turbine blades. (The number of elements were purposely made different to minimize the possibility of frequency reinforcement among the various parts.) The turbine exhaust gas is then guided by sheet metal structure through a 180 degree turn to be consumed in the MCC. The turbine blades are about one inch long by half an inch wide with a ribbed extension called a "fir tree," which it resembles (Figure 17). The blades are installed by inserting the fir trees into matching slots in the gold plated turbine disc, and they are held in place by pressure loading and centrifugal force. The blades are structurally independent of each other except for small spring-like devices that fit between the blade shanks in slots provided at the blade platforms. These are called dampers and are used to dampen blade vibration. Because the power generated by the HPFTP amounts to about 600 horsepower per blade, the blades are under tremendous stress. The power bending stress and the centrifugal stress are each approximately 50,000 psi for every blade. The

Figure 18. HPFTP Turbine Section (Photo No. SC433-20)

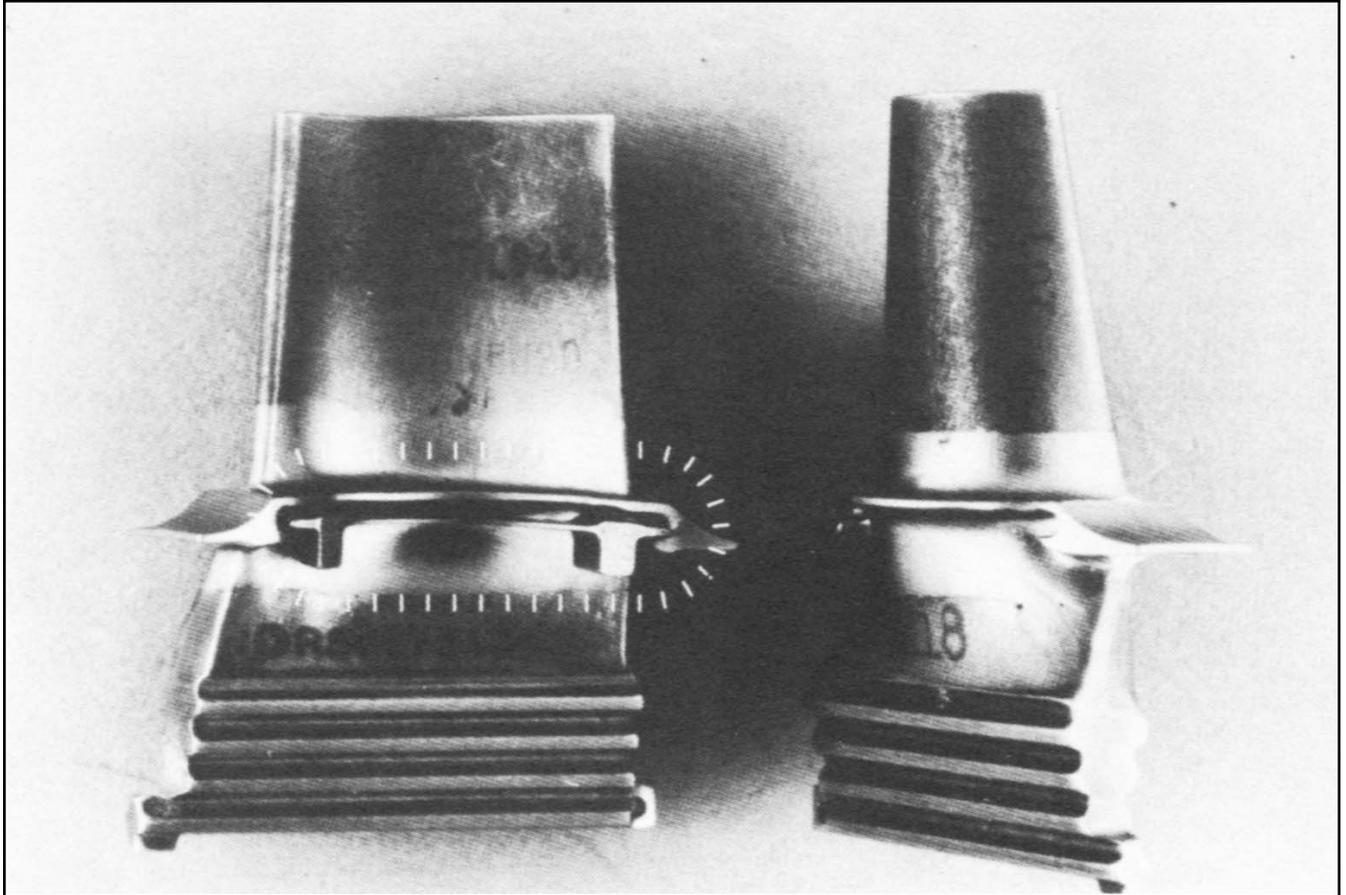
Figure 19. HPFTP First Stage Made Precision Damper (Photo No. 307-291A)

and that all damper configurations tested were effective in reducing the effect of engine-induced vibration modes that could contribute to blade failure. An optimized, lightweight precision-tolerance damper design was selected after a review of the Whirligig test data (Figure 19). The new damper design was incorporated along with changes to preclude blade lock-up either in the wheel or blade-to-blade. A looseness verification

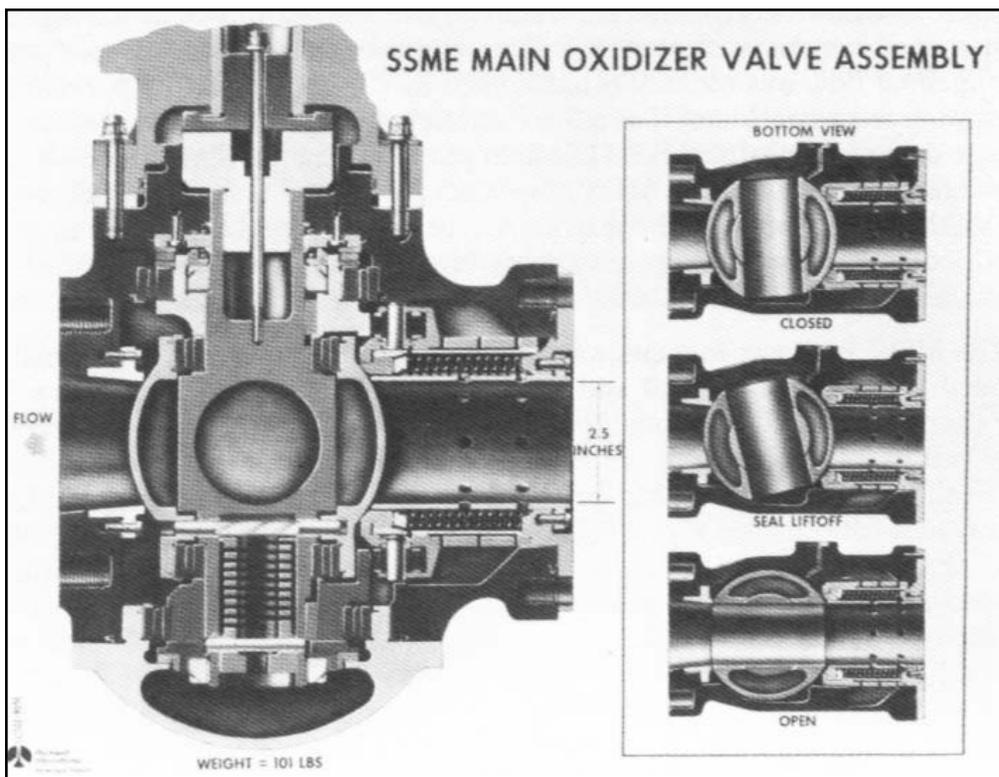
The MOV is shown in a cutaway representation in Figure 20. It is a ball valve fabricated with an integral ball and shaft. The valve is rotated by a hydraulic actuator (not shown) spline-coupled to the shaft at the top of the valve assembly. The hollow ball is approximately 5 inches in diameter with a 2.5 inch tubular flow passage. At the FPL flow rate of 850 pounds per second, the fluid velocity through the valve exceeds 350 feet per second. The ball seal is a machined

Figure 20. Main Oxidizer Valve (Photo No. LC301-865E)

plastic ring which is loaded against the inlet side of the ball by a bellows. The shaft has two integrally machined cams which push against a cam follower mechanism which lifts the seal from the ball during the first six degrees of valve rotation. The LOX flow for the MCC ASI is supplied from a port immediately downstream of the seal and begins to flow as soon as the seal is lifted. To minimize turbulence, a 2.5 inch diameter inlet sleeve is bolted to the valve inlet, isolating the bellows from the flow environment and aligning the flow stream with the ball tubular flow passage in the open position. The sleeve was positioned to a fixed gap between the ball and sleeve by using a stack of 0.002 inch thick stainless steel shims under the bolted inlet flange.

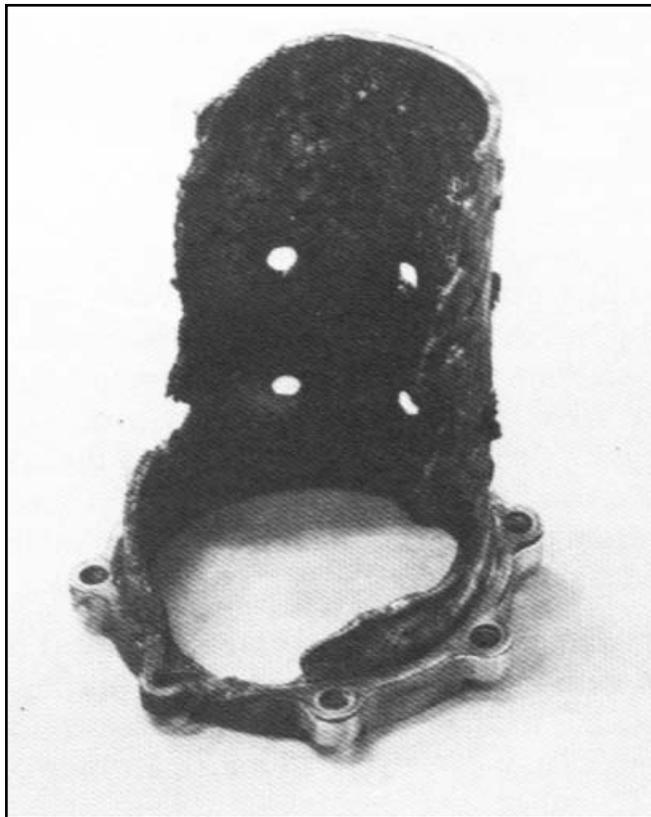
Figure 21. MOV Inlet Sleeve After Test 9001-225. (photo No. 307-971)

Disassembly of the MOV from the incident test revealed that the bellows had been burned away and the inlet sleeve was 50 percent consumed. (see Figure 21) A dynamic analysis using two-dimensional and three-dimensional models, showed that the inlet sleeve had a fundamental natural frequency of about 1,900 Hz, which corresponded to a high energy vibration generated by the HPOTP (four times pump speed). This was augmented by data obtained from a simulated LOX feed system test facility set up by NASA at MSFC to study flow under controlled laboratory test conditions [31]. It was shown that the energy generat-

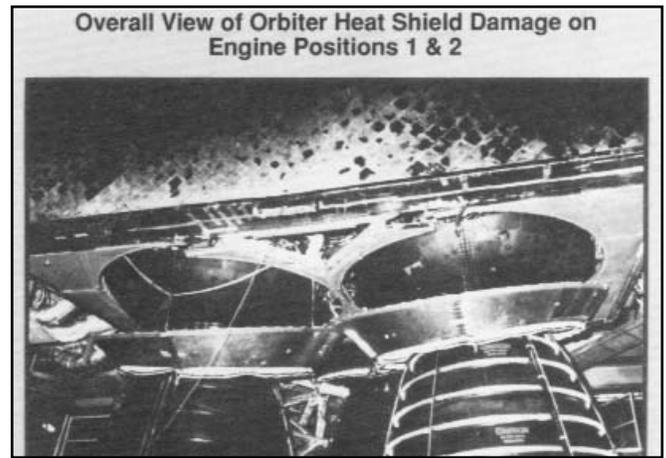
Figure 22. MPTA Heat Shield Failure (Photo No. SC89C-4-1010)

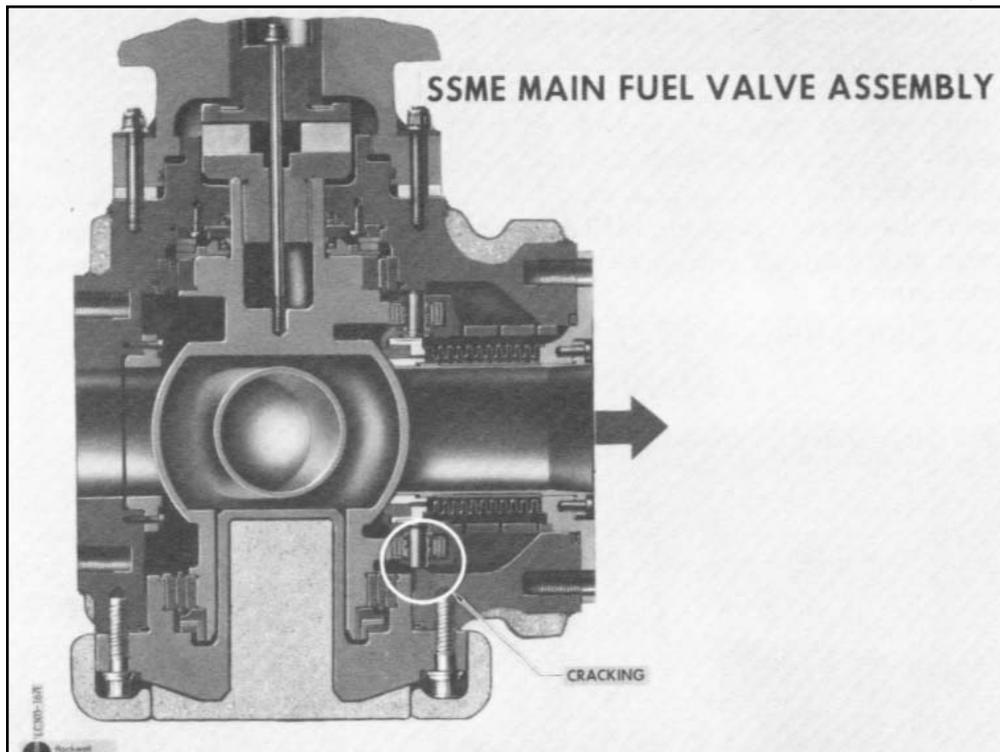
The MFV is similar in construction to the MOV (Figure 23). It is the same size as the MOV, but it operates at 50 percent higher pressure, 100 R colder temperature, and three times the fluid velocity. Three major differences between the valves are due to the higher pressure and colder temperature. The forged MFV housing is made from an alloy of titanium instead of INCO 718 in order to withstand the high pressure with a minimum weight valve. Because titanium has a significant gain in strength at very low temperature, the MFV was turned around with the bellows-loaded seal at the valve outlet rather than the valve inlet. This orientation allows the valve to be thoroughly chilled before engine start, thereby assuring maximum strength prior to being subjected to the operating pressure. The third difference is insulation. The LH2 temperature is below 40 R, which is well below the boiling point of liquid nitrogen. To preclude the formation of liquid nitrogen on the valve surface, the housing is covered with an insulator.

Figure 23 Main Fuel Valve (Photo No. LC303-167E)

to overload. The SEM analysis clearly indicated the fracture origin to be at the location of a cutout in the housing designed for the ball seal retraction cam follower (see Figure 23). There was no evidence of material or forging defects, and the microstructure was normal for this titanium alloy. The material composition was verified to be correct by chemical analysis. Proper mechanical properties were verified by testing forging samples which were made as extensions on the housing in the original forging and then using sample bars machined from the fractured housing. Although SEM analysis identified areas in the originating fracture surface that indicated propagation by fatigue, other features identified by the SEM were indistinguishable from stress corrosion, hydrogen embrittlement, or low amplitude fatigue.

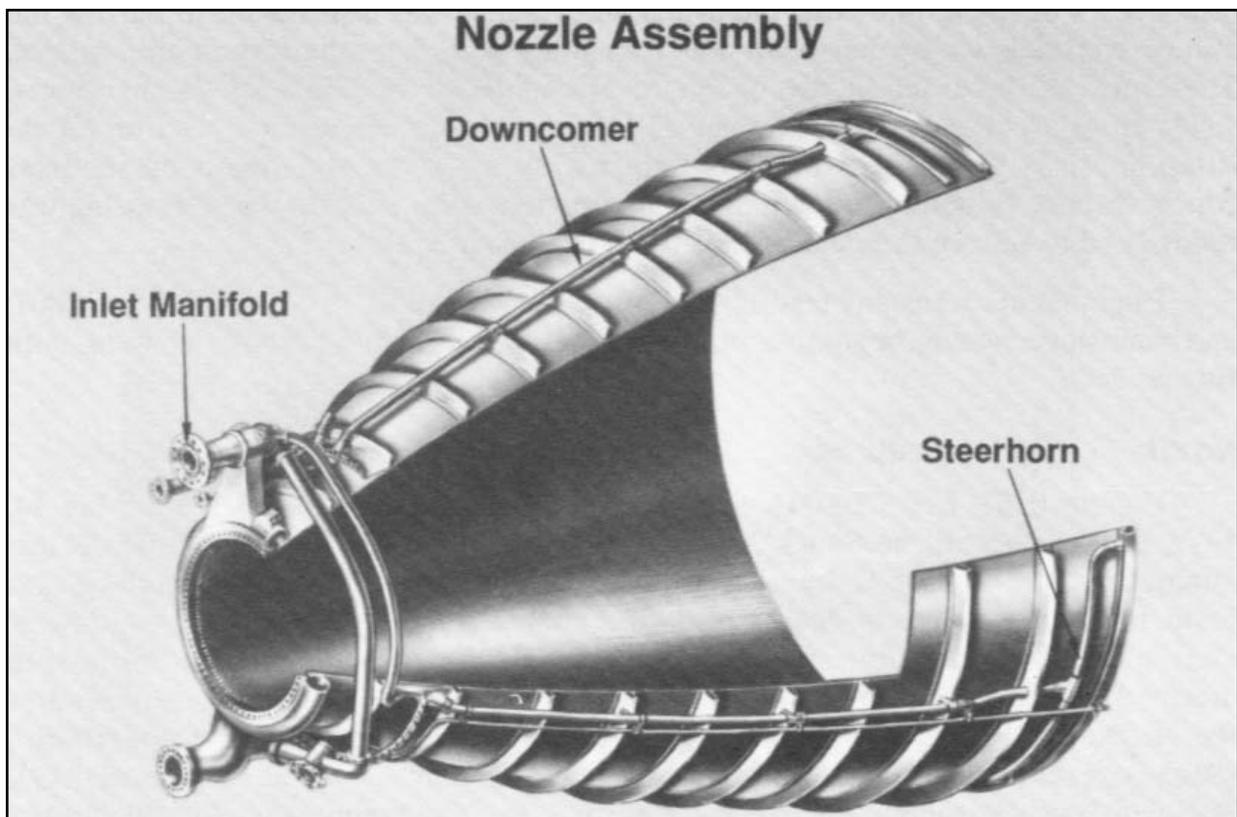
The nozzle is a regeneratively cooled extension bolted to the MCC which completes the combustion gas expansion from a 5 to 1 expansion ratio to a 77.5 to 1 expansion ratio. It has the contour of an optimized 80.6 percent bell nozzle (80.6 percent of equivalent 15 degree cone length) to minimize overall engine length. Figure 24 shows a cutaway representation of the nozzle with the configuration that was used through the first five flights. The nozzle is ten feet long, almost eight feet wide at the exit and weighs about 1,000 pounds. The tubular construction consists of 1,080 stainless steel (A286) tubes brazed together and to a surrounding structural jacket with coolant manifolds welded to each end of the tube assembly. The MFV is mounted on the nozzle inlet manifold which receives all of the MFV fuel flow.

Immediately, 20 percent of the LH2 is re-routed to the MCC coolant circuit. One half of the remaining LH2 is routed through the CCV (see Figure 3) to the two preburners. The remaining 40 percent of the fuel is distributed equally among three fuel transfer ducts (downcomers) for delivery to the nozzle aft manifold. Less than a foot from the end of the nozzle, the downcomers terminate in a tee fitting, which splits the flow into two tubes, each perpendicular to the downcomer. Each tube is then routed through ninety degree turns to enter the aft manifold at one of six equally spaced inlets around the circumference, creating three inverted

Figure 24 SSME Flight Nozzle (Photo No. SC89c-4-1012)

“steerhorns”. The LH2 flows from the aft manifold into each of the 1,080 tubes and provides nozzle wall cooling while flowing forward to the outlet manifold. After exiting the outlet manifold, the fuel is mixed with the outlet flow of the CCV prior to combustion in the preburners.

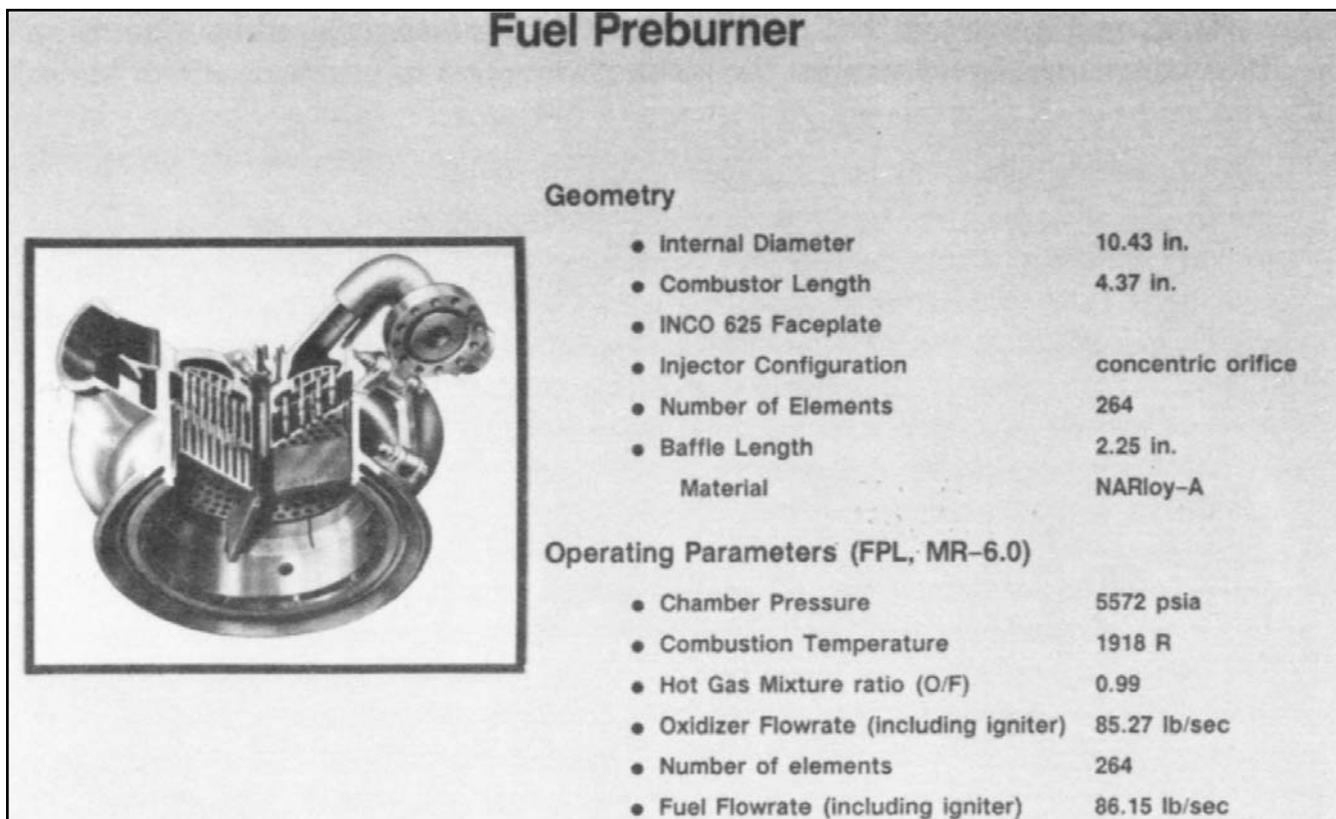
The FPB (Figure 25) provides the turbine drive gas for the HPFTP. It consists of two propellant manifolds, a centrally located ASI, an injector and a short combustor section welded together into the major hot gas manifold that also includes the oxidizer preburner, the high pressure turbine exhaust gas flow path and the injector for the main combustor. The FPB injector is a coaxial element injector with each element having low

Figure 25 Fuel Preburner (Photo SC89c-4-1020)

velocity LOX flowing in a center post, with high velocity gaseous hydrogen in a surrounding annulus to promote uniform mixing. Combustion takes place below the INCO 625 faceplate in three compartments which are separated by 2.25-inch-long copper alloy baffles to prevent tangential modes of instability. The baffles and the faceplate are cooled by hydrogen flowing through drilled holes into the combustion chamber. The outer structural body of the combustor is cooled by the use of a concentric cylindrical liner with hydrogen flowing between the liner and the combustor wall. This same hydrogen is used to cool the HPFTP turbine bellows by the utilization of a welded-in liner extension.

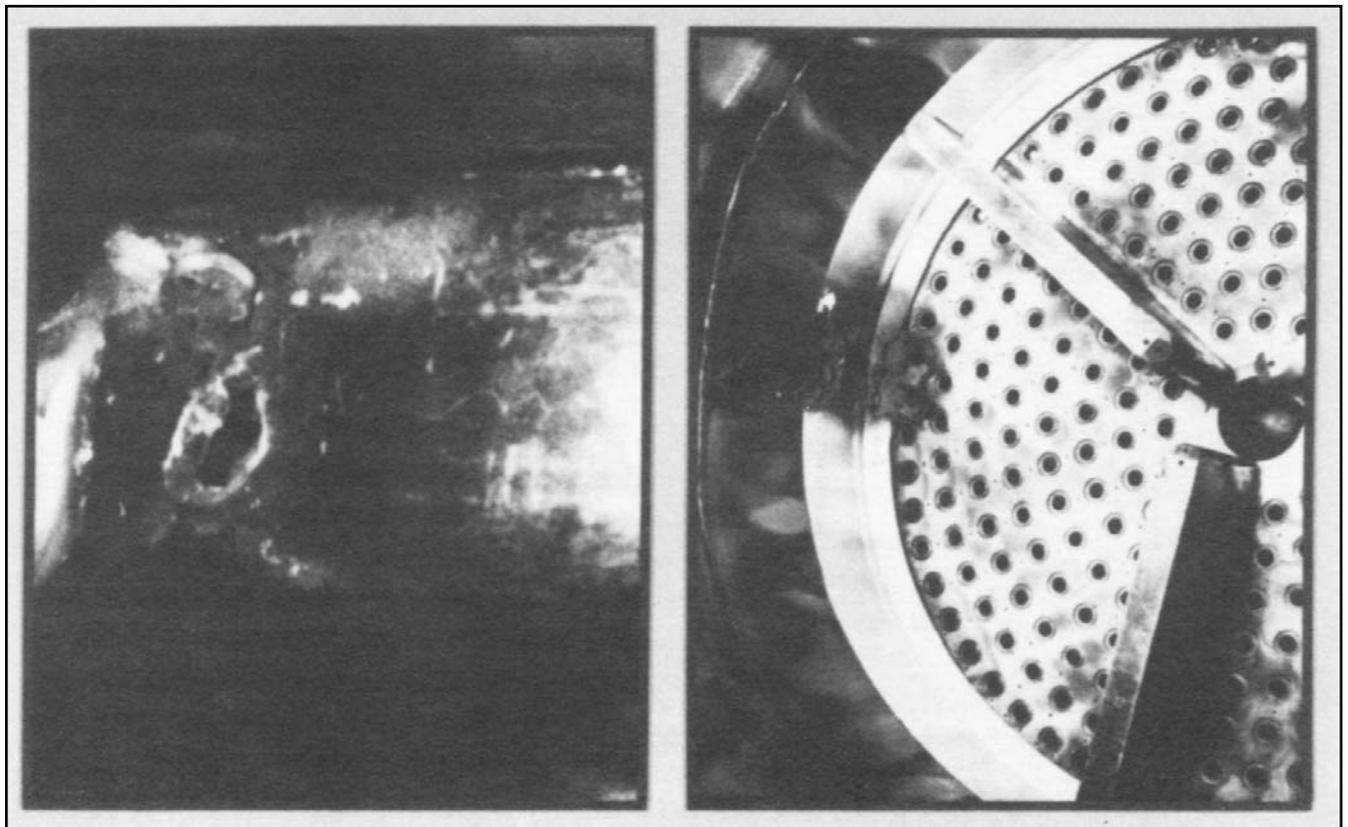
Figure 26 Engine 0006 Fuel Preburner (Photo No. SC89C-4-1013)

The second failure, in 1980, was located six elements away from a baffle (Figure 26) and was determined to be caused by a different mechanism [39]. Inspection of the preburner elements showed no evidence of contamination which could have caused fuel blockage; however, it was discovered that the individual element LOX posts were not concentric with the fuel annuli, causing a fuel restriction on the outboard side of the outer row elements. Further inspection showed that the lack of concentricity was caused by a deformity of the face plate in which it was bowed outward almost a tenth of an inch, half way between the center and the outer row. The investigating team [39] concluded from the inspection of all other preburners that the bowed condition was unique to the failed unit. In addition, a review of historical problem reports disclosed that this FPB had experienced more reported cases of overheating or minor erosion than all other preburners combined. The cause of the deformity was never identified; however, periodic inspections were added for all preburners to verify outer row element concentricity in the future.

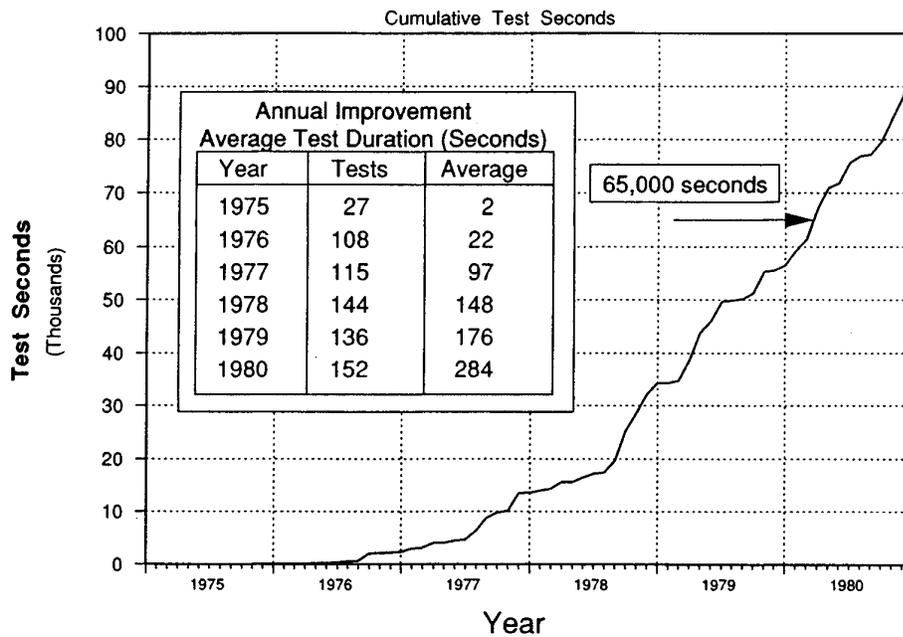
Figure 27 Single Engine Test History (Photo No. 89C-4-1018)

Engine 0002 Test 902-056. The most significant test milestone was established in terms of total accumulated test duration of the single engine ground test program (excluding MPTA). A goal of 65,000 seconds was set by John Yardley as representing a sufficient level of development maturity to consider the engine flight worthy. NASA Headquarters considered the achievement of this goal to be a flight constraint. The goal of 65,000 seconds was reached on March 24, 1980 during a test on Engine 2004. Figure 27 shows the growth of the accumulated test time over the years and also the annual improvement in average test duration that made it possible to reach the goal in that time period. The dramatic increase in average test duration

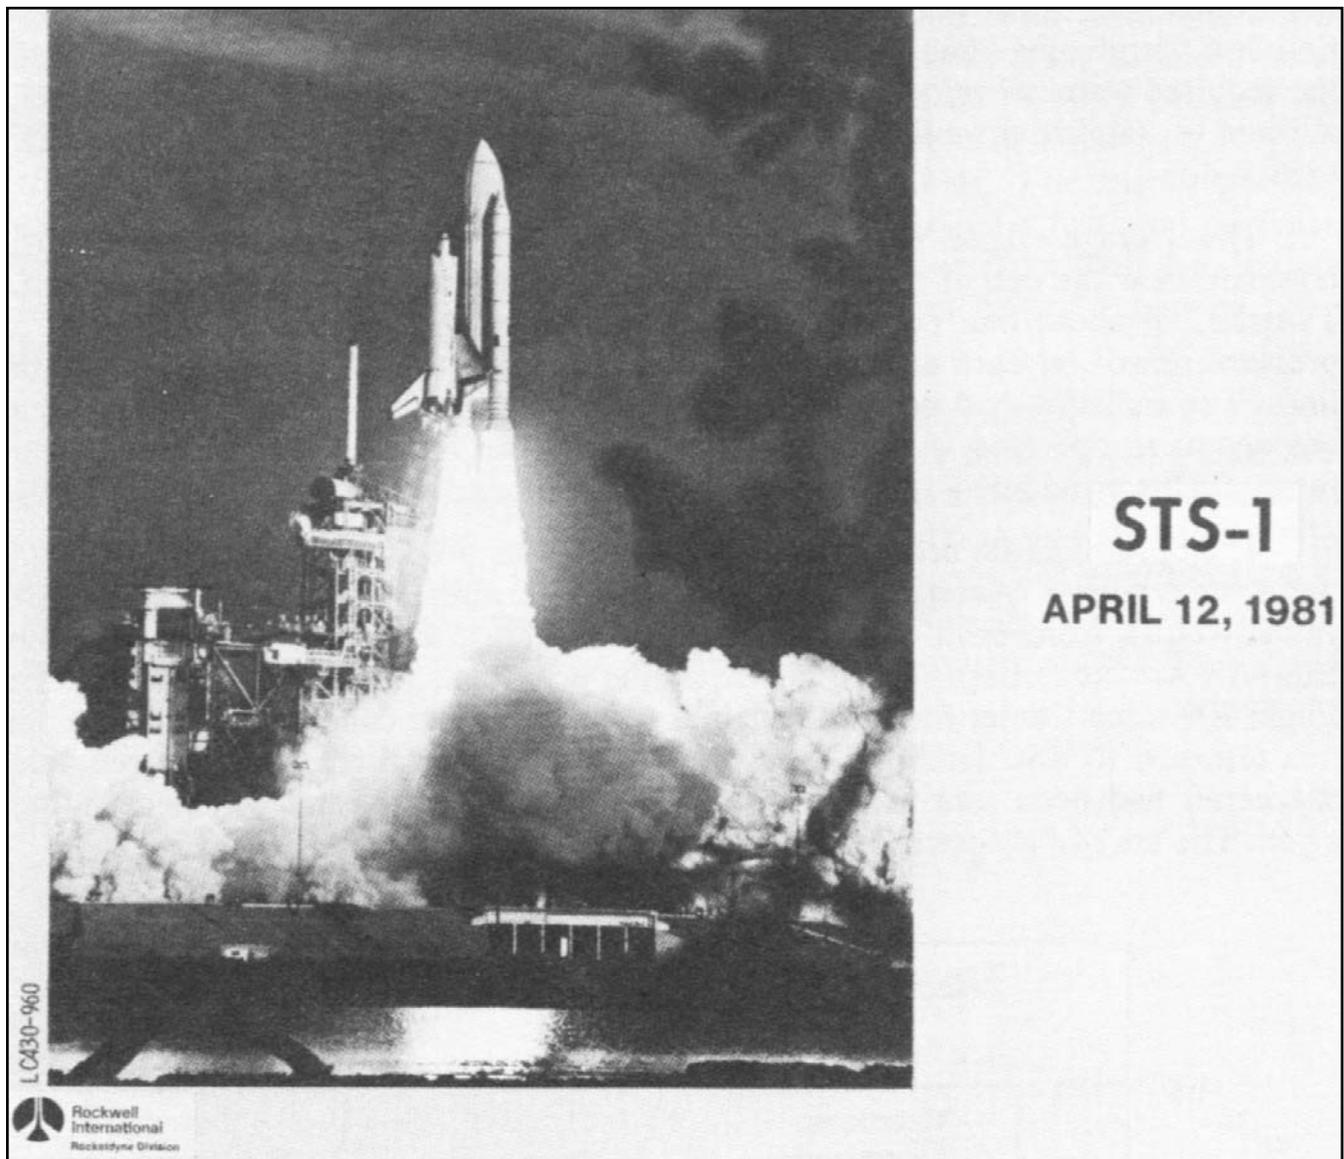
Figure 29 The First Space Shuttle Flight - STS-1 (Photo No. LC430-960)

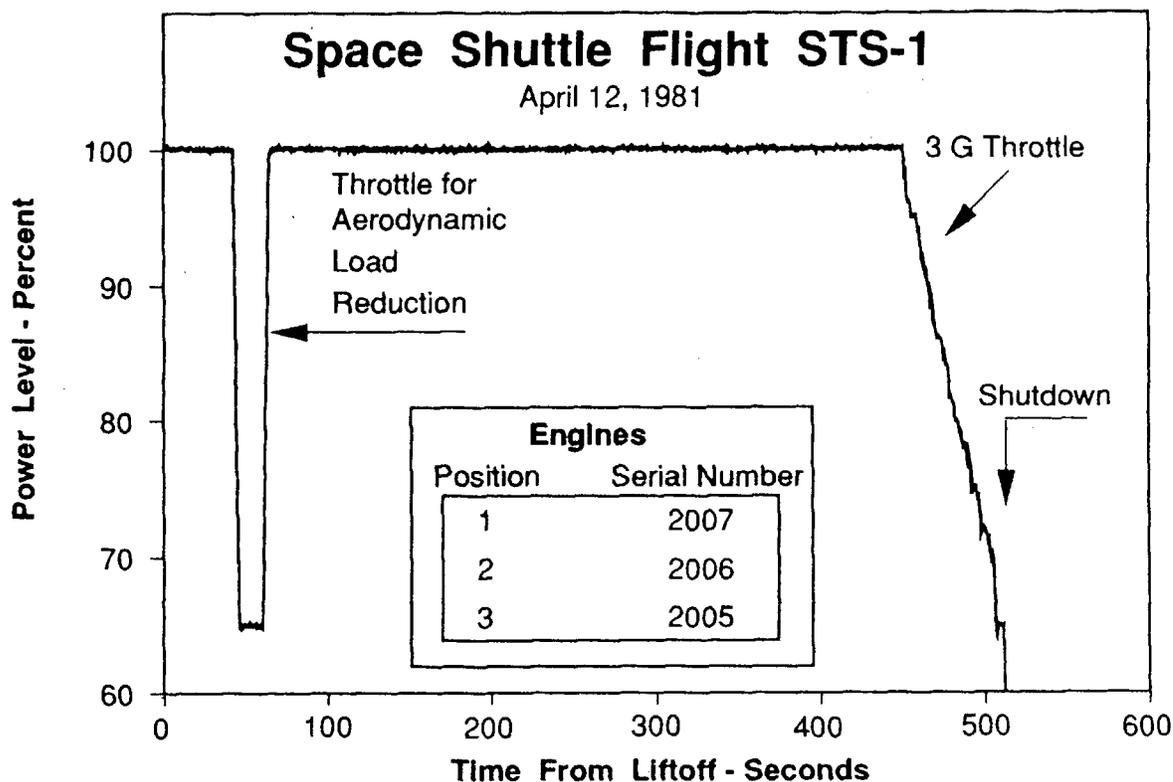
Figure 30 STS-1 Engine Performance (Photo No. 89c-4-1028)

The average engine performance was well within specification requirements; however, near the end of the flight, a small drift in mixture ratio was observed [41]. The shift of about one percent was found to be caused by radiant beating of a pressure sensor on each engine, located near the warm HPOTP turbine seal drain lines. The radiation had no effect during ground testing or even in flight until the engines were operated in the vacuum -of space. The anomaly was eliminated on future flights by adding a small amount of insulation and a radiation shield.
