INTERDEPARTMENTAL COMMUNICATION

DATE: OCTOBER 12, 1988
CONTROL NUMBER: LTPE-88-125-ACF

SUBJECT: STS 26R CREW DEBRIEF AT JSC

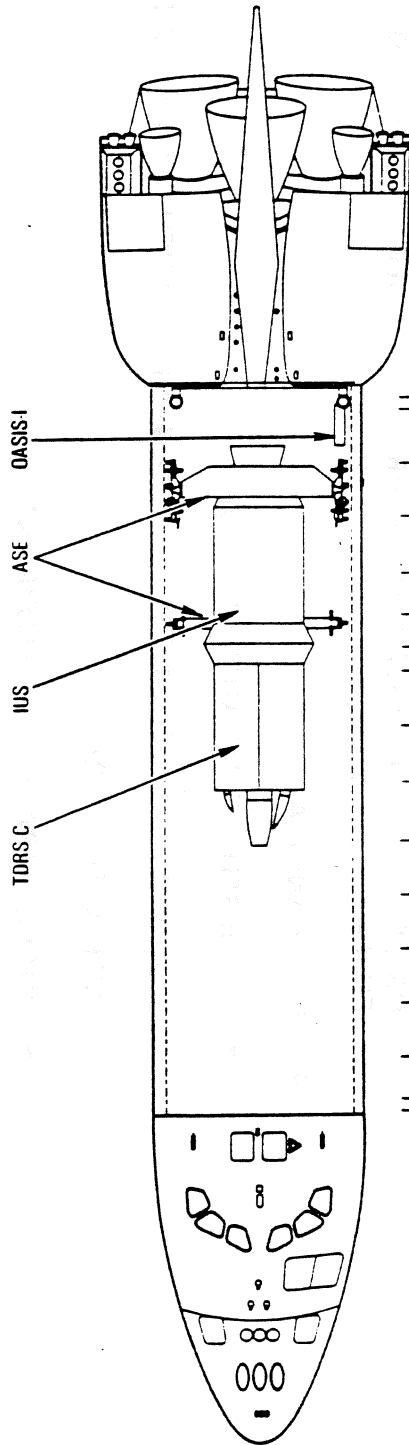
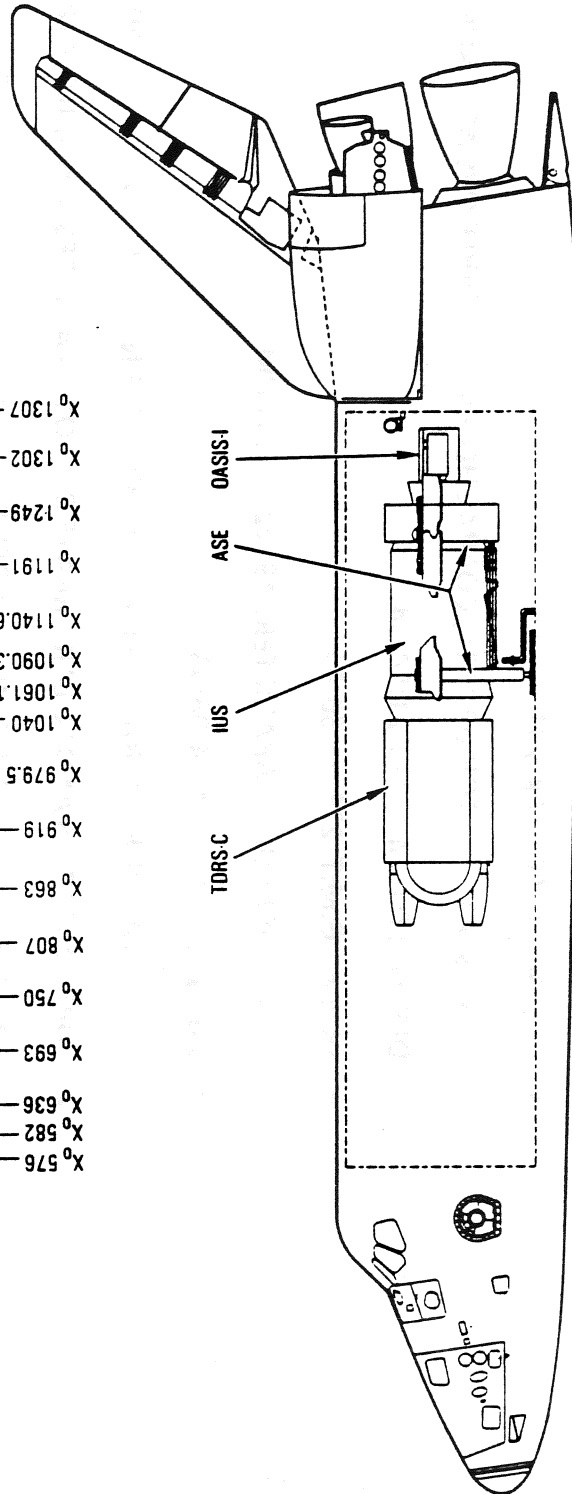
- X⁰ 576
- X⁰ 582
- X⁰ 636
- X⁰ 693
- X⁰ 750
- X⁰ 807
- X⁰ 863
- X⁰ 919
- X⁰ 979.5
- X⁰ 1040
- X⁰ 1061.13
- X⁰ 1090.33
- X⁰ 1140.67
- X⁰ 1191
- X⁰ 1249
- X⁰ 1302
- X⁰ 1307

- ASE - AIRBORNE SUPPORT EQUIPMENT
- IUS - INERTIAL UPPER STAGE
- OASIS - OEX (ORBITER EXPERIMENT) AUTONOMOUS SUPPORTING INSTRUMENTATION SYSTEM
- TDRS - TRACKING AND DATA RELAY SATELLITE

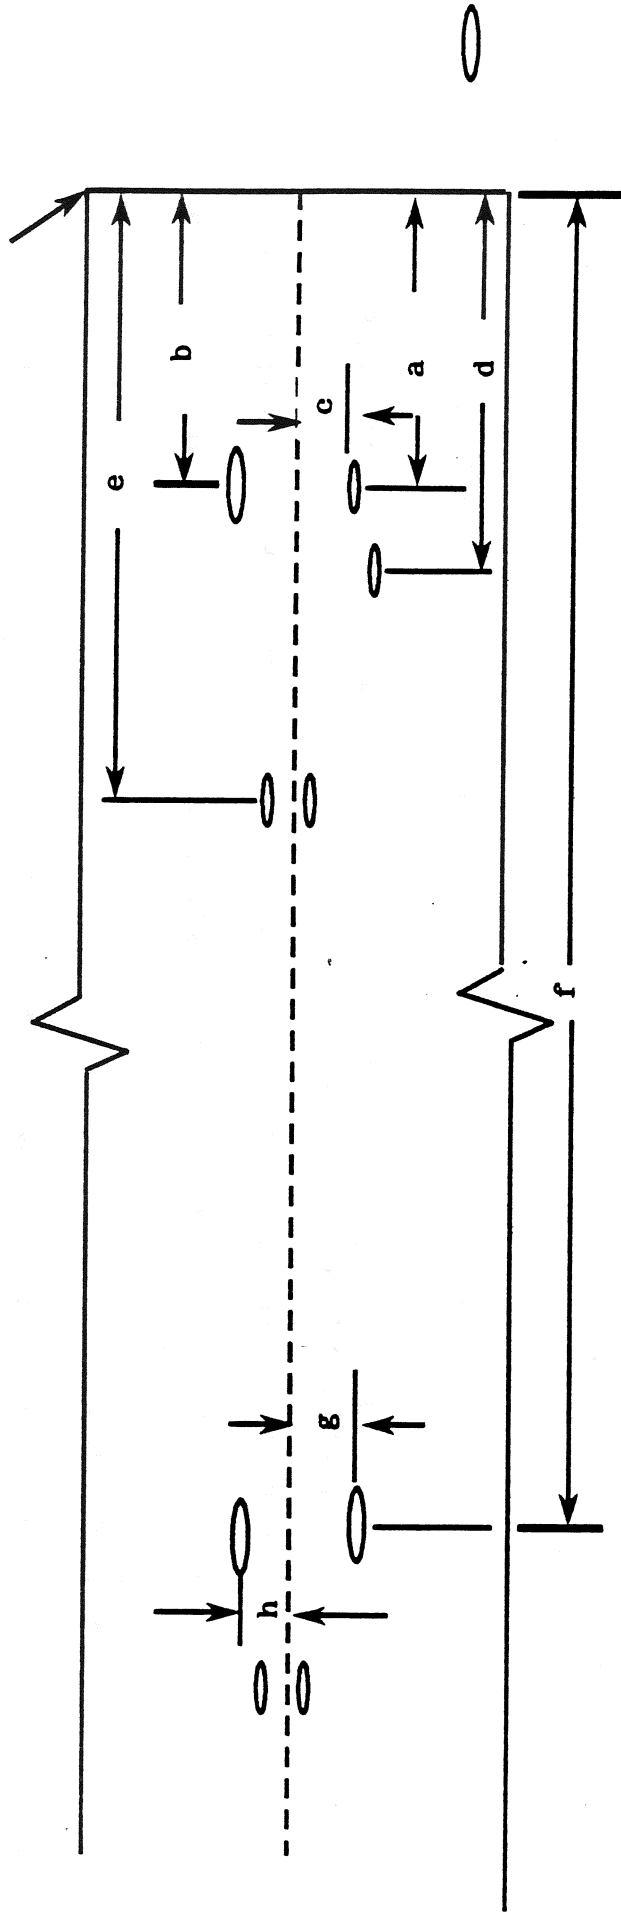
RUNWAY THRESHOLD (DISPLACED)

- a. LEFT MAIN TOUCHDOWN TO THRESHOLD
- b. RIGHT MAIN TOUCHDOWN TO THRESHOLD
- c. LEFT MAIN LATERAL DISPLACEMENT FROM RUNWAY CENTER LINE
- d. SUBSEQUENT TOUCHDOWN (RT MAIN STAYED DOWN, LT MAIN OFF AT 27166 FT)
- e. NOSE GEAR TOUCHDOWN
- f. MAIN GEAR STOP TO THRESHOLD
- g. LEFT MAIN LATERAL DISPLACEMENT
- h. RIGHT MAIN LATERAL DISPLACEMENT
- i. ROLLOUT DISTANCE

2587 FT
2569 FT
16 FT LT OF CL
2825 FT LT MAIN TD
5671 FT 16 FT LT OF CL
10020 FT
~ 16 FT LT OF CL
~ 8 FT RT OF CL
7451 FT
